Mary River Catchment Recreational Fishing Habitat Improvement & Education Project

Mary River Catchment Recreational Fishing Habitat Improvement and Education Project

Mary River Catchment Coordinating Committee **Quality Control Statement**

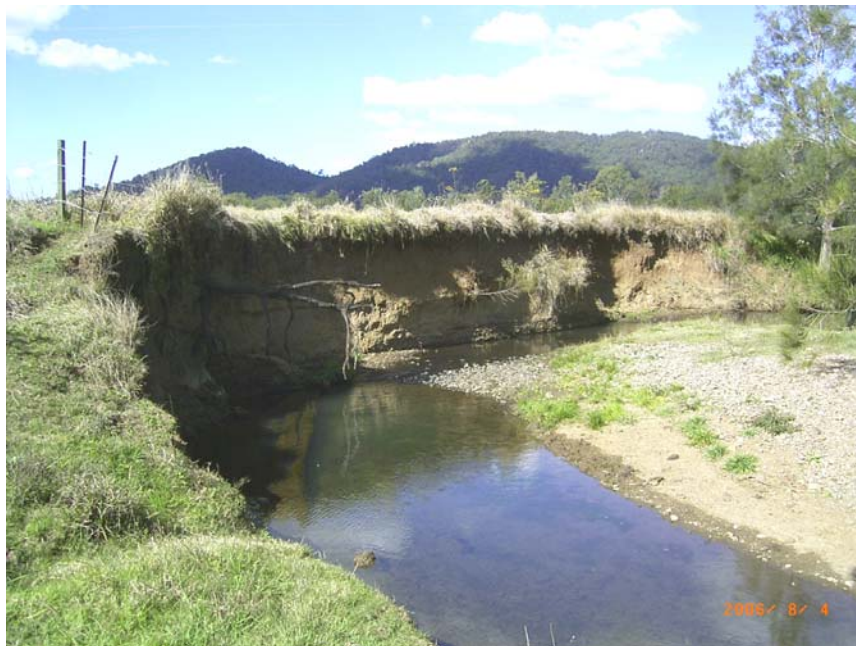
Garmany Site – Looking upstream at eroded bank

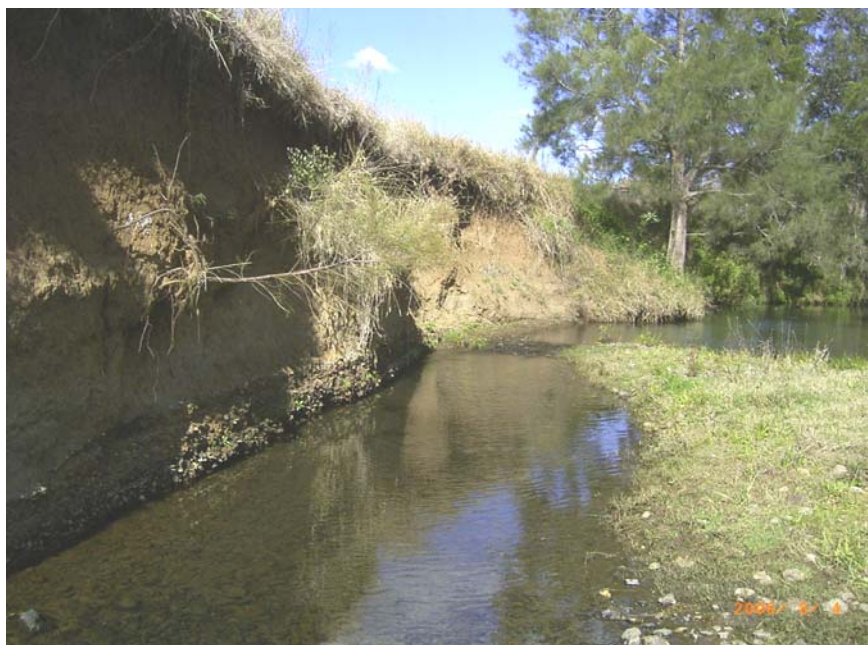
Garmany Site – Looking upstream at eroded bank

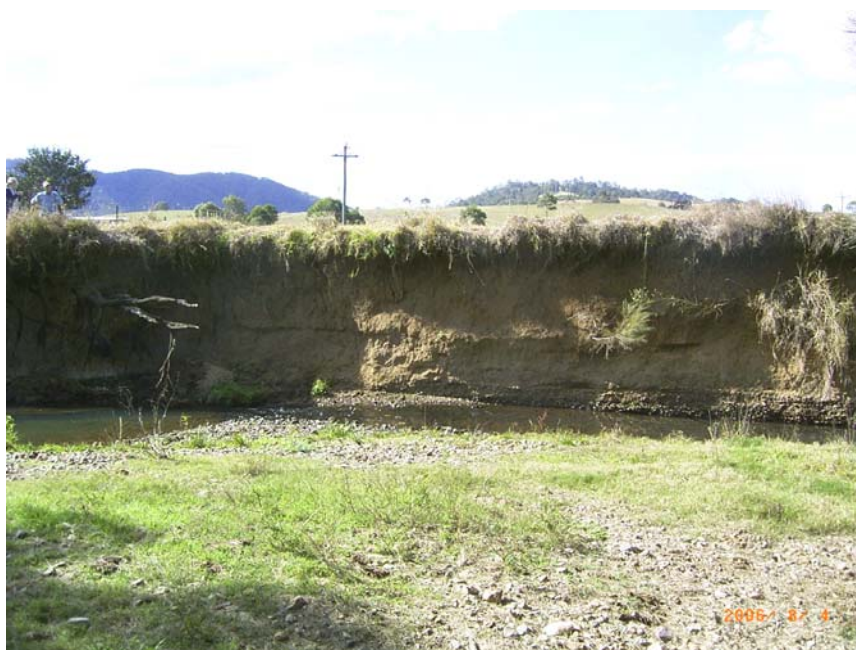
Garmany Site – Facing eroded bank form inside gravel bend

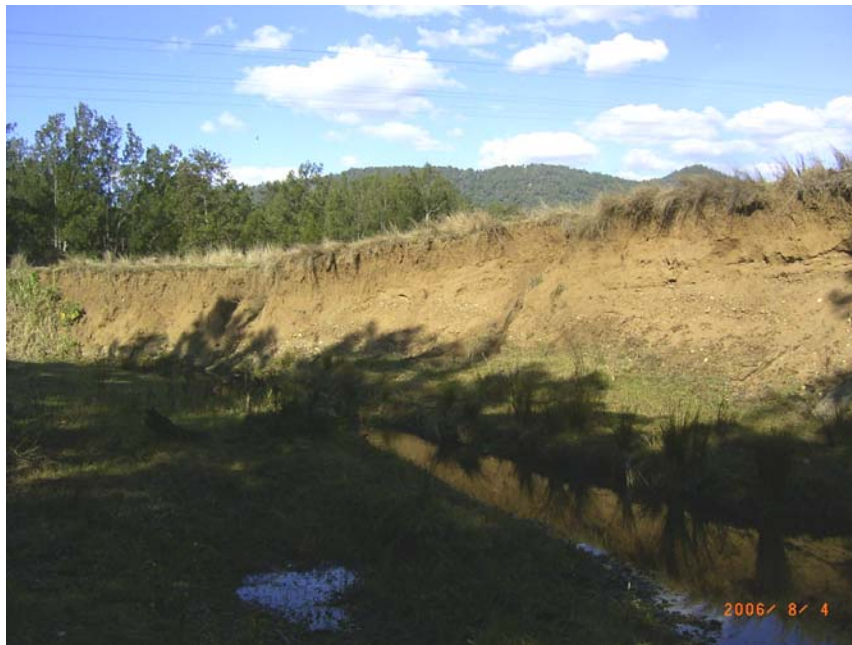
Cork Site – Looking upstream at eroded bank

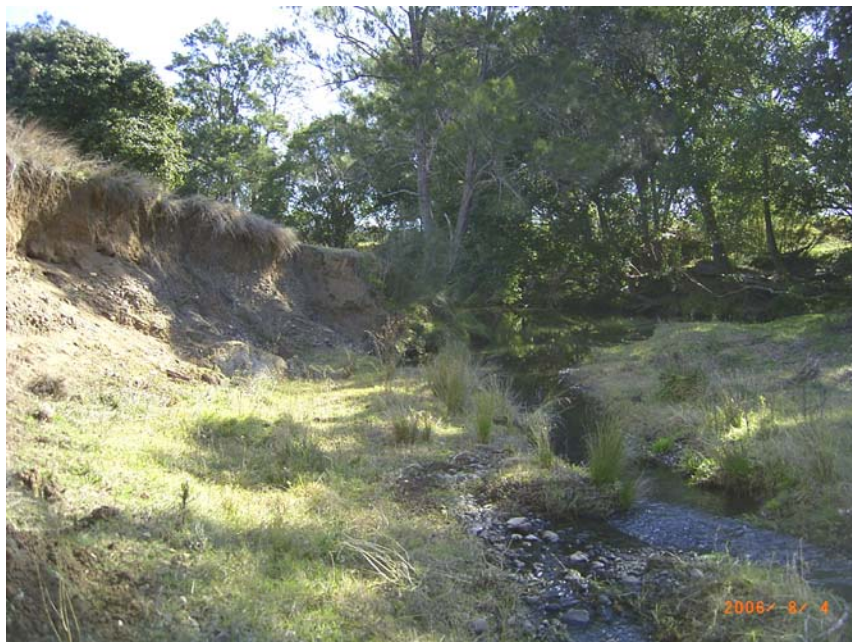
Cork Site – Looking downstream at eroded bank

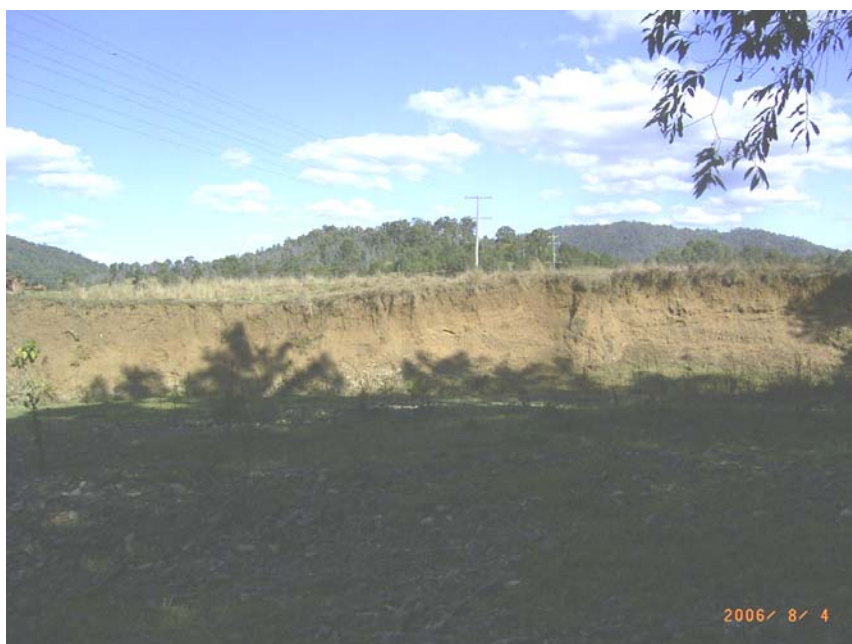
Cork Site – Looking at eroded bank from inside gravel bench

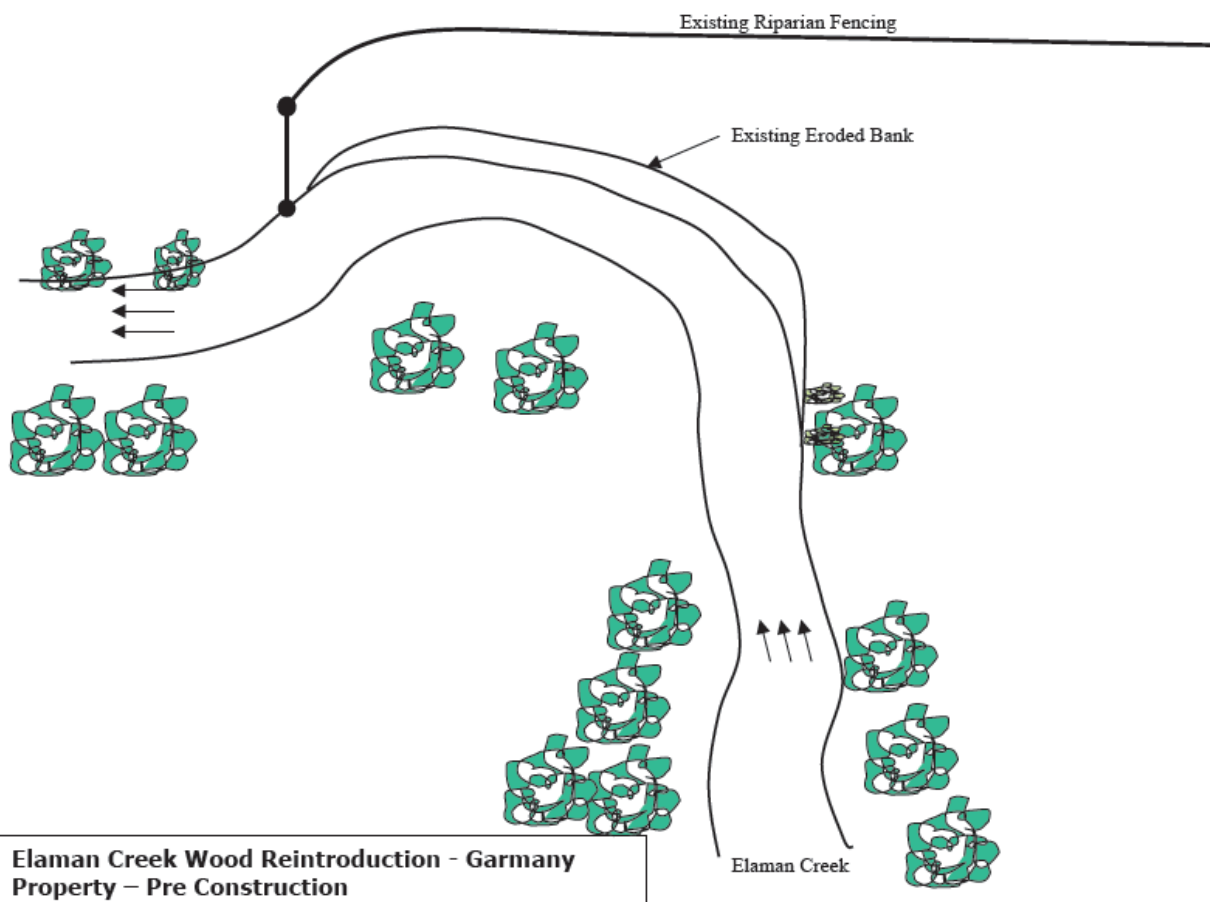
Figure 9. Garmany Site – Pre Wood Reintroduction

Local powerlines cross Elaman Creek at both of the wood reintroduction sites. Underneath these powerline crossings are the two severe stream bank erosion scours. Both of the powerline crossings (and scoured banks) are located on bends in the creek where streambank erosion is most likely to occur. It is possible that due to some clearing under the powerlines in the past, a weak spot in the bank may have been created due to a lack of riparian vegetation.
