**IMPLEMENTING THE MARY RIVER  
& TRIBUTARIES  
REHABILITATION PLAN**

**MONITORING & EVALUATION REPORT  
2003**

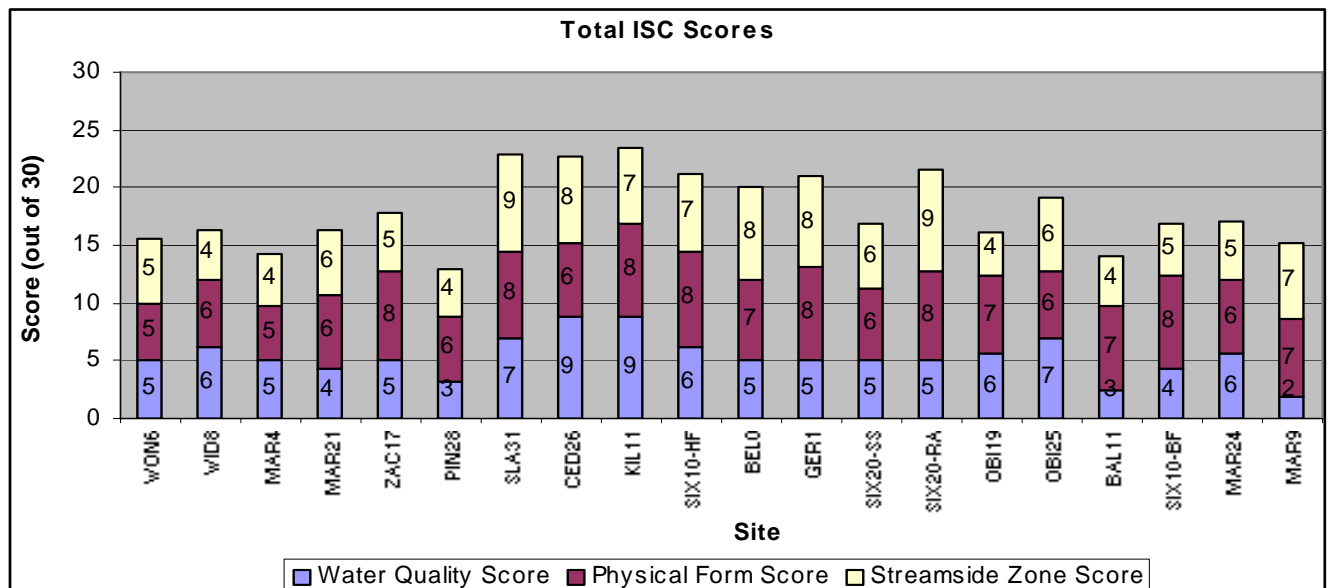
Figure 3.3

The total ISC score for each of the monitoring sites is shown in Figure 3.3. The three sections of each bar represent the three components of the ISC. The variety of resulting ISC scores, ranging from 14 to 23, indicate that the sites monitored were in various stages of degradation.

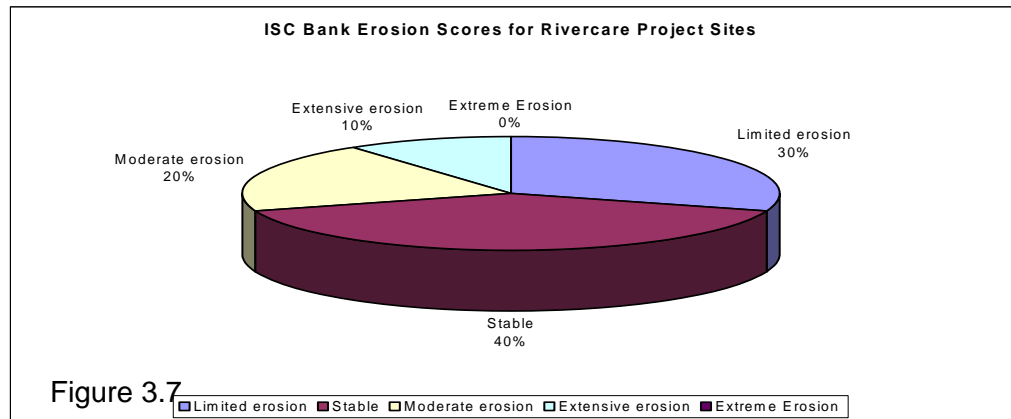
Figure 3.7 reveals that the overall bank stability of the sites is in fair condition, with 40% classed as stable and 30% recorded as having only limited erosion. None of the sites obtained a score of '0' (extreme erosion). When comparing

Observation showed that the bank erosion occurring was predominately scour erosion (removal of individual sediment particles or aggregates by flow. Mass failure (slumping) was noted on occasion. This was expected particularly in the lowland areas where bank height increased (Abernethy & Rutherford, 1999).

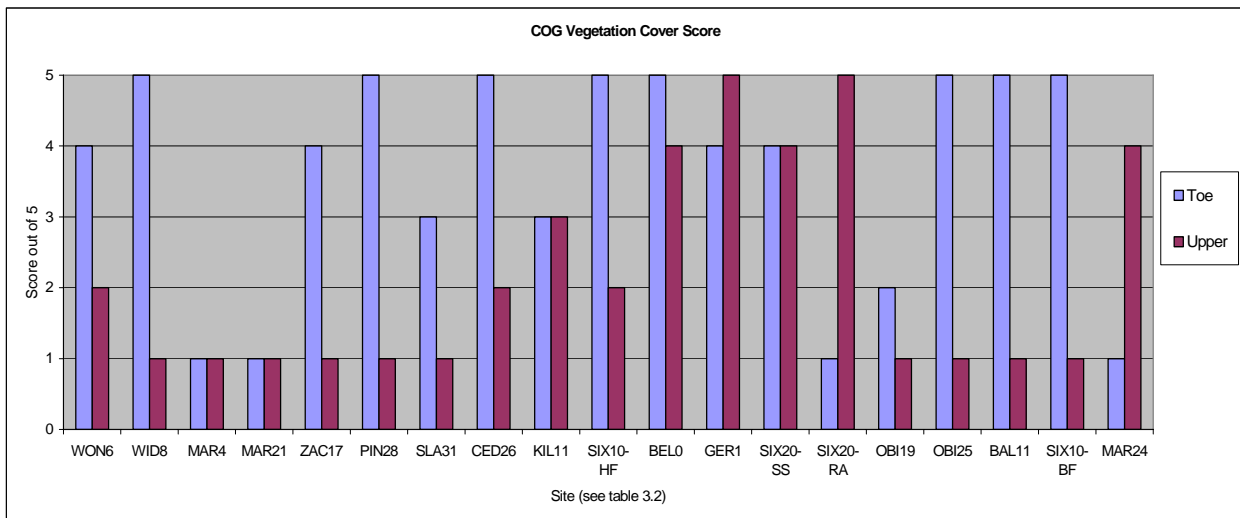
Figure 3.9 depicts the relationship between vegetation and bank position. It shows that for 12 sites the vegetation cover is higher at the toe of the bank, while only 3 sites exhibit a higher percent cover on the upper section of the bank. Four sites have equal cover at the toe and upper part of the bank. The definition of the top of the streamside zone used most often, that is to the change in land use, may explain the low percentages of vegetation cover on the upper bank sections. The upper transect was, in many cases, located within a strip of pasture grass which ran from the fence to the beginning of the riparian vegetation. The pasture strips averaged 7 meters wide.

It is apparent from Figure 3.9 that the vegetation cover scored well at the toe of the project sites banks. This may be viewed as a positive sign in terms of stream health as lack of shaded instream habitat is thought to be a major reason for the rarity or absence of the Mary River Cod in many areas (Simpson & Jackson, 1996). It may also be noted that while the over storey will have a large influence over the process of slumping erosion, shrubs and grasses are equally important for controlling scour erosion (Abernethy & Rutherford, 1999).

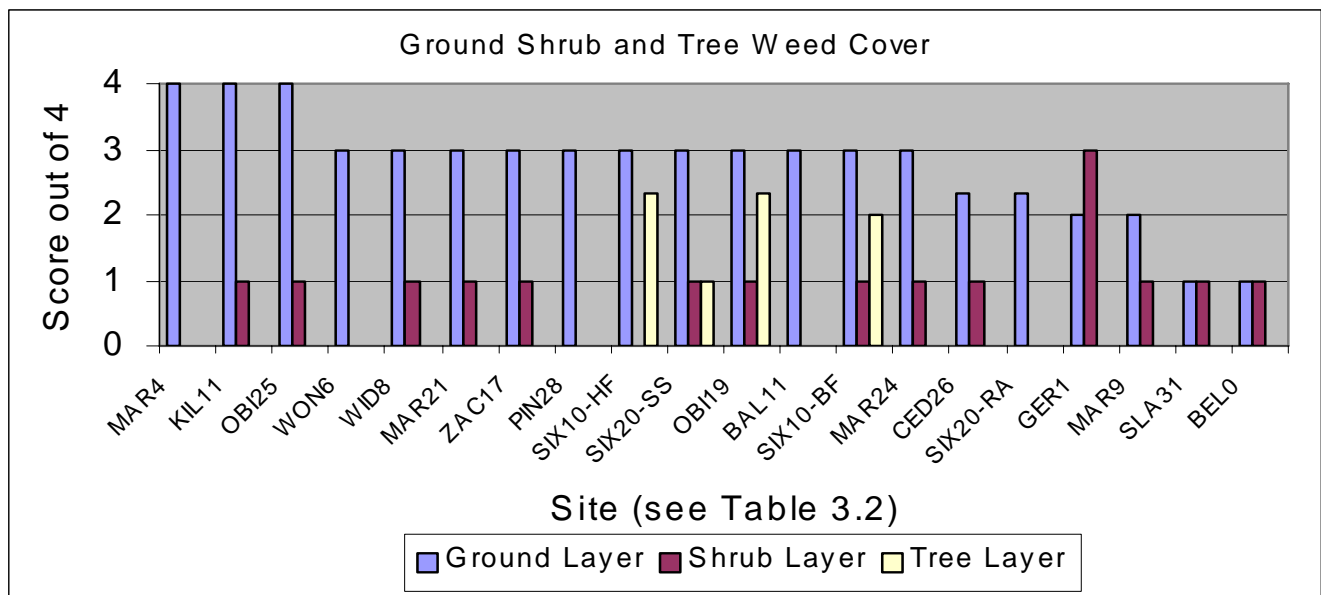
Figure 3.10

By viewing Table 3.7 and figure 3.10, it can be seen that the ground layer of weeds is identified as the most significant problem in terms of weed coverage of the riparian zone, while the tree layer is of least concern. As cattle have been removed from a significant number of sites, this may have a combined affect on the cover of ground weeds. Firstly certain weed species will no longer be suppressed by cattle grazing, and secondly the disturbed environment created by past cattle access often produces an ideal environment for weed invasion.

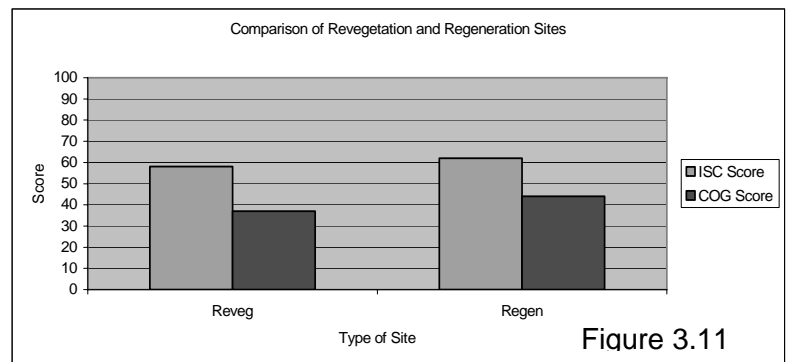
Figure 3.11

A comparison between the vegetation management techniques of active revegetation and natural regeneration was attained, as seen in Figure 3.11. Using both the ISC and COG scores it can be seen that total scores are a little higher for the regeneration sites. A possible explanation for this may lie in the fact that the sites left to regenerate were the ones with no cause for revegetation as they were in the best condition, therefore reflecting the slightly better scores.

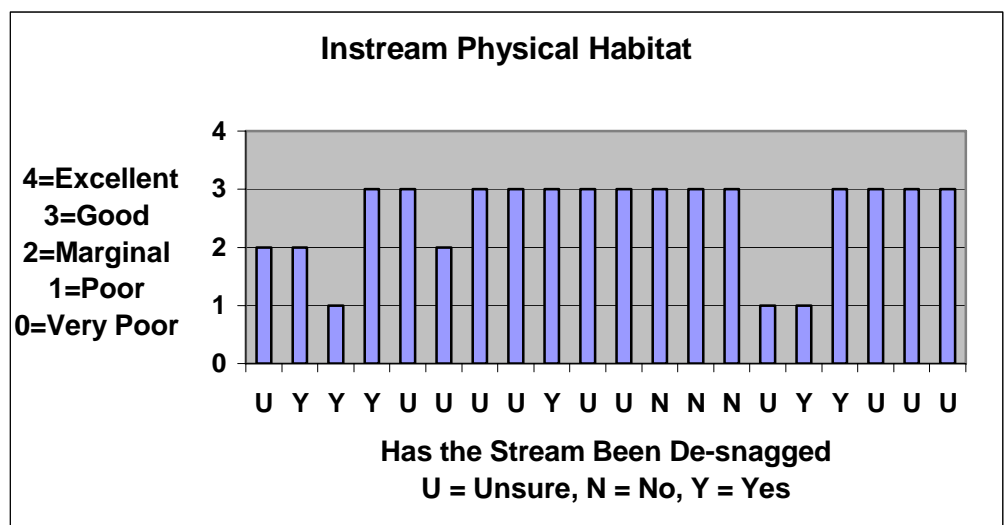
Figure 3.12

The results show that the majority of sites had “good” instream physical habitat. Radio tracking research on the Mary River Cod has revealed that 93 percent of all cod observations occurred within 2m of submerged timber (Simpson & Jackson 1996), suggesting that suitable woody debris habitat for cod is available at most of the sites monitored.
