**IMPLEMENTING THE MARY RIVER  
& TRIBUTARIES  
REHABILITATION PLAN**

**MONITORING & EVALUATION REPORT  
2003**

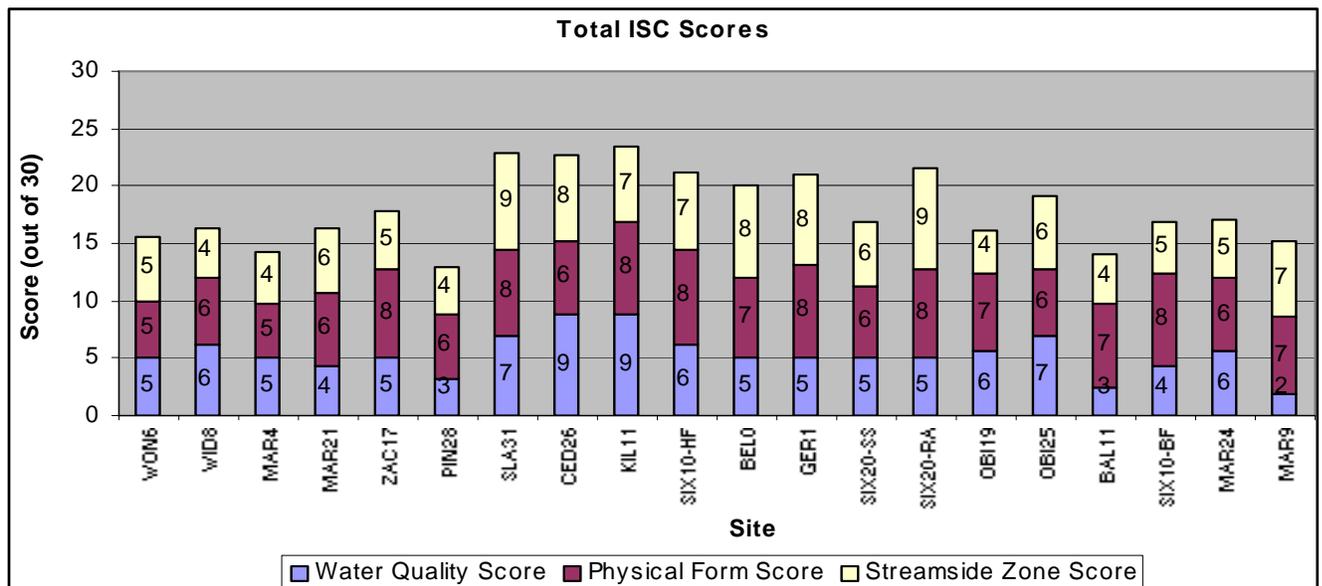
Figure 3.3

The total ISC score for each of the monitoring sites is shown in Figure 3.3. The three sections of each bar represent the three components of the ISC. The variety of resulting ISC scores, ranging from 14 to 23, indicate that the sites monitored were in various stages of degradation.

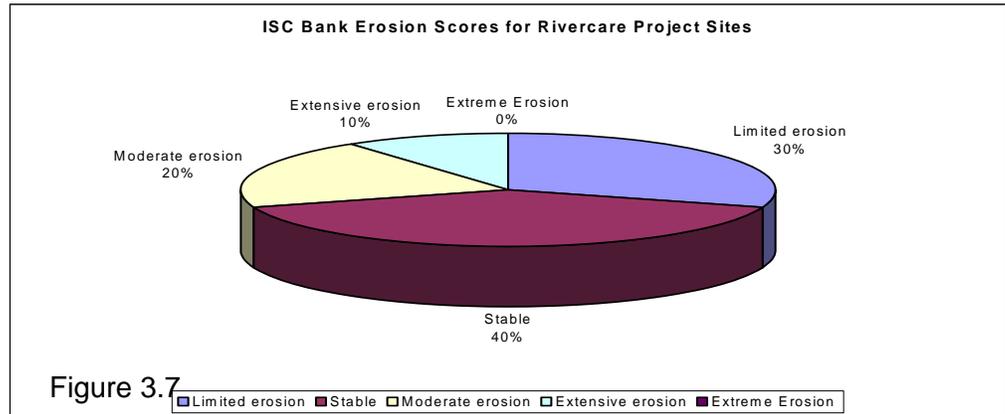
Figure 3.7 reveals that the overall bank stability of the sites is in fair condition, with 40% classed as stable and 30% recorded as having only limited erosion. None of the sites obtained a score of '0' (extreme erosion). When comparing

Observation showed that the bank erosion occurring was predominately scour erosion (removal of individual sediment particles or aggregates by flow. Mass failure (slumping) was noted on occasion. This was expected particularly in the lowland areas where bank height increased (Abernethy & Rutherford, 1999).

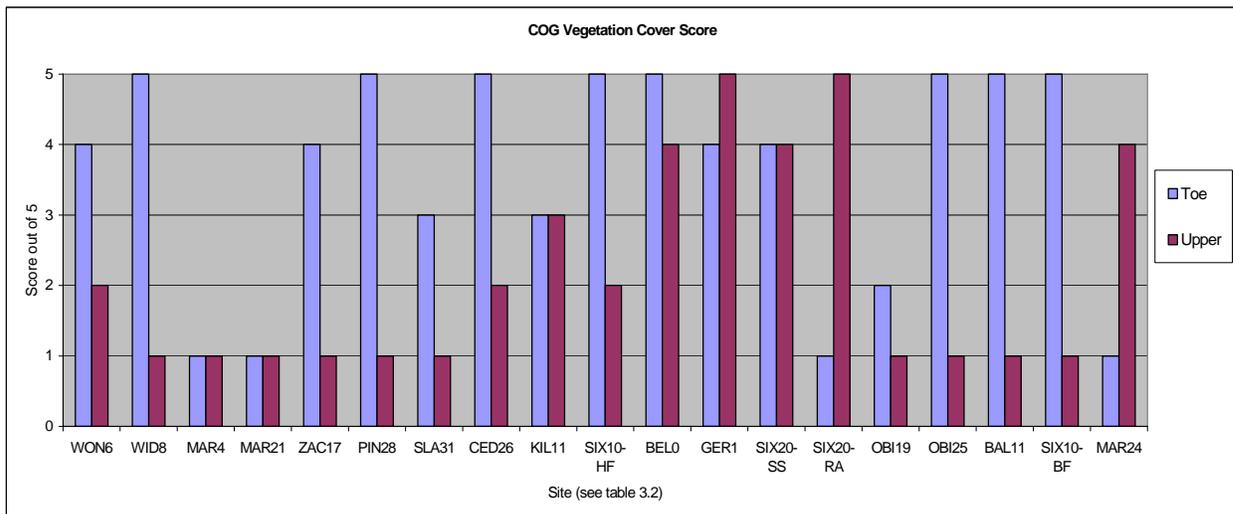
Figure 3.9 depicts the relationship between vegetation and bank position. It shows that for 12 sites the vegetation cover is higher at the toe of the bank, while only 3 sites exhibit a higher percent cover on the upper section of the bank. Four sites have equal cover at the toe and upper part of the bank. The definition of the top of the streamside zone used most often, that is to the change in land use, may explain the low percentages of vegetation cover on the upper bank sections. The upper transect was, in many cases, located within a strip of pasture grass which ran from the fence to the beginning of the riparian vegetation. The pasture strips averaged 7 meters wide.

It is apparent from Figure 3.9 that the vegetation cover scored well at the toe of the project sites banks. This may be viewed as a positive sign in terms of stream health as lack of shaded instream habitat is thought to be a major reason for the rarity or absence of the Mary River Cod in many areas (Simpson & Jackson, 1996). It may also be noted that while the over storey will have a large influence over the process of slumping erosion, shrubs and grasses are equally important for controlling scour erosion (Abernethy & Rutherford, 1999).

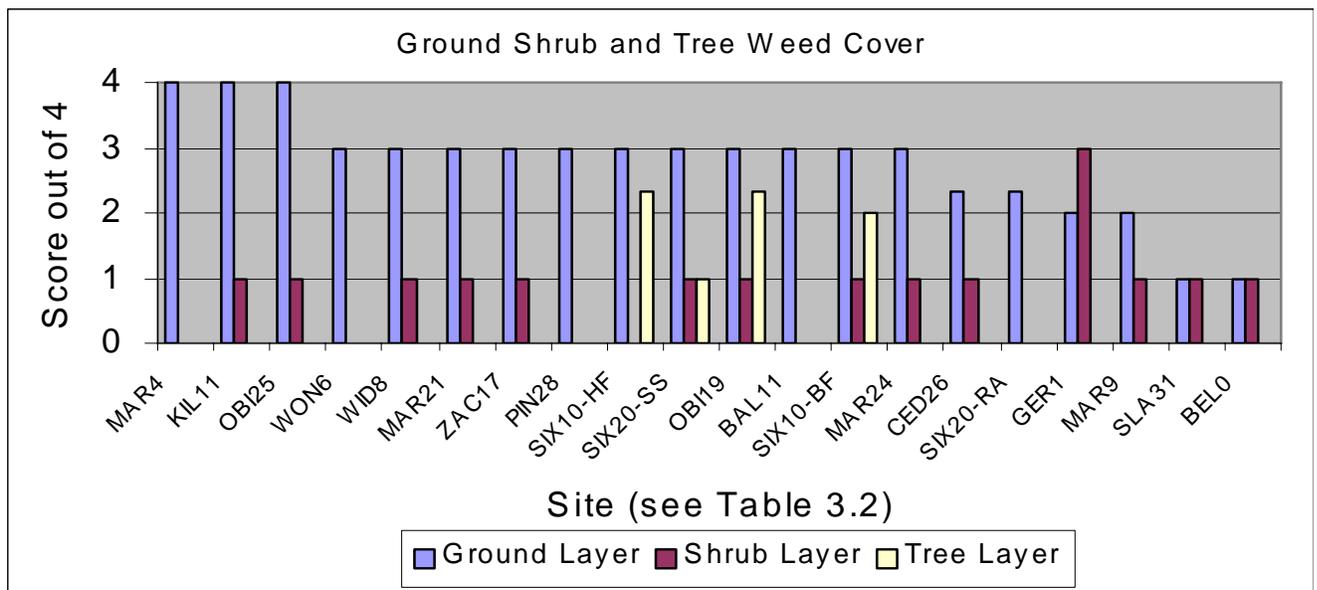
Figure 3.10

By viewing Table 3.7 and figure 3.10, it can be seen that the ground layer of weeds is identified as the most significant problem in terms of weed coverage of the riparian zone, while the tree layer is of least concern. As cattle have been removed from a significant number of sites, this may have a combined affect on the cover of ground weeds. Firstly certain weed species will no longer be suppressed by cattle grazing, and secondly the disturbed environment created by past cattle access often produces an ideal environment for weed invasion.

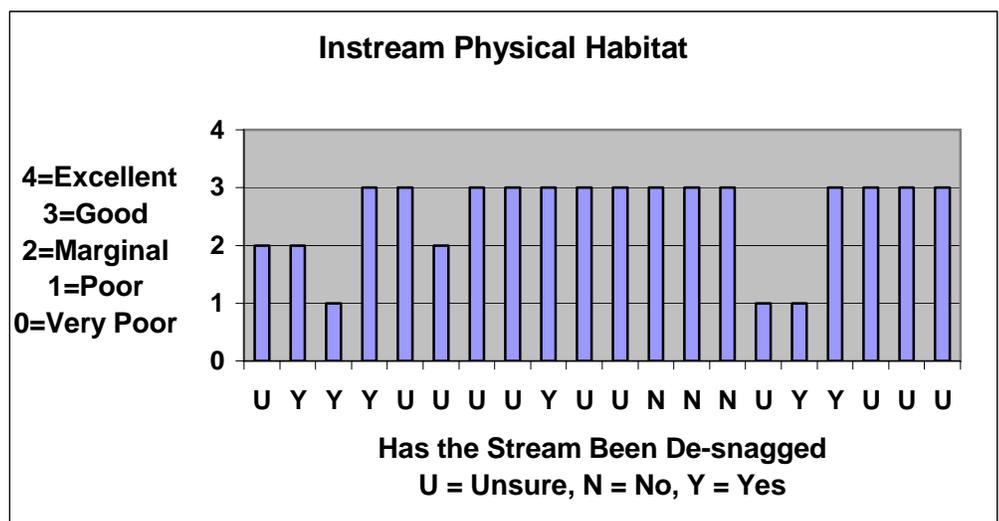
Figure 3.12

The results show that the majority of sites had “good” instream physical habitat. Radio tracking research on the Mary River Cod has revealed that 93 percent of all cod observations occurred within 2m of submerged timber (Simpson & Jackson 1996), suggesting that suitable woody debris habitat for cod is available at most of the sites monitored.
