Rehabilitation of Erosion Gullies

Adaptations and Learnings from the Mary River Catchment

Mary River Catchment Coordinating Committee

Version 2, July 2022

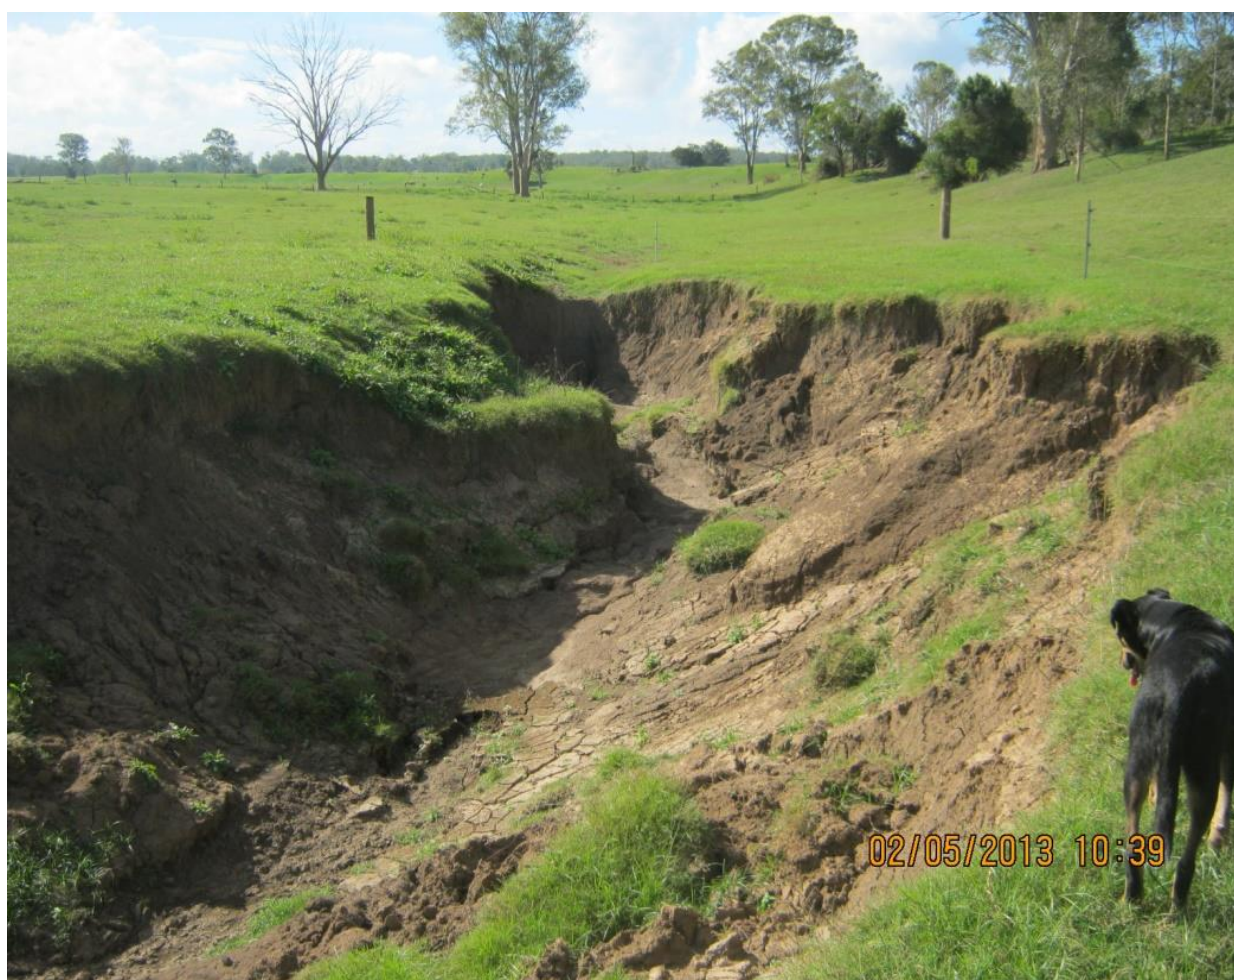
Photo 1 Mary River flood plain gully head before works commenced.

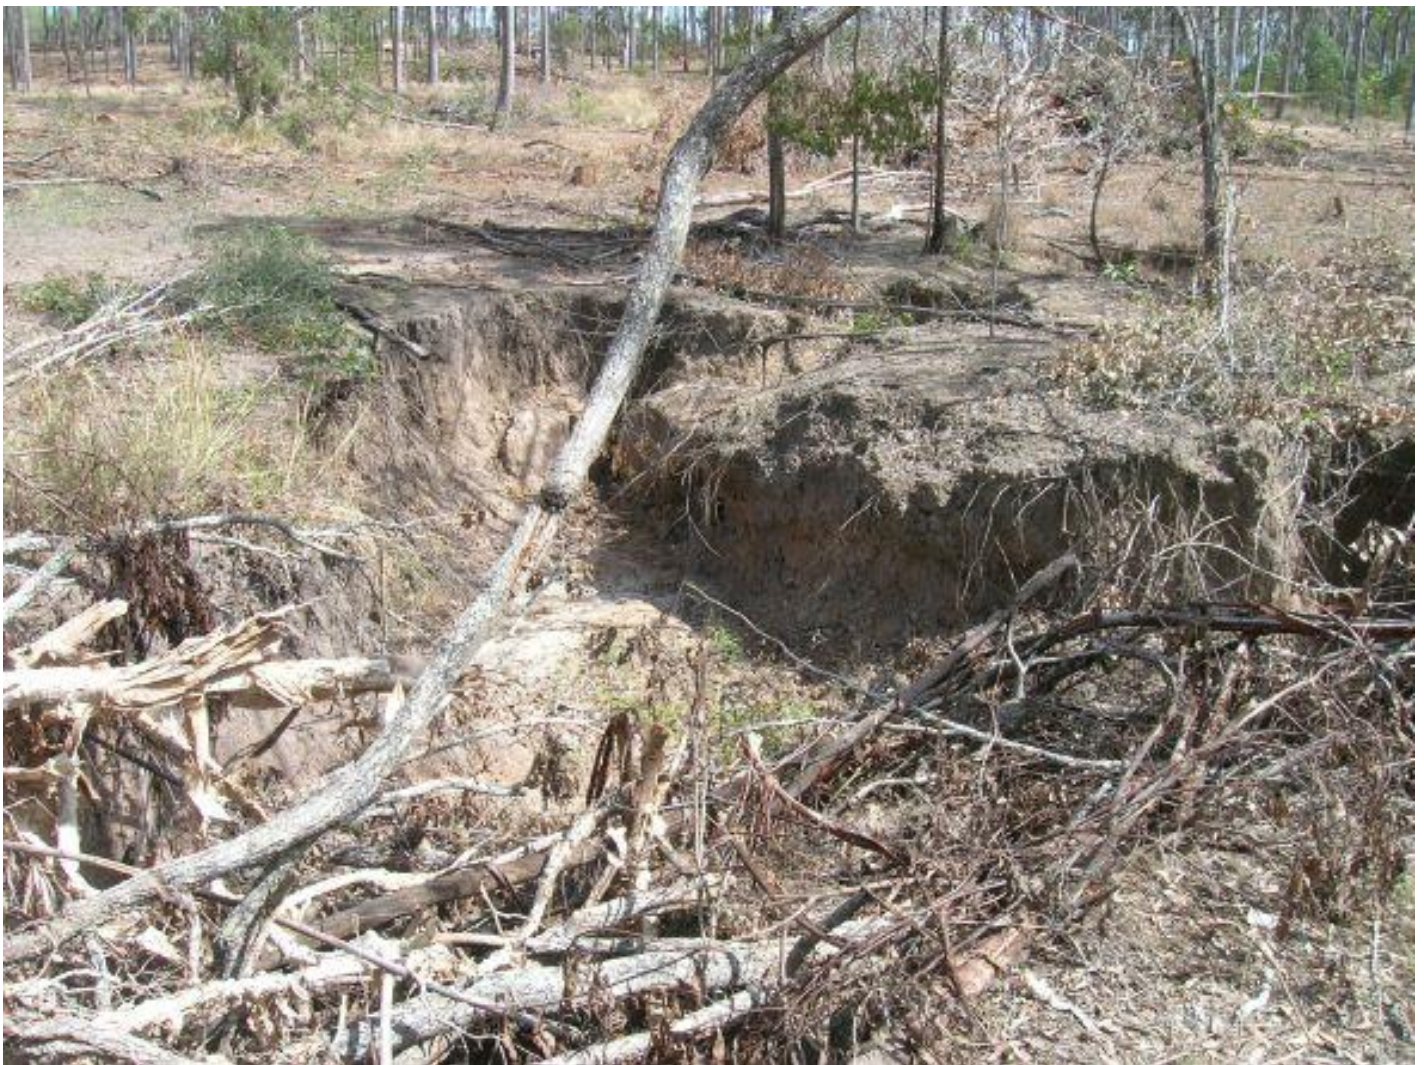
Photo 19 Main gully head, with side gully head coming from the right of picture.

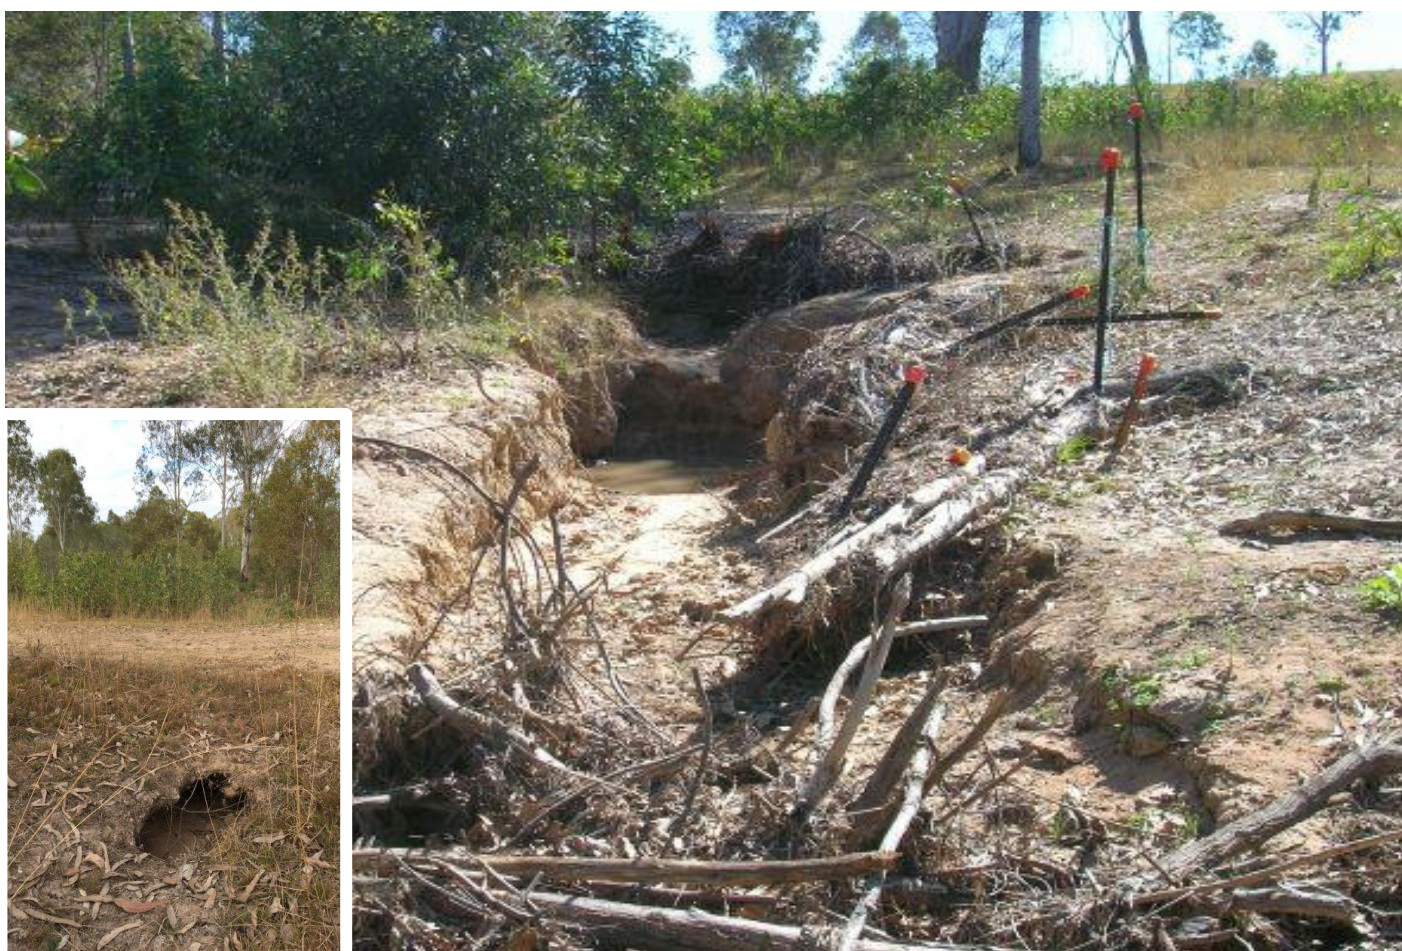
Photo 33 Gully erosion with multiple head cuts. Inset: tunnel erosion in the catchment immediately upstream of the gullies.

The landholder's previous efforts to remediate this gully site had failed due to lack of appropriate design and contractor's unfamiliarity with gully remediation in fragile landscapes with highly dispersive subsoils.

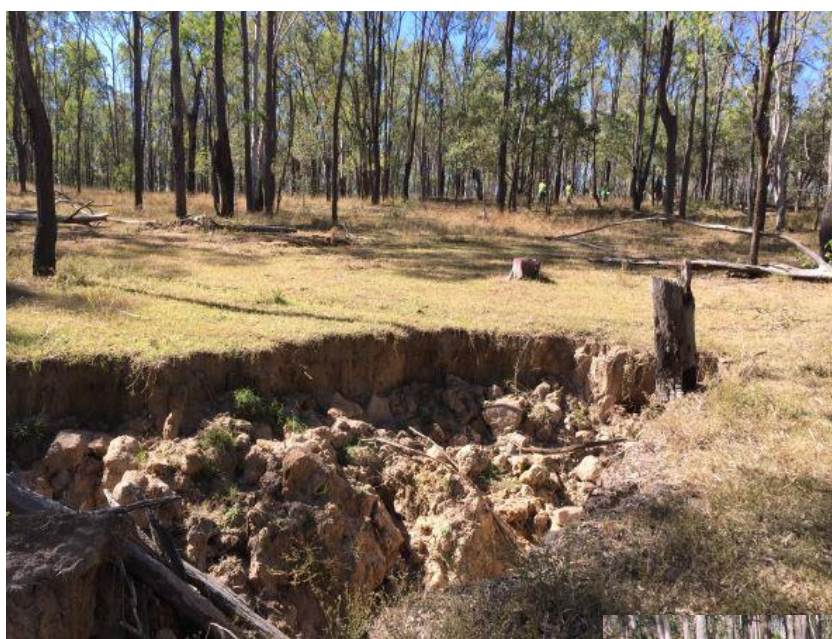
Photo 47 and Photo 48 Iron bark and Box ridge gully prior to rehabilitation

The delivery of water from the contour system to the ridge was suitable under normal rainfall conditions up to the 1 in 10 rainfall event which the contour system was designed for. The system worked quite well for many years. However the increased flow on the receiving catchment resulted in the formation of a new gully which advanced rapidly up the slope during the 2011 and 2013 flood events. The soil at the gully site is texture contrast with a shallow 0.3m loam topsoil over dispersive clay subsoil derived from decomposing granite bedrock. The total catchment is 16ha with a peak flow estimated of $2.6\text{m}^3/\text{sec}$ in a 1 in 20 year rainfall event.

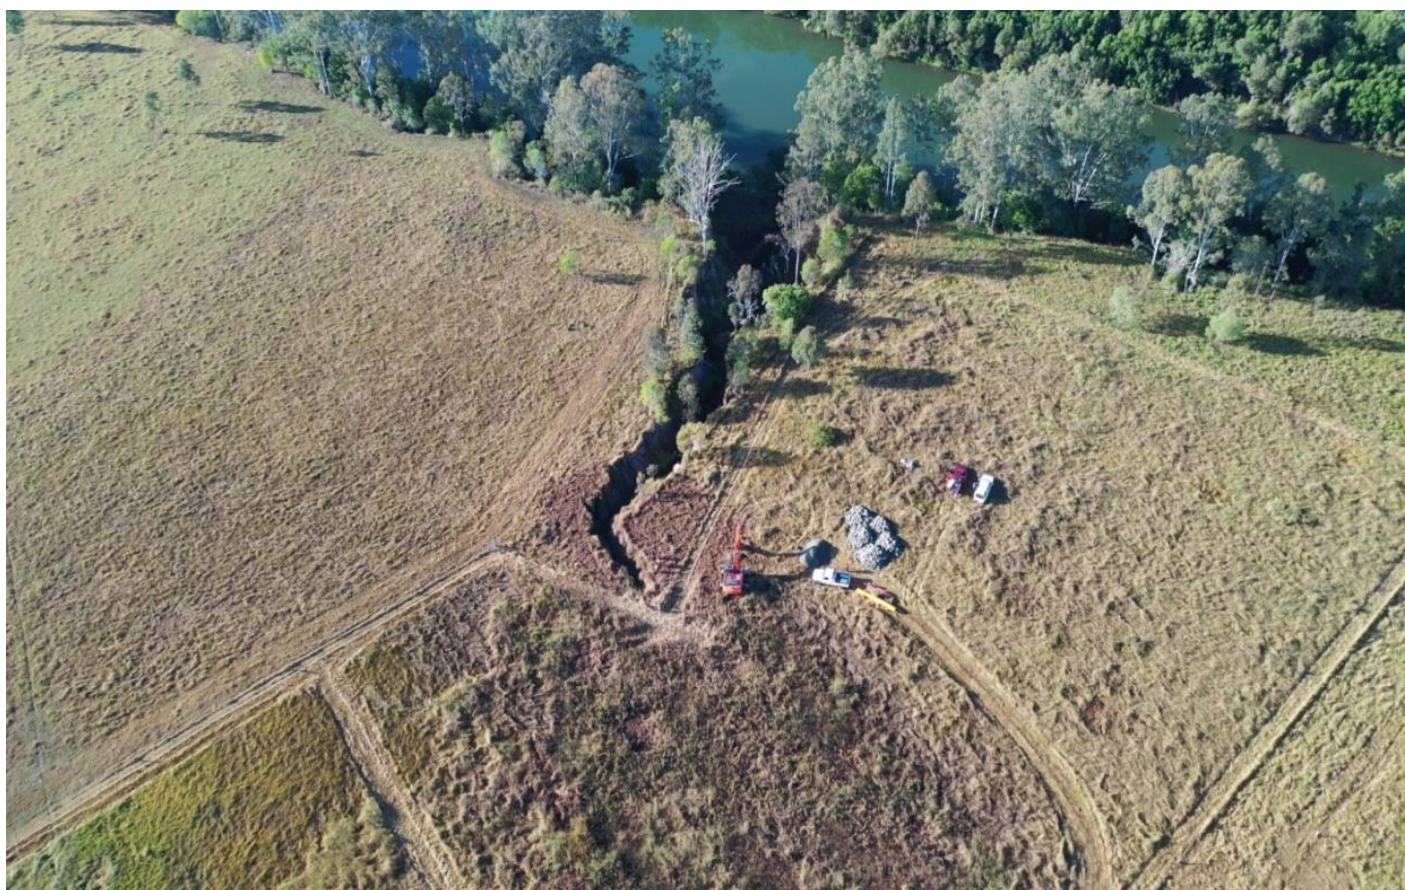
Photo 69 Aerial view of the gully before construction started, with the Mary River in the background.

This property is a small lifestyle block with approximately 110m of Mary River frontage. A large gully that started on the downstream neighbouring property in the 1950s had crossed the property boundary into this property. Historical imagery shows a small gully in 1952, and a slip circle failure on the riverbank immediately downstream by 1958. These erosion features continued to grow individually before the peninsular between them collapsed and they joined around 1984-87. Flood imagery from 1999 shows the gully at bank-full height. This inundation from back water was an important factor to consider for rehabilitation.

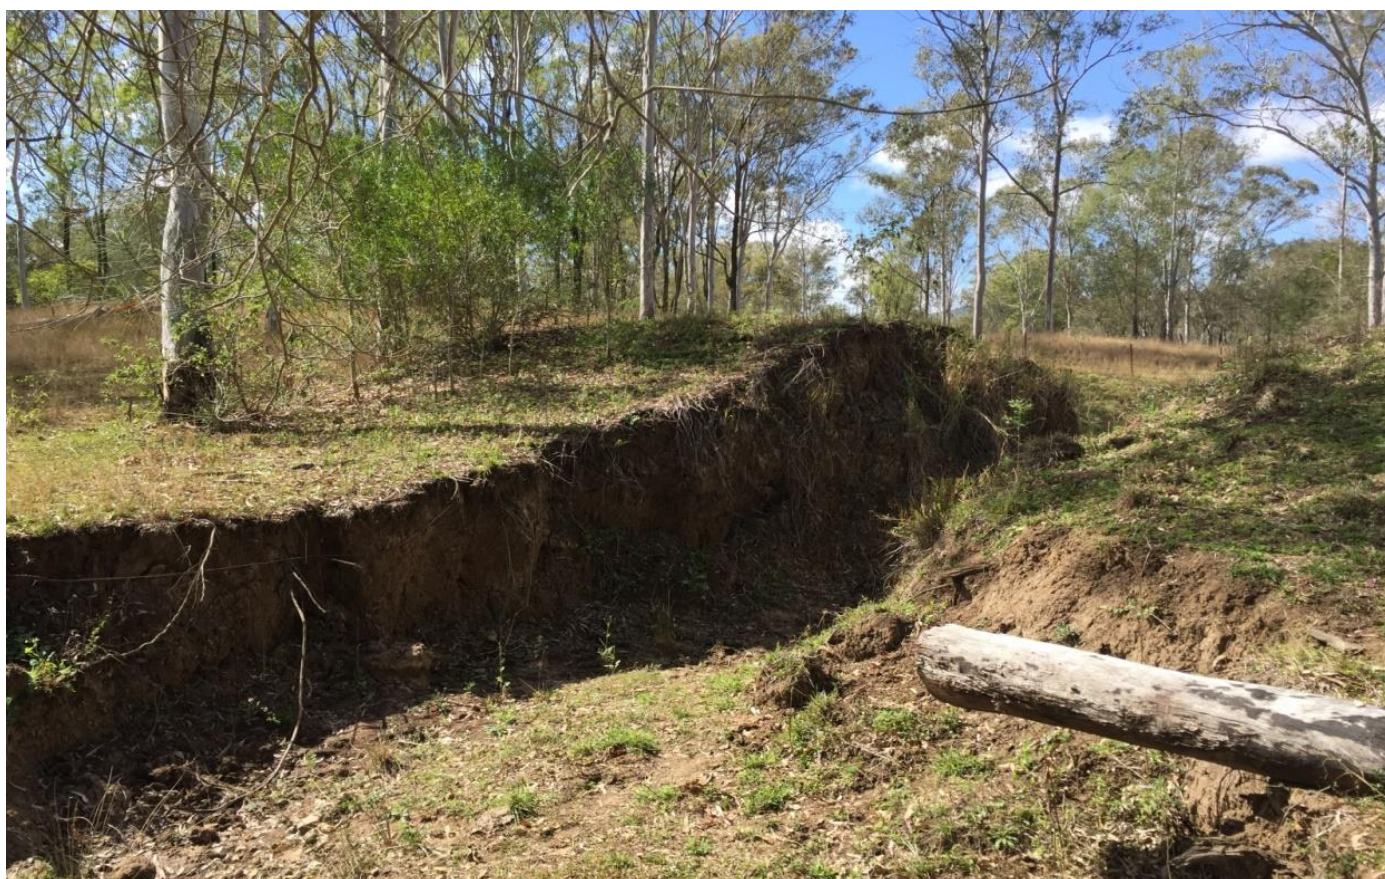
Photo 88 Break in dam wall prior to work

This small dam is located on a small stream. It had failed in the past and repair efforts also later failed. Following the last failure, a deep gully formed which was cutting its way back through the stream bed towards the dam excavation which was still holding at least 2m of water – a valuable resource for the landholder. Soils are texture contrast with a loam A horizon and a deep dispersive sodic B horizon. The land type is blue gum flats at the dam and grey box in the majority of the dam catchment. The catchment delivering to the gully is approximately 31ha. The peak flow at the gully head is approximately 9m³/sec for a 1 in 50 rainfall event, estimated using the Rational Method and Qld Globe topographic data.

- The addition of bentonite to the excavation before the gravel, geofabric and rock were introduced, was a refinement to reduce the potential for seepage under and through the foundations of the structure. The previous failures of the dam wall, regardless of good repair technique, prompted this addition.

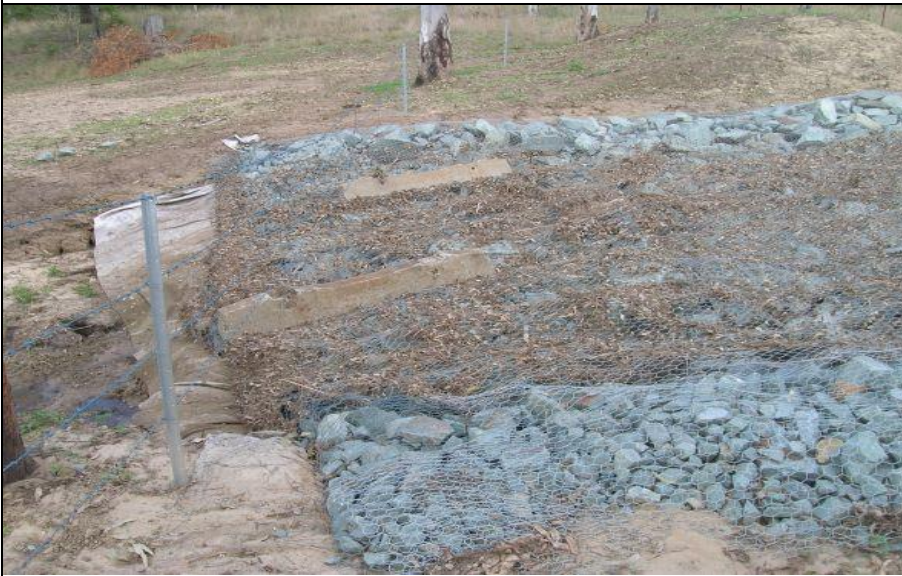
Photo 99

No damage observed to the structure and some organic deposition – a critical first step in rehabilitation

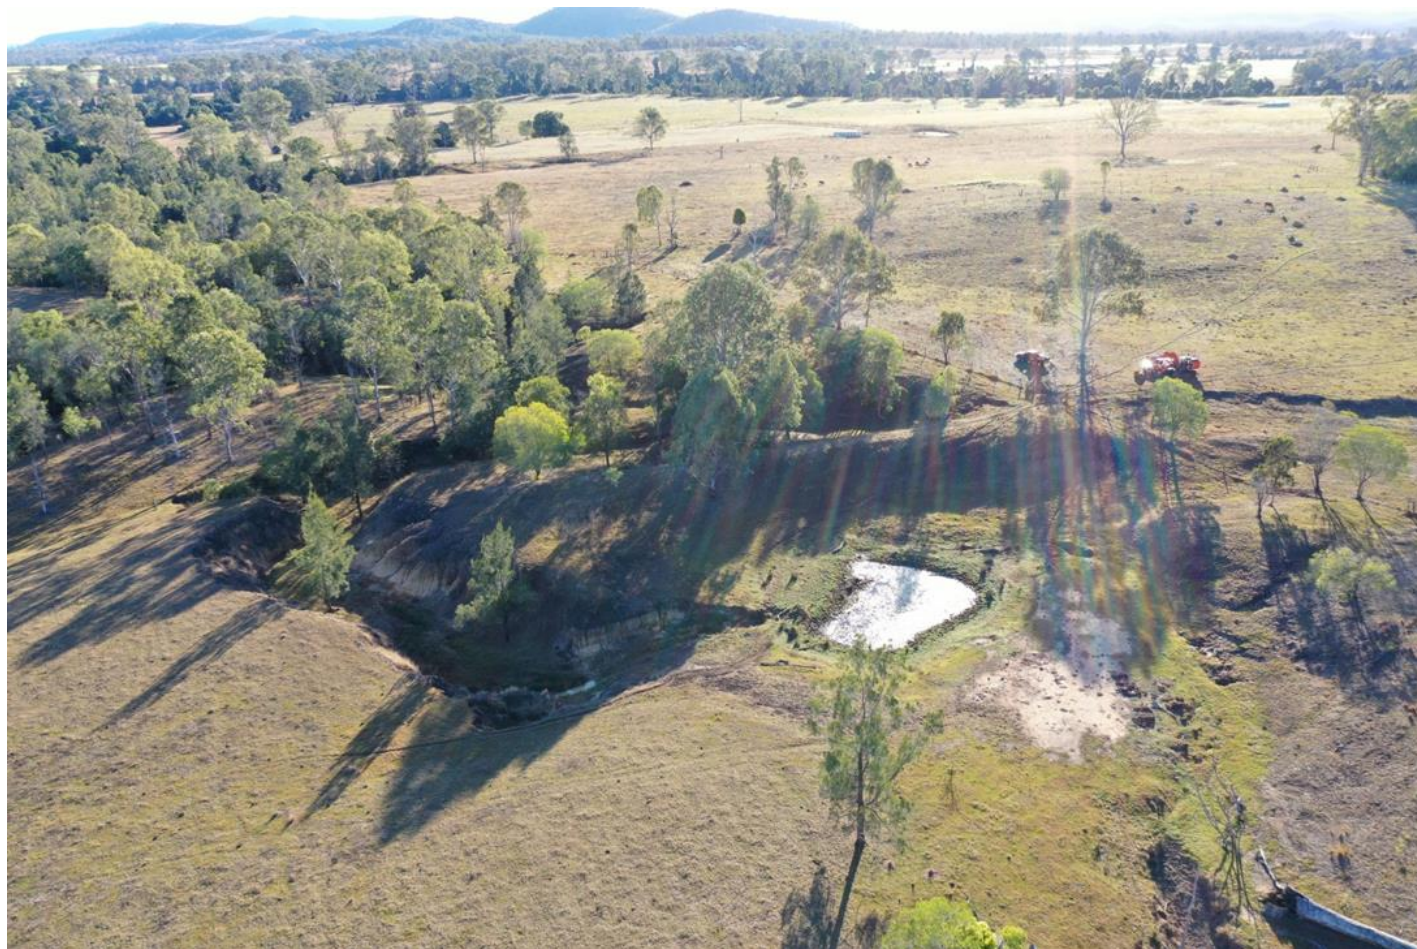
Photo 102 Aerial view of the site prior to start of works, eroded bywash on left

The dam was constructed in the 1980s and the by-wash started to erode badly with the first filling rains. The large floods of 2010, 2011 and 2013 completely emptied the dam except for a small excavation which became a bog hazard for stock. The site had very deep and active erosion as a result of a poorly designed and constructed by-wash for the large dam.

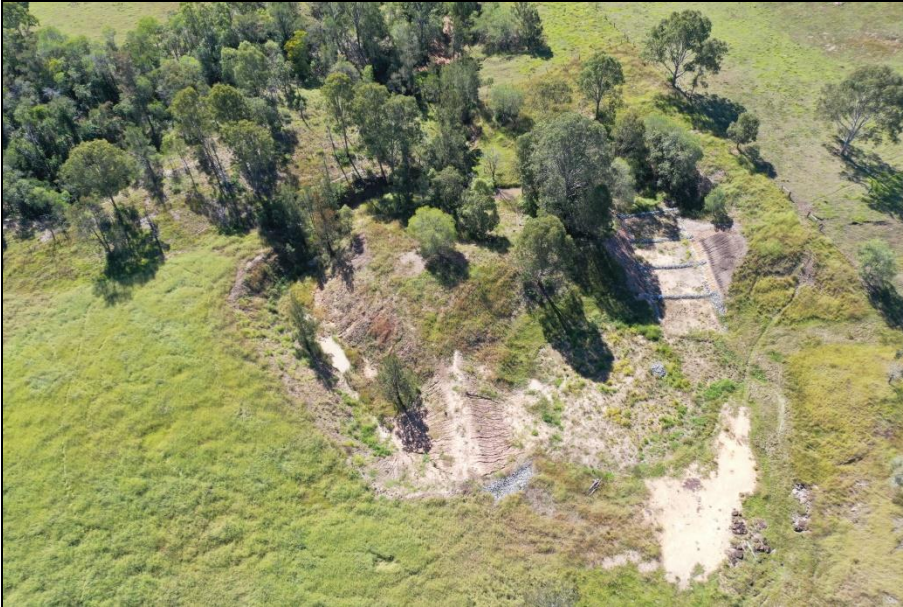
<p><i>Photo 117</i></p> <p>May 2021 – post wet season</p> <p>Nine months since construction. Some rilling has occurred over the wet season. More grass seed applied to exposed areas.</p>

To ensure further gullying does not occur at the end of this bank, the landholder will need to be vigilant in sealing any signs of rilling.

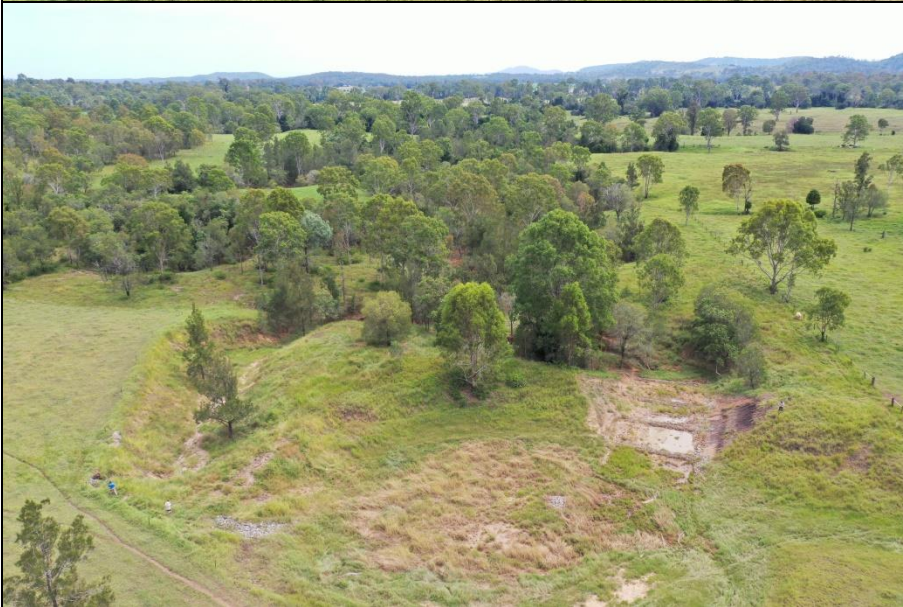
<p><i>Photo 118</i></p> <p>February 2022 – mid wet season</p> <p>The main channel and groynes remain intact after inundation from the 2022 floods. Most of the site has grass cover. The batters on the dam wall cut are still bare but stable. Water from the flats has concentrated its flow on the downstream side of the by-wash bund and caused some erosion. The landholder will extend the diversion bank to again take the flows down the rock chute on the upstream side of the bund wall.</p>

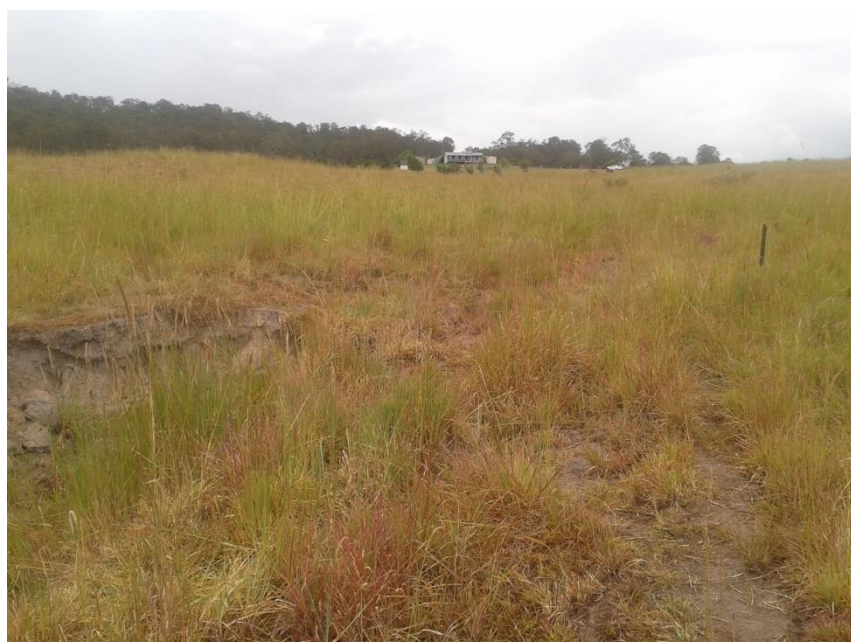
Photo 129 Gully head before rehabilitation. Note cattle tracks running alongside the gully system.
