# Erosion gully rehabilitation

Adaptations and learnings from sites in the Mary River Catchment

By John Day, Becky Watson and Caitlin Mill  
Mary River Catchment Coordinating Committee

July 2023

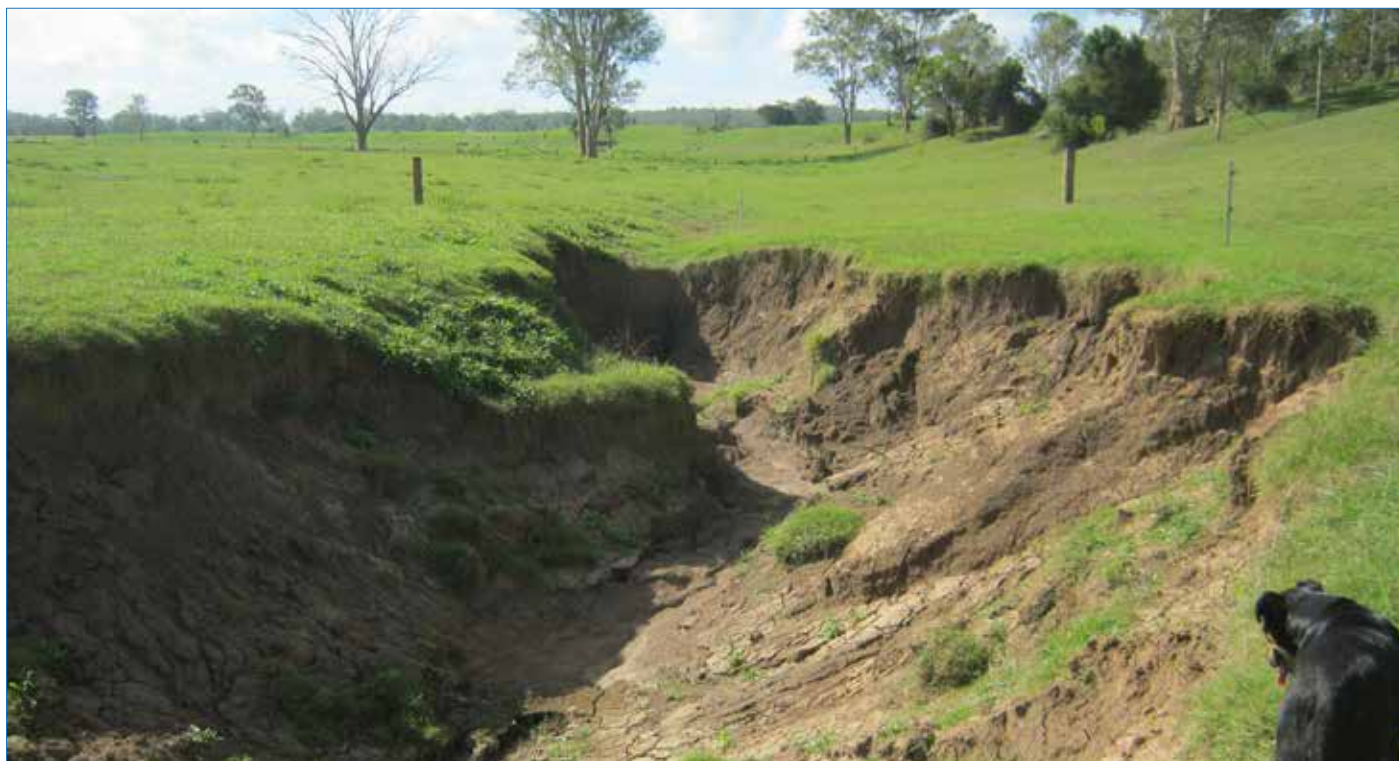
This gully had a 2 m deep head cut on a lateral runner from the main river. The head was narrow and deep, and the catchment delivering to the gully head was approximately 104 ha of river flats. The design team used the Rational Method to estimate peak flow as 5.5 m<sup>3</sup>/s for a 1-in-20 rainfall event. The gully head had retreated significantly, releasing 66 t/yr of fine sediment. If left unchecked, the gully would eventually isolate a section of productive grazing land.

**Photo 1** Mary River flood plain gully head before works commenced.

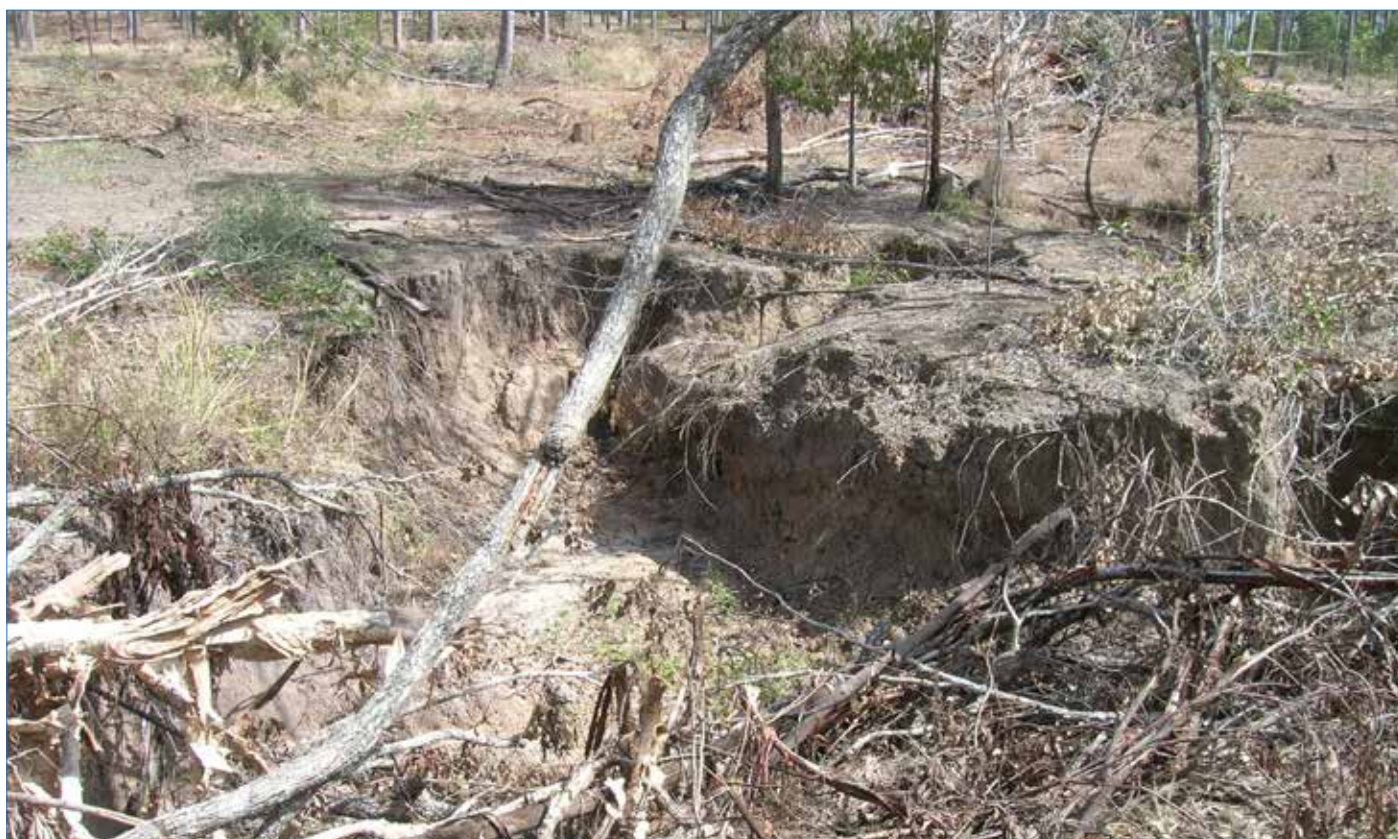
The biggest challenge at this site is the large catchment size, generating a large peak flow. The gully system is long and, several large lateral gullies have formed off the main gully over time. At the most upstream gully head, another lateral gully had recently developed. Another challenge at this site was the presence of tunnel erosion.

**Photo 19** Main gully head, with side gully head coming from the right of picture.

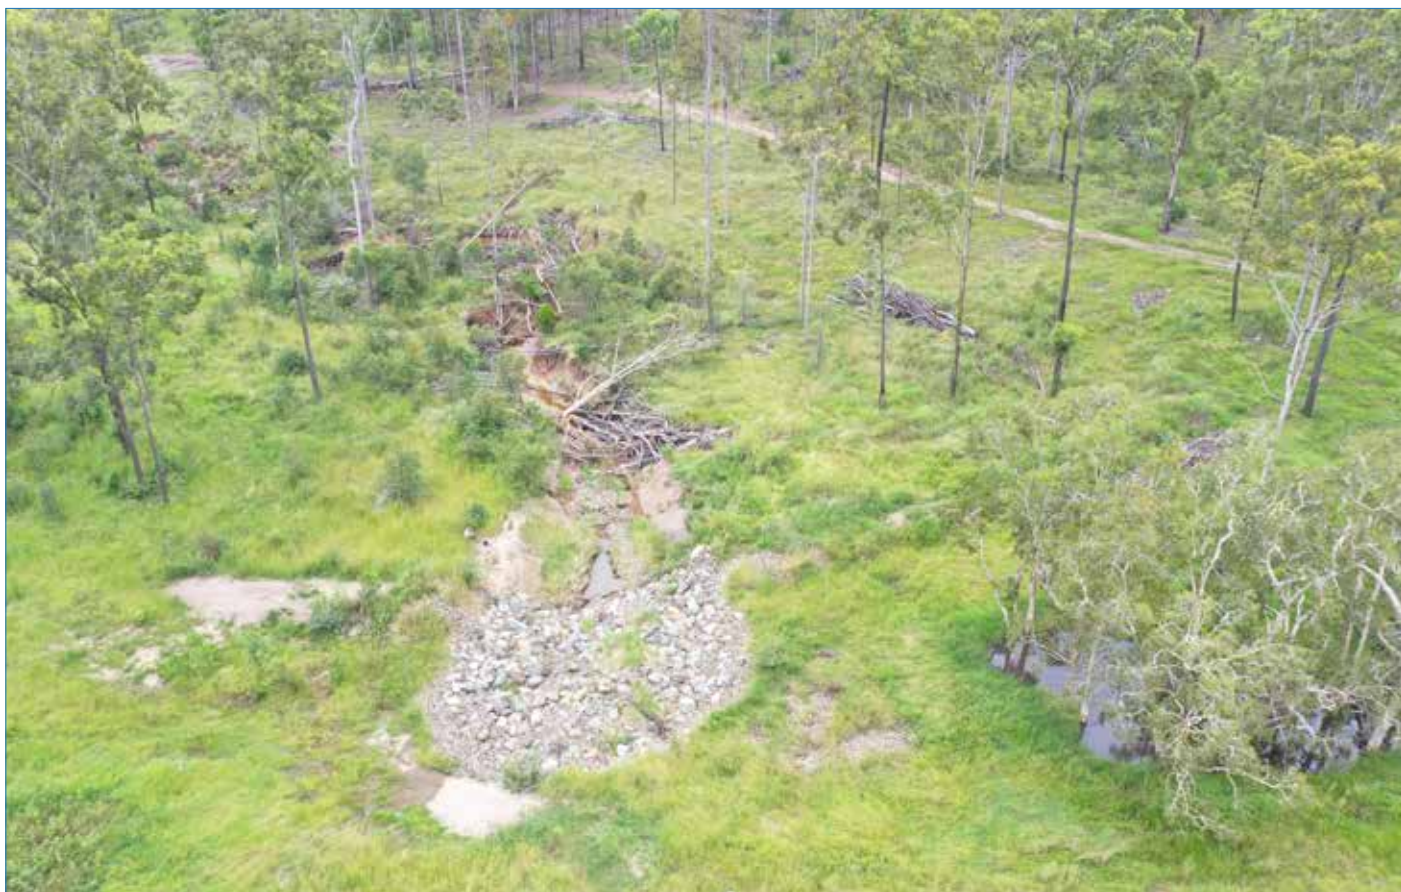
**Photo 32** February 2022 after major floods in the area.  
24-hour rain totals exceeded 600 mm in the area.

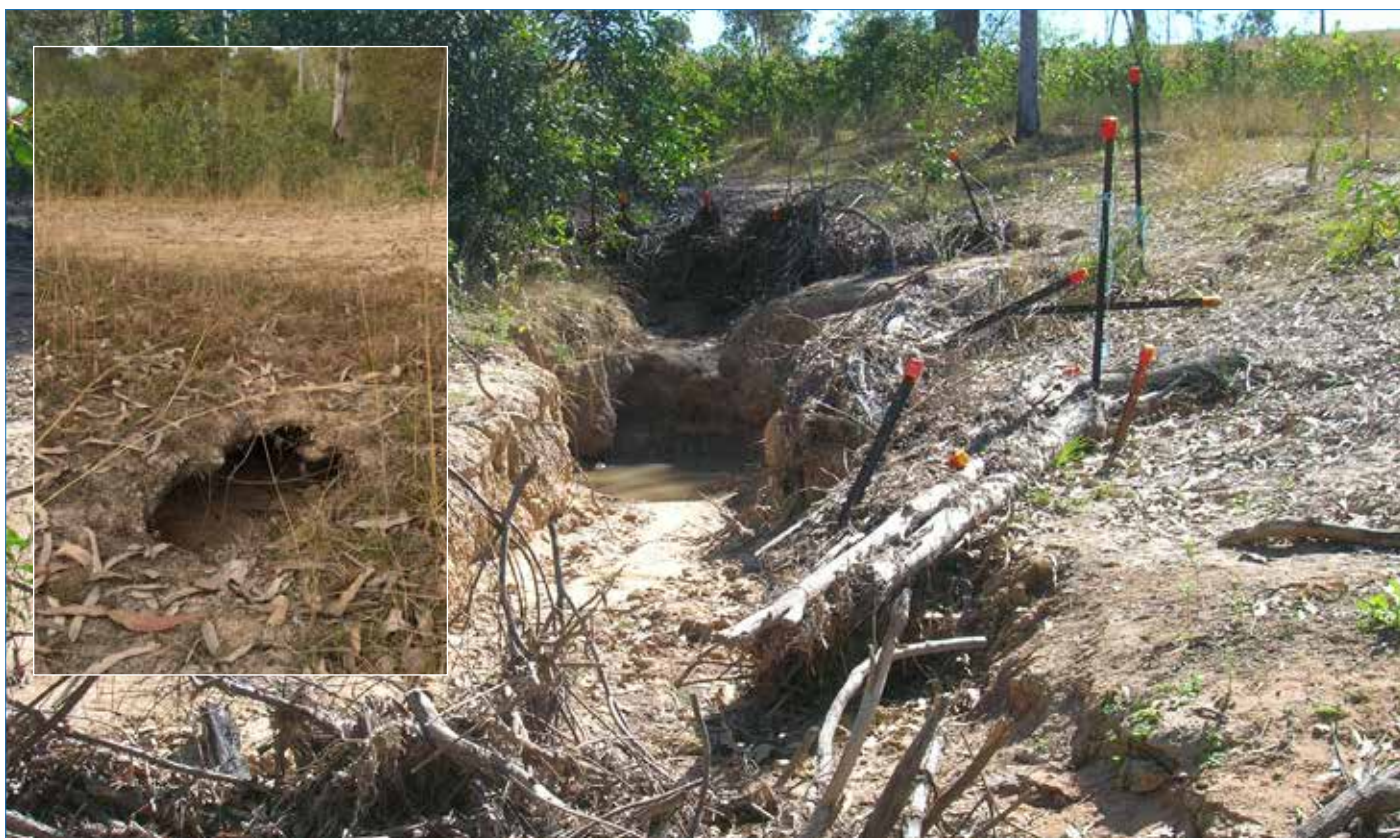
The landholder's previous efforts to remediate this gully site with battering and then porous check dams had failed due to inappropriate design and the contractor's unfamiliarity with gully remediation in fragile landscapes with highly dispersive subsoils.

**Photo 33** Gully erosion with multiple head cuts and failed porous check dams. Inset: tunnel erosion in the catchment immediately upstream of the gullies.

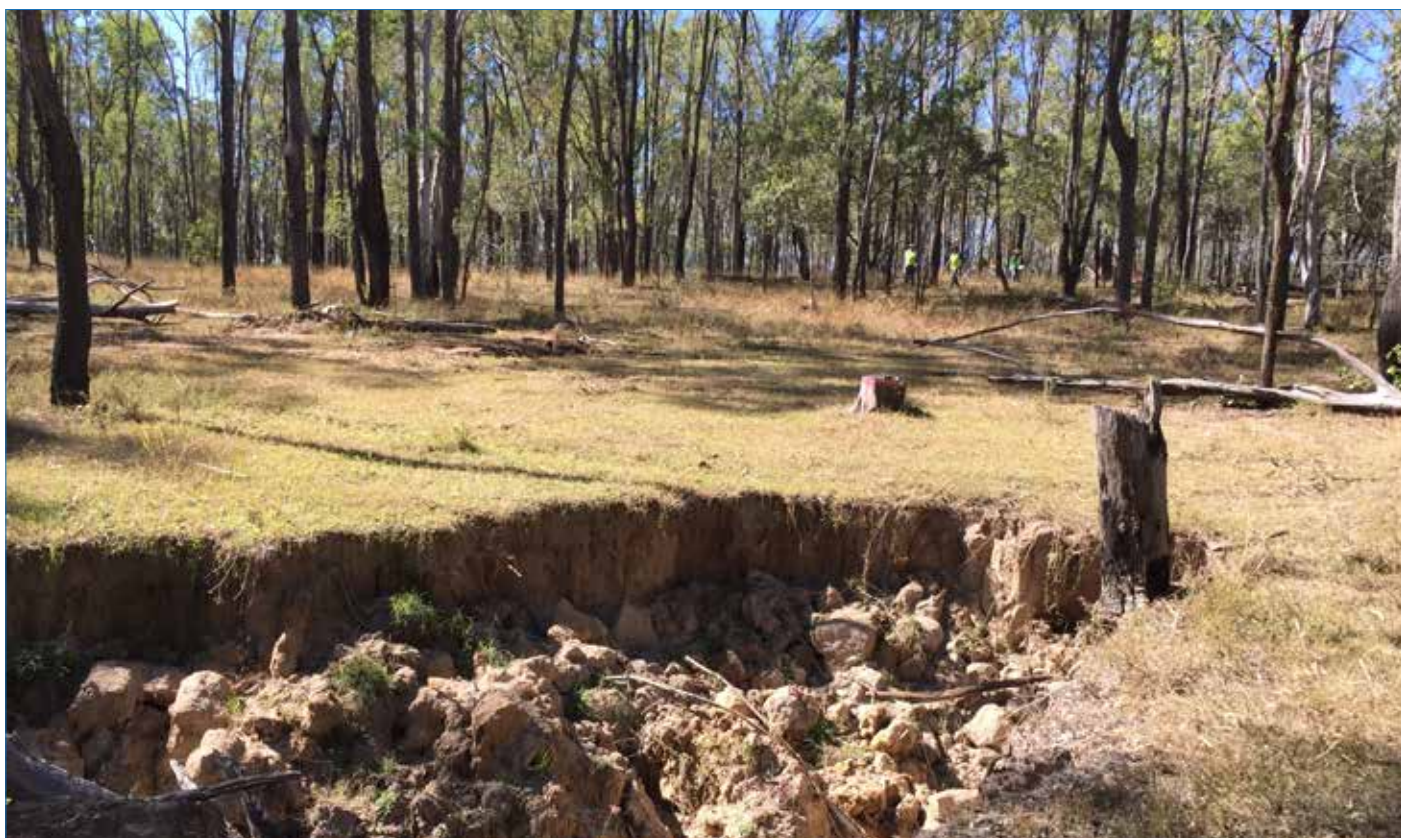
This gully erosion site is due to the diversion of water from a historic 15 ha contoured catchment onto an adjacent ridge top rather than into the eroded natural drainage line. Diverting water away from an erosion site is a common strategy, and the system worked quite well for many years. The contour system to the ridge design was suitable for normal rainfall conditions up to the 1-in-10 rainfall event. However, during the 2011 and 2013 flood events, the increased flow on the receiving catchment resulted in a new gully, which advanced rapidly up the slope.

**Photo 47** Iron bark and Box ridge gully prior to rehabilitation.

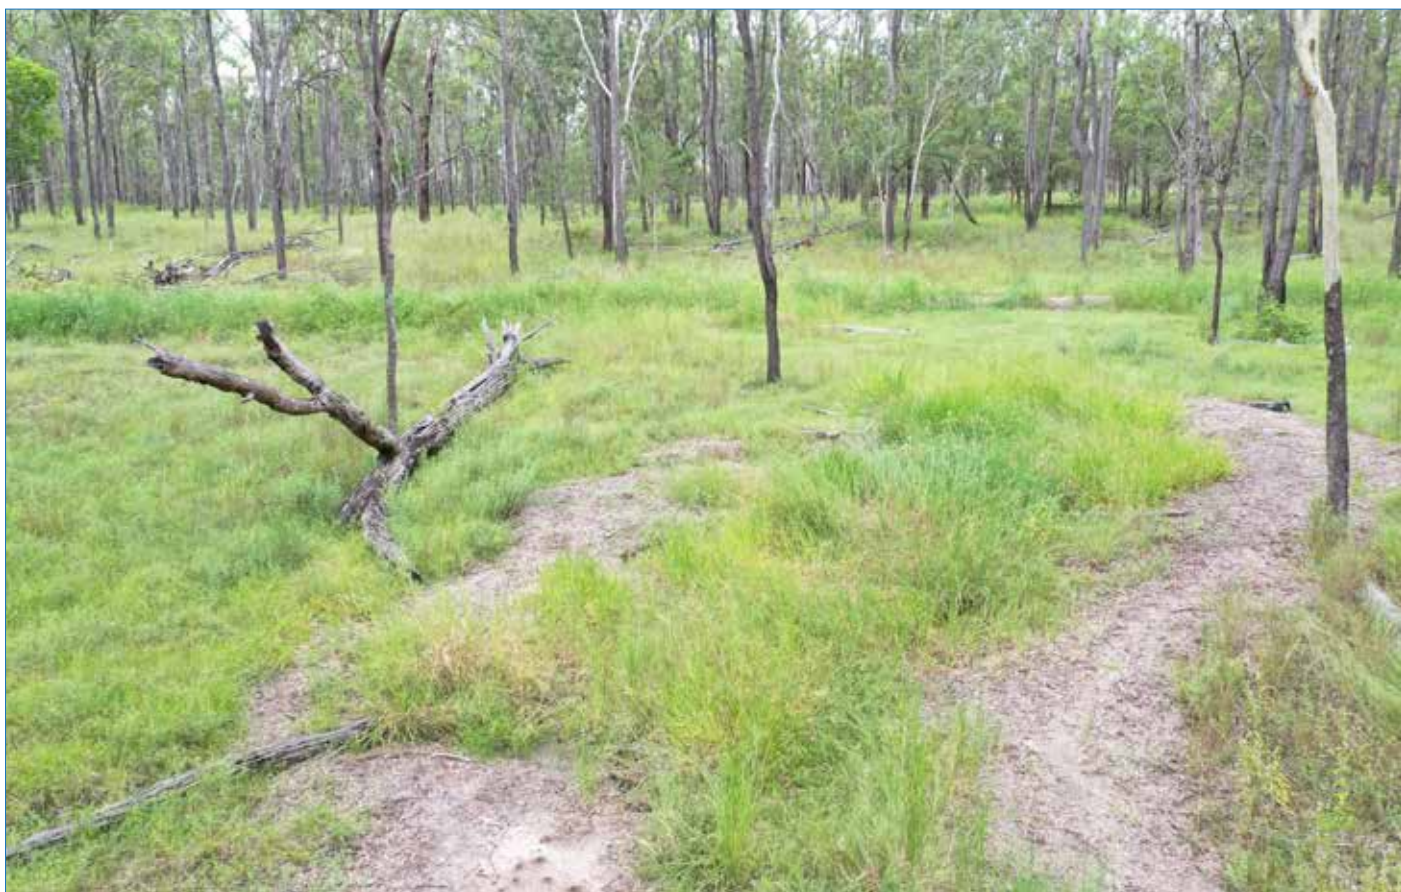
**Photo 68** February 2022 post-flood.  
Fill in the gully head sank slightly. However, ground cover has established well in this slight depression.  
The landholder has placed stick lines adjacent to the flow to trap soil and prevent further rilling.

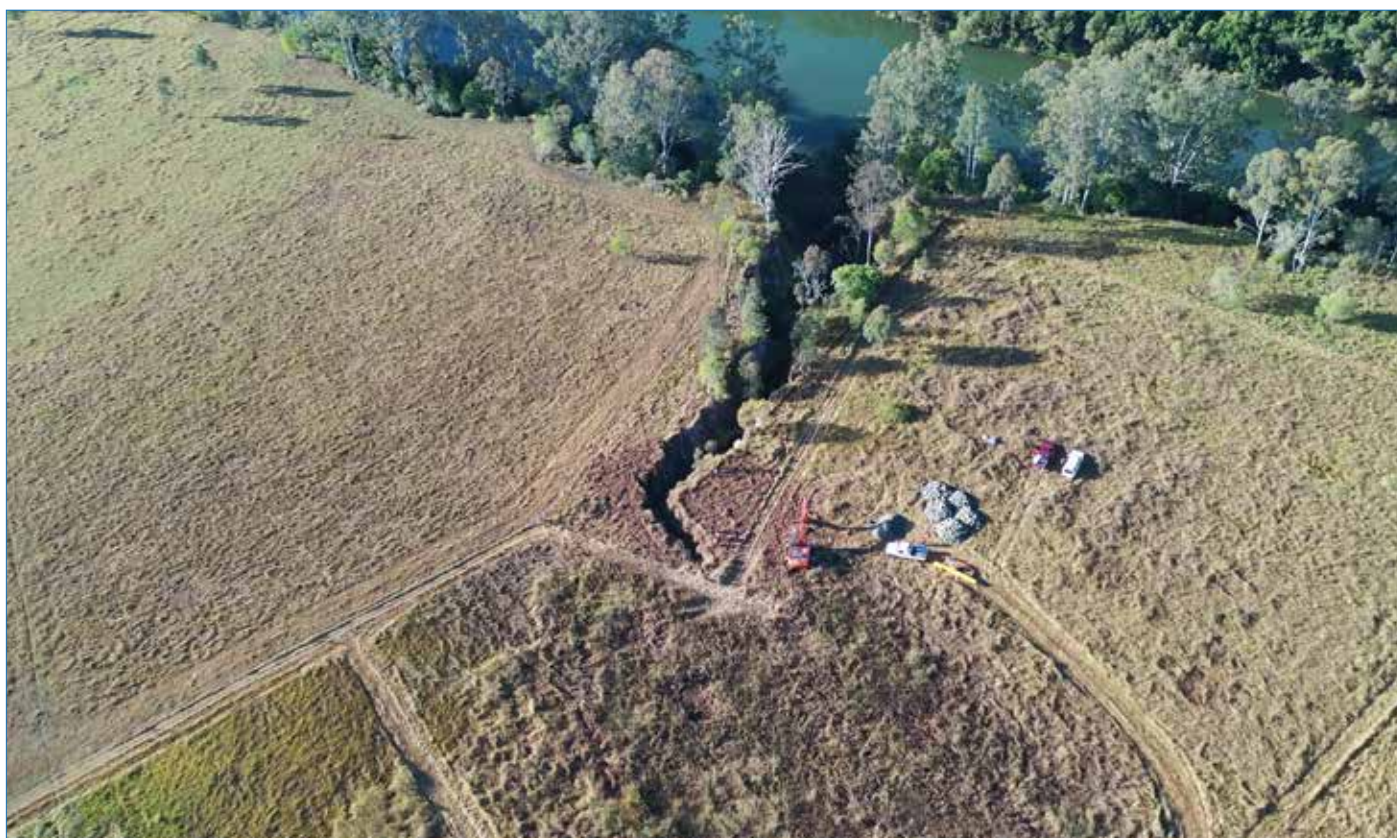
This property is a small lifestyle block with approximately 110 m of Mary River frontage. A large gully that started on the downstream neighbour's property in the 1950s had crossed the boundary into this property. Historical imagery shows a small gully in 1952 and a slip circle failure on the riverbank immediately downstream by 1958. These erosion features continued to grow individually before the peninsular between them collapsed, and they joined around 1984–87. Flood imagery from 1999 shows the gully at bankfull height. Inundation from backwater was an important factor to consider for rehabilitation.

**Photo 69** Aerial view of the gully before construction started, with the Mary River in the background.

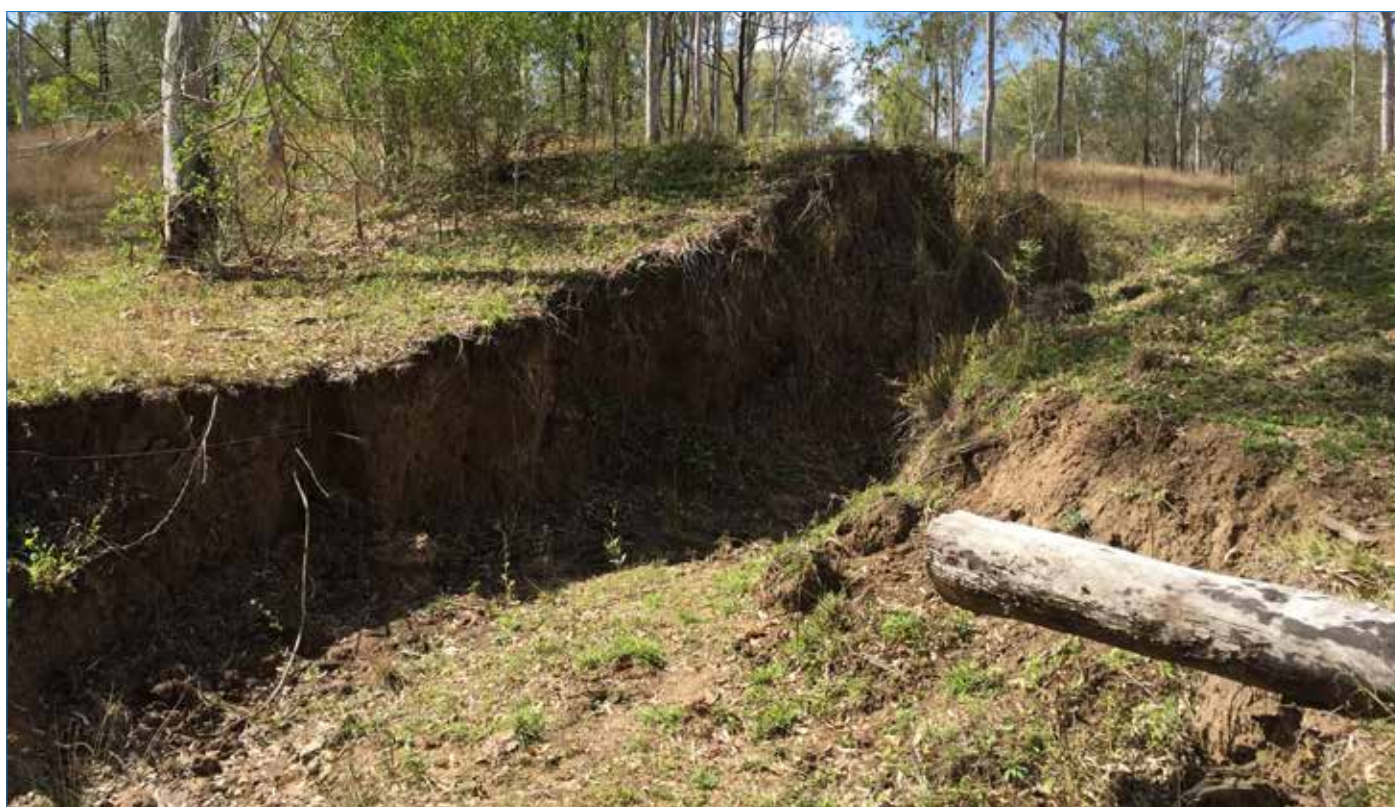
This dam wall on a small stream breached, and the repair efforts also later failed, leaving a deep gully downstream. The active gully head was moving upstream towards the dam excavation, which still held at least 2 m of water – a valuable resource for the landholder. The soil is texture-contrast with a loam A horizon and a deep dispersive sodic B horizon. The land type is 'Blue gum flats' at the dam, and most of the dam catchment area is 'Grey box' land type. The catchment delivering to the gully is approximately 31 ha.

**Photo 88** Break in dam wall prior to work.

Adding bentonite to the excavation before the gravel, geofabric and rock was a refinement to reduce the potential for seepage under and through the foundations of the structure. The previous failures of the dam wall, regardless of good repair techniques, prompted this addition.

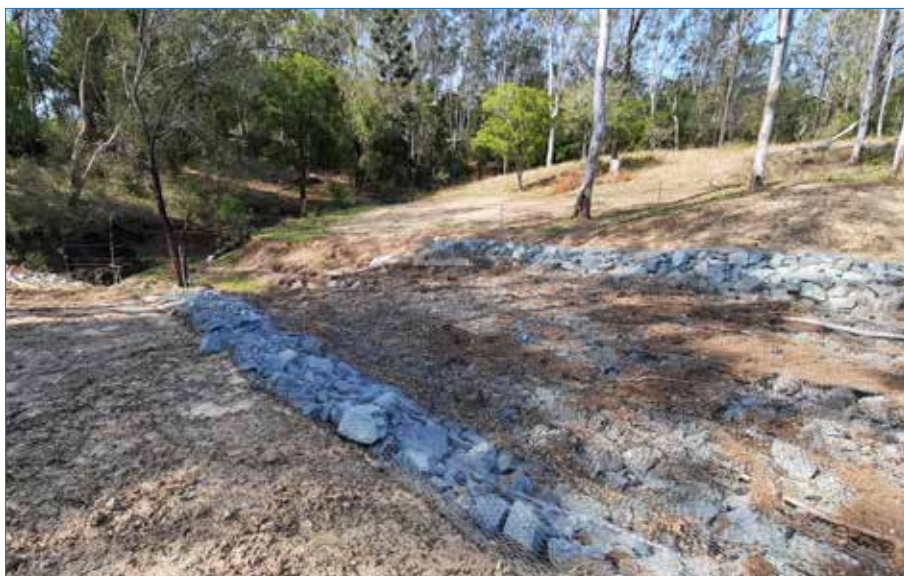
**Photo 98** October 2020 – after the first rain event.

No damage observed to the structure and some organic deposition – a critical first step in rehabilitation.

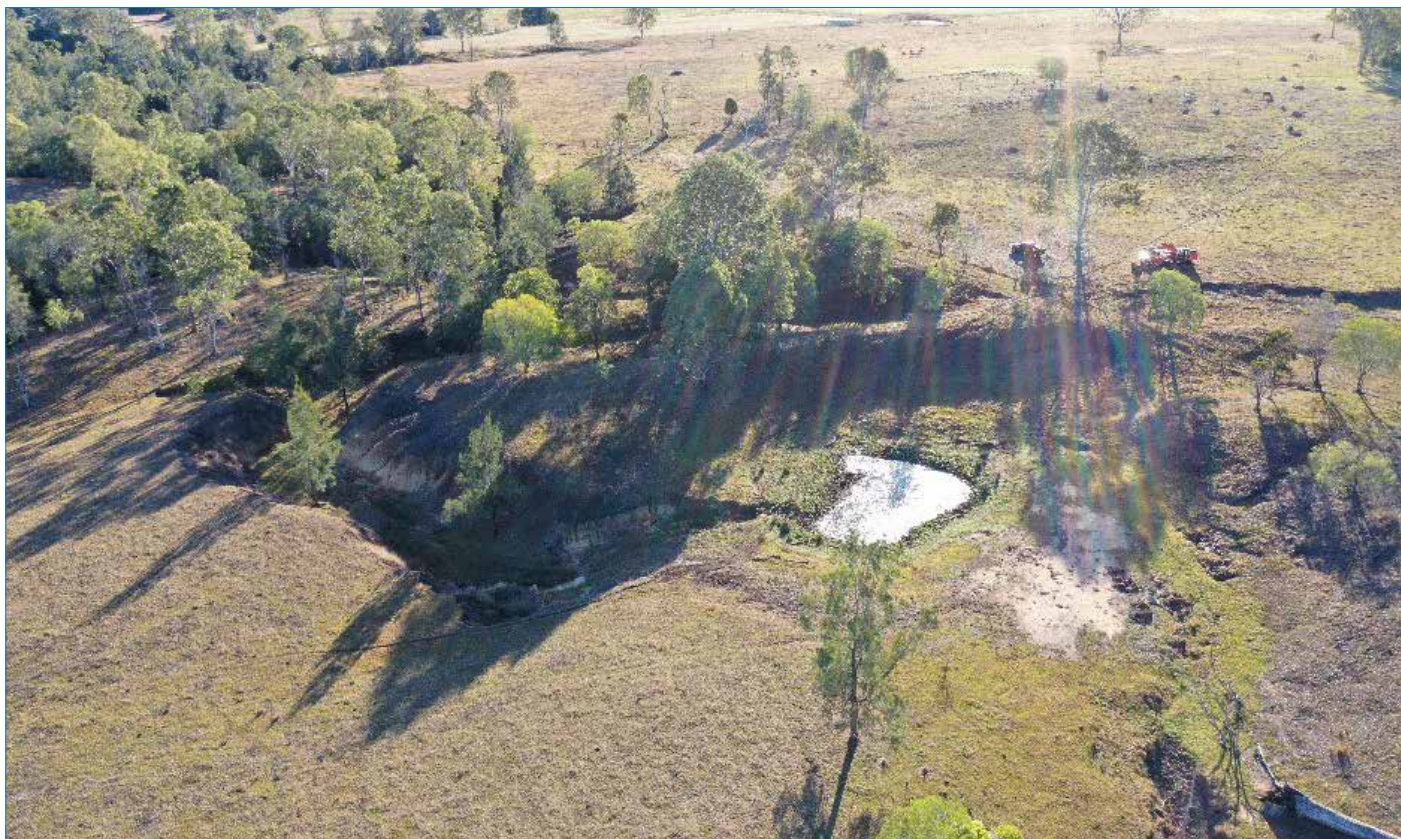
The dam was constructed in the 1980s, and the by-wash started to erode badly with the first filling rains. The large floods of 2010, 2011 and 2013 completely emptied the dam except for a small excavation which became a bog hazard for stock. The site had deep and active erosion due to a poorly designed and constructed by-wash for the large dam.

**Photo 102** Aerial view of the site prior to start of works, eroded bywash on left.

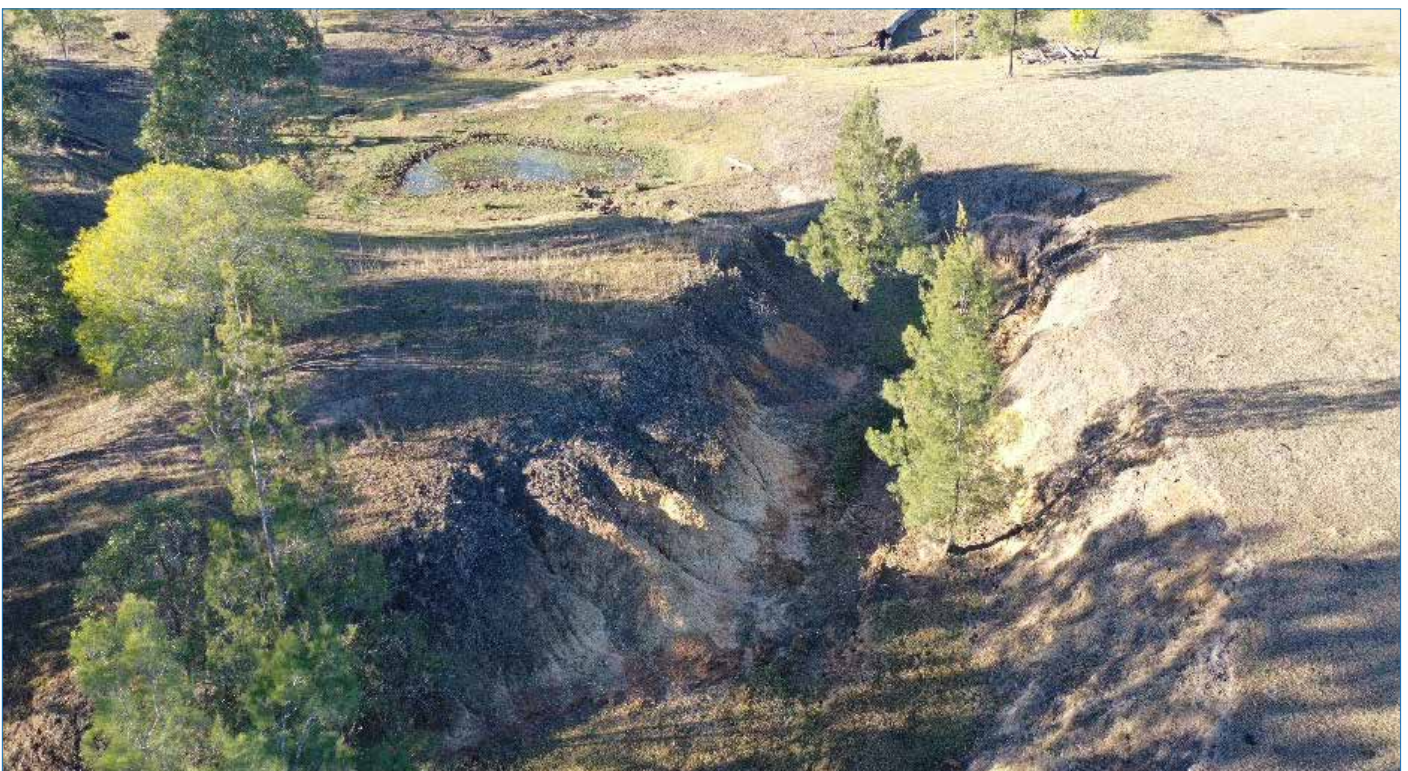
**Photo 103** Looking upstream along the eroded by-wash.

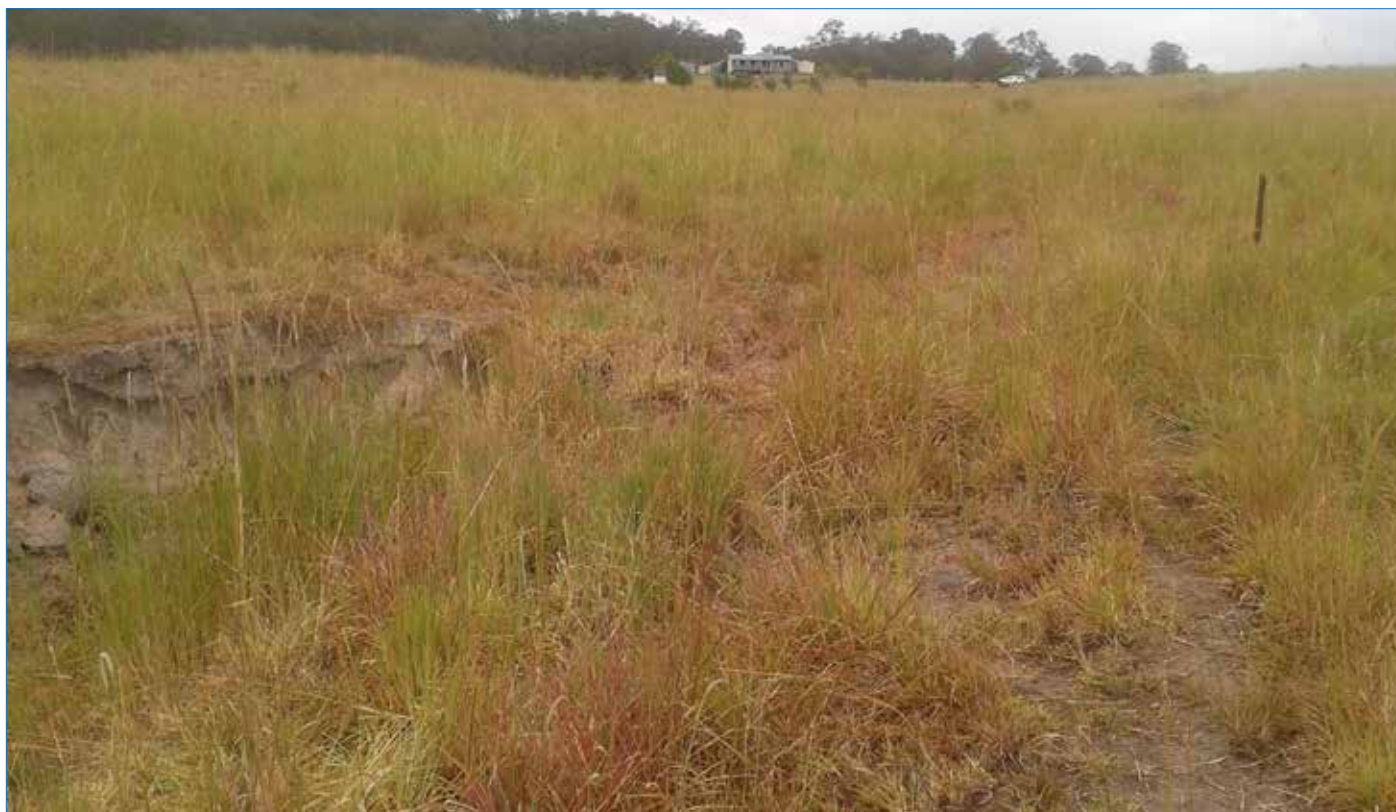
**Photo 129** Gully head before rehabilitation. Note cattle tracks running parallel with the gully system.
