## Mary River Rehabilitation Plan – Gympie Reach

May 2026

This report has been prepared by Alluvium Consulting Australia Pty Ltd for **[Mary River Catchment Coordinating Committee]**

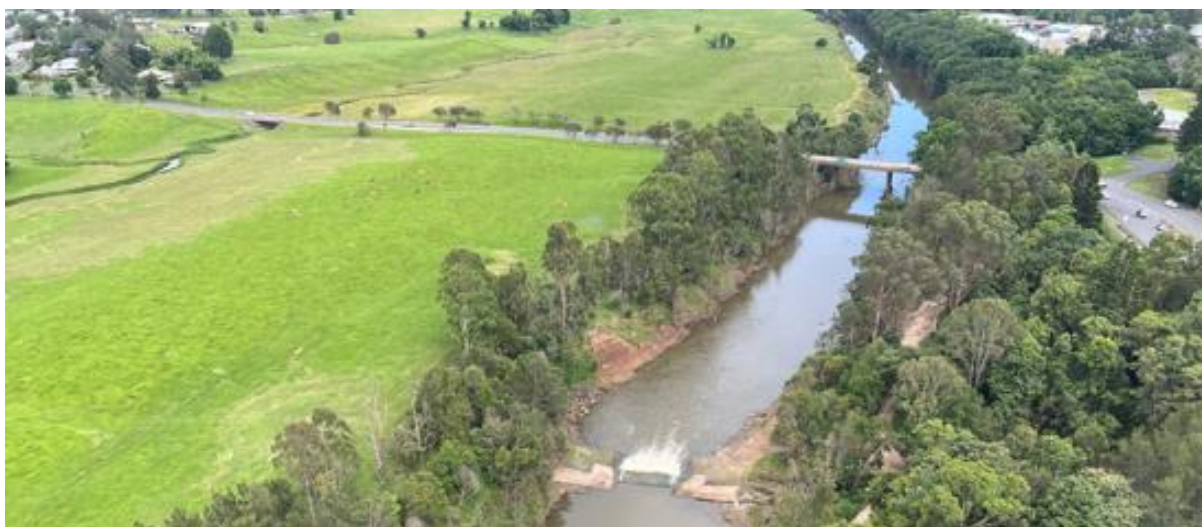
**Figure 23.** *Example of Good riparian condition on the right bank at the upstream extent of Sub-reach 1 (photo looking downstream)*

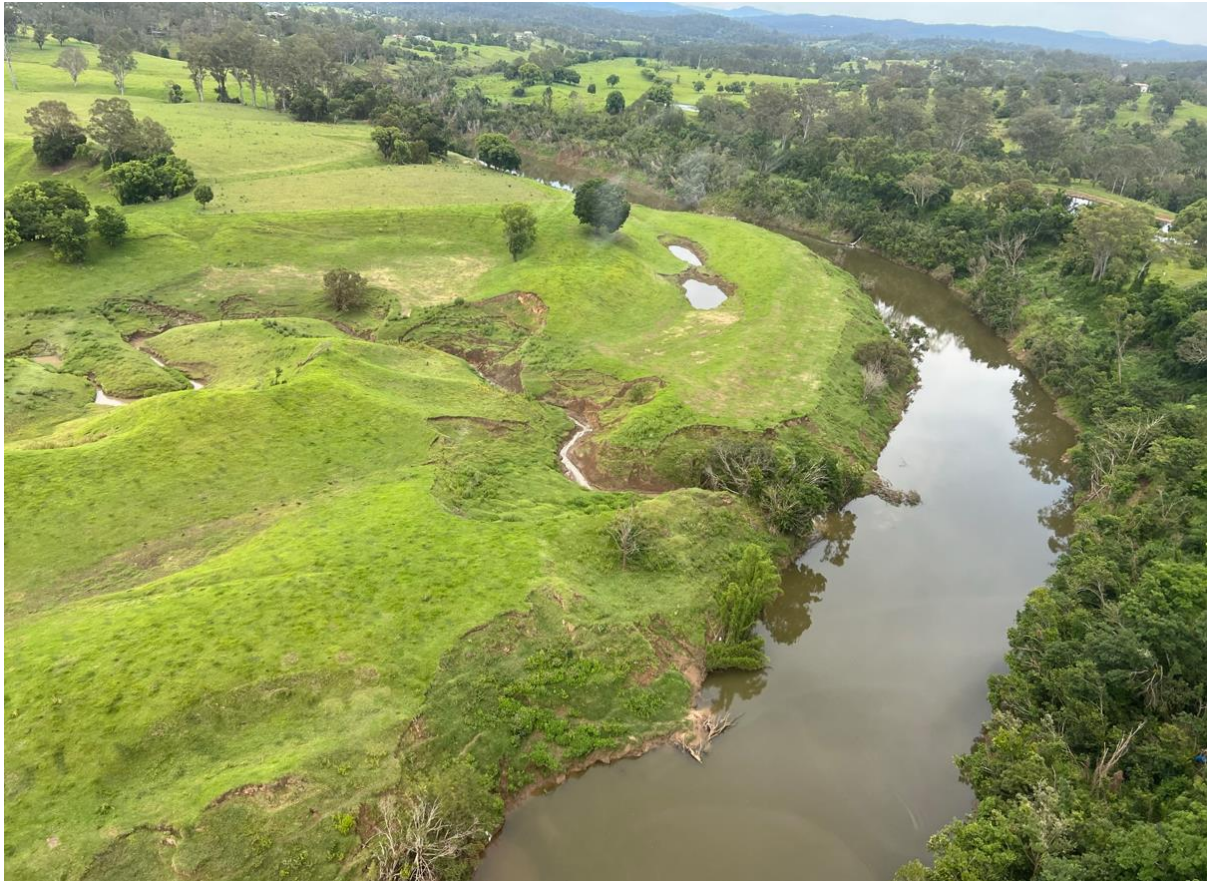
**Figure 24.** *Example of slightly degraded riparian condition on the right bank and highly degraded riparian condition on the left bank in Sub-reach 1.*

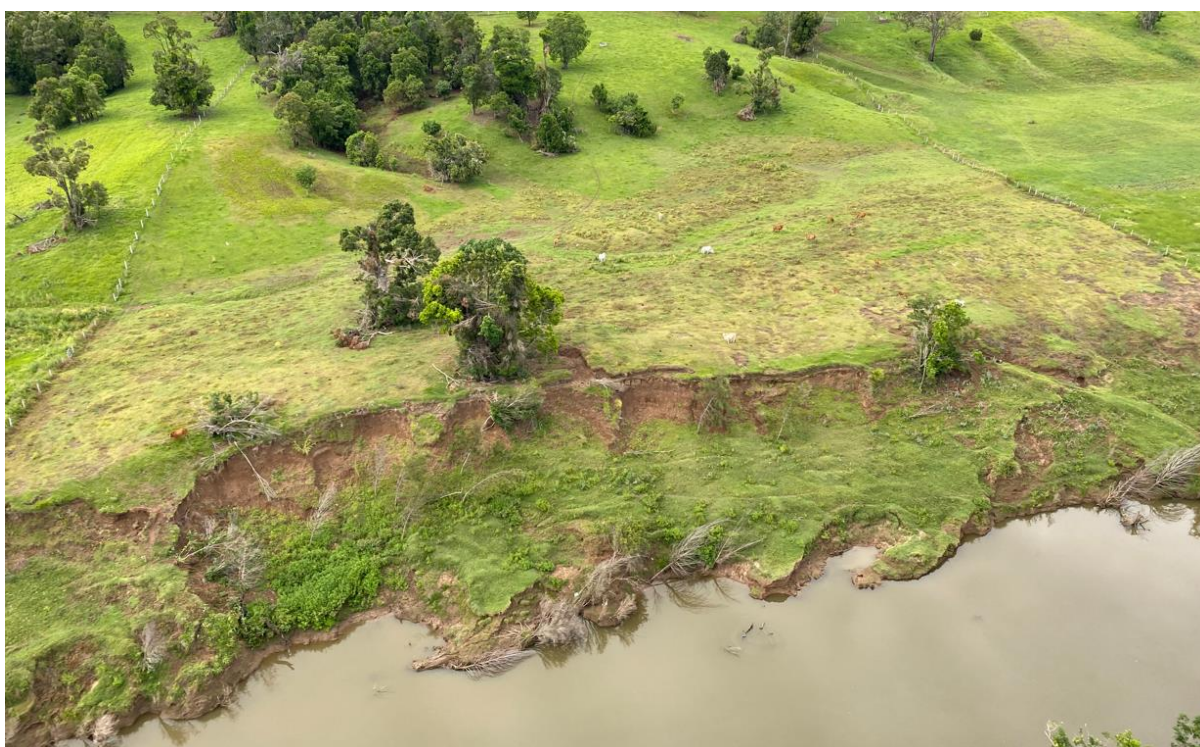
**Figure 26.** *Example of section of bank with a moderate erosion potential in the lower portions of Sub-reach 1.*

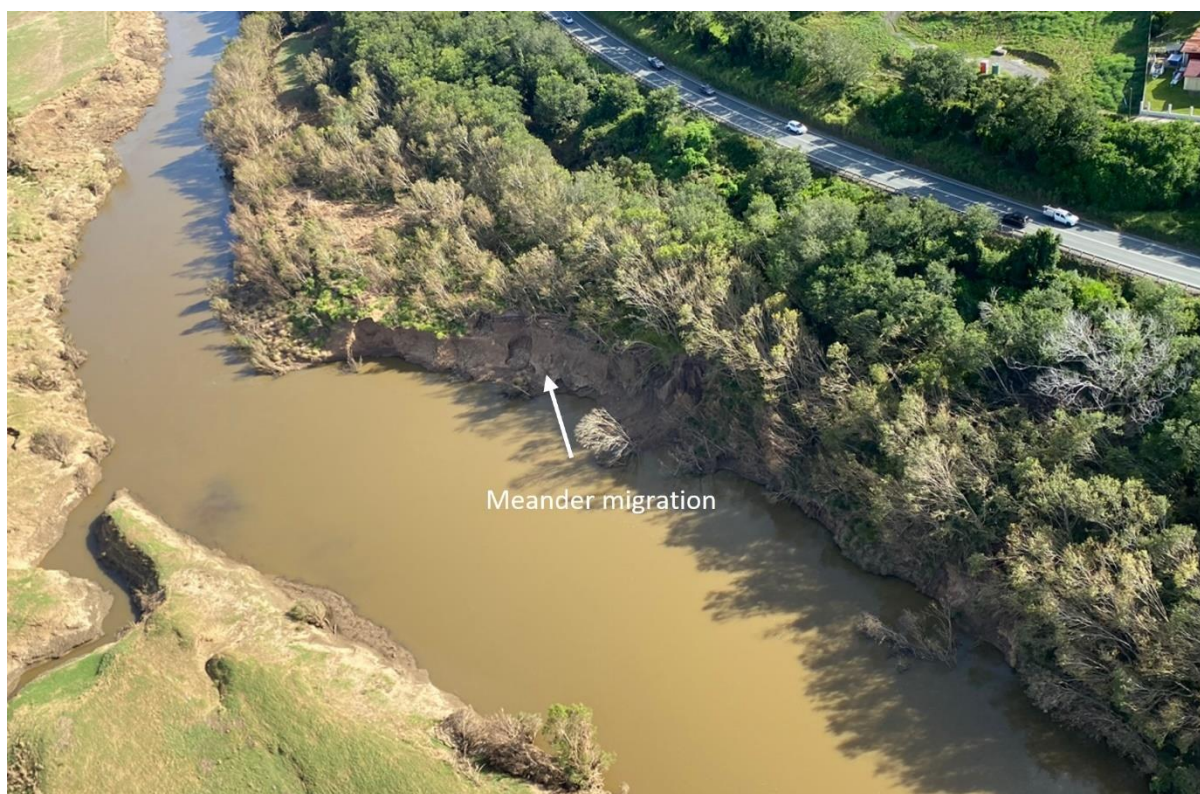
**Figure 31.** Active meander migration on the northern bank approximately 800 m downstream of Jones Hill Weir

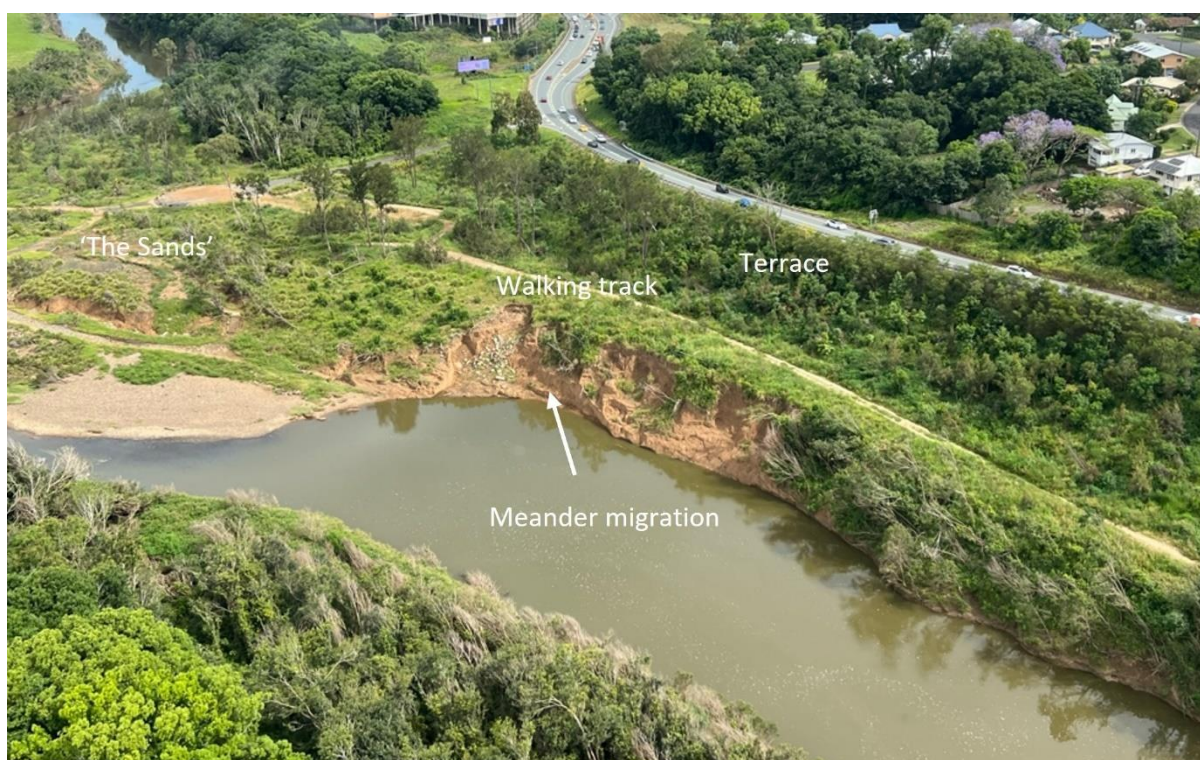
Multi-temporal LiDAR analysis was undertaken for two periods between 2009 and 2024 (Figure 30). The analysis shows that there was relatively widespread erosion of the floodplain units on the southern side of the channel. The erosion identified was a combination of mass failures or ‘wet flow failures’ and fluvial scour. The mass failures were largely concentrated on the southern banks. There were two bends on the northern side of the channel where there was significant erosion from meander migration processes. The first site is located approximately 800 m downstream of the Jones Hill Weir (Figure 31). The bank is approximately 10 m high and retreated up to 10 m between 2009 and 2024. The second site is located immediately adjacent to the Sands Reserve and is approximately 12 m high and retreated up to 18 m between 2009 and 2024. Ongoing erosion at this site threatens the adjacent walking track however future erosion will likely be limited to the terrace boundary which is currently approximately 15 m away (Figure 32).

**Figure 32.** Active meander migration on the northern bank adjacent to the Sands reserve

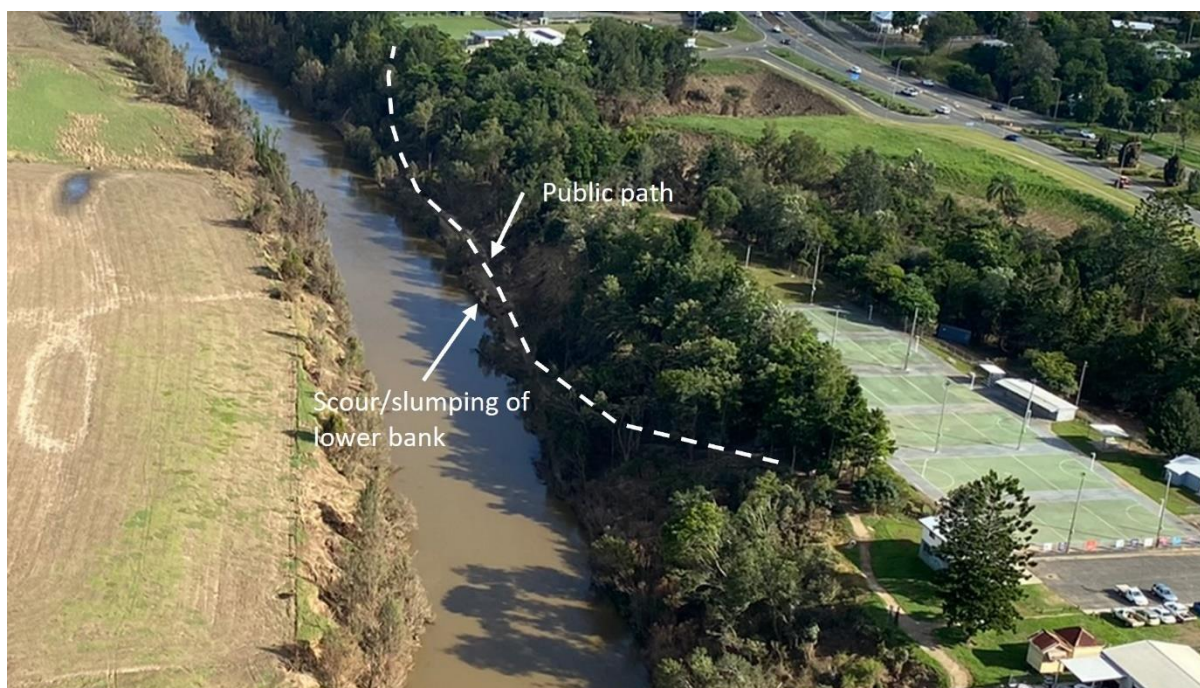
**Figure 33.** Erosion of lower bank adjacent to public walking track in the lower portion of Sub-reach 2

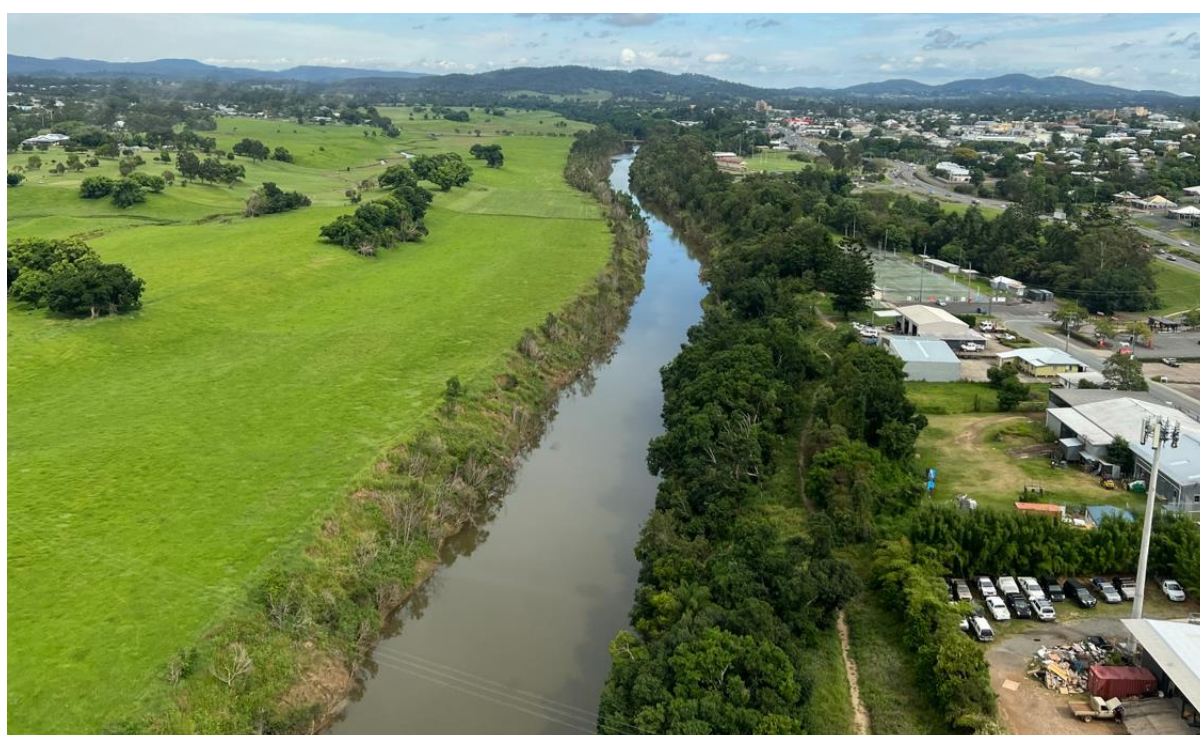
**Figure 35.** *Example of Good riparian condition on the right bank and highly degraded riparian condition on the left bank in Sub-reach 2 – photo looking downstream*

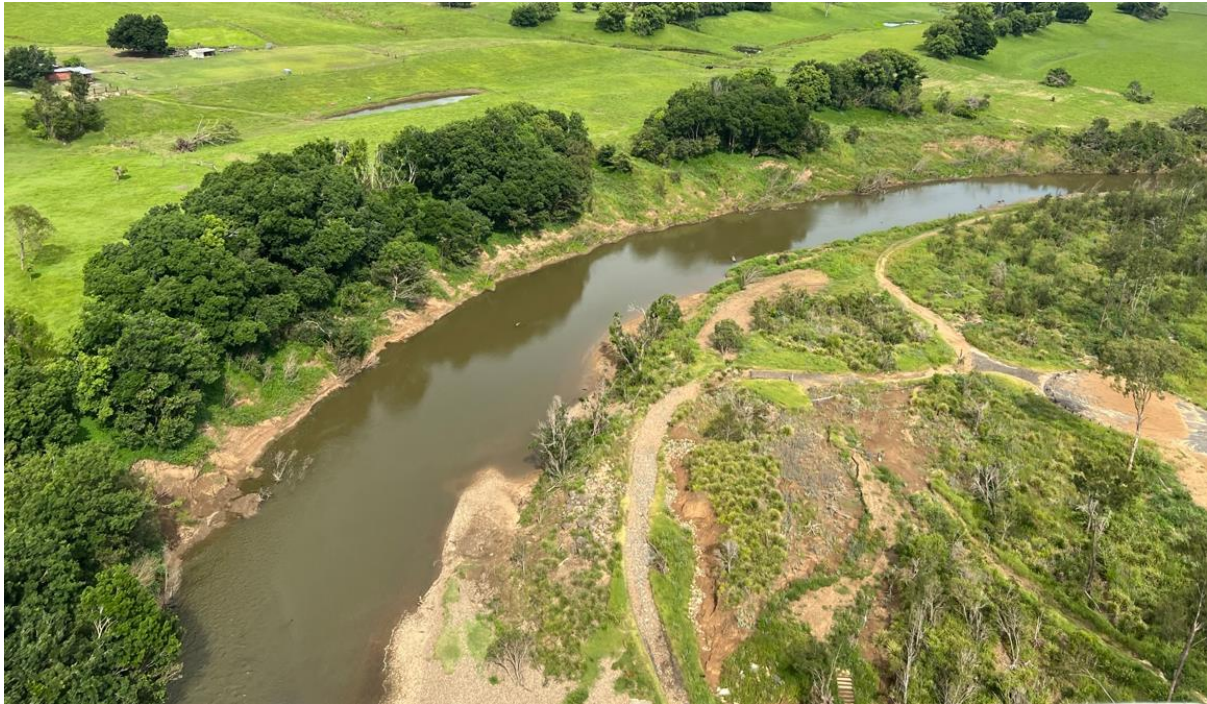
**Figure 36.** *Example of Slightly Degraded riparian condition on the left bank and highly degraded riparian zone at ‘the Sands’ reserve in Sub-reach 2 – photo looking downstream*

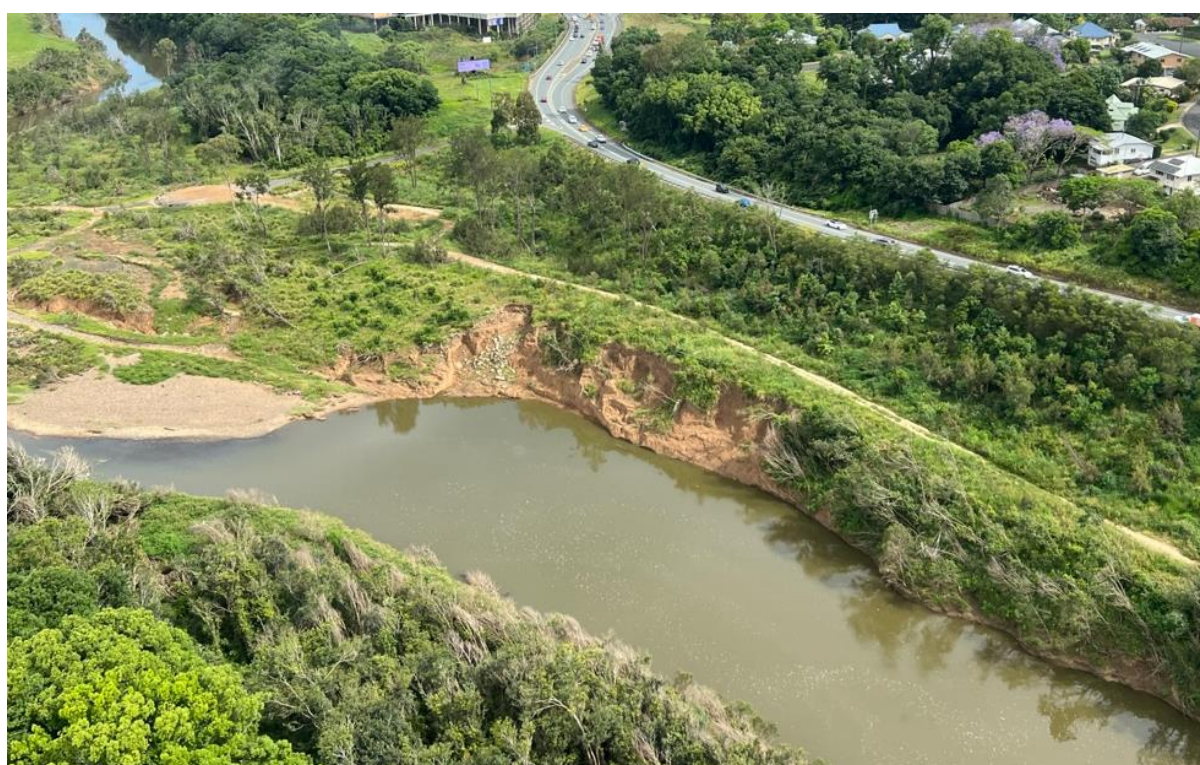
Figure 38. Example of section of bank with a very high erosion potential in Sub-reach 2

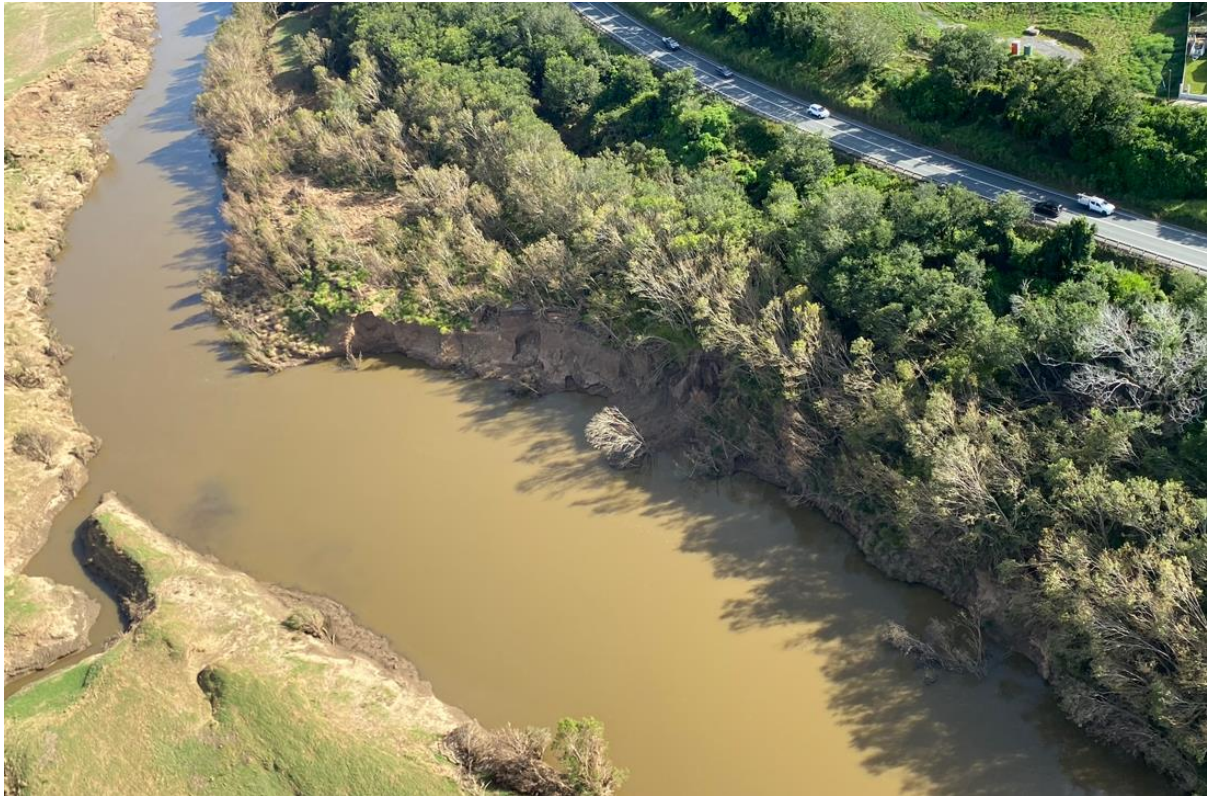
**Figure 39.** *Example of bank with high erosion potential in Sub-reach 2*

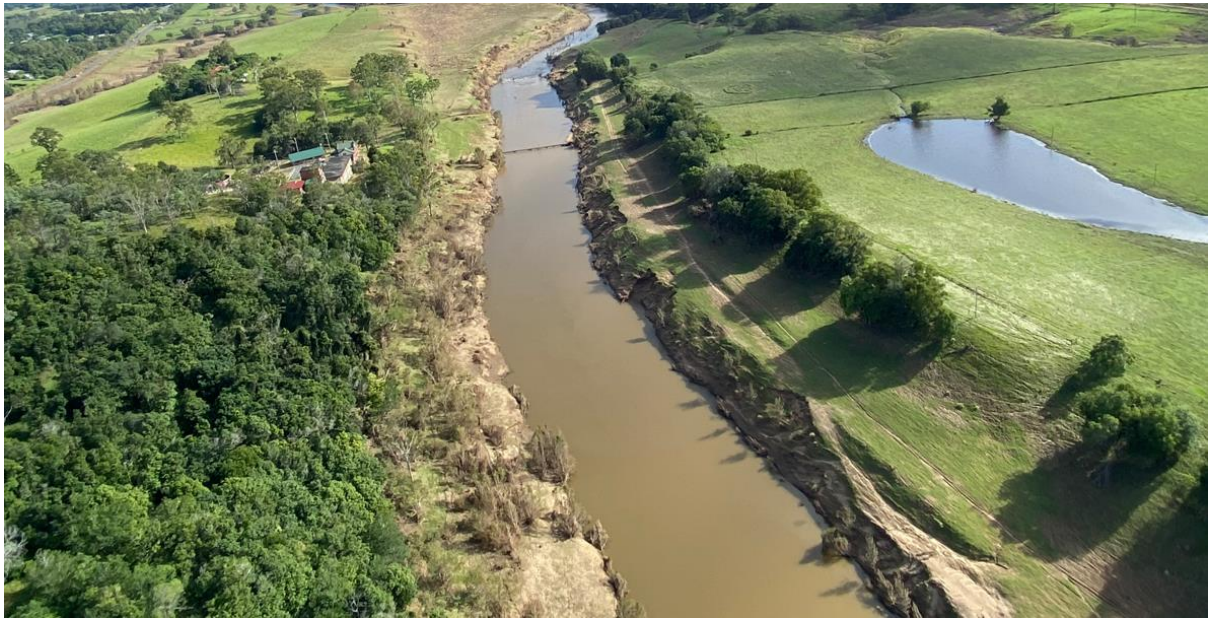
**Figure 45.** *Example of slightly degraded riparian condition on the left bank and highly degraded riparian condition on the right bank in Sub-reach 3 – photo looking downstream*

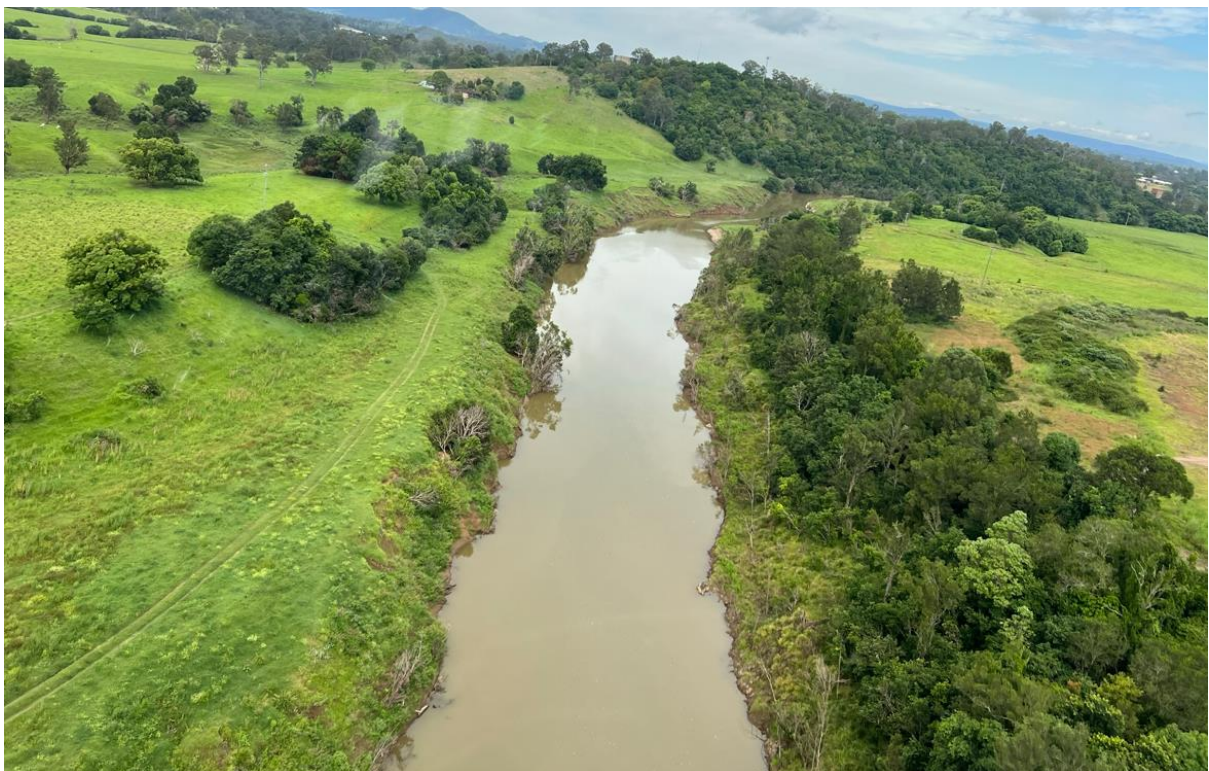
**Figure 46.** *Example of good riparian condition on the right bank and highly degraded riparian condition on the left bank in Sub-reach 3 – photo looking downstream*

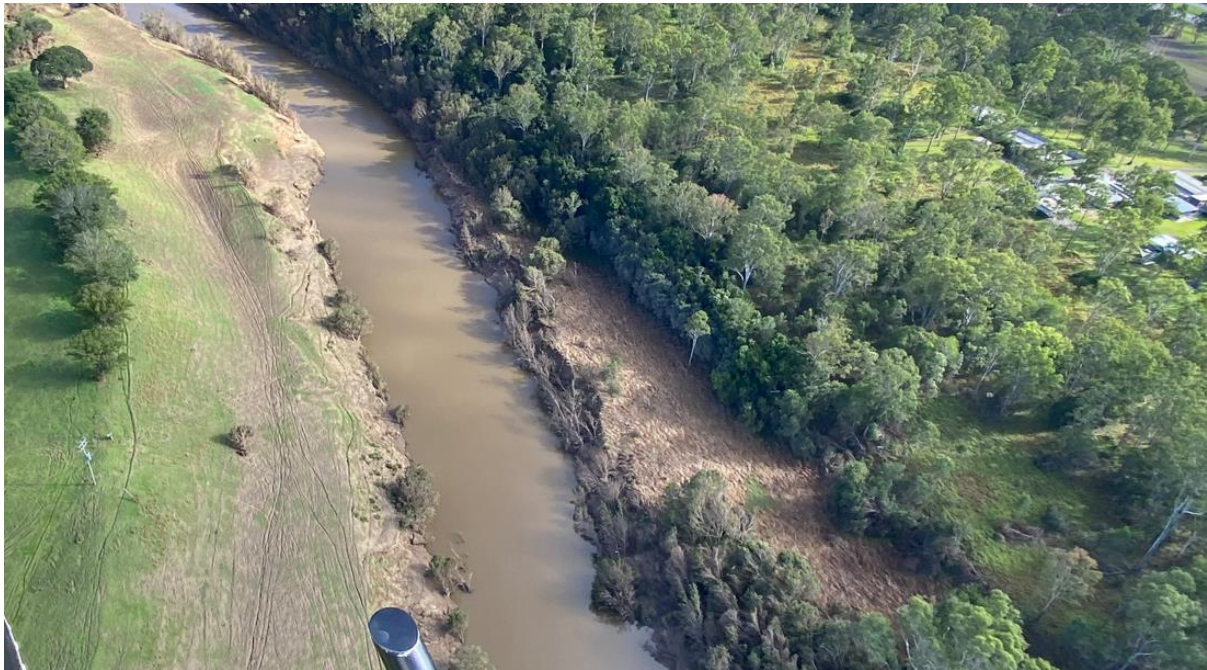
bank was classified as having Moderate erosion potential. The channel abuts the grazed floodplain through these sections and there is limited existing riparian vegetation. There is currently large areas of unrestricted stock access to the banks, which can result in increased erosion risk through pre-weakening or sub-aerial preparation, and limits the chance of natural vegetation regeneration. Some erosion is likely in future flood events either through wet flow failures or fluvial scour. Vegetation may be able to reduce the likelihood of future erosion. An example of a section of bank with a moderate erosion potential is presented in Figure 48.

**Figure 48.** *Example of section of bank with a moderate erosion potential in Sub-reach 3*
