**IMPLEMENTING THE MARY RIVER  
& TRIBUTARIES  
REHABILITATION PLAN**

**MONITORING & EVALUATION REPORT  
2003**

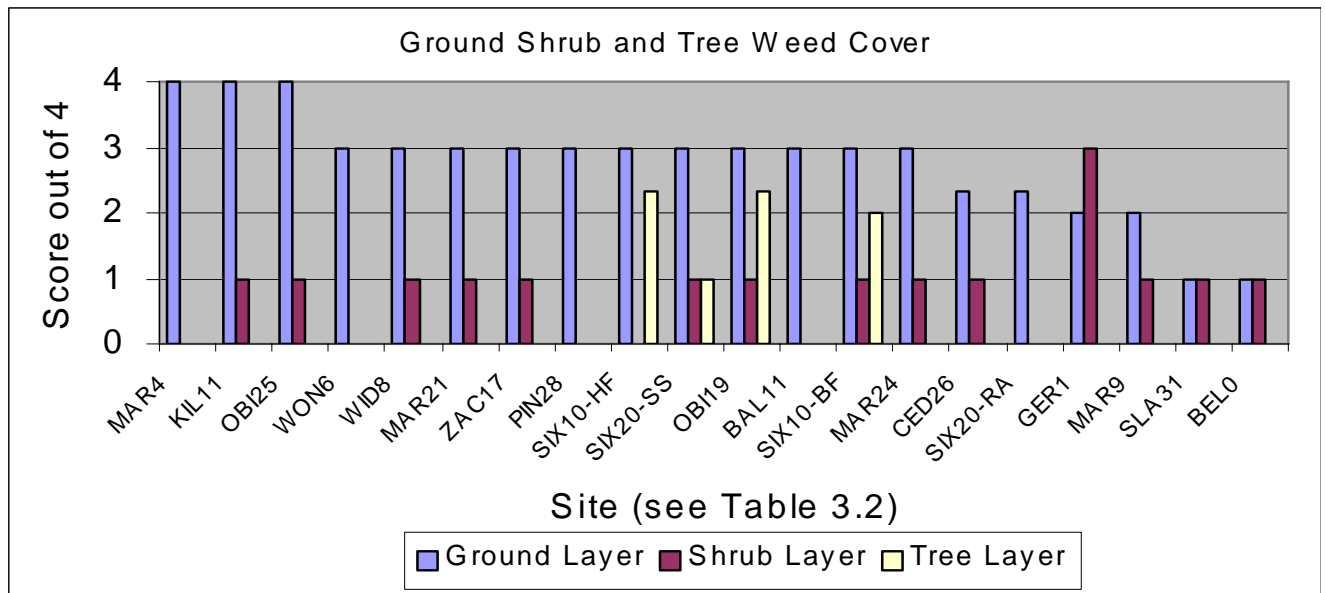
Figure 3.10

By viewing Table 3.7 and figure 3.10, it can be seen that the ground layer of weeds is identified as the most significant problem in terms of weed coverage of the riparian zone, while the tree layer is of least concern. As cattle have been removed from a significant number of sites, this may have a combined affect on the cover of ground weeds. Firstly certain weed species will no longer be suppressed by cattle grazing, and secondly the disturbed environment created by past cattle access often produces an ideal environment for weed invasion.

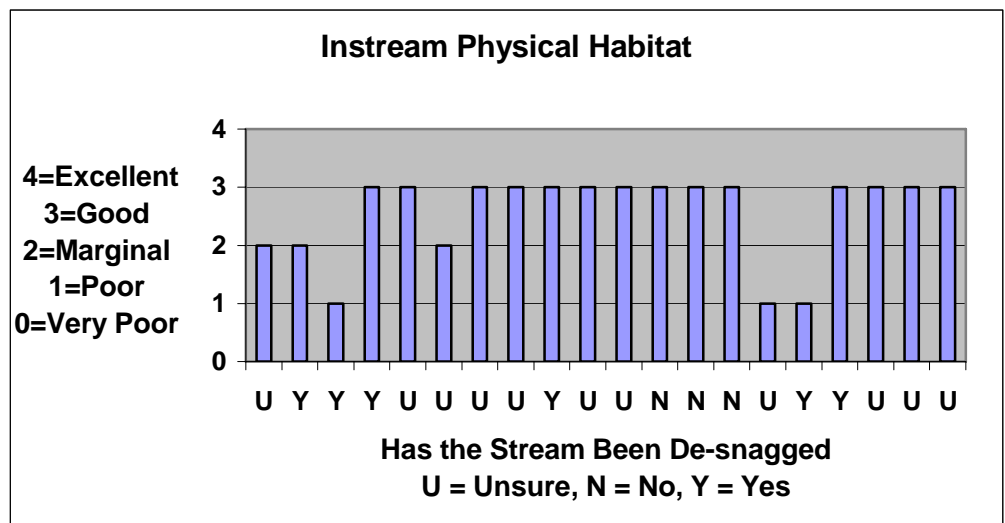
Figure 3.12

The results show that the majority of sites had “good” instream physical habitat. Radio tracking research on the Mary River Cod has revealed that 93 percent of all cod observations occurred within 2m of submerged timber (Simpson & Jackson 1996), suggesting that suitable woody debris habitat for cod is available at most of the sites monitored.
