## Gympie – Amamoor Waterwatch Report

2011 – 2012

Report prepared by:  
Brad Wedlock, Steve Burgess  
MRCCC Catchment Officers

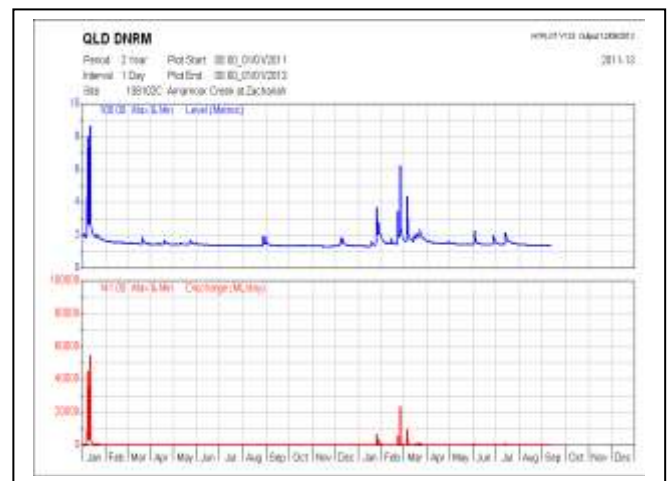
### Amamoor Ck - January 2011 to August 2012

Characterised by several highly erosive flood events during summer 2011/12, with several very rapid rises, but not to the same extent as the district experienced in January 2011.

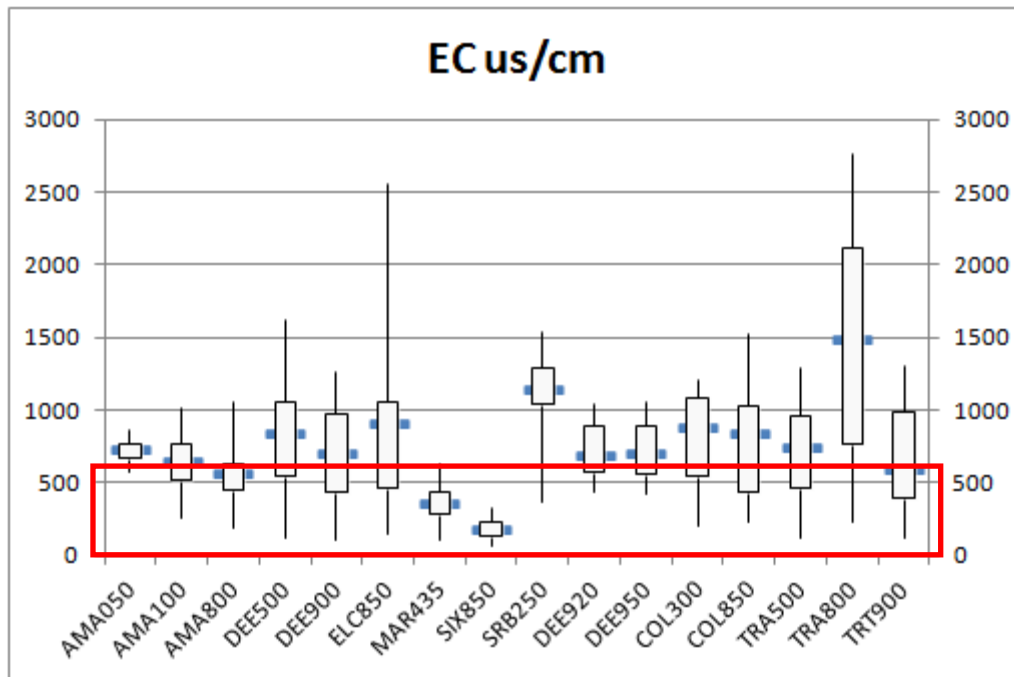
**Long-term inter-site comparison of electrical conductivity (salinity)  
in the Gympie Amamoor Waterwatch Network**

- This graph illustrates all the long-term data collected from each site, not just the last year's data. The red line represents the electrical conductivity guideline level of 580 us/cm – EC should be below this level to meet guideline values. However, it may be more appropriate to apply the Western Catchments EC guideline of 1200 us/cm (outlined in the Qld Water Quality Guidelines) for this network.

- These graphs reflect the variation in conditions experienced at these sites over the time the data has been collected. Some of these sites have a long history of data, including a long period of drought and low flows. More recent data does not include these long drought periods, eg. the Kandanga Creek site (KAD500) has only had data collected during relatively good seasons.

- Mary River and Six Mile Creek have consistently complied with EC guidelines - lowest EC values
- The more intermittently flowing creeks such as Scrubby, Eel, Coles and Traveston Creeks generally record higher EC values, and larger variation. Traveston Creek (TRA800) has the highest EC level and shows exceptional variation in electrical conductivity.

- Deep Creek displays similarly high EC values and large variations, although Deep Creek has more reliable flow than the intermittently flowing creeks within the Waterwatch network (as above).

- The majority of sites in the Gympie – Amamoor Waterwatch network has consistently recorded higher than the electrical conductivity (salinity) guideline for many years. Based on past experience salinity issues (e.g. salt-scalds) crop up after good seasons when the water-table is recharged and groundwater has moved up the soil profile closer to the soil surface. Consequently the district could experience salinity outbreaks over the next few years.

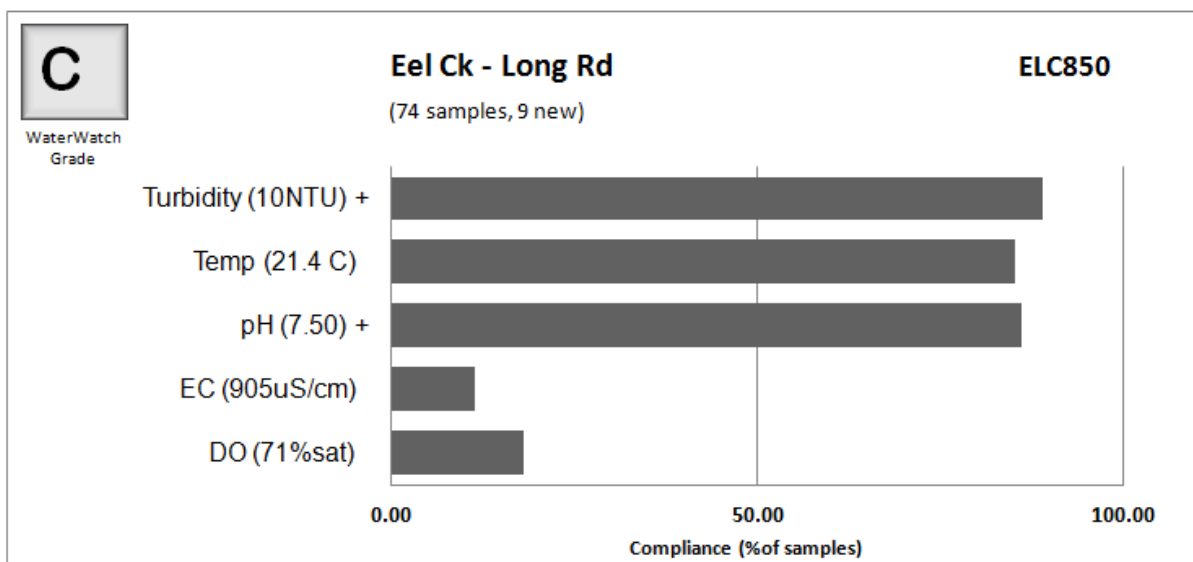
#### Eel Creek

- Good sample size
- Consistently higher EC levels than Amamoor and Deep Creeks
- This year turbidity, temperature and pH values were all compliant with guidelines

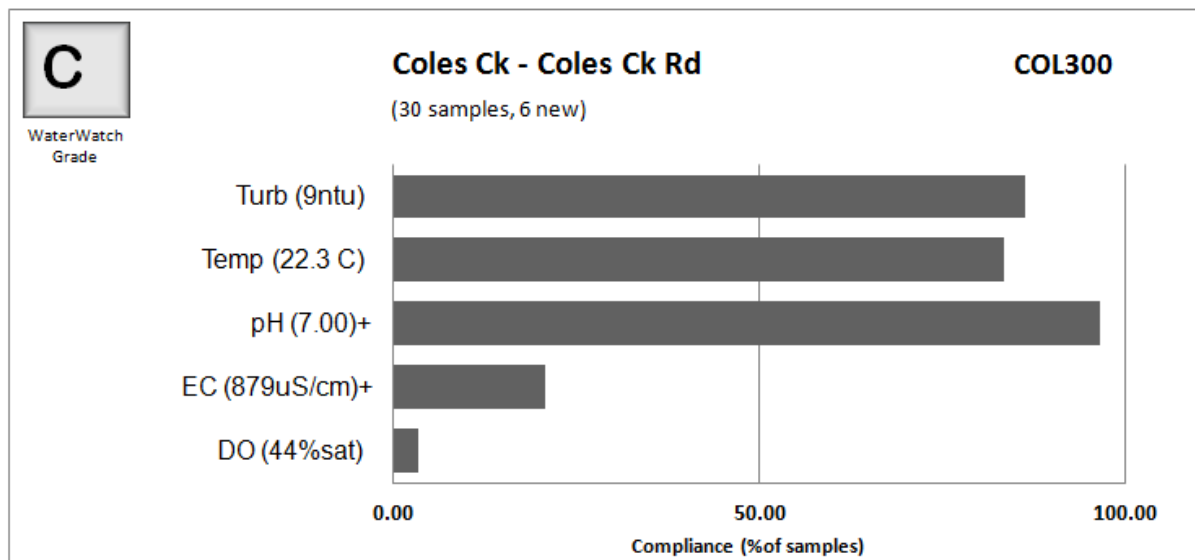
- At the Coles Creek sites the low compliance with dissolved oxygen guidelines is due to very low overall levels of dissolved oxygen during the period sampled. Generally Coles Creek has low to nil flows coupled with high leaf litter inputs from the shaded riparian zone.
- At the Coles Creek (COL300) site EC is consistently above the guideline level
