Obi Obi Creek

Large Woody Debris

Reinstatement Project

2003

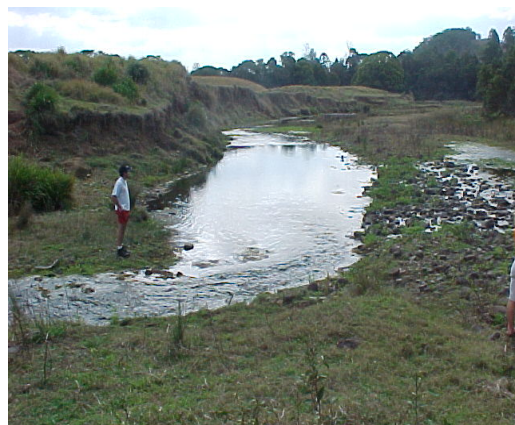
Figure 2: Obi Obi Creek Test Reach - 2001

The project site's southern bank has been improved for pasture and has no existing riparian vegetation as is highlighted in figure 1 & 2. The dominant flora species found on site was Kikuyu Grass. For later comparison (of the current pasture to the future revegetation), an extensive weed survey on the project site's southern bank, between ISC 2 and ISC 3 (approximately 430 m) was compiled (see figure 12). A riparian planting from ISC 2 downstream to ISC 3 upstream is planned for this bank, following the completion of on-ground works.

The ISC highlights that the 'Physical Form' and especially 'Streamside Zone' of the Pryor project site, are much degraded (see figures 2, 5, 7 & 9).

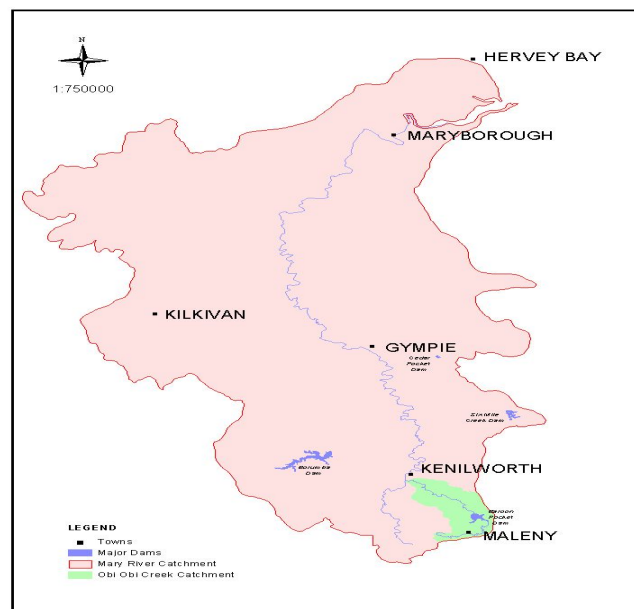
Figure 4: Obi Obi Creek Catchment

Obi Obi Creek drains 202km² in the south of the Mary River Catchment (Figure 4), and has a mean annual discharge of 156 000 ML (Stockwell 2001, pp 28). This represents approximately 2.1% of the total Mary Catchment area, and 6.1 % of the total discharge volume of the Mary River.

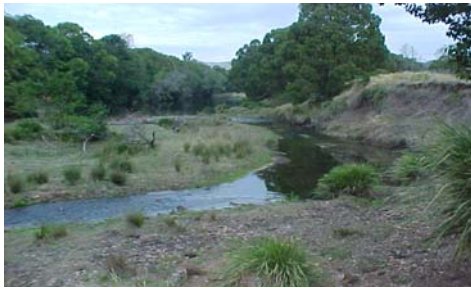
Figure 7: Obi Obi Creek Pryor test reach – looking upstream (island on left)

The project site has been chosen for LWD works as it exhibits an approximate 450 metre incised, over widened, regulated high energy stream (Dudgeon, 2000) with unstable, undercut, rapidly eroding and slumping southern banks to a height of up to four metres (Wedlock, B. pers. Comm (verbal) 2002) see figure 7. Being void of any natural riparian vegetation, the project site is exhibiting an erosion rate of 1.80 metres per year (Pryor, J., Pers. Comm. (verbal), 2002) see figure 8.

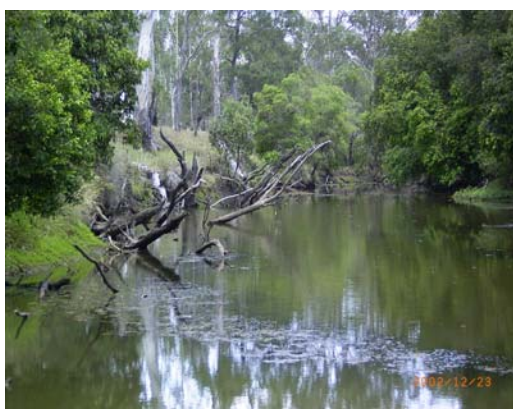
Figure 8: Excellent example of large woody debris – Munna Creek, Mary River Catchment

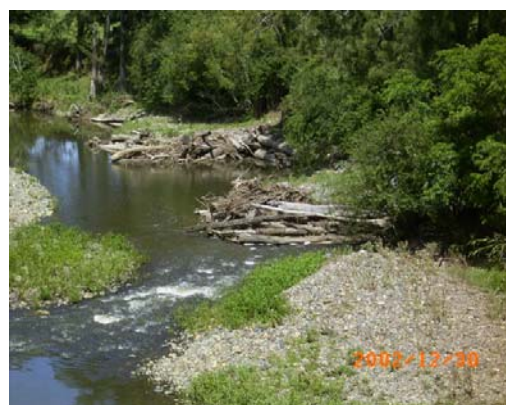
Figure 9: Engineered log-jam – Williams River, Hunter River Catchment (NSW)

and erosion (figure 9). They also help to store sediment and hold pools in the stream system. They are particularly important in sand or loose material beds (Dudgeon 2000, p1).

The LWD project at the Pryor project site was designed by Department of Natural Resources and Mines (DNR&M), Rivercare Officer Stephen Dudgeon, with further recommendations and designs by Nick Marsh (CRC Catchment Hydrology) and Brad Wedlock (see figure 14). The project aims to arrest the erosive processes acting upon the southern bank while increasing in-stream habitat for the endangered Mary River Cod. This design was modeled and developed on Brooks (2001) work in the Williams River, NSW (figure 9).

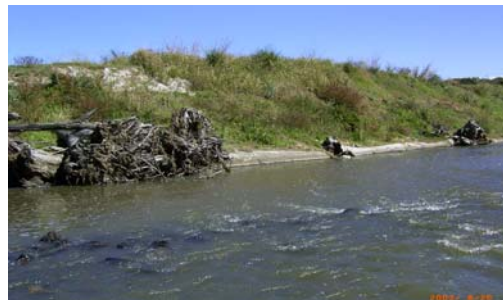
Figure 11: log revetment placed on Pryor project site, note log groyne in left of picture

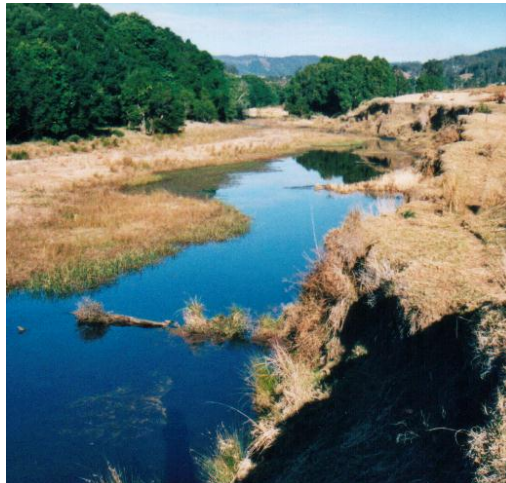
Obi Obi Creek Pryor Test Reach (2001) –
note very bad erosion on right of photo

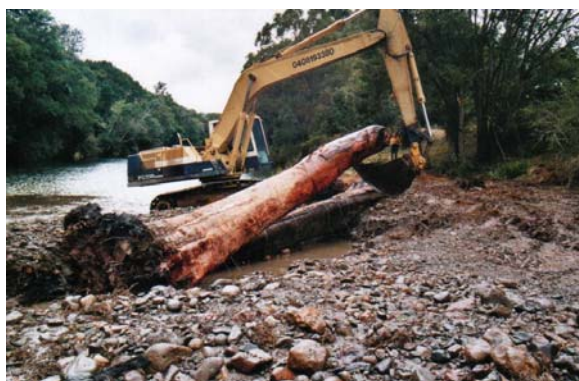
Figure 15: Constructing the double log sill structure to raise riffle crest height and divert base-flows into a secondary channel.

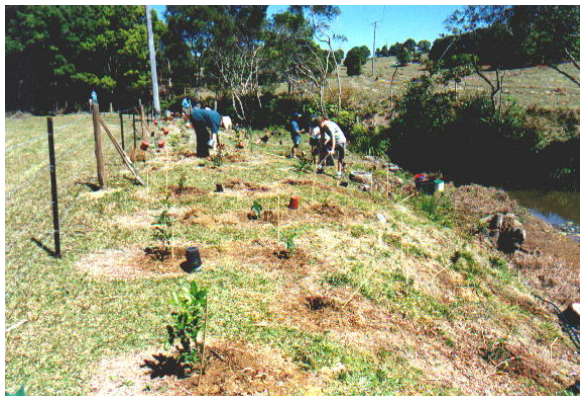
Figure 16: Appropriate riparian tree-planting width, without the basic allowance of 5 metres. In some instances this is impractical due to loss of good agricultural land to revegetation by the landowner.

Using Abernethy (1999) the appropriate planting width is to be a minimum of 14.4 metres, based on a basic allowance of five metres, a height allowance of four metres, and erosion rate of 1.8 metres and a three year maturity of the riparian species.

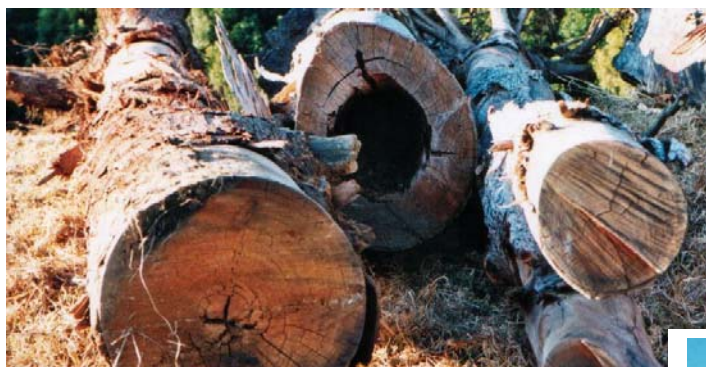
Figure 17: Timber used in the LWD project

Another fourteen (14) logs were sourced from Buderim and Peregrine in October 2002 with an average volume of 7.46 m^3 , equalling 104.44 cubic metres of timber.

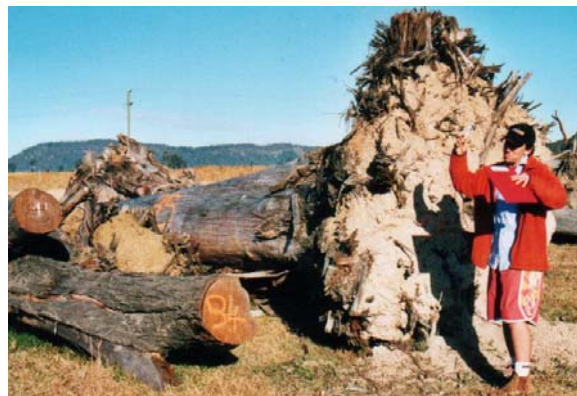
Figure 18: Timber used in the LWD project – note height of root-wad

It is imperative that all LWD have attached a substantial rootwad (Dudgeon, S., Pers. Comm. (verbal), 2001). A log with an attached rootwad potentially has twice the weight of a comparatively similar log lacking a rootwad. The rootwad in its own right weighs as much as the log itself and this was proven by the positioning of the excavator log grabs during loading. For the excavator to successfully “grab” and place the balanced log on semi trailer, the operator positioned the grabs as close to the rootwad as possible, thus proving the distribution of weight throughout the entire log (see Figure 31 & 32).

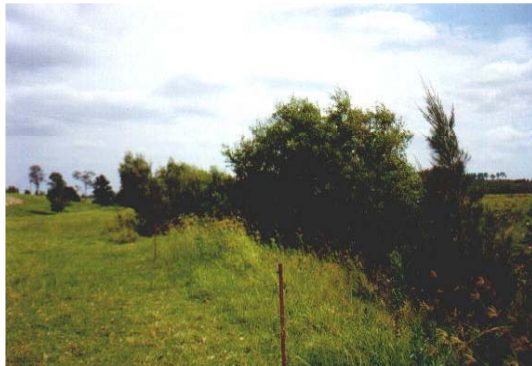
Figure 21: Typical 2-strand hotwire electric fence on the Mary River, Goomong

- A 4-strand barbwire conventional fence, that is set back from the creek to prevent damage from flooding.
- A 2-strand hotwire electric fence, this style of fence can be dropped quickly prior to a flood event, and is light and easy to re-erect. The flexibility of this style of fence makes it suitable for riparian zones, as they can be easily moved closer to the creek or further away. However some maintenance is required to ensure grasses and groundcovers do not create contact and earth the electrical system, thereby reducing effective charge (Figure 19).

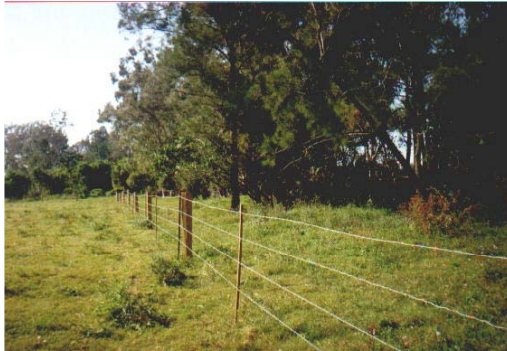
Figure 22: Typical drop-down fence on the Mary River, Tiaro

- A permanent drop-fence can be erected. This style of fencing can be constructed of galvanized pipe, with the posts concreted in the ground. Each post has a hinge at the base, with a pin. By releasing the pin the fence can hinge downwards and be dropped down prior to a flood event. Another method of constructing a drop-fence is to use ordinary strainer and split posts, but instead of wiring these up, smaller posts (like tomato

stakes) are wired up, like a fence, and these tomato stakes are then wired to the strainer and split posts using low tensile wire. This allows quick and easy cutting of the low tensile wire from the posts prior to a flood event (Figure 20).

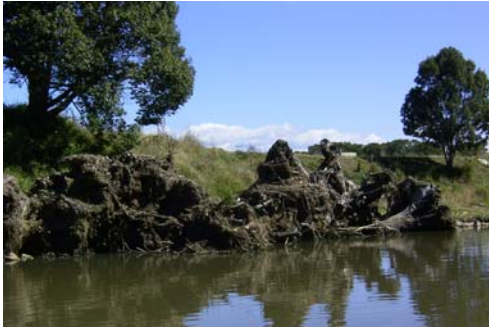
Figure 23: 1st major log-jam from water level

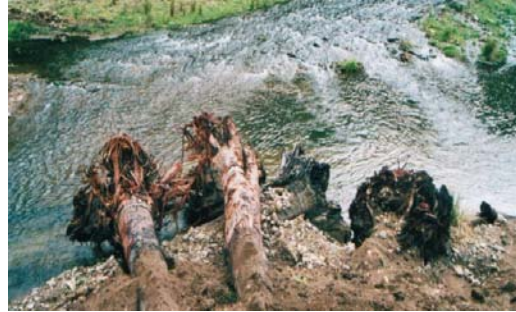
Figure 24: 2nd log-jam below riffle

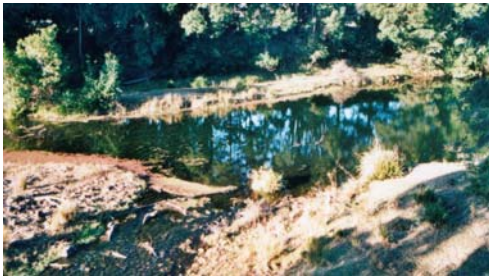
Figure 25: 1st riffle; pre-construction of double log sill

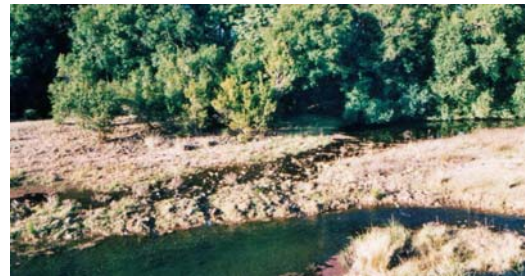
Figure 26: 2nd riffle; pre-construction of large woody debris upstream

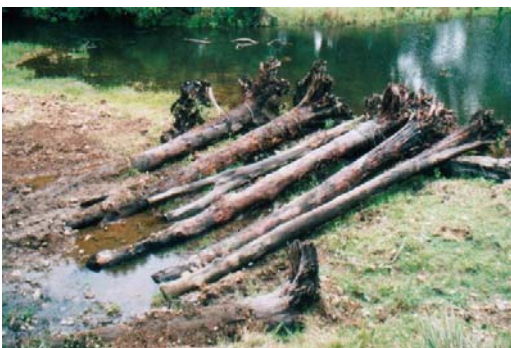
Figure 27: 1st riffle; 9 months post construction

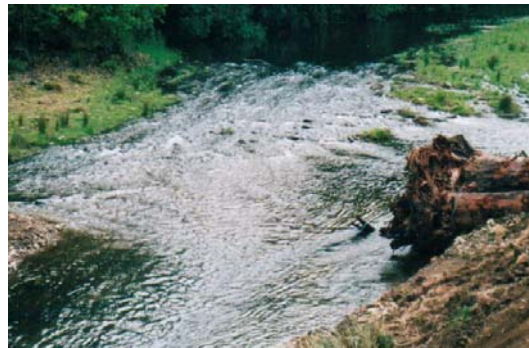
Figure 28: 2nd riffle; 9 months post construction, note log-jam on right

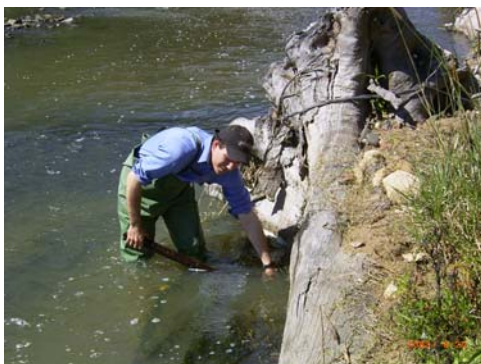
Figure 29: Showing length of undercut bank generated by turbulence from root-wad

Documented in Marsh, Rutherford & Jerie (2001), Mary River Cod are known to use LWD for the spawning of their adhesive eggs. He continues by stating that, 'LWD (also) creates hydraulic diversity by creating areas of high velocity, low velocity and turbulent flow. The local velocity fluctuations produce small scour and depositional areas around the LWD providing variations in water depth' (see figure 29 & 30). Variations which due to de-snagging are now rare and which prove vital in providing habitat favorable to the Mary River Cod. Moreover, this deposition of stream bed material is intended to reverse the erosive processes acting upon the exposed face of the southern bank, which together with the extensive riparian revegetation will render this southern bank stable. In support of this statement, Brooks (1999) states that, 'The presence of LWD near the bed and banks of a channel provides roughness to the flow, effectively educing the net energy of the flow which in turn reduces the ability of the stream to erode the bed and banks'.

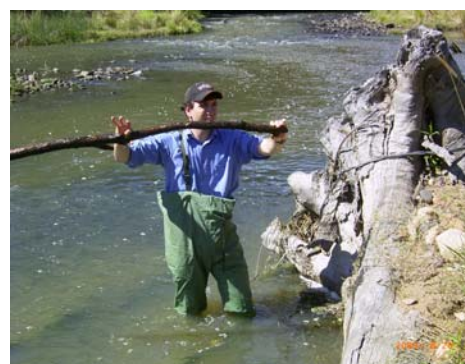
Figure 30: Approximately 60 cm of undercut bank created by scour from the root-wad

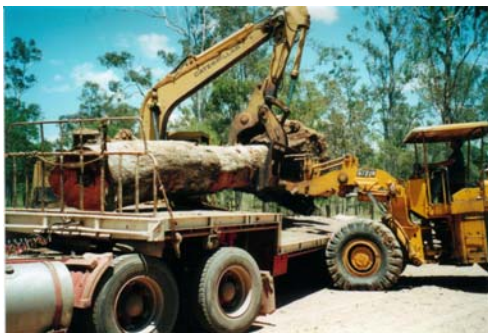
Figure 31: Note front-end loader and excavator lifting log onto truck

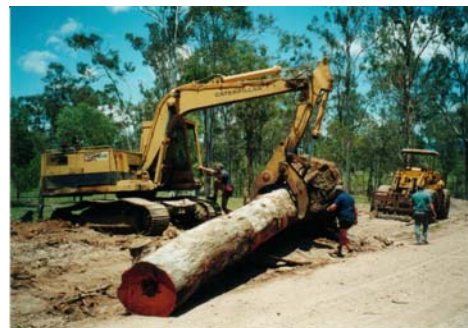
Figure 32: Note lifting point of log with excavator
