## Wide Bay – Widgee Creek Waterwatch Network Report

June 2011

MRCCC Catchment Officers

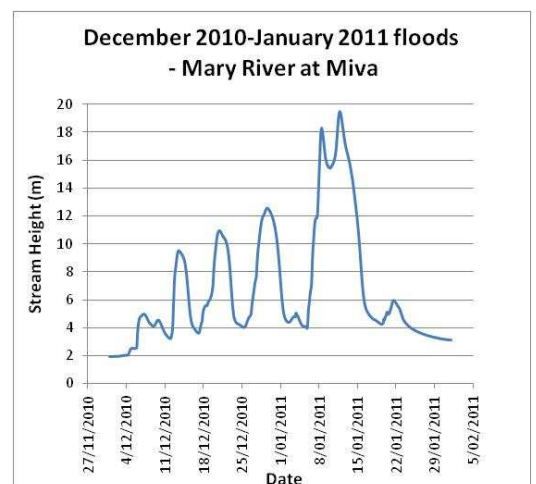
### 4. Mary River, at Miva

Characterised by several rises and falls in the river during December, and an extended double flood peak in early January 2011 which contributed to two separate urban flood events in Maryborough. The flood peak at Miva was the 5<sup>th</sup> highest recorded since 1910.

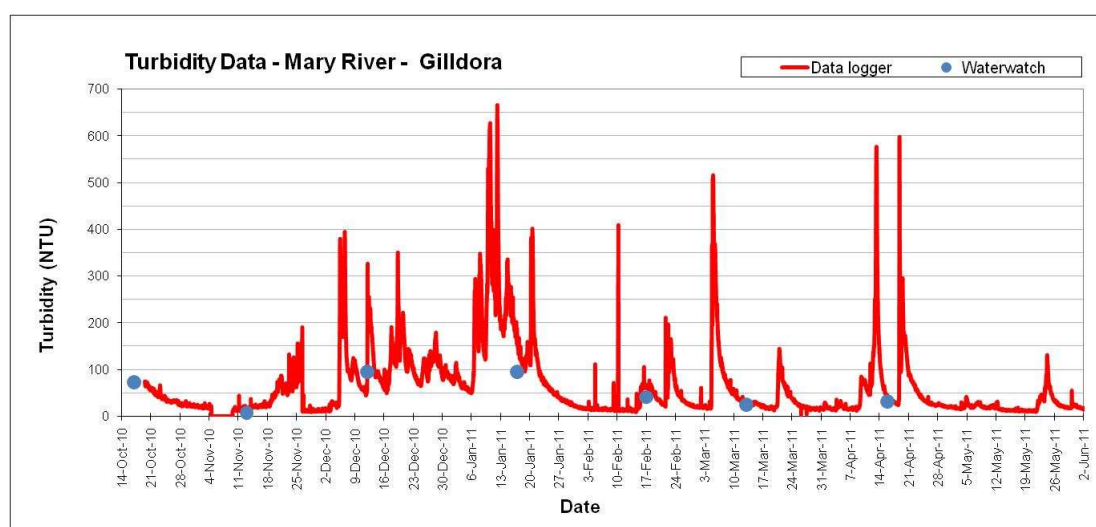
The graph below shows turbidity data recorded from an automated turbidity data logger installed in the Mary River upstream of Gympie (Gilldora). This clearly shows the extreme turbidity levels (more than 600 NTU's) recorded in the Mary River during the summer 2010/11 flood events. MRCCC's previous data using hand-sampling techniques has not measured any turbidity levels over 500 NTU's. The automated equipment was able to sample during the dirtiest and most dangerous part of the flood, which we would not ordinarily be able to sample safely.

To put this into perspective a turbidity measurement of 600 NTU's combined with the peak flow rate recorded in the Mary River at Miva equates to approximately 237 tonnes of sediment (or seven dump trucks) flowing under the Dickabram bridge every minute.

The ambient turbidity sampling conducted by the volunteers cannot measure this impact on water quality because turbidity measurements are not taken during the peak flood events. The graph below shows the monthly Waterwatch turbidity measurements recorded for the year at a nearby Waterwatch site compared to the turbidity data recorded from the automated turbidity logger installed at Gilldora. This clearly shows that the Waterwatch turbidity data does not capture the peak events.

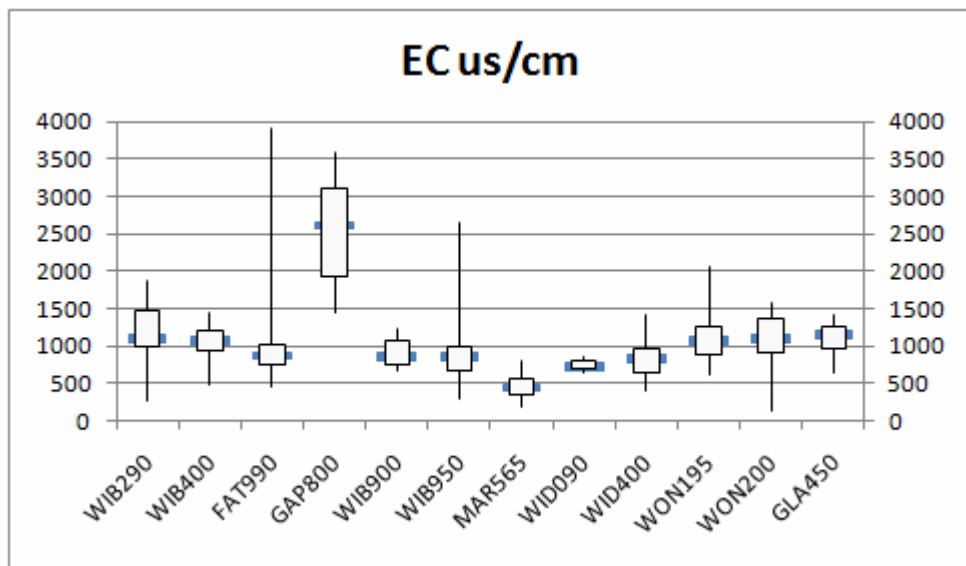
### Long-term inter-site comparison of electrical conductivity (salinity)

- This graph illustrates all the long-term data collected from each site, not just the last year's data
- These graphs reflect the variation in conditions experienced at these sites over the time the water quality data has been collected. Data at some of these sites has been collected over a long time (ie. many years), which includes a long period of drought and subsequent low flows. However sites that have only been recently included in the network does not include these long drought periods, eg. at the Widgee Creek site (WID090), consequently there is little variation in the data due to the majority of data being collected during relatively good seasons.

- Overall EC levels in this network are higher than the levels observed in all the other Waterwatch networks of the Mary River catchment.
- Gap Creek is a statistically different outlier amongst the entire Waterwatch network for electrical conductivity.
