## Gympie – Amamoor Waterwatch Report 2010 – 2011

Report prepared by:

June 2011

## Introduction

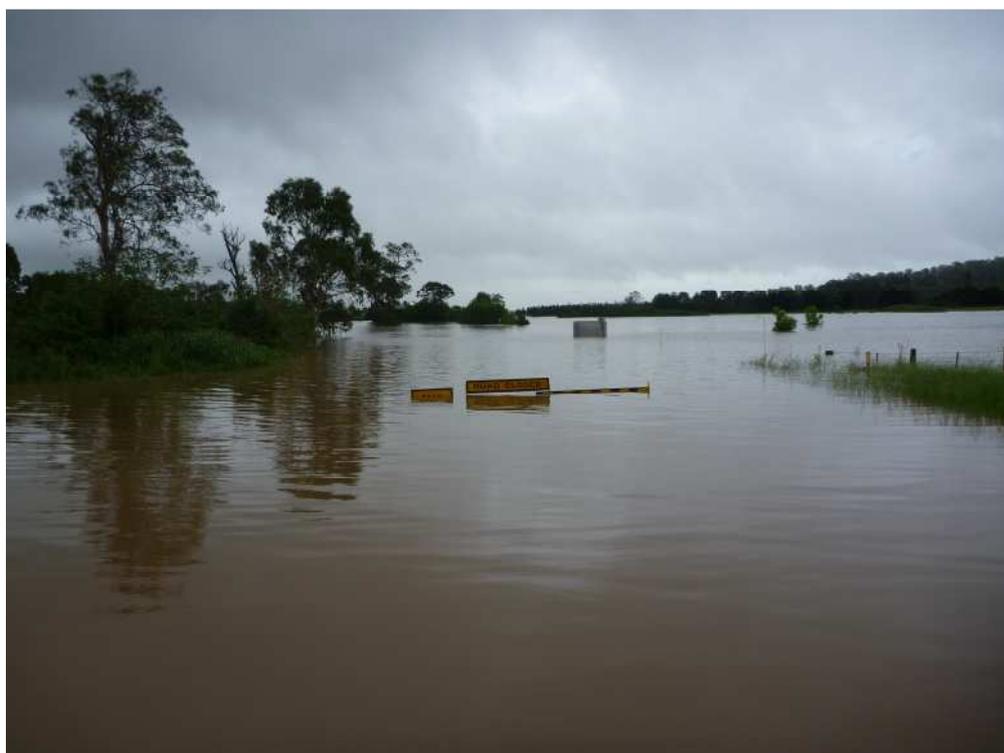
The ambient turbidity sampling conducted by the volunteers cannot measure this impact on water quality because turbidity measurements are not taken during the peak flood events. The graph below shows the monthly Waterwatch turbidity measurements recorded for the year at a nearby Waterwatch site compared to the turbidity data recorded from the automated turbidity logger installed at Gilldora. This clearly shows that the Waterwatch turbidity data does not capture the peak events.
