# Kenilworth & District Waterwatch Report 2010 – 2013

Report prepared by: Brad Wedlock, Steve Burgess MRCCC Catchment Officers, October 2013 v2

# 2013 flood heights from gauging stations

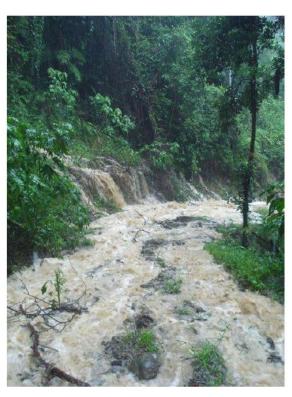
January 2011 flooding rainfall, upper Mary River
