Upper Mary River Catchment

Waterwatch Report

2010 – 2013

Report prepared by:
Brad Wedlock, Steve Burgess
MRCCC Catchment Officers, October 2013 v2

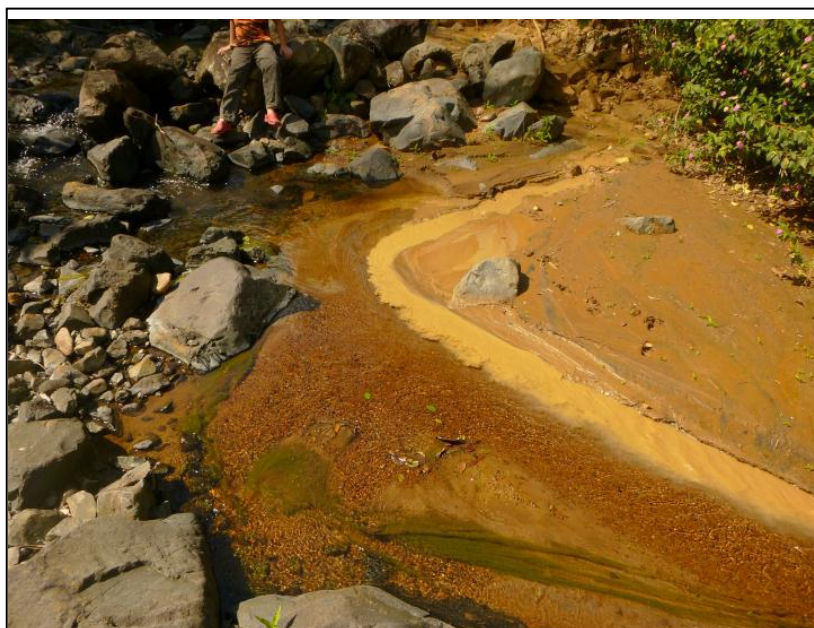
Sediment entering the river from an active landslip far upslope

In the lower Mary catchment, many volunteers have expressed concern about rising electrical conductivity (EC) levels over the winter 2012 period, however this was not an issue in the upper catchment. The extended dry season which gave us an insight into the baseflow conditions of the creeks after all the alluvial aquifers have been recharged due to good rainfall conditions over the past few years. In the upper catchment, volunteers have expressed concern about high sediment concentrations which stem from a number of active landslips high in the catchment which have reactivated following intense rainfall events over the last three wet seasons.

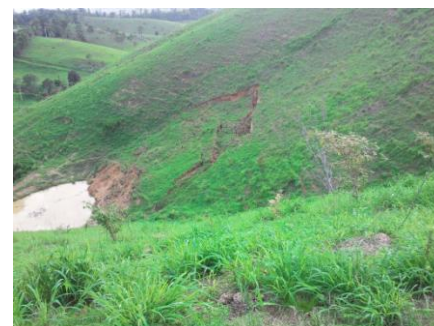
Landslip at Glastonbury, west of Gympie

New landslips have been reported on the Maleny plateau, the red soils of the Amamoor, Dagon, Glastonbury, Woolooga and Widgee districts and on the steeper land on the eastern-side of the catchment, primarily in the Six Mile Creek sub-catchment e.g. Pinbarren district. These districts are historically prone to landslips following heavy rain, with Maleny located on the basalts and the Eastern catchments located on the phyllitic shales of the Kin Kin beds. Gympie bean-growers using green manure crops on the steeper volcanic-derived soils have experienced very little soil movement.

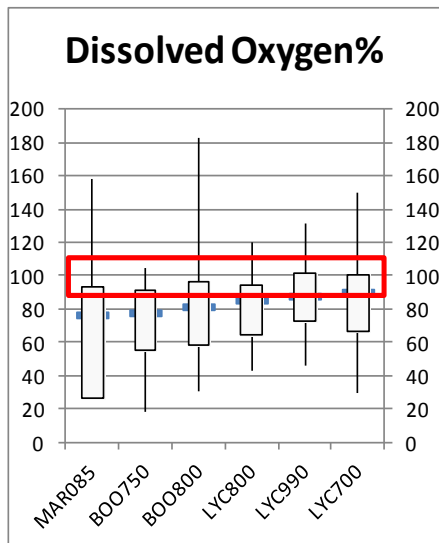
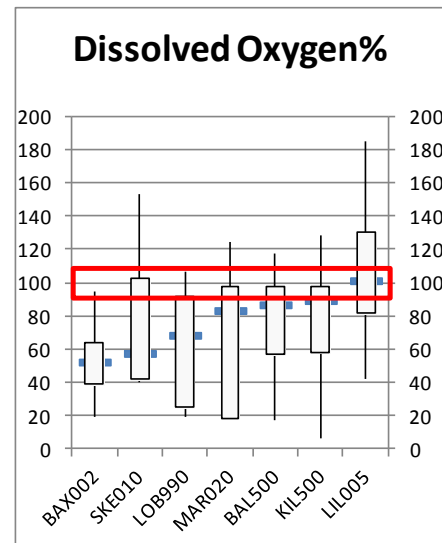
Long-term inter-site comparison of dissolved oxygen levels (all data collected)

- These graphs illustrate all the long-term data collected from each site, not just the last three year's data – the red rectangle represents the scheduled dissolved oxygen guideline level.

- Dissolved oxygen levels can change remarkably over the course of a day. In disturbed waterways with high nutrient and light levels dissolved oxygen can vary over a wide range eg. 30% to 150%. In undisturbed waterways the oxygen levels are generally maintained within a smaller range .

- The Mapleton lillyponds (LIL005) show an overall high level of dissolved oxygen, but this is not necessarily an indicator of good stream health . High levels of aquatic weed growth in sunny open conditions will produce high levels of oxygen in the afternoon, and very low levels in the early morning.

- All of these sites tend to sit below the scheduled guidelines, even in relatively undisturbed areas. In most cases, this is due to the ephemeral nature of the creeks, and high inputs of organic matter from vegetation.

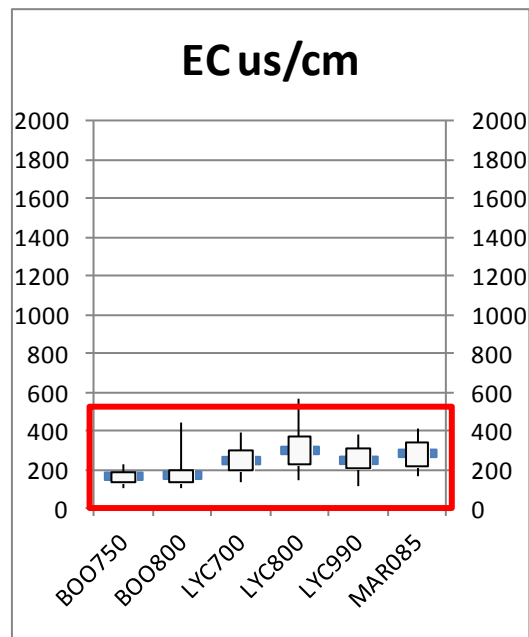
**Long-term inter-site comparison of electrical conductivity (salinity)
in the Upper Mary Catchments Waterwatch Network**

- These graph illustrates all the long-term data collected from each site, not just recent data. The red line represents the electrical conductivity guideline level of 580 us/cm – EC should be below this level to meet guideline values. There is no dissolved oxygen guideline difference between upland and lowland sites.

- Even though the period of time that these data were collected from include some very dry spells, there is no indication of electrical conductivity at any of these sites that lies outside the guideline levels.

- Balgowlah Creek is quite different to Kilcoy Creek, (to which it is a tributary). This may be an indication of a local geological influence.
- The site in Little Yabba Creek downstream of Charlie Moreland campground looks to have slightly higher overall levels of EC than the site upstream. This could be tested with a more detailed statistical analysis of the paired upstream and downstream tests to see if the difference is significant.

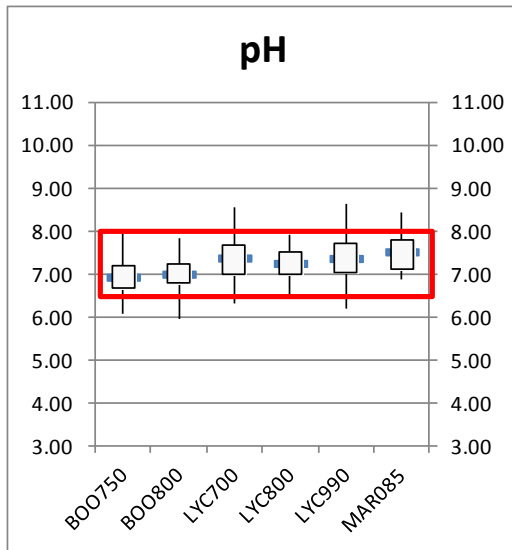
Long term inter-site comparison of acidity in the Upper Mary Catchments Waterwatch Networks

- This graph illustrates all the long-term data collected from each site, not just the last year's data – the red rectangle represents the pH guideline levels (pH should be between these levels to meet guideline values)

- All sites show generally good compliance with pH, with the exception of the sites draining the upper parts of the Mapleton plateau.
- The low pH of the Baxter and upper Skene's Creek sites is likely to be the result of underlying geology. It is consistent with other waterwatch data from Fryers Creek on the Maleny plateau. There is probably a case for setting local pH guidelines for creeks draining the deep red soils of the Maleny/Mapleton plateau.

- The large variation in pH in the Mapleton lillyponds is most likely associated with large variations in dissolved oxygen and carbon dioxide levels as a result of profuse aquatic plant growth in the open conditions of the lillyponds. This also contributes to an overall higher pH level recorded because waterwatch samples are taken during the day (on the high side of the diurnal pH cycle)

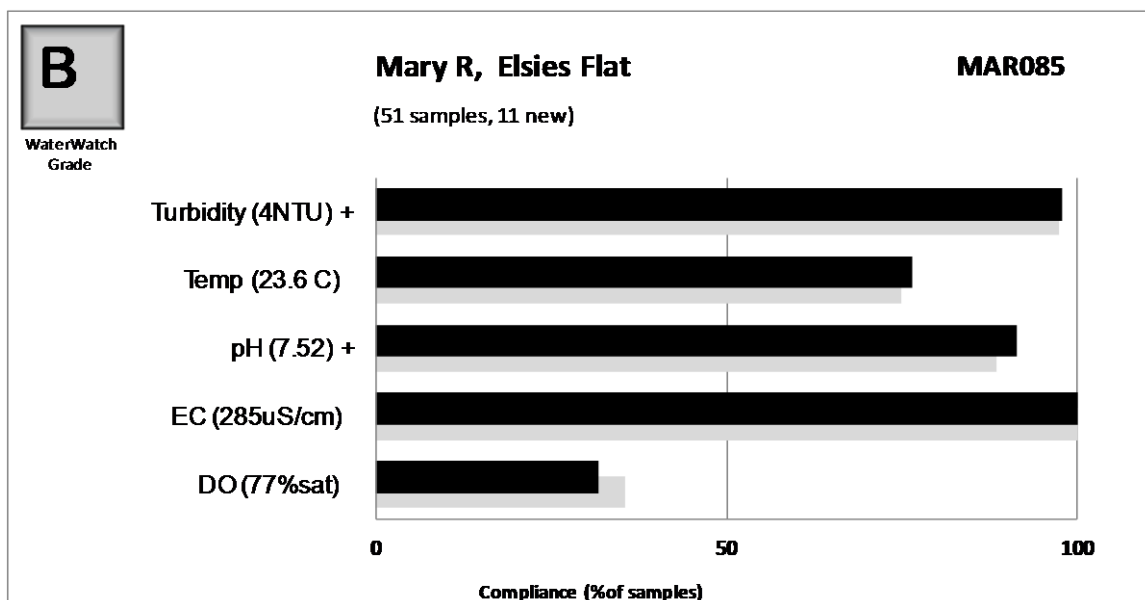
- Good sample size
- Significant increase in compliance for pH and turbidity guidelines over the past 3 years
- Excellent compliance for electrical conductivity guidelines
- The most concerning aspect of this site is the low dissolved oxygen compliance in a regularly flowing section of the river.
- Maintaining an overall grade of B (2010 Waterwatch Grade = B)
