Wide Bay – Widgee Creek Waterwatch Network Report

2012 / 2013

October 2013

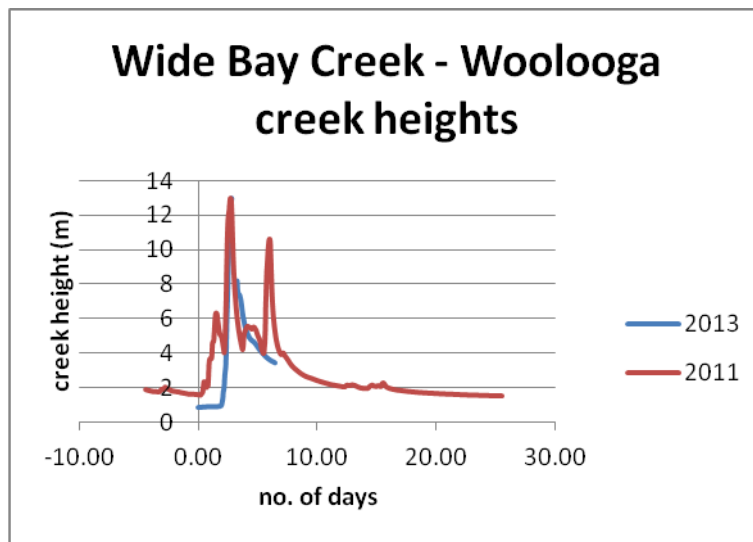
Figure 5 – 2011 & 2013 flood comparisons at Wide Bay Creek, Woolooga

In 2013 a new record flood peak was recorded on Wide Bay Creek at Woolooga, surpassing the record set in January 2011. Figure 5 compares the flood peaks and rises from the 2011 and 2013 floods from the Wide Bay Creek (Brooyar) gauging station near Woolooga. The graph shows that the two floods displayed very similar rate of rise, although the 2013 flood started from a much lower point in the creek. The creek height increased at a rate of approximately 50cm per hour. Considerable damage was sustained in Wide Bay Creek at Kilkivan with a new possible flood peak record.

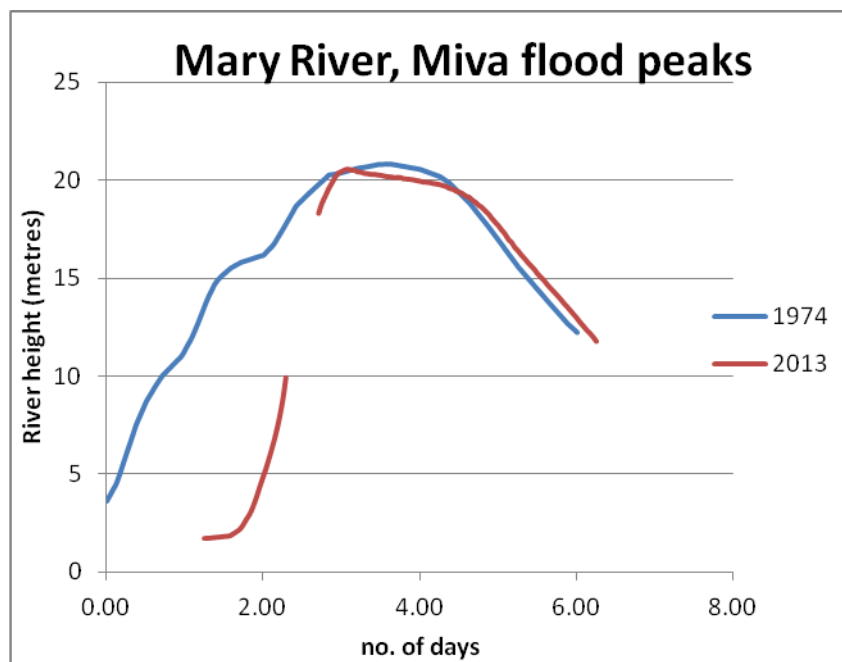
Figure 4 – comparison of 1974 & 2013 flood peaks on the Mary River at Miva

In 2013 the Mary River at Miva recorded its 3rd highest flood peak since 1910, only 30cm below the flood recorded in 1974. Maryborough recorded a flood peak of 10.7m (8am 29/1/13) - its 4th highest flood peak since 1893. The Mary River at Home Park recorded a new peak height of 23.565m, the highest since recording began at this location in 1982. Figure 3 compares the flood peaks on the Mary River at Miva from 1974 and 2013. Comparing the 2013 flood to the 1974 flood at Miva, the 2013 flood increased to approximately the same height, but rose much quicker from a significantly lower initial river height.

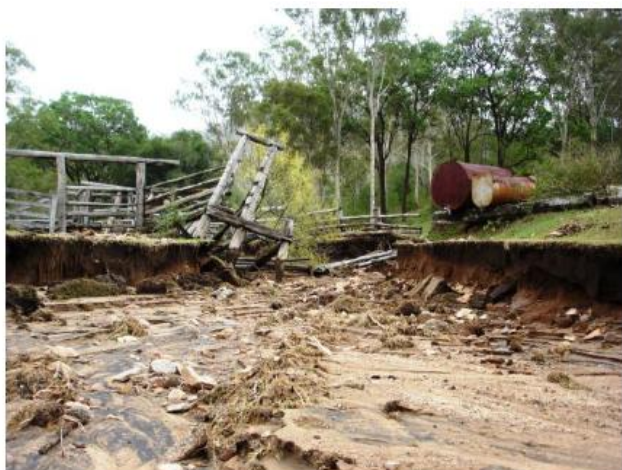
Station Creek streambed erosion, Upper Thornside

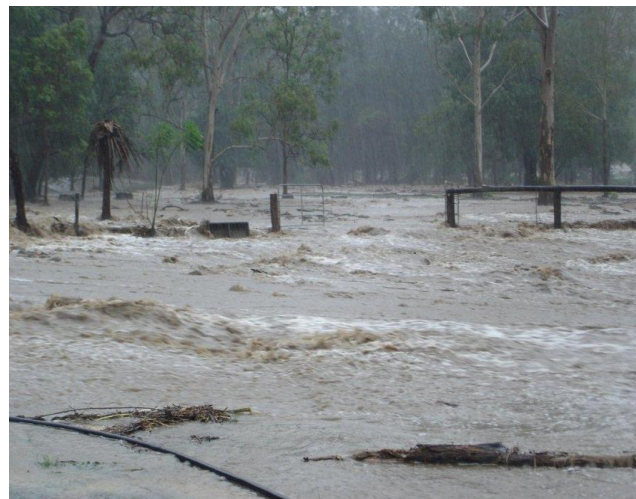
Widgee Creek flood flows

Widgee Creek experienced significant flooding and flood damage, with significant road damage, creekbank and streambed erosion. Glastonbury Creek recorded a new flood peak, with the previous peak recorded in 1955.

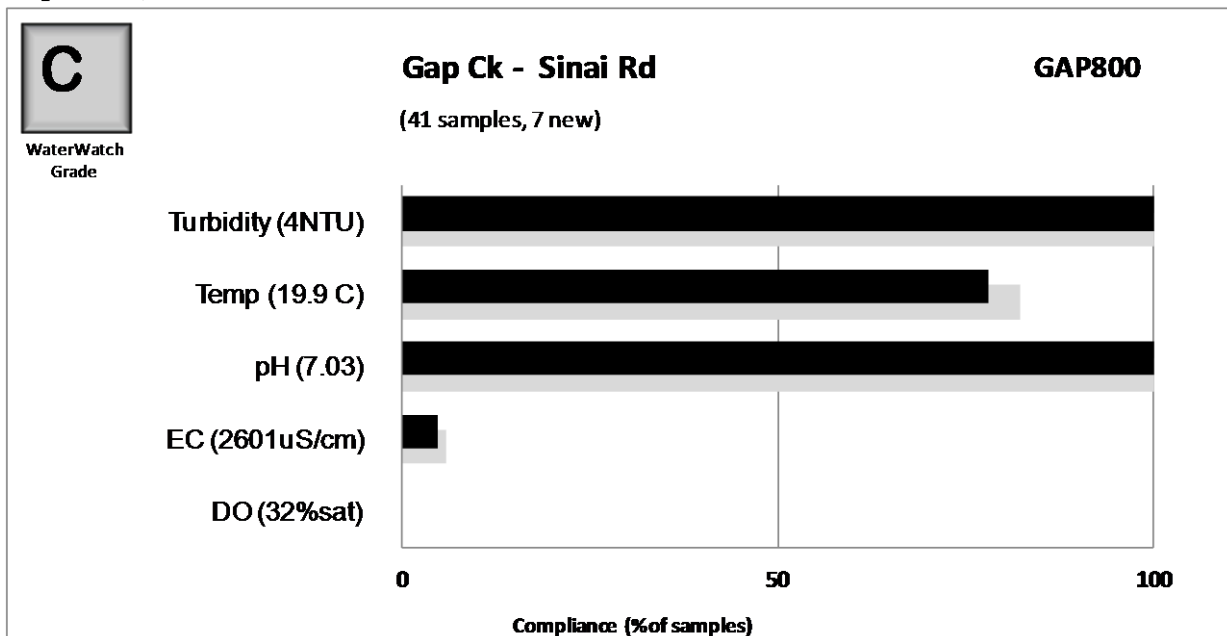
Gap Creek, Oakview

- Sample size good, very interesting site.
- The EC levels at this site are significantly higher than all other sites within the network - one of the highest EC sample sites in the entire Mary River Catchment Waterwatch program.
- Good compliance with turbidity, temperature and pH
- Exceptionally very little variance in pH - with a neutral pH.
- Consistently very low dissolved oxygen levels recorded, which do not comply with guidelines.
- Consistently constrained to an overall grade of C (2011 & 2012 Waterwatch Grade = C)

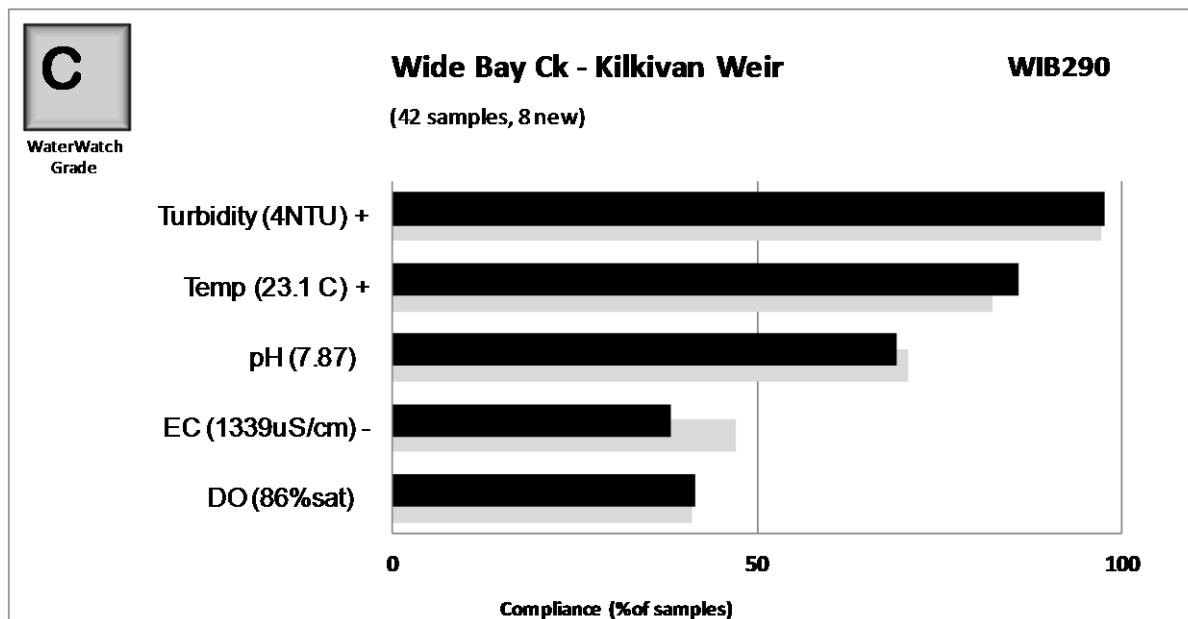
Wide Bay Creek

- Good sample size
- Significant improvement in turbidity and water temperature
- Relatively high pH levels (alkaline), but still complies well with guidelines
- The overall water quality dropped at this site to a “C” (2012 grade = B) as a result of high electrical conductivity readings during the dry period in late 2012 to January 2013.

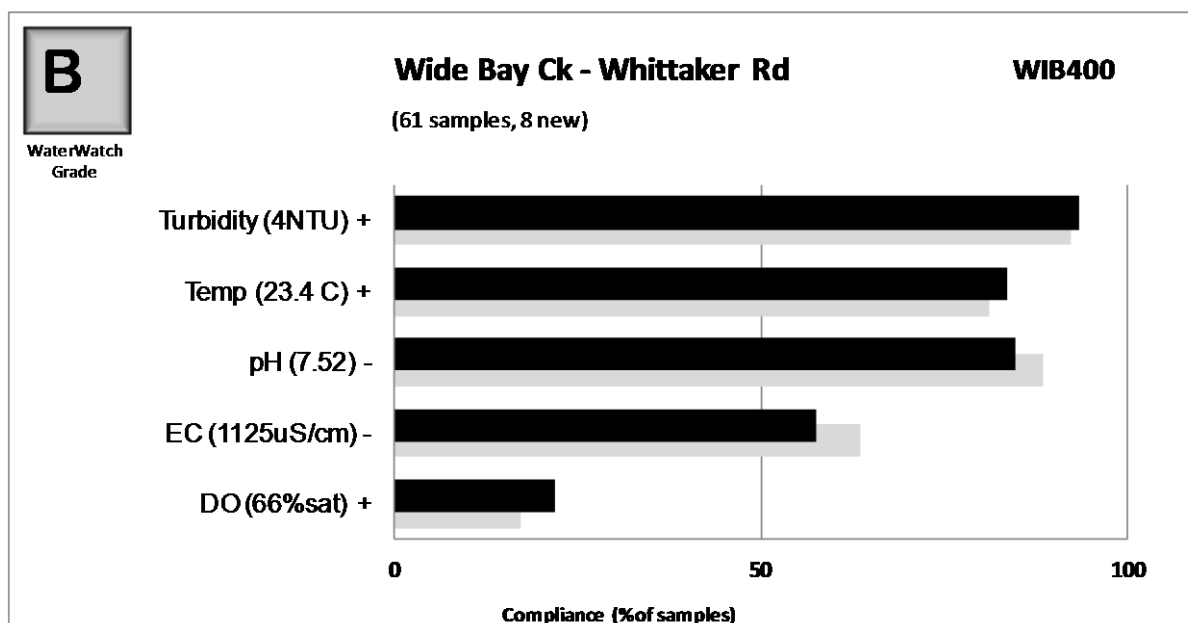
- Good sample size
- Electrical conductivity (salinity) compliance levels have dropped significantly over the past 12 months due to the dry period between July 2012 and January 2013.
- Maintaining an overall grade of B (2011 & 2012 Waterwatch Grade = B) over the past 12 months
