## Gympie Region Waterwatch Report 2013 – 2016

Report prepared by:  
Brad Wedlock, Jess Dean  
MRCCC Catchment Officers  
November 2016, Version 2.

Welcome to the 2016 edition of the Gympie Region water quality report card.

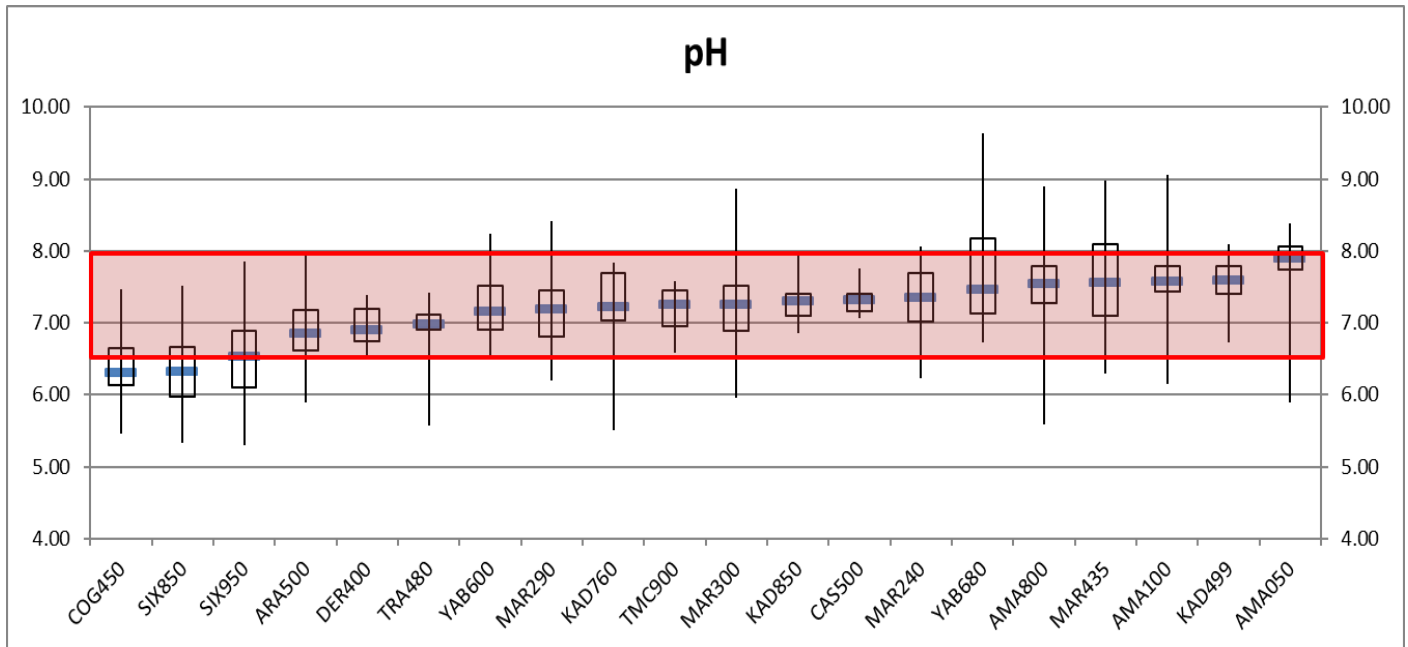
- This graph illustrates all the long-term data collected from each site, not just the last three year's data – the red rectangle represents the pH guideline level of 6.5 to 8 (pH should be between these levels to meet guideline values).
- Generally all sites in the Mary Valley show good compliance with pH guidelines.
- Six Mile Creek consistently shows low pH (acidic) levels, which is consistent with the nature of the sub-catchment. There is now a case for developing a set of local water quality guidelines for the Six Mile Creek catchment.
- High variability in pH can indicate eutrophication causing algae and weed growth eg. AMA800.

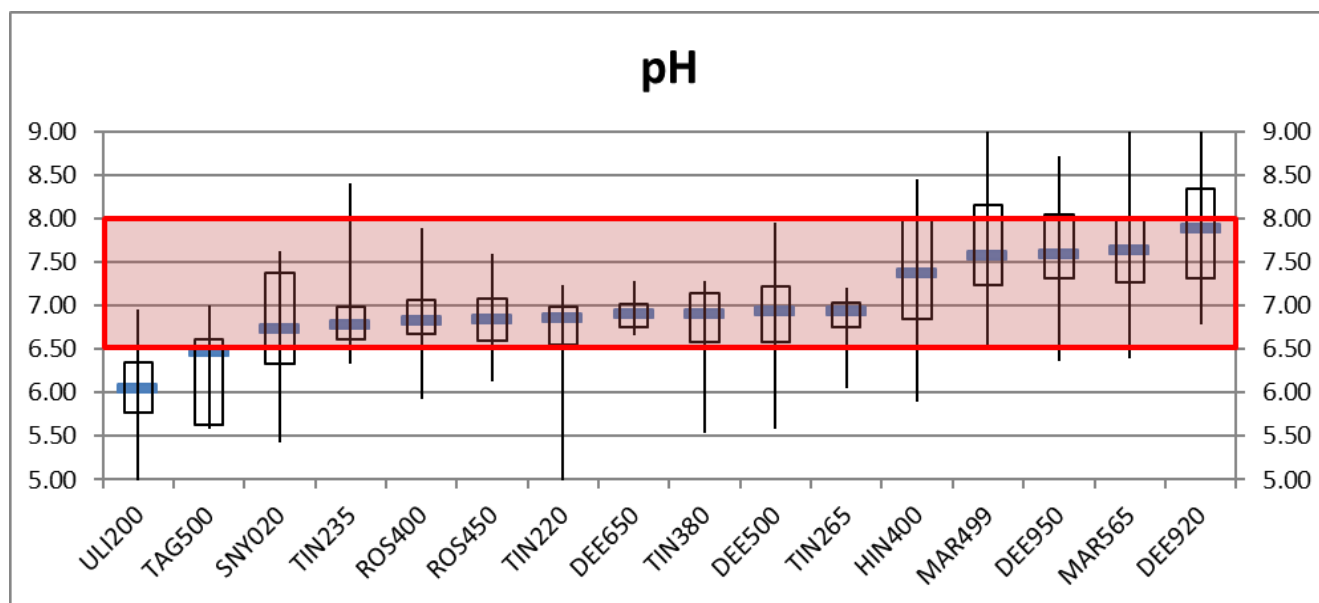
- This graph illustrates all the long-term data collected from each site, not just the last three year's data – the red rectangle represents the pH guideline level of 6.5 to 8 (pH should be between these levels to meet guideline values).
- Generally all sites in the Gympie District show good compliance with pH guidelines.
- Ullirrah Creek consistently shows low pH (acidic) levels, which is consistent with the nature of the sub-catchment.
- High variability in pH can indicate eutrophication causing algae and weed growth eg. the Deep Creek sites.
- The Mary River and Deep Creek sites are more alkaline compared to the other sites.

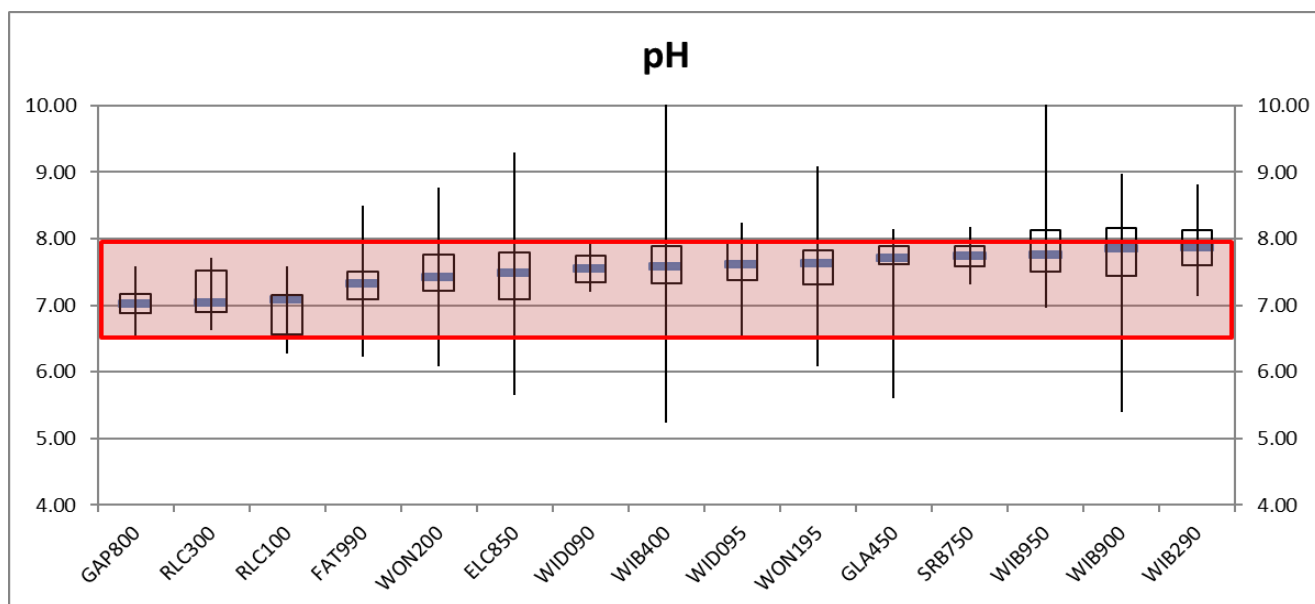
- This graph illustrates all the long-term data collected from each site, not just the last three year's data – the red rectangle represents the pH guideline level of 6.5 to 8 (pH should be between these levels to meet guideline values).
- Generally all sites in the Widgee Wide Bay network show good compliance with pH guidelines.
- All sites apart from Gap Creek and the Reedy Lagoons have pH measurements greater than 7, indicating alkalinity.
- Gap Creek (GAP800) is consistently different from the other sample sites with consistently neutral pH.
- Wide Bay Creek (WIB400, WIB900 and WIB950) has recorded extreme variations in pH levels over the monitoring period with high variability in pH possibly indicating eutrophication causing algae and weed growth.

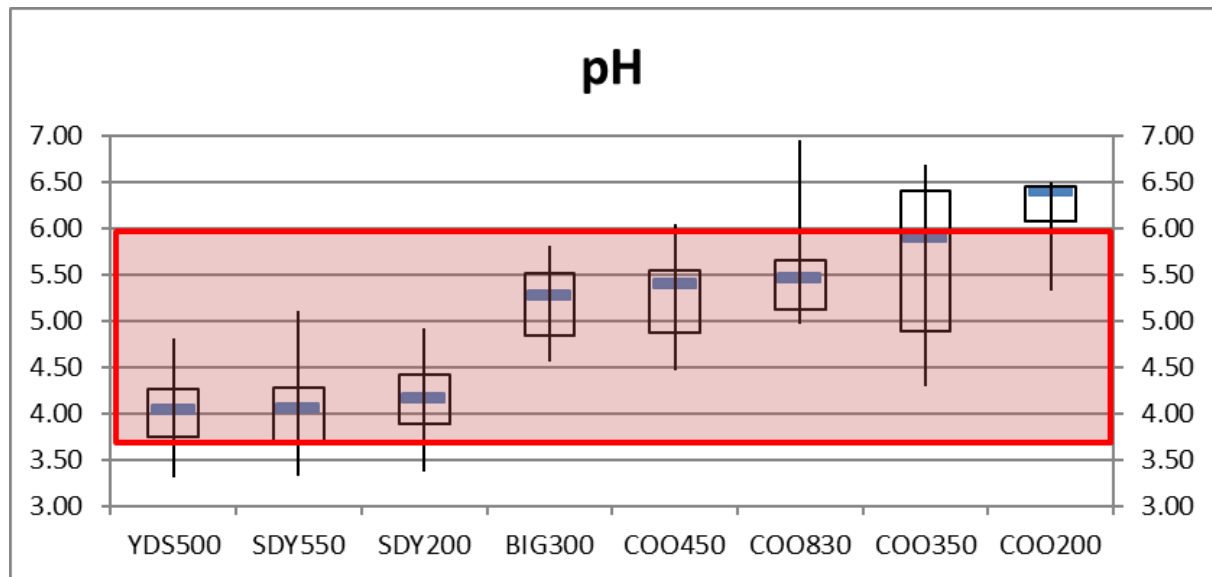
- This graph illustrates all the long-term data collected from each site, not just the last three year's data – the red rectangle represents the pH guideline level of 3.6 to 6 (pH should be between these levels to meet guideline values).
- These streams in the eastern section of the Mary River catchment have their own pH guideline due to their inherently acidic nature.
- All sites apart from the upper Coondoo Creek comply with these tannin stained, acidic water quality guidelines.
- The Yards and Sandy Creek sites are distinctly more acidic than the pH recorded at the other sites.
- More pH data from these sites is required to fully understand the complexities of these streams, in particular the Upper Coondoo Creek system.
- These sites are all located in the HQP Toolara State Forest.

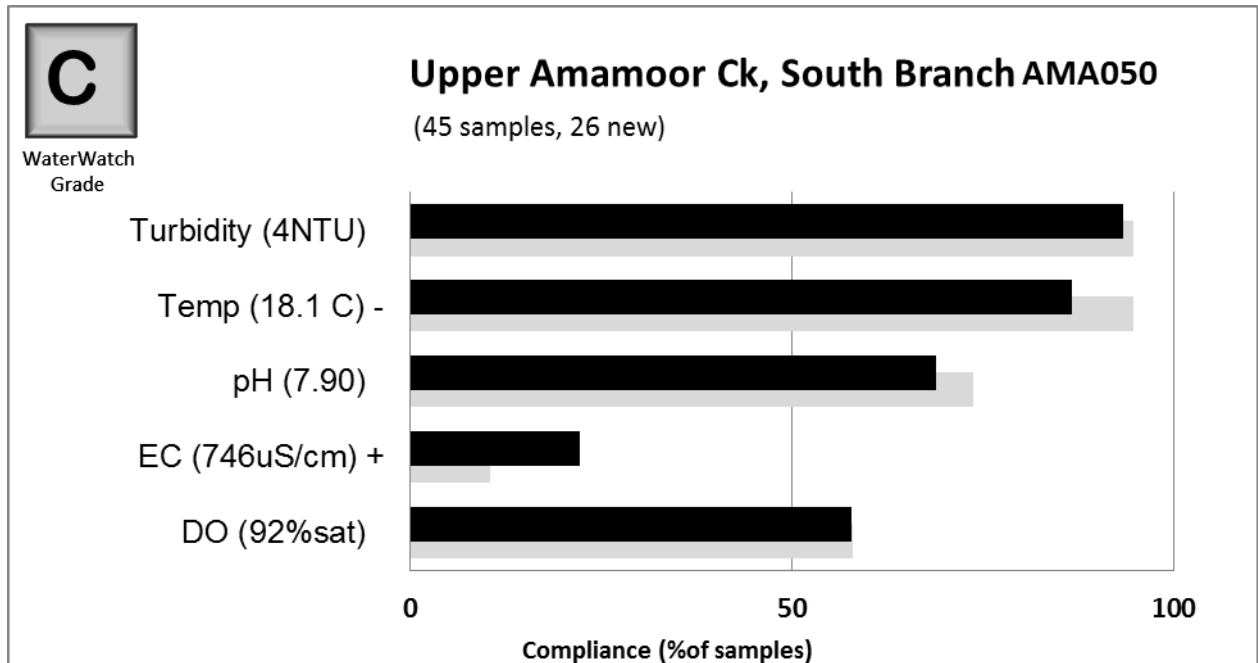
- Good sample size.
- A decline in compliance for temperature over the last three years which is contrary to the previous report where a temperature improvement was observed.
- Turbidity has remained very low, with good compliance.
- Electrical conductivity (salinity) levels rarely comply with guidelines - which is consistent with the nature of the sub-catchment. However, EC has significantly improved over the past three years.
- Maintaining an overall grade of C (2013 Waterwatch Grade = C) over the past 3 years.

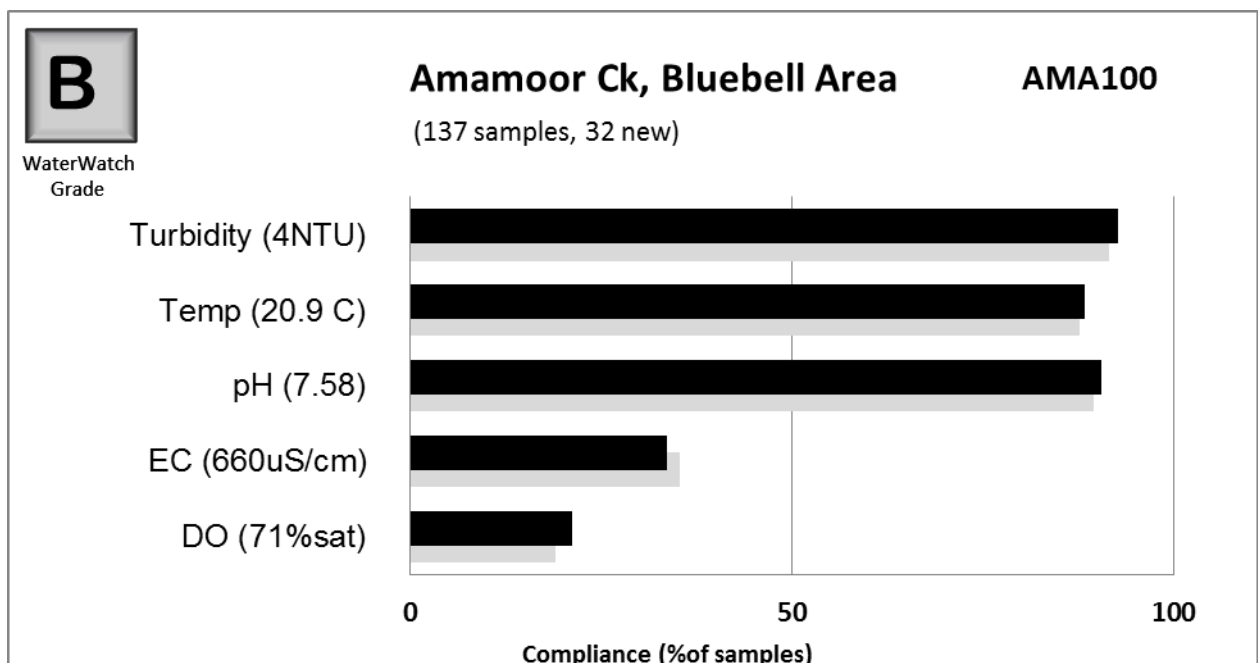
- Excellent sample size.
- Dissolved oxygen levels are gradually improving. Over the past three years dissolved oxygen is now more compliant than 2011/12 report and the 2013 report.
- Electrical conductivity (salinity) levels rarely comply with guidelines (see above comment).
- Very good turbidity results, reflected in low sediment loads of the sub-catchment.
- Maintaining an overall grade of B (2013 Waterwatch Grade = B) over the past 3 years.

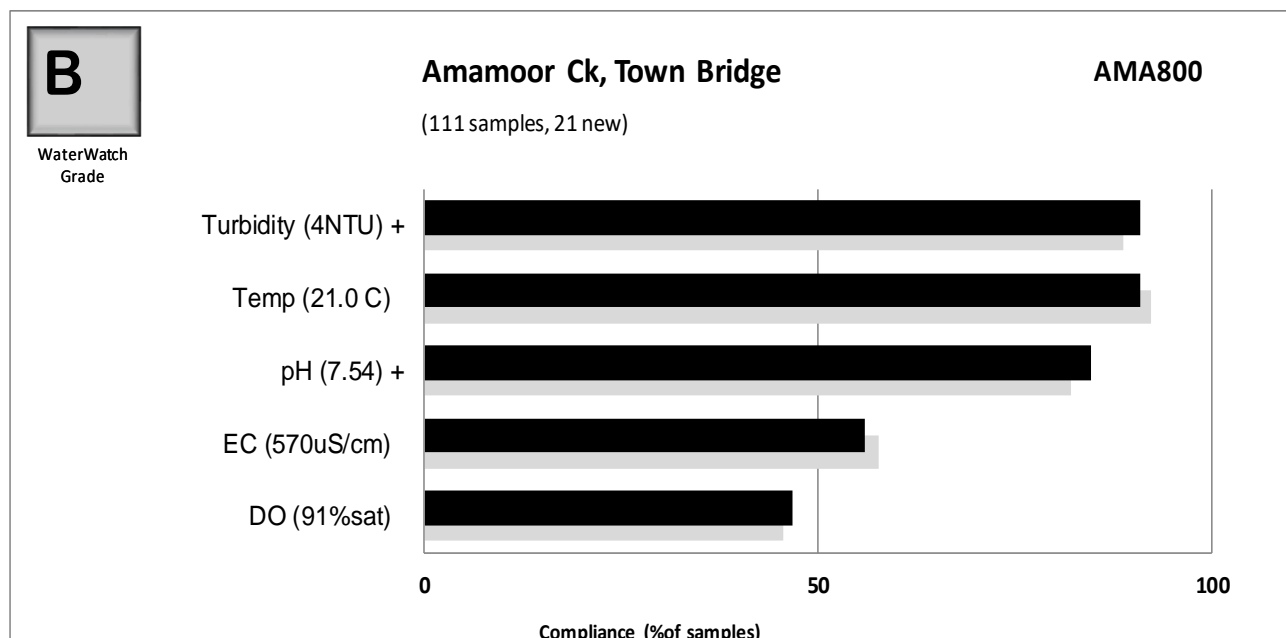
- Excellent sample size.
- This site has seen an improvement in compliance with pH and turbidity in the last 3 years.
- Better electrical conductivity (salinity) and dissolved oxygen compliance than Amamoor Creek, Bluebell – most likely due to more reliable creek flows because the site is located lower in the sub-catchment.
- Maintaining an overall grade of B (2013 Waterwatch Grade = B) over the past 3 years.

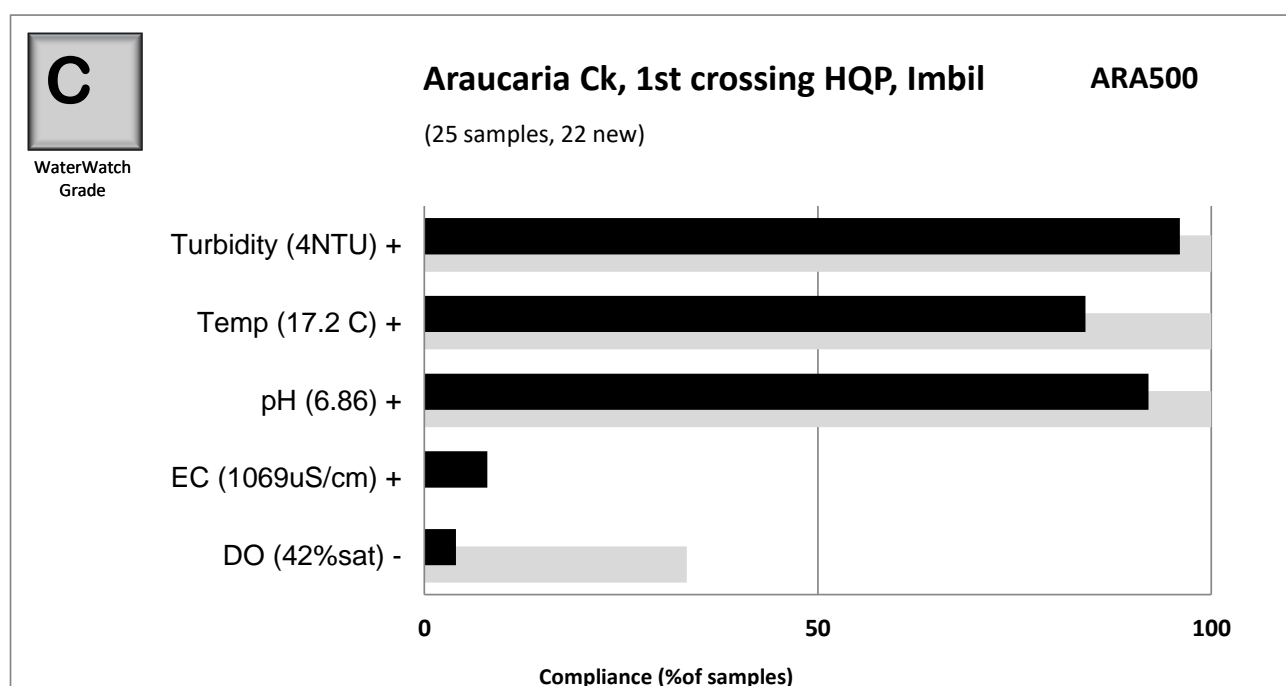
- New site, good sample size to make comments on trends.
- Consistently higher electrical conductivity (salinity) levels than other sub-catchments in the district – higher EC levels than Amamoor Creek, with very low compliance with guideline level.
- This site has highly variable dissolved oxygen levels resulting in a low compliance level overall.

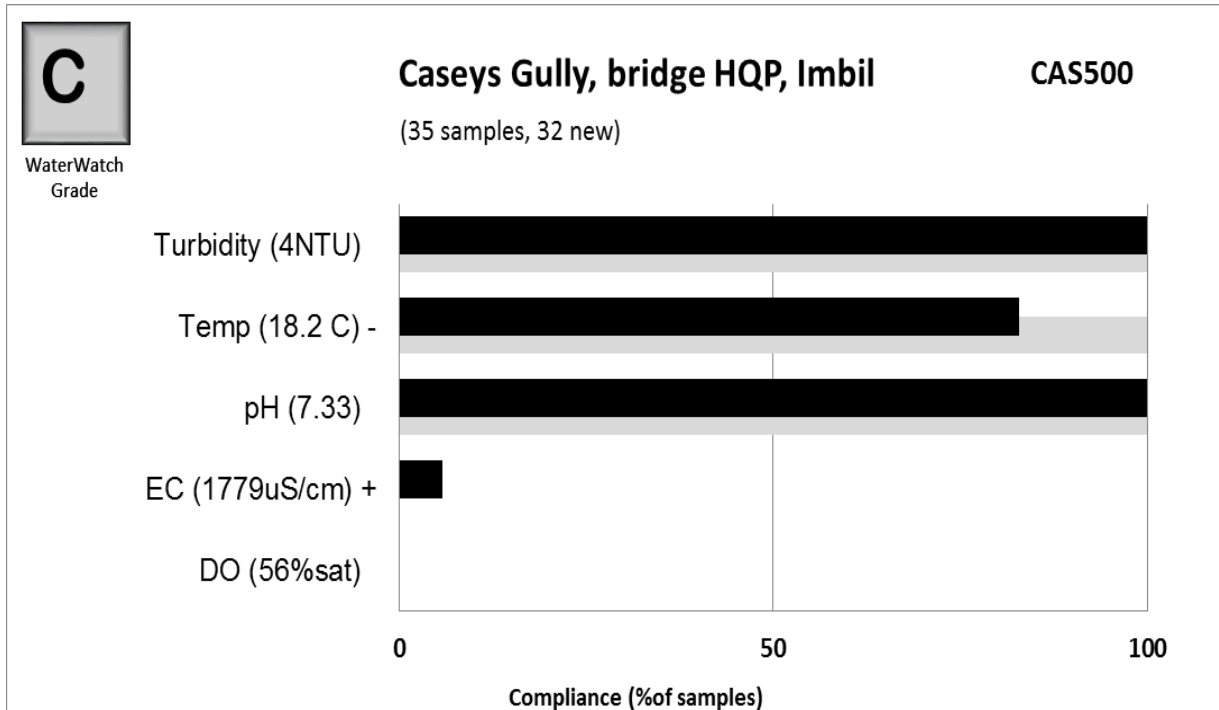
- Good sample size.
- A decline in compliance for temperature over the last three years.
- Excellent compliance with turbidity and pH.

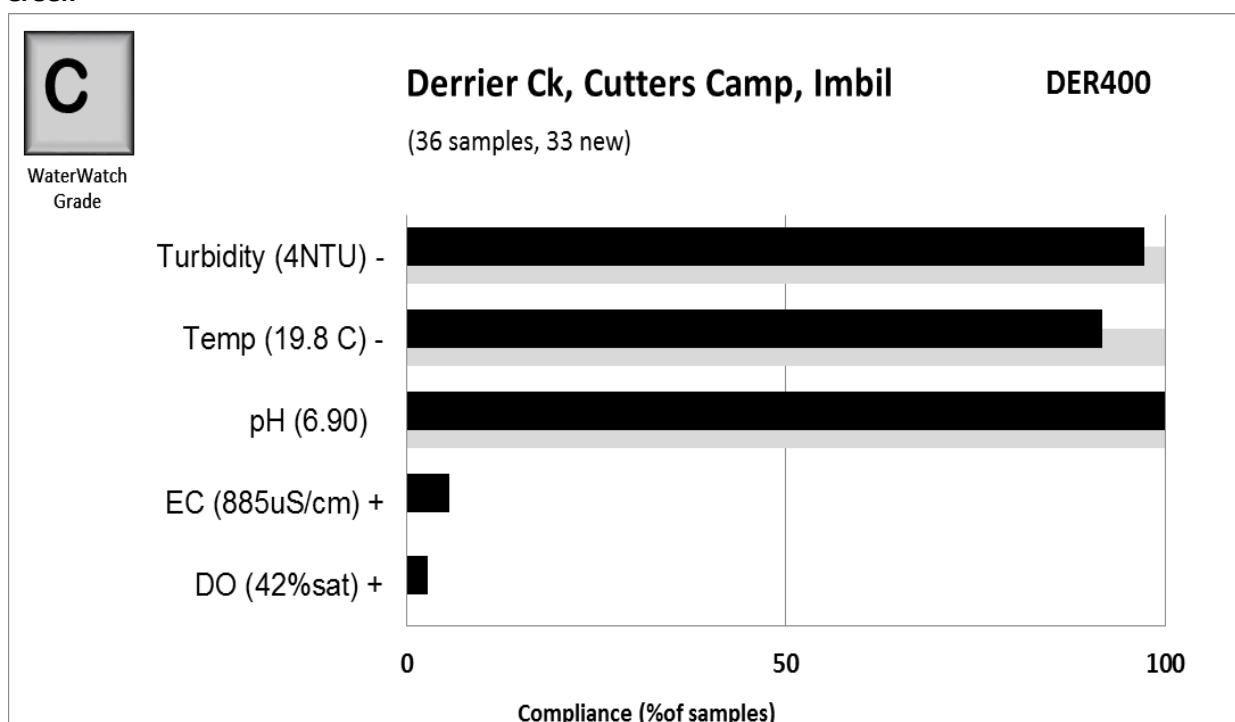
- Good sample size.
- A significant decline in compliance for temperature and turbidity over the last three years.
- Excellent compliance with pH.

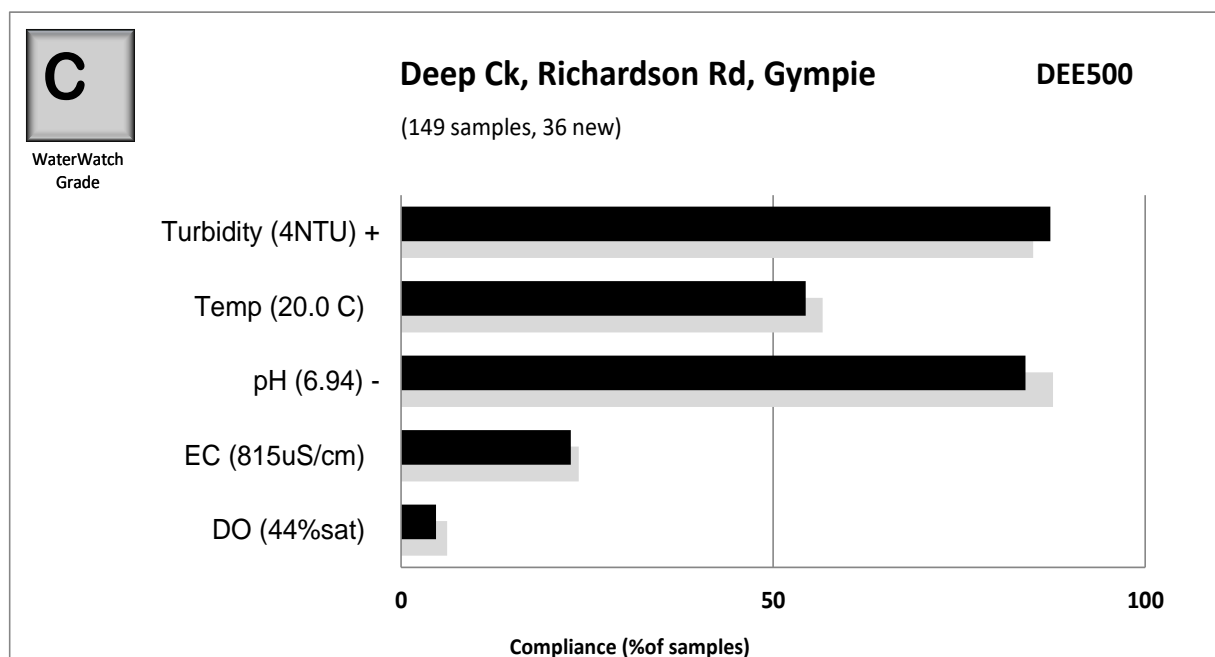
- Excellent sample size.
- Good compliance for turbidity and temperature (an improvement in turbidity since the last report).
- Gradual decline in pH compliance compared to 2011/12 report and the 2013 report (site is becoming slightly acidic).
- Consistently higher electrical conductivity (salinity) levels than other sub-catchments – higher EC levels than Amamoor Creek.
- Maintaining an overall grade of C (2013 Waterwatch Grade = C) over the past 3 years.

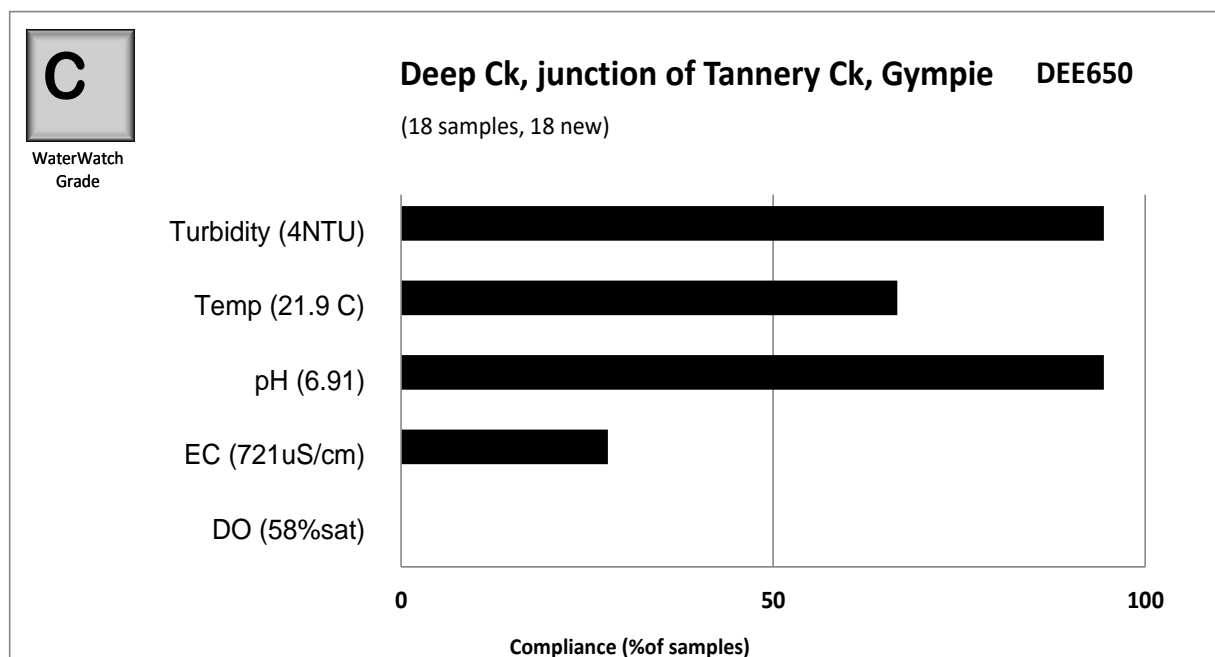
- New site, sample size large enough for interpretation.
- Results similar to the DEE500 site, located up stream.
- Median temperature is lower compared to the DEE500 site.

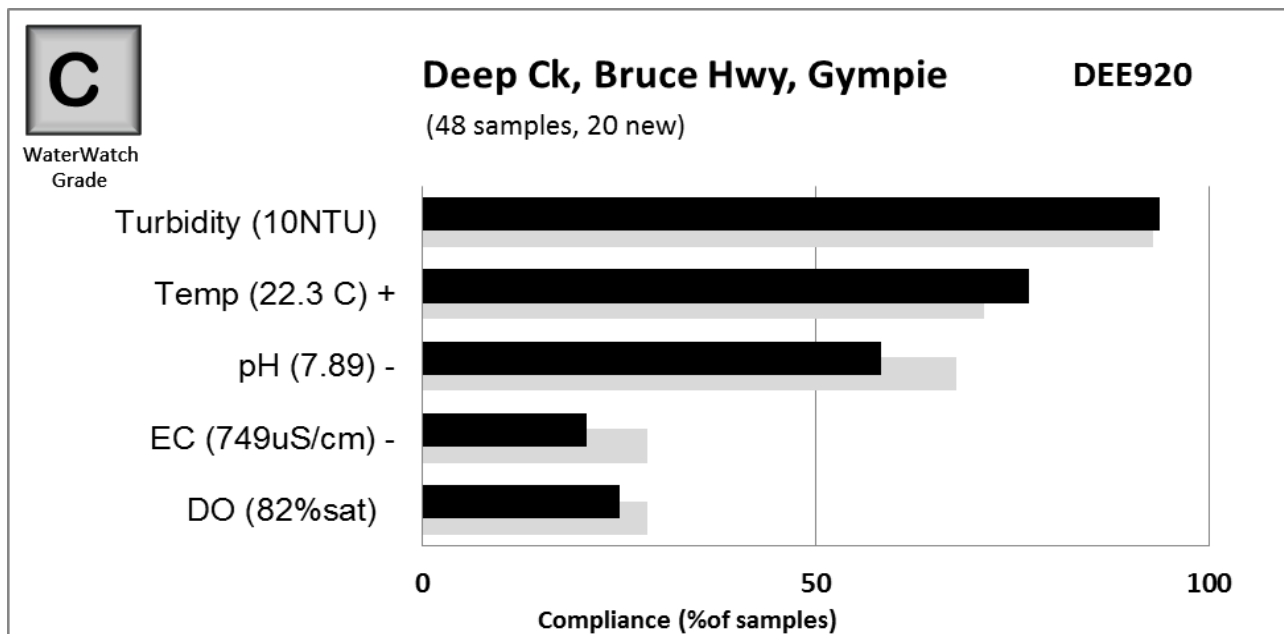
- Good sample size for interpretation.
- Continued low compliance with guidelines for dissolved oxygen, however better compliance than DEE500 site.
- Decline in EC over the past three years – similar to the DEE500 site.
- Significant rise in pH over the past three years (2013 median = 7.7pH).
- Maintaining an overall grade of C (2013 Waterwatch Grade = C) over the past 3 years.

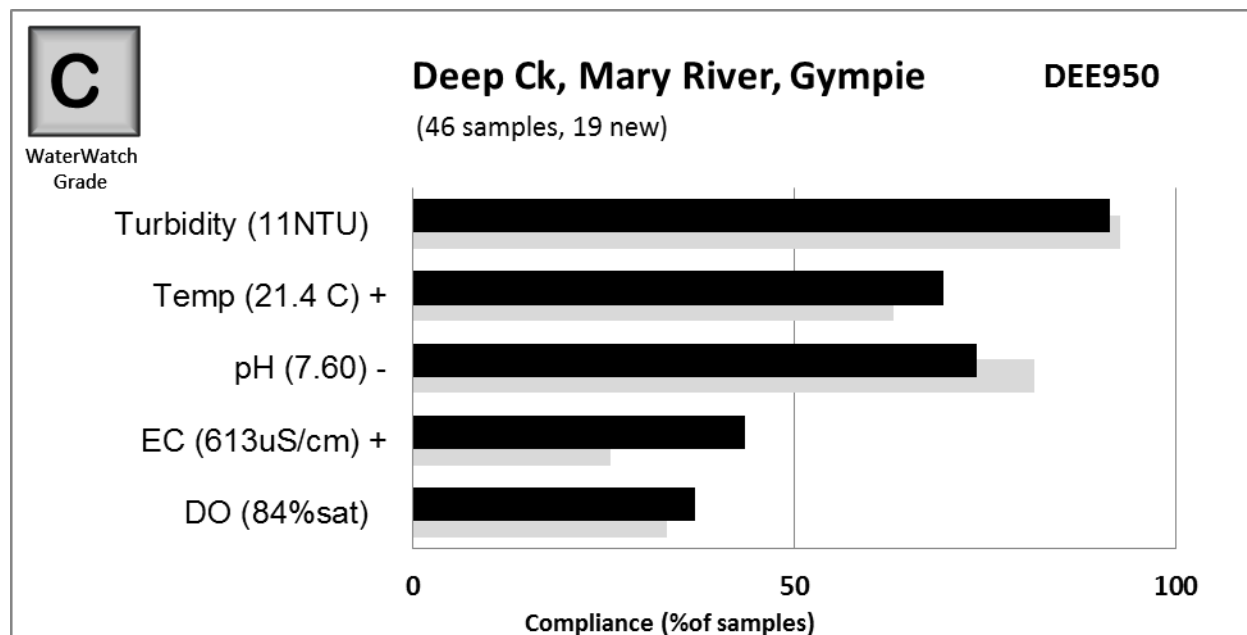
- Good sample size to make comments on trends.
- Electrical conductivity (salinity) levels have shown an improvement in compliance over the past three years. Possibly due to backup effect of the Mary River, which has a lower EC than Deep Creek.
- Maintaining an overall grade of C (2013 Waterwatch Grade = C) over the past 3 years.

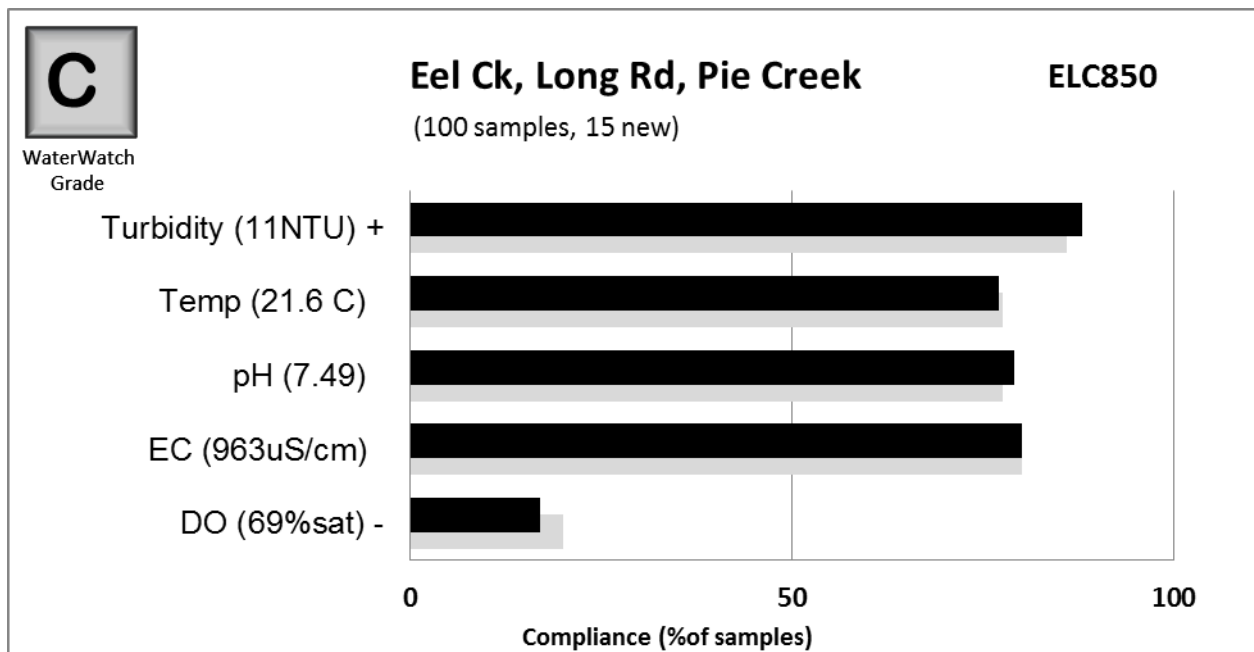
- Good sample size, gold medal award winner!
- Consistently higher electrical conductivity (salinity) levels than Amamoor and Deep Creeks.
- Turbidity compliance has improved over the last three years.
- Dissolved oxygen compliance has declined over the last three years.
- Maintaining an overall grade of C (2013 Waterwatch Grade = C) over the past 3 years.

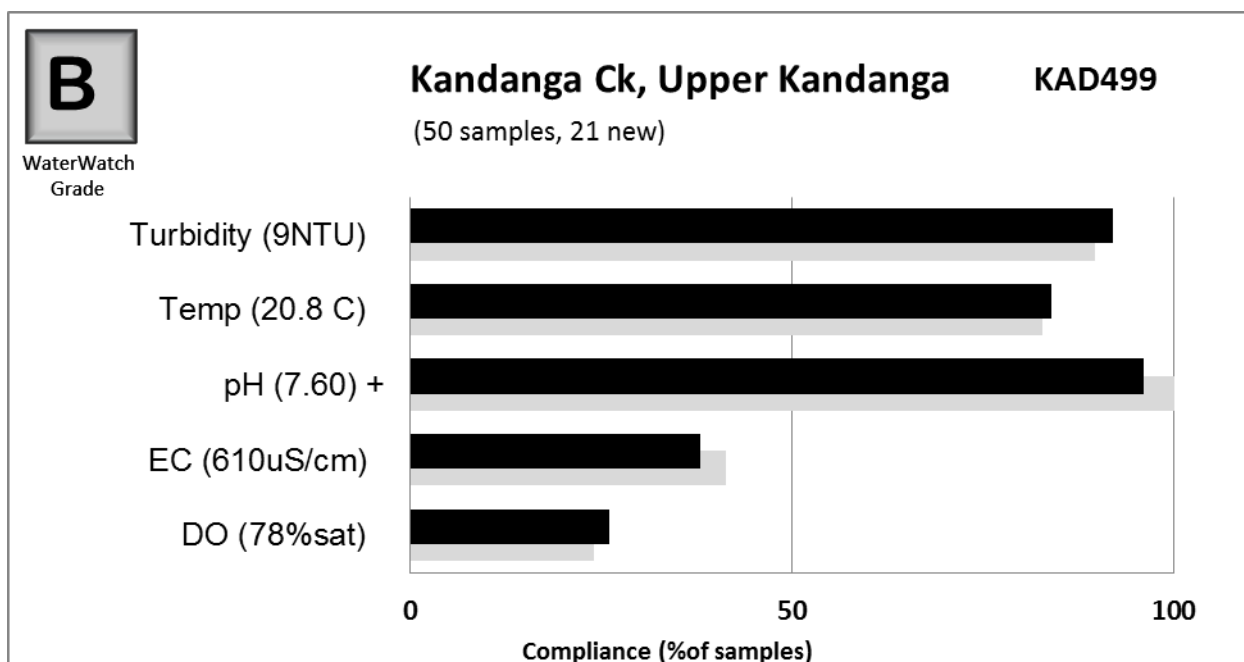
- Good sample size.
- This year's data indicates an improvement in pH compliance over the past 3 years.
- Maintaining an overall grade of B (2013 Waterwatch Grade = B) over the past 3 years.

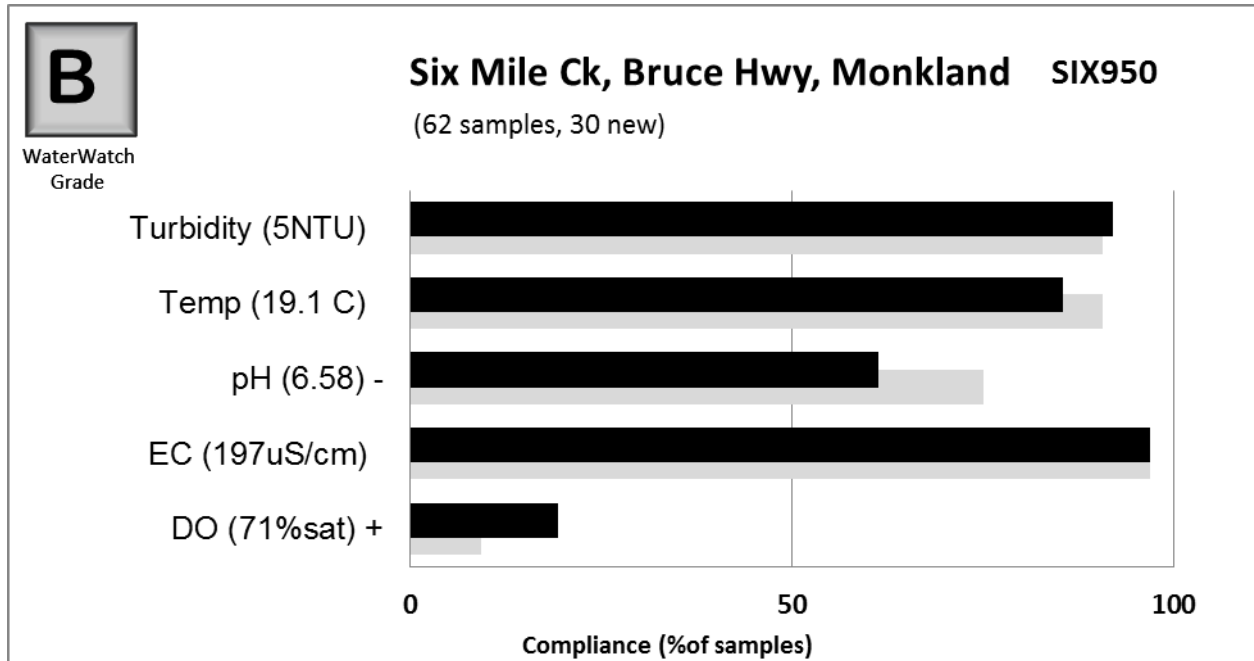
- Good sample size.
- pH compliance has dropped over the last three years - Six Mile Creek is a naturally acidic sub-catchment.
- Improved compliance over the last three years for dissolved oxygen.
- Low overall dissolved oxygen compliance, however results are consistently just below the 85% saturation guideline. This dissolved oxygen level does not appear to be detrimental to aquatic life eg.fish. However on going monitoring will help to inform this assumption.

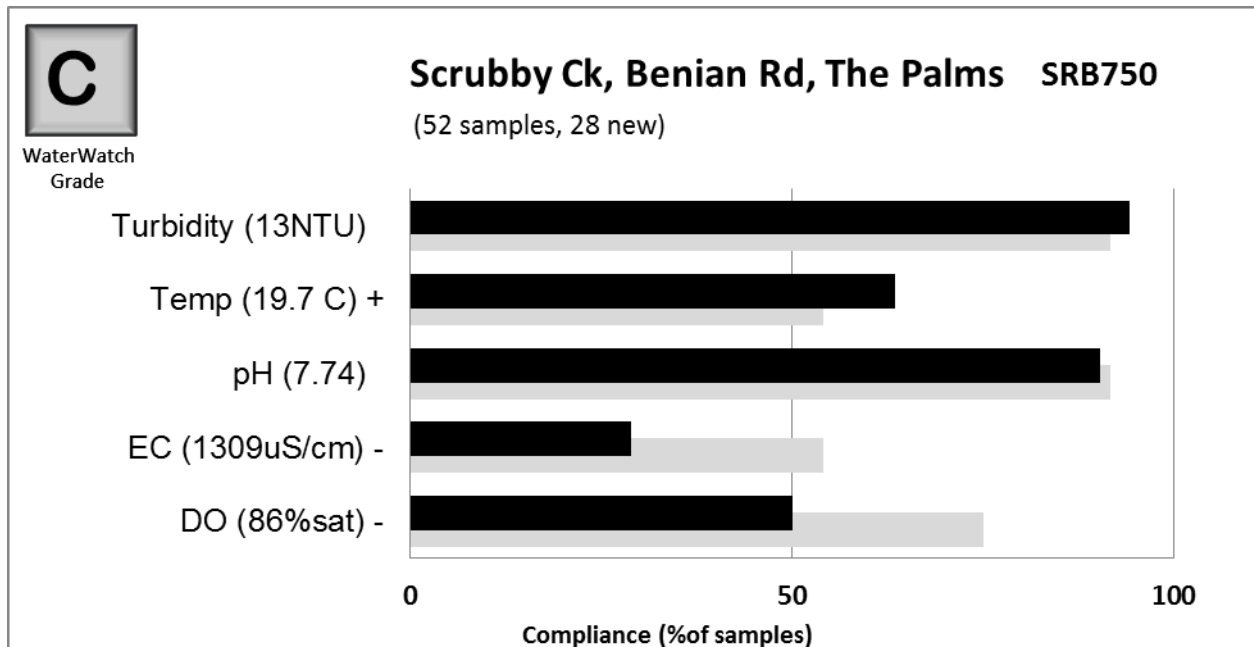
- Good sample size.
- A very high EC level is consistently recorded at this site. The North-western Mary Catchment EC guidelines (<1200 us/cm) has been applied at this site.
- EC compliance has significantly declined over the last three years – possibly due to lower than average rainfall and stream flow.
- Dissolved oxygen compliance has significantly declined in the last three years.

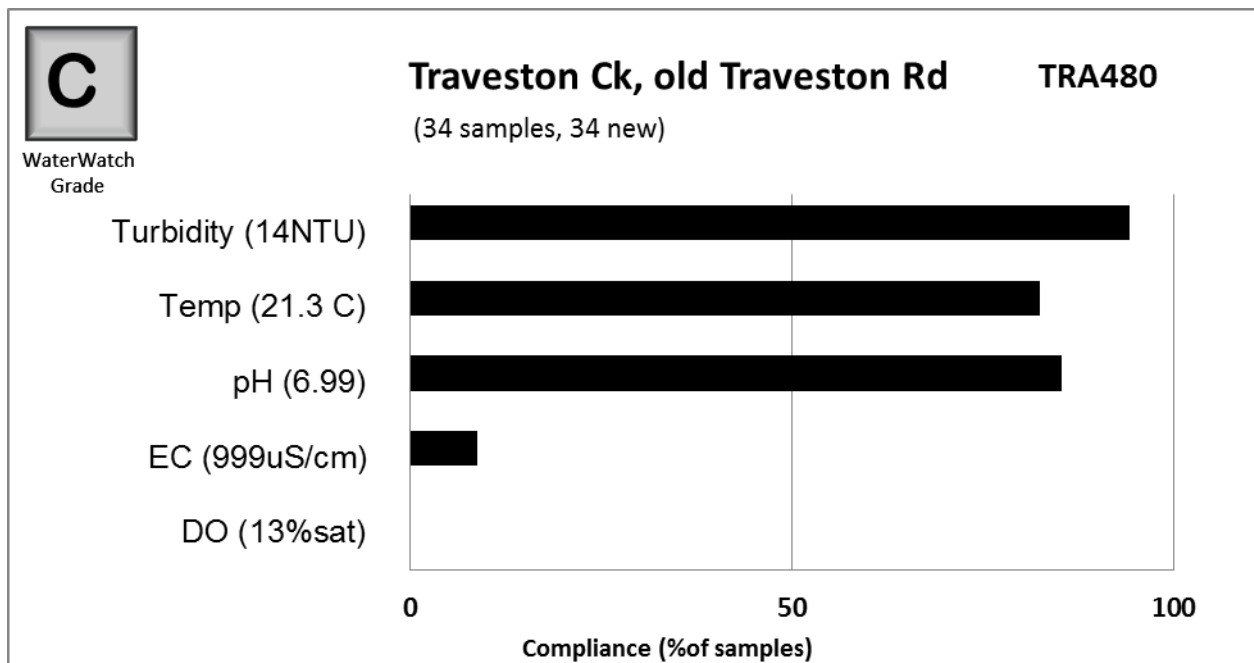
- Good sample size.
- Site consistently not complying with dissolved oxygen guidelines. Generally Traveston Creek has low to nil flows coupled with high leaf litter inputs from the shaded riparian zone.
- Very low EC guideline compliance, with relatively high EC results for this district.

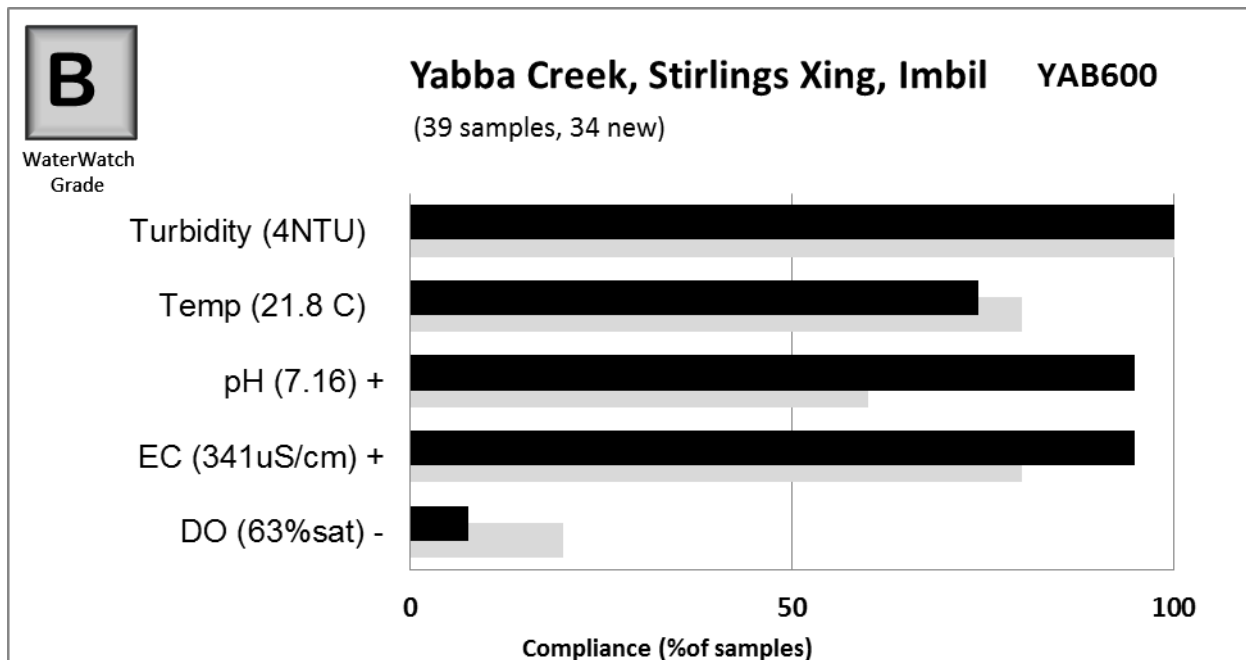
- New site, good sample size.
- Low dissolved oxygen compliance, however results are consistently just below the 85% saturation guideline. This dissolved oxygen level does not appear to be detrimental to aquatic life eg.fish. However on going monitoring will help to inform this assumption.

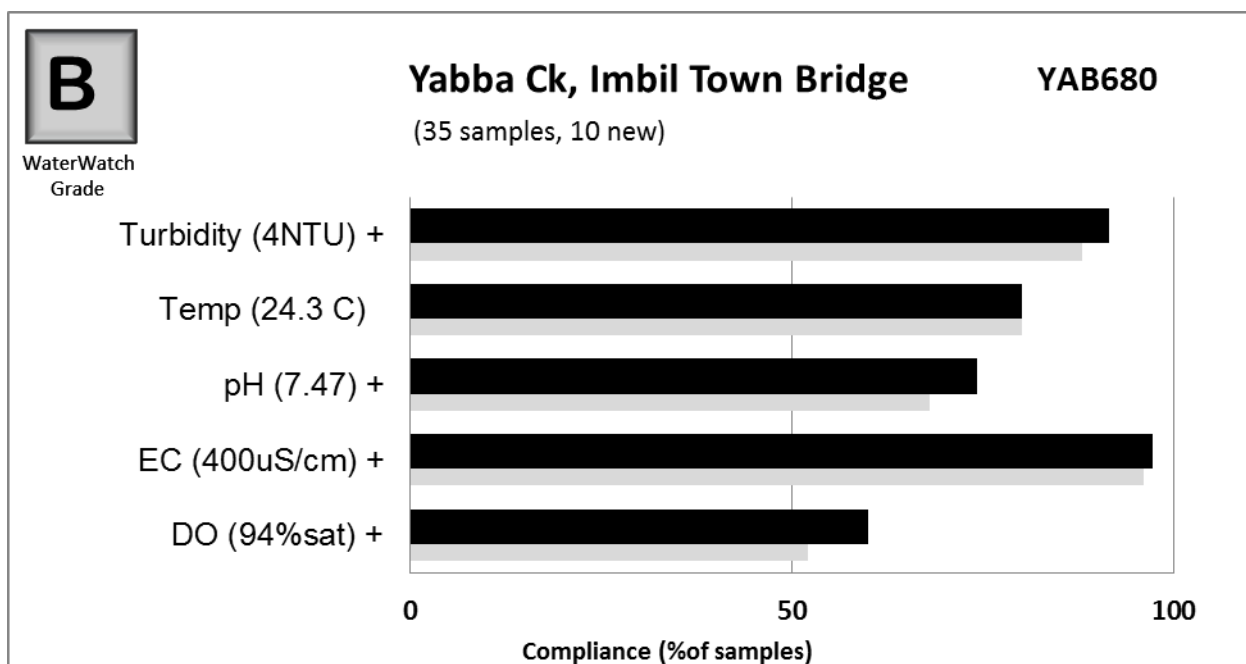
- Good sample size.
- Turbidity levels are highly compliant with guideline level.
- In the past this site has shown high pH levels (alkaline) because of profuse growth of aquatic plants and algae. However pH compliance has improved significantly over the last 3 years.
- Analysis shows DO levels have been highly variable at this site with 60% compliance and 94% median value.
- Maintaining an overall grade of B (2013 Waterwatch Grade = B) over the past 3 years.

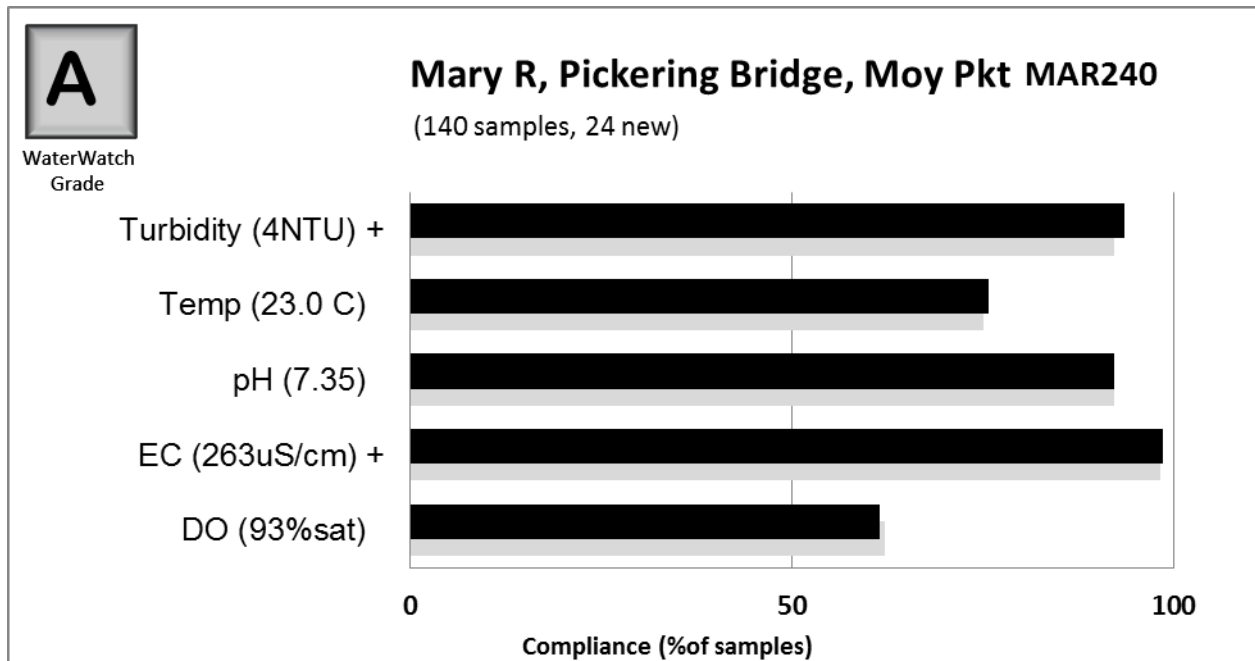
- Excellent sample size.
- Excellent electrical conductivity compliance over the past three years.
- Significant improvement in compliance for turbidity over the past three years.
- Maintaining an overall grade of A (2013 Waterwatch Grade = A) over the past 3 years.

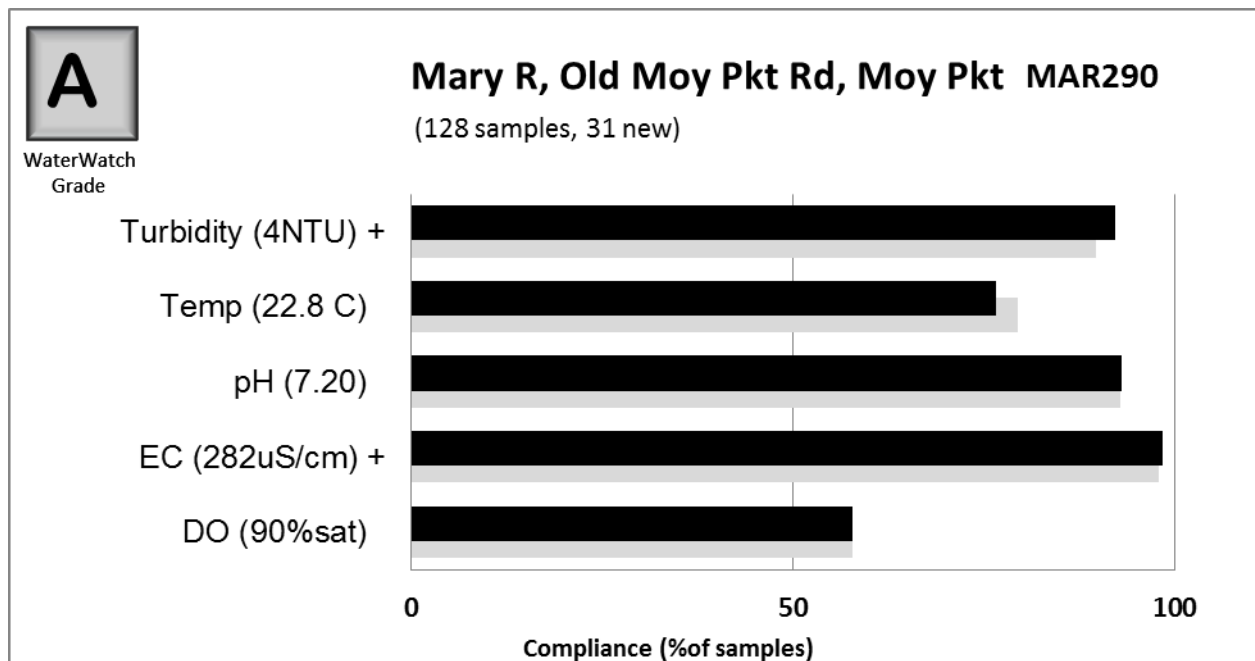
- Excellent sample size, gold medal award winner!
- Excellent electrical conductivity compliance.
- Significant increase in compliance for turbidity over the past three years.
- Maintaining an overall grade of A (2013 Waterwatch Grade = A) over the past 3 years.

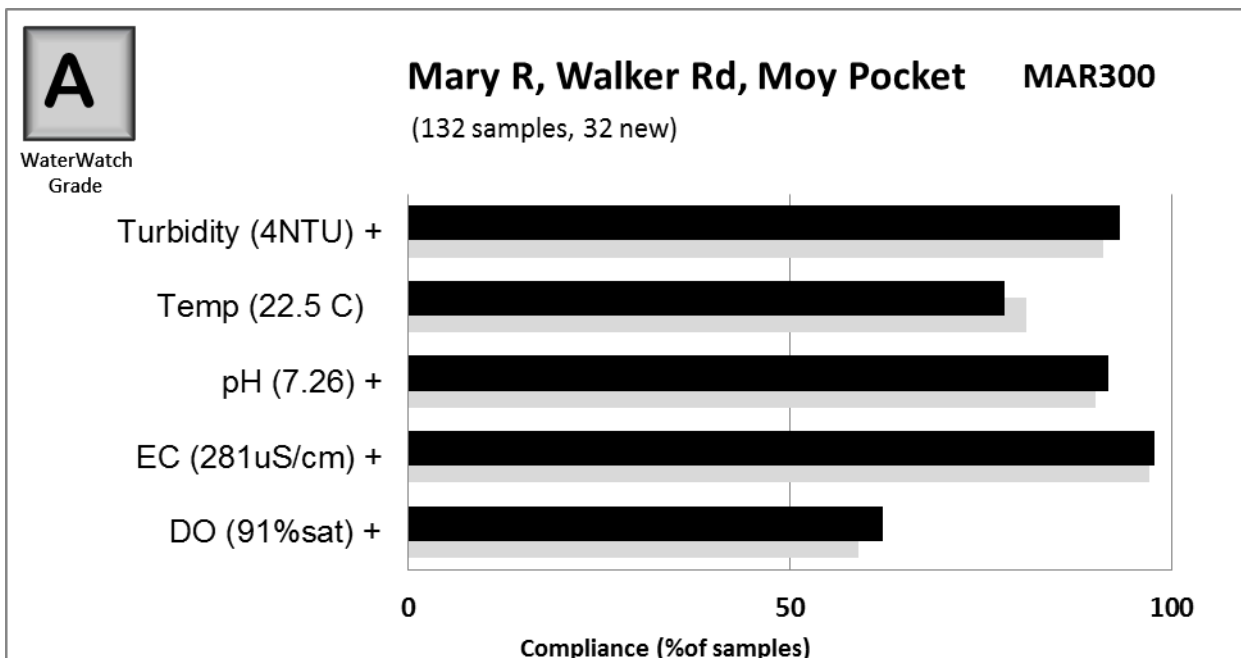
- Excellent sample size, gold medal award winner!
- Excellent electrical conductivity compliance.
- Significant improvement in compliance for turbidity, pH and DO over the past three years.
- Maintaining an overall grade of A (2013 Waterwatch Grade = A) over the past 3 years.
