## Gympie Region Waterwatch Report 2013 – 2016

Report prepared by:  
Brad Wedlock, Jess Dean  
MRCCC Catchment Officers  
November 2016, Version 2.

Welcome to the 2016 edition of the Gympie Region water quality report card.

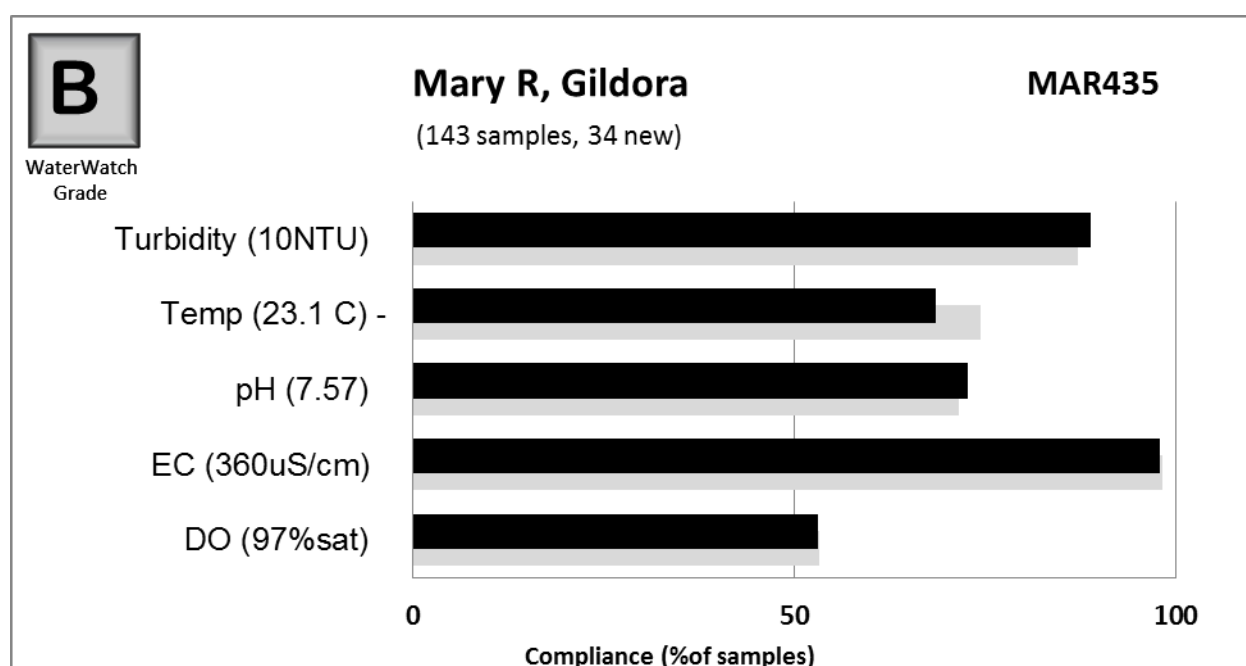
- Excellent sample size.
- In 2013 the electrical conductivity (salinity) and pH values improved compliance, bringing the report card from a "B" to "A". However over the past three years the report card has dropped back to a "B".
- Dissolved oxygen levels have decreased over the past three years (2013 median = 99%).
- Water temperature compliance decreased resulting in the drop from an A to a B.
- Mary River sites have considerably higher water temperature levels than the sample sites located on creeks, possibly due to less riparian vegetation shading the water.

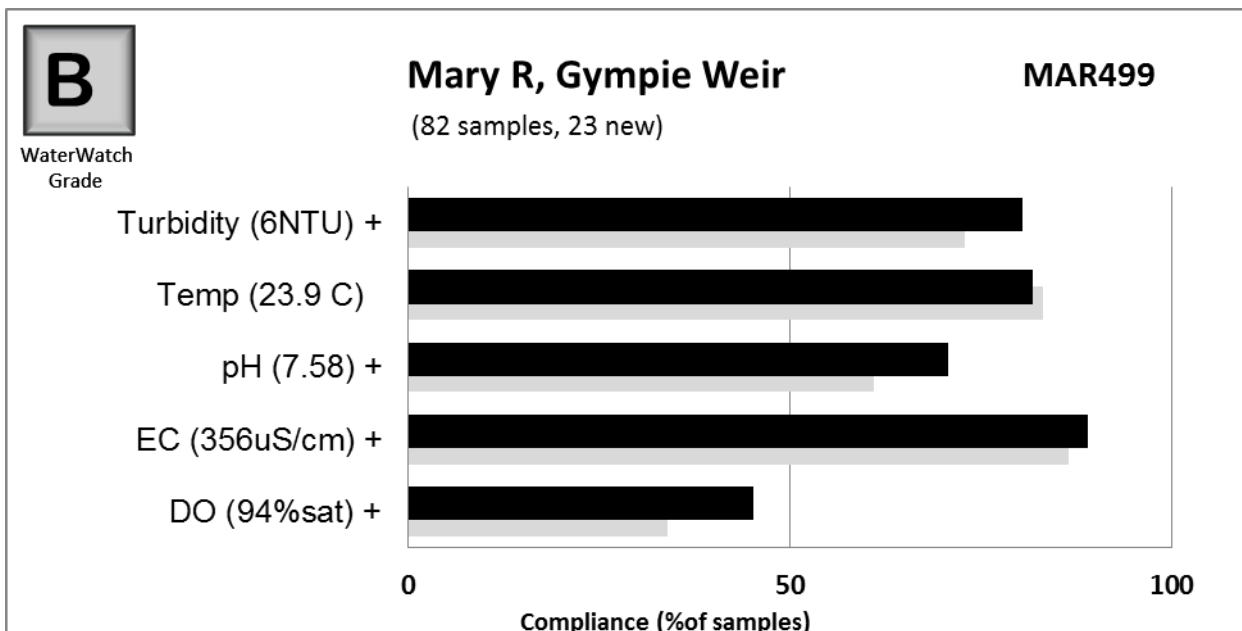
- Good sample size.
- Improvement in compliance for turbidity, EC, pH and DO over the past three years.
- Significant improvement in DO results.

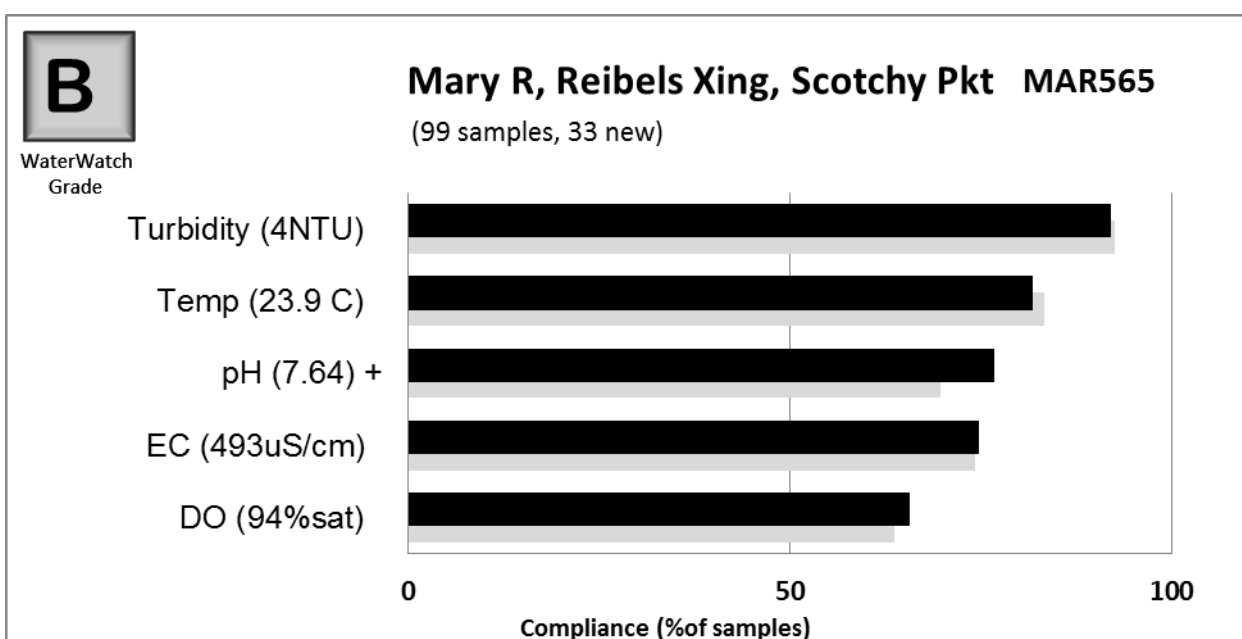
- Good sample size.
- Improvement in compliance for pH over the past three years.
- Dissolved oxygen levels are reasonably good, correlated with regular river flows and the water passing through a series of riffles / cobble beds.
- The water temperature median value (23.9 degrees) at this site and MAR499 (Gympie Wier) are the warmest Mary River sites monitored in the Gympie Region.
- Maintaining an overall grade of B (2013 Waterwatch Grade = B) over the past 3 years.

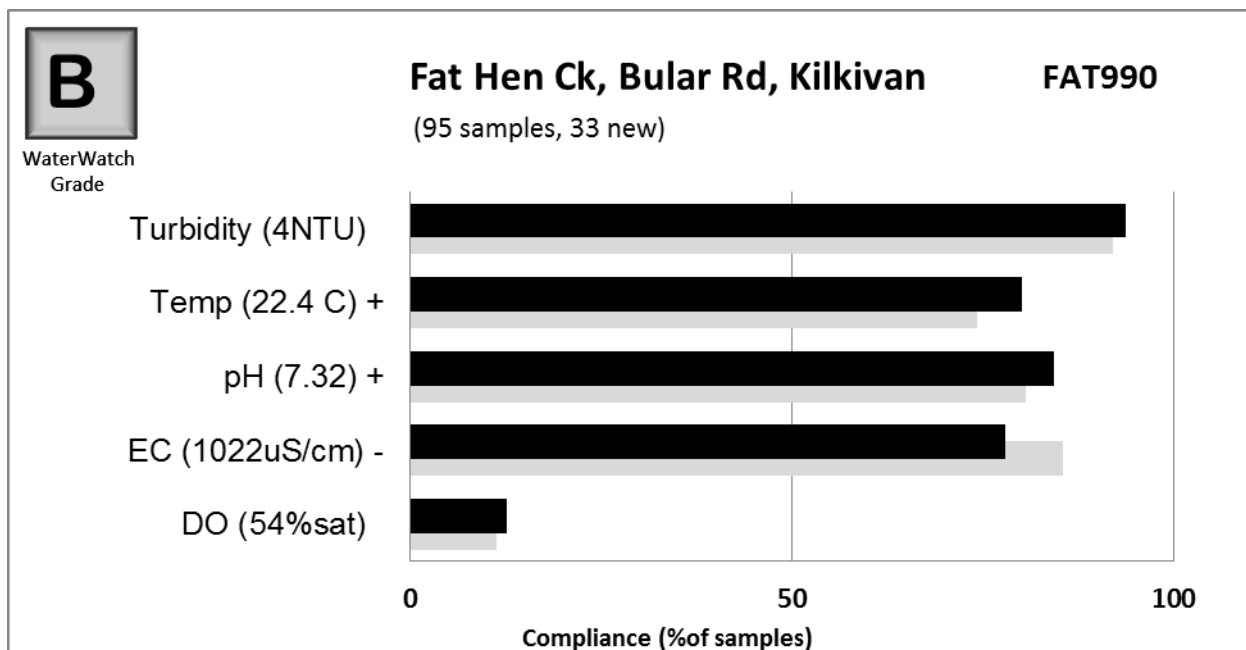
- Good sample size.
- Over the past three years there has been a significant decline in EC, which could be due to lower than average rainfall and stream flow.
- pH and temperature have improved compliance over the past three years.
- Maintaining an overall grade of B (2013 Waterwatch Grade = B) over the past 3 years.

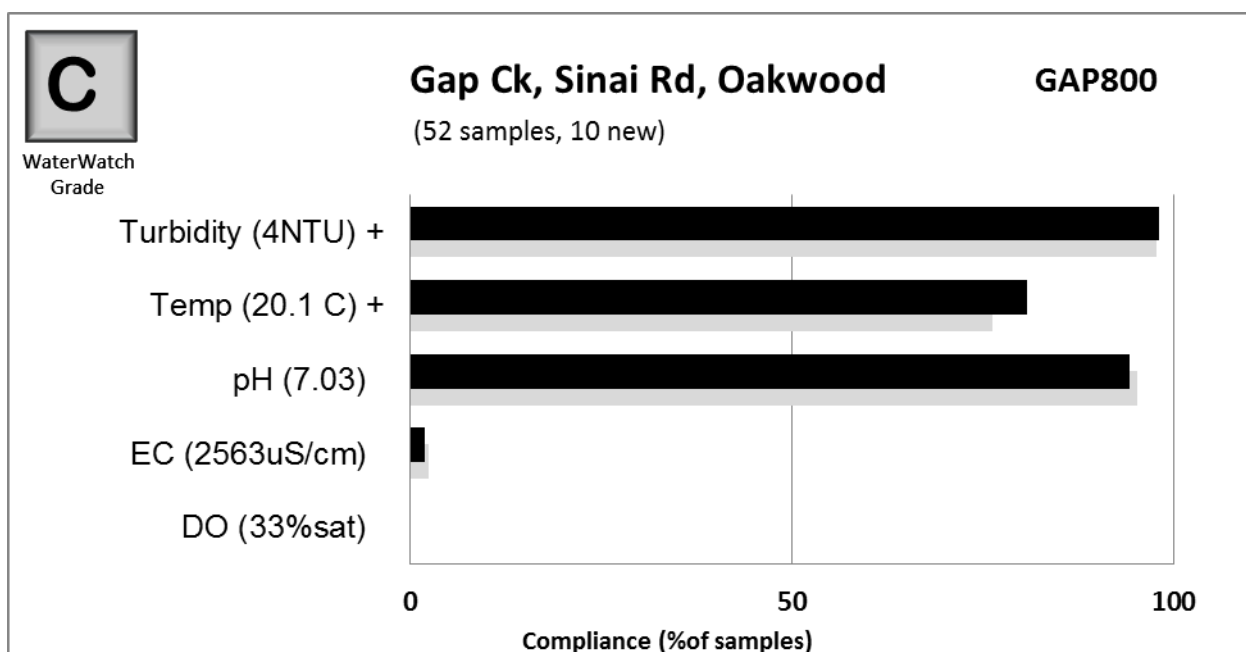
- Sample size good, very interesting site.
- The EC levels at this site are significantly higher than all other sites within the Gympie Region, one of the highest EC sample site in the entire Mary Rivery Catchment Waterwatch program.
- Good compliance with turbidity, temperature and pH.
- Exceptionally very little variance in pH over many years - with a neutral pH.
- Consistently very low DO levels recorded, which do not comply with guidelines.
- Consistently constrained to an overall grade of C (2011 & 2013 Waterwatch Grade = C).

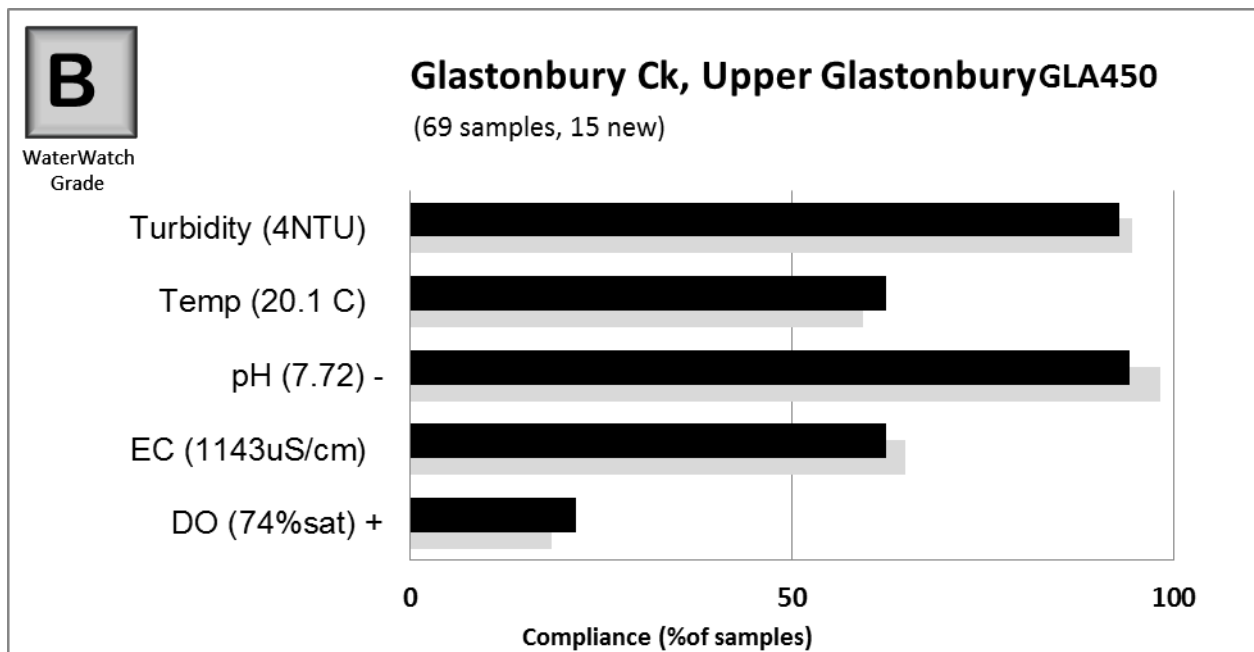
- Good sample size.
- There has been a decline in pH level compliance over the past three years and continues to be relatively alkaline.
- Maintaining an overall grade of B (2013 Waterwatch Grade = B) over the past 3 years.

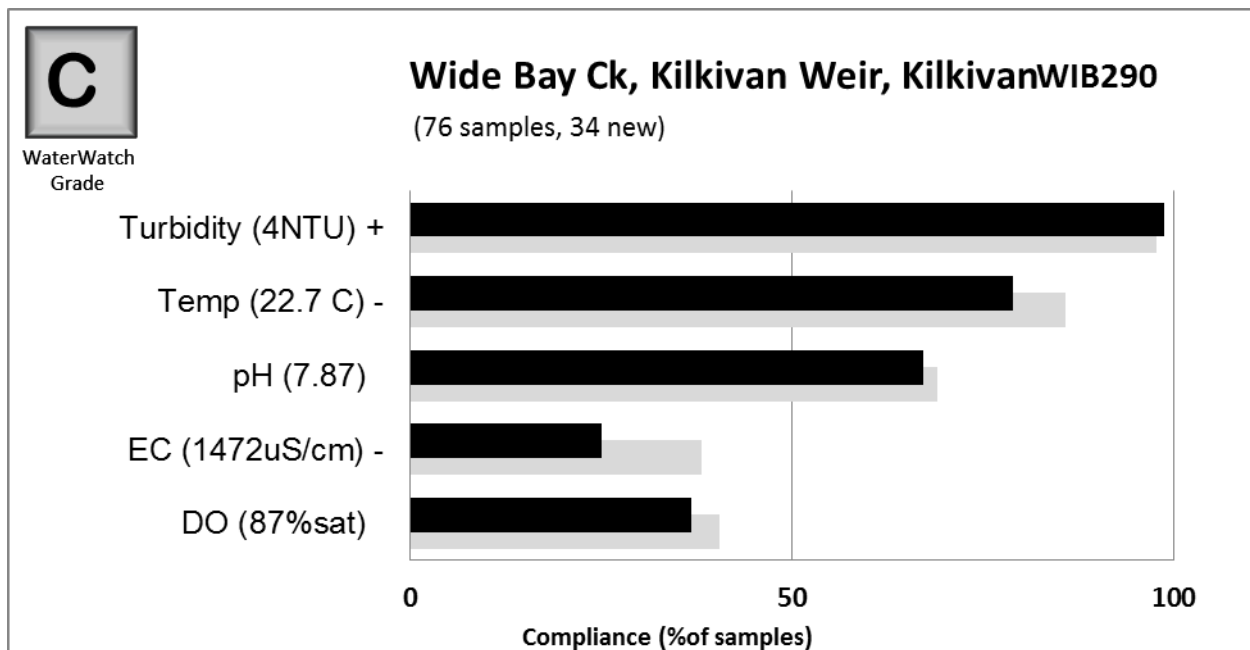
- Good sample size.
- Significant improvement in turbidity over the past three years.
- Relatively high pH levels (alkaline), but still complies well with guidelines.
- There has been a significant decline in EC possibly due to lower than average rainfall and stream flow.
- Maintaining an overall grade of C (2013 Waterwatch Grade = C) over the past 3 years.

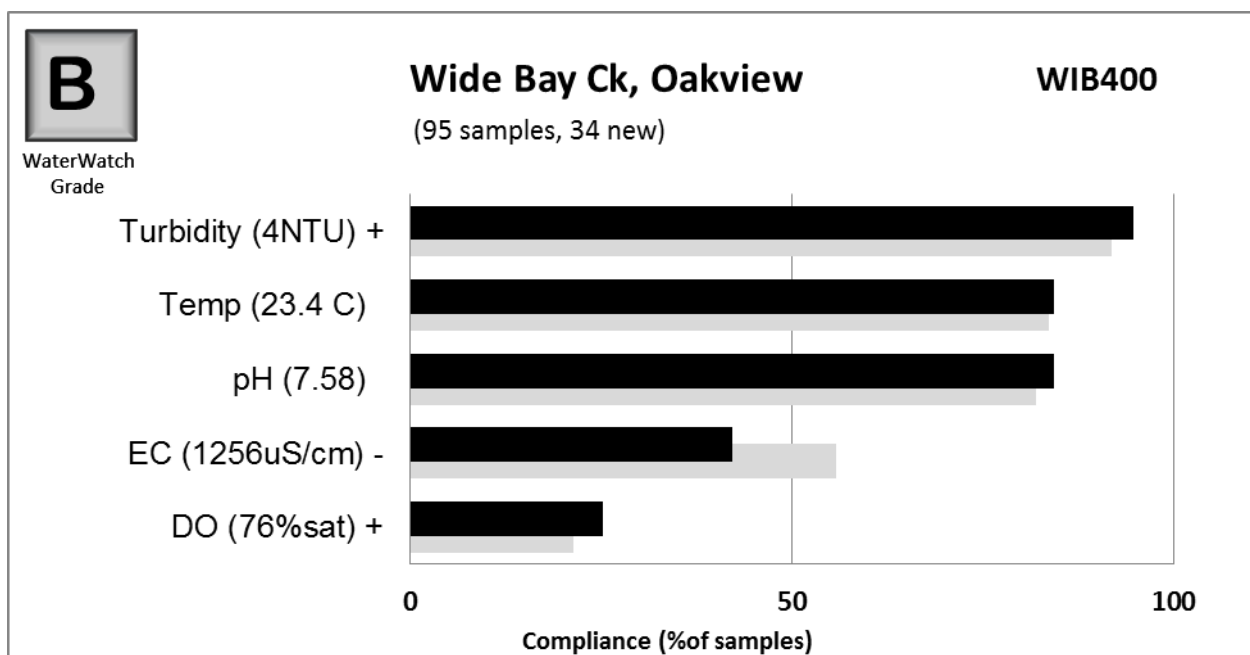
- Good sample size.
- Electrical conductivity (salinity) compliance levels have dropped significantly over the past three years, possibly due to lower than average rainfall and stream flow, which is consistent with the WIB290 site.
- Maintaining an overall grade of B (2013 Waterwatch Grade = B) over the past 6 years.

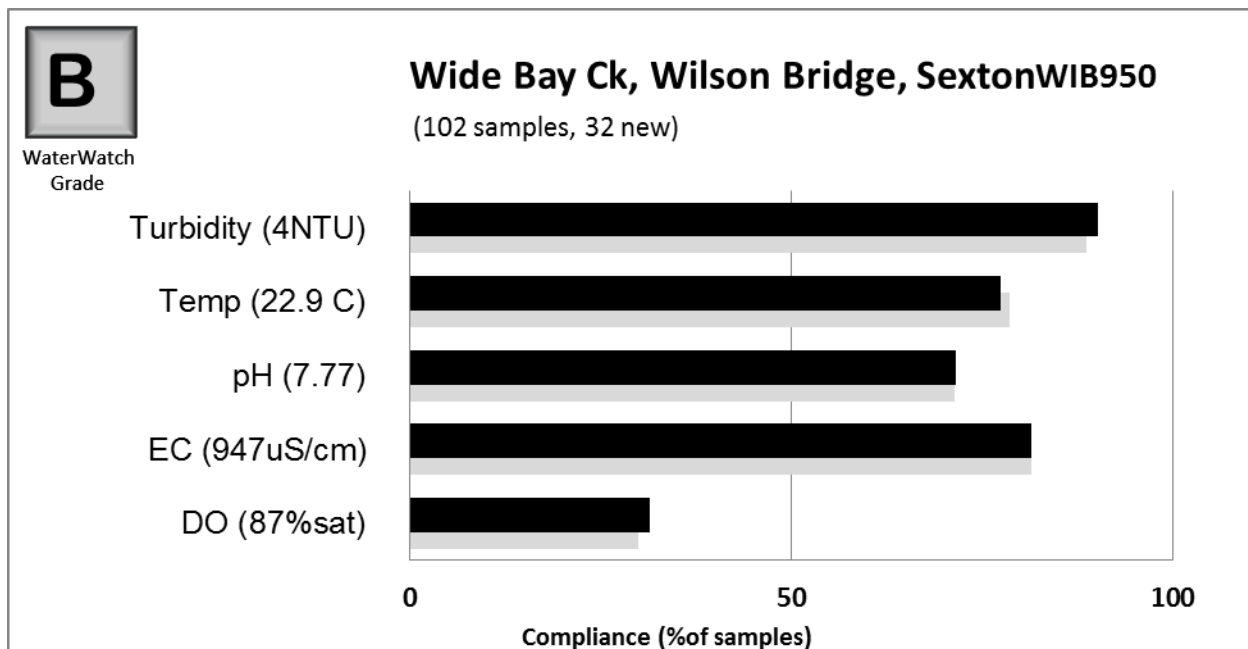
- Excellent sample size, gold medal award winner!
- This site has maintained all water quality parameters over the past three years.
- EC results at this site are much lower than the Wide Bay Creek Kilkivan and Oakview sites above.
- Maintaining an overall grade of B (2013 Waterwatch Grade = B) over the past 6 years.

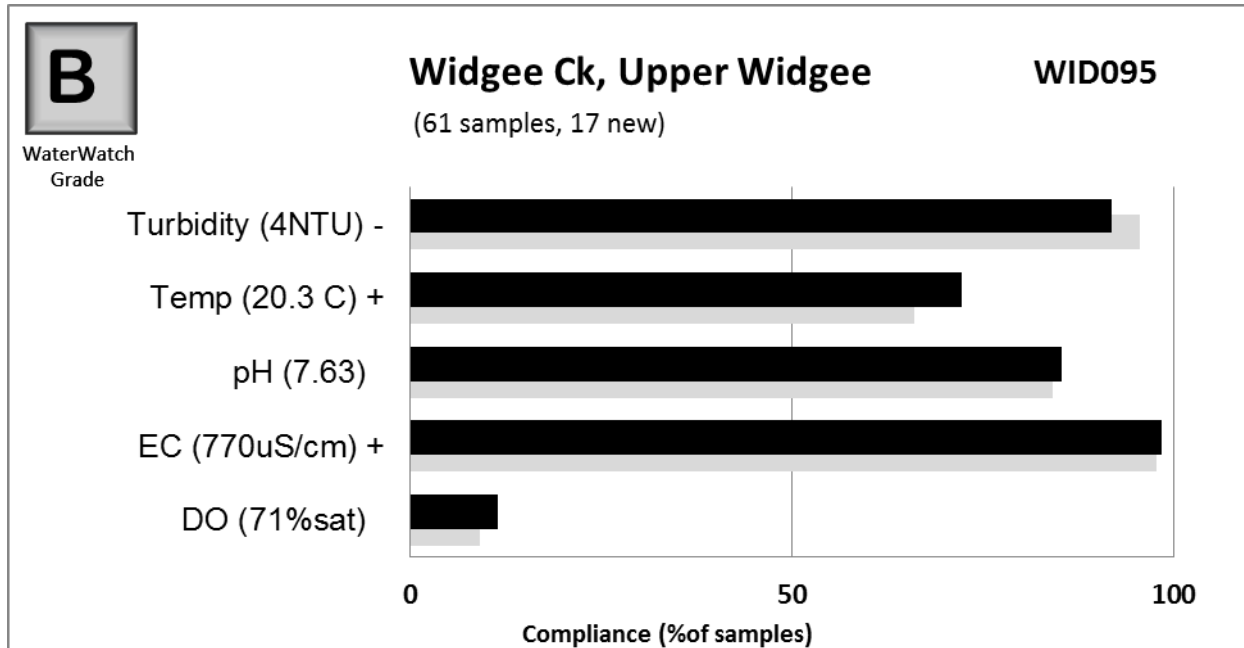
- Good sample size.
- This site experiences very little variation in dissolved oxygen levels - nearly all the readings are between 60% and 80% saturation which is just below guideline levels but is still indicative of a healthy creek.
- Excellent compliance for electrical conductivity (salinity) over the last six years.
- Exceptionally very little variance in pH - with a consistently neutral pH.
- Maintaining an overall grade of B (2013 Waterwatch Grade = B) over the past 6 years.

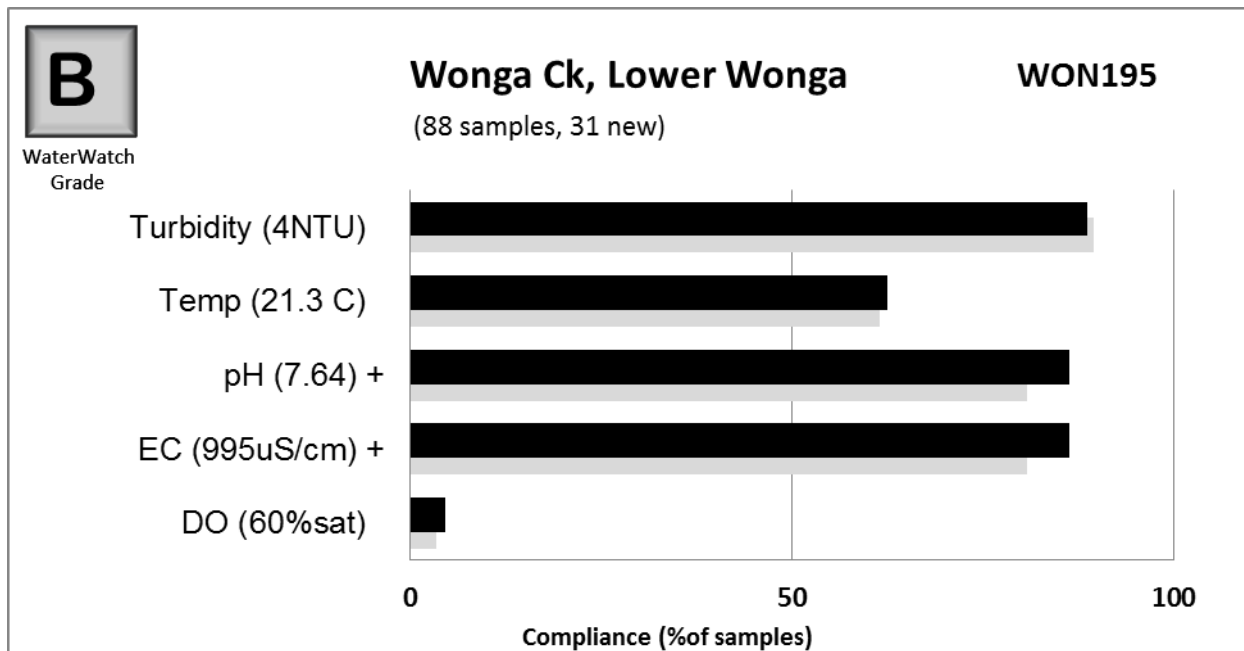
- Good sample size.
- Both Wonga Creek sites are on a borderline between a “B” and “C” rating.
- Significant improvement in electrical conductivity (salinity) levels at both sites has continued over the last six years.
- Wonga Creek at these sites is an intermittent creek which effects dissolved oxygen levels.
- Consistently low dissolved oxygen levels have been recorded at this site.
- Maintaining an overall grade of B (2013 Waterwatch Grade = B) over the past 6 years.

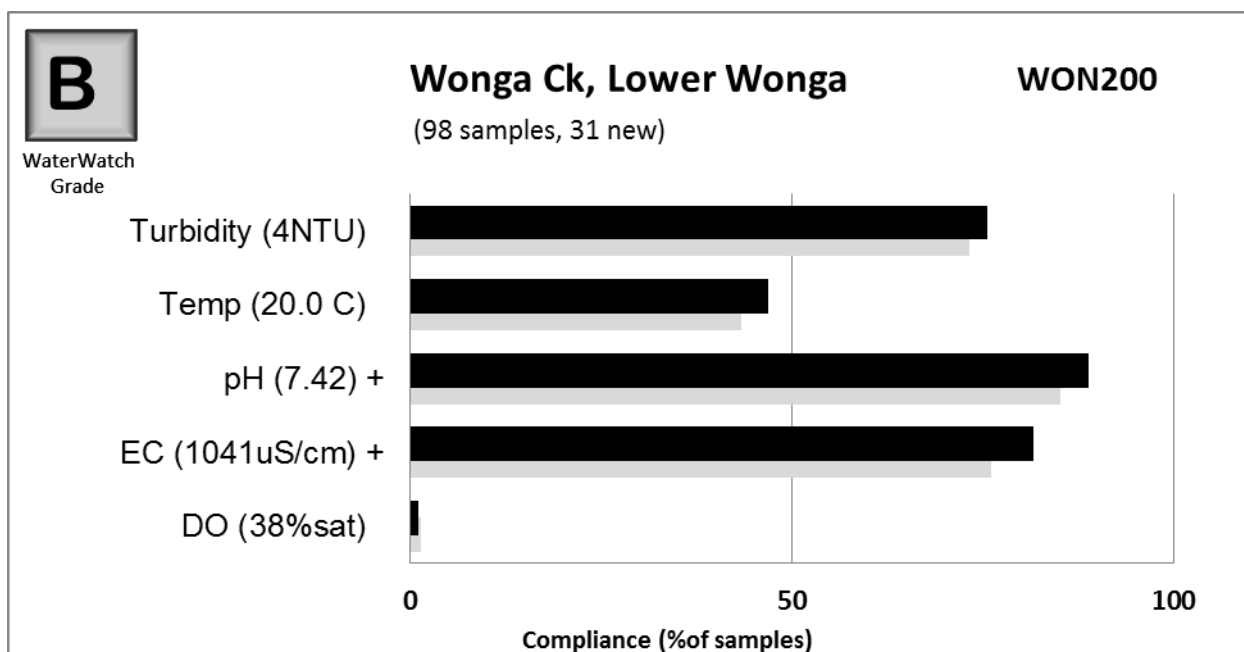
- Good sample size.
- Significant improvement in compliance of pH and electrical conductivity at this site over the past six years.
- Interestingly, water temperature at this site is cooler than the WON195 site.
- Improved overall grade to B (2013 Waterwatch Grade = C) over the past 3 years.

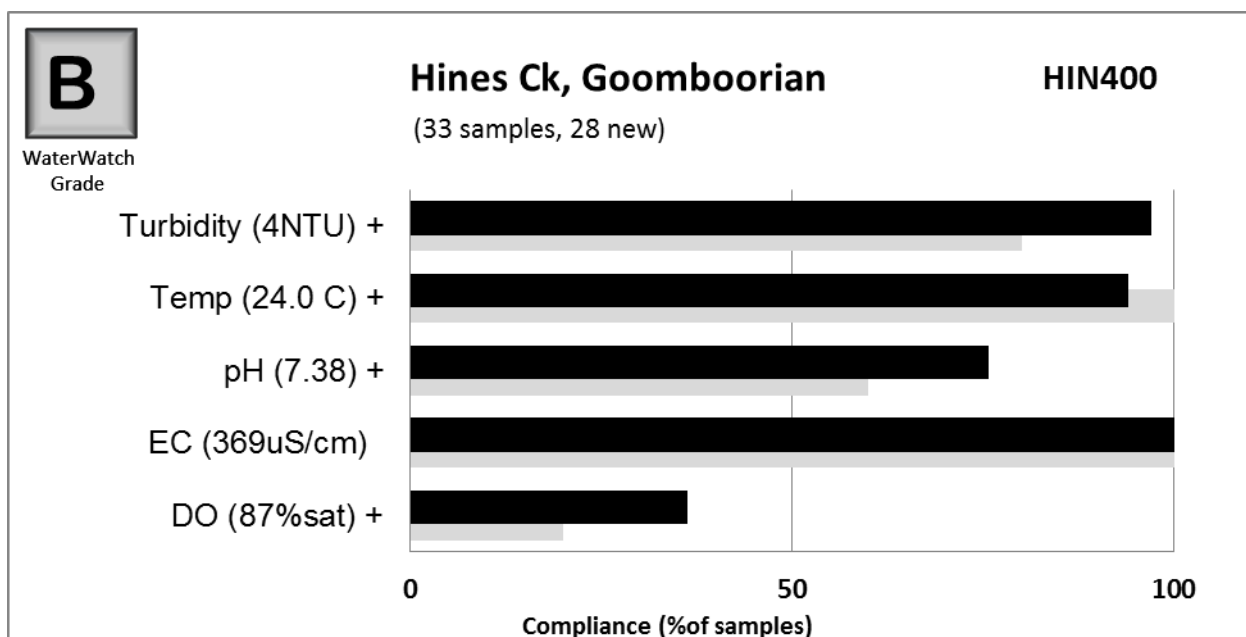
- New site, good sample size.
- Improvements in turbidity, temperature, pH and DO due to more data capturing the conditions of the site.
- This site has a relatively high water temperature (warmer than the Gympie Weir – Mary River site).

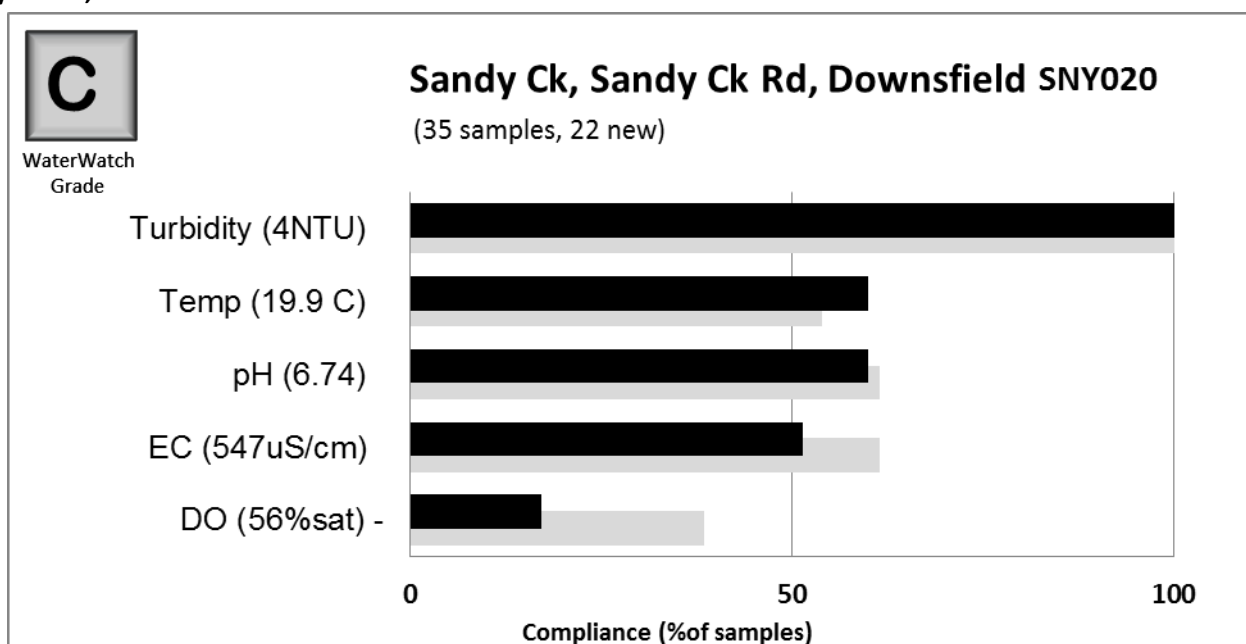
- Good sample size.
- Significant decline in DO compliance over the past three years possibly due to lower than average rainfall, which has resulted in a drop from an B to a C grade.
- Good turbidity compliance.
- Electrical conductivity (salinity) is relatively high in comparison to the Tinana Creek sites (in December 2012, maximum of 959us/cm was recorded).
- A decline in the overall grade to C (2013 Waterwatch Grade = B) over the past 3 years.

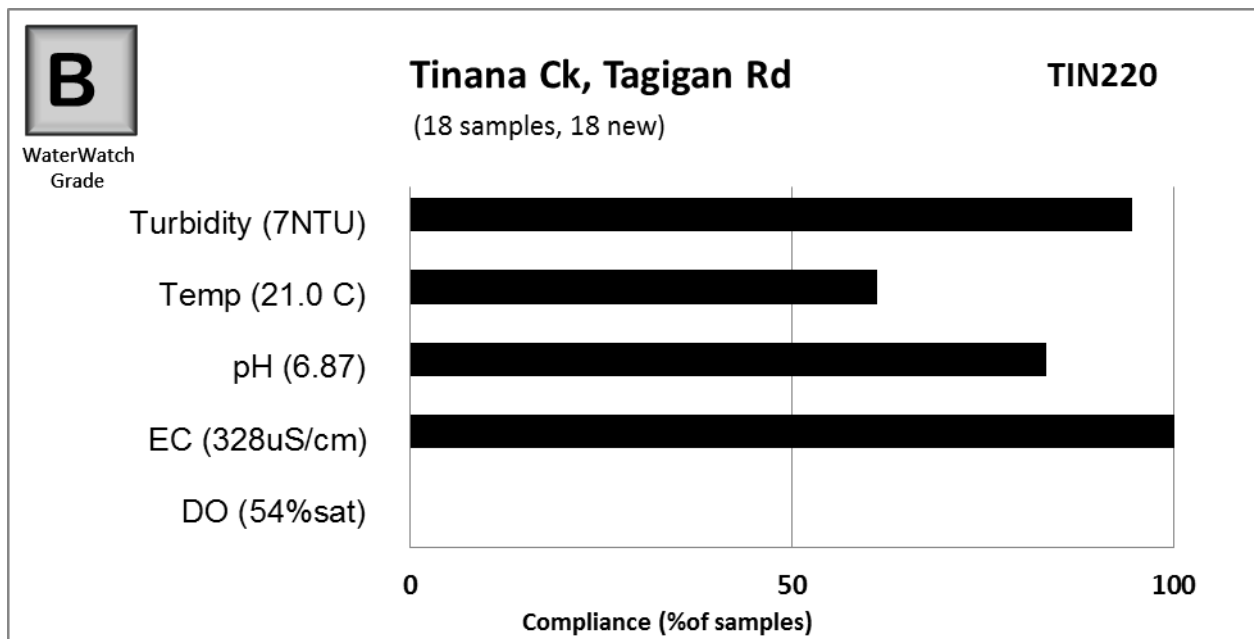
- New site.
- Sample size is not yet sufficient to make definitive comments on trends.
- Tinana Creek exhibits low natural pH levels due to the nature of this sub-catchment.
- Dissolved oxygen levels are low compared to guideline levels, which is likely to be typical of Tinana Creek – more data required to confirm this assumption.

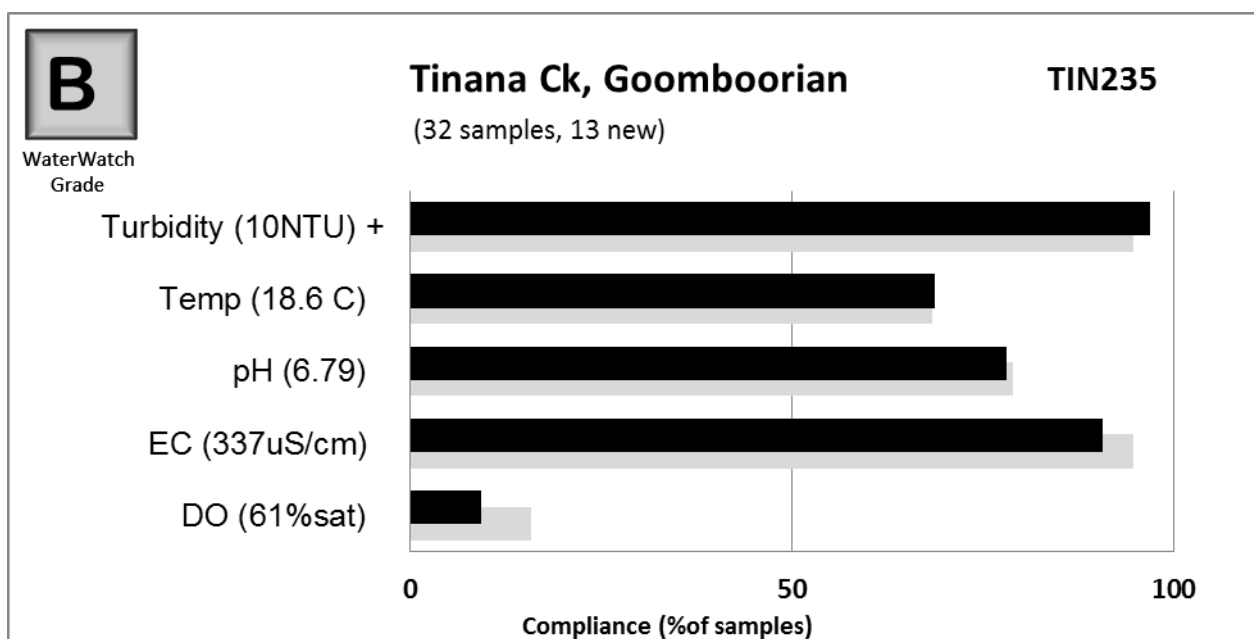
- Good sample size.
- Good compliance for all parameters tested, apart from DO.
- Tinana Creek sites have considerably lower water temperature levels than the sample sites located on the Mary River, due to more riparian vegetation shading the water on Tinana Creek.

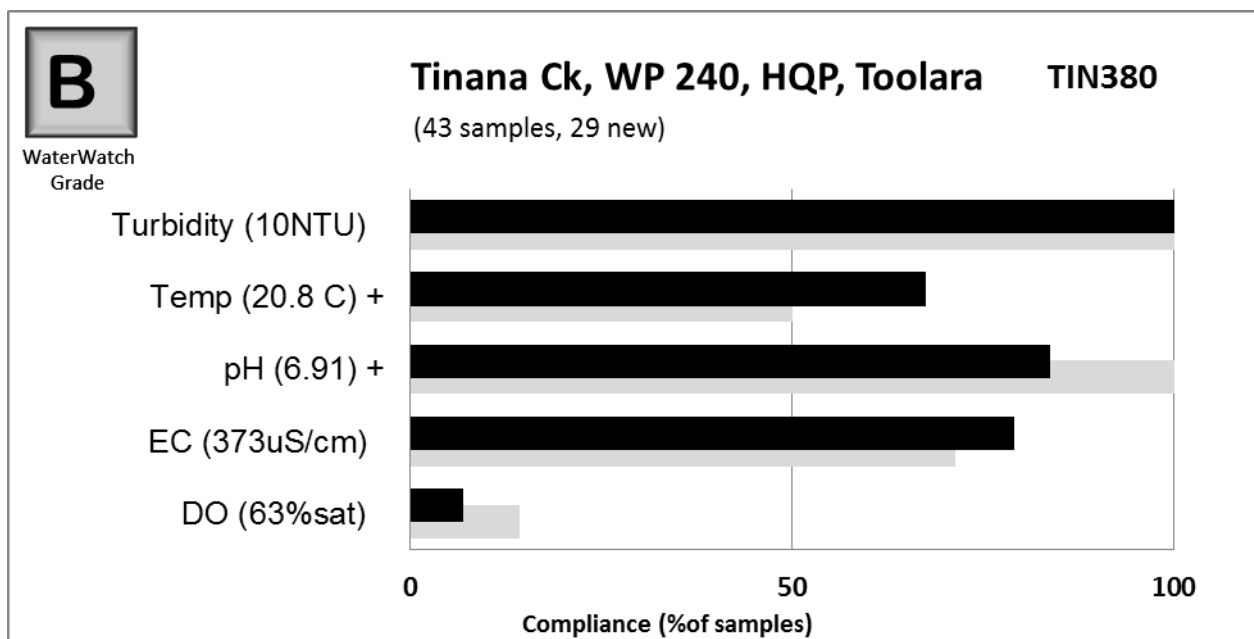
- Good sample size.
- Improvement in pH and temperature compliance over the last three years.
- Dissolved oxygen compliance is low which is consistent with all other Tinana Creek sites.
- Maintaining an overall grade of B (2013 Waterwatch Grade = B) over the past 3 years.

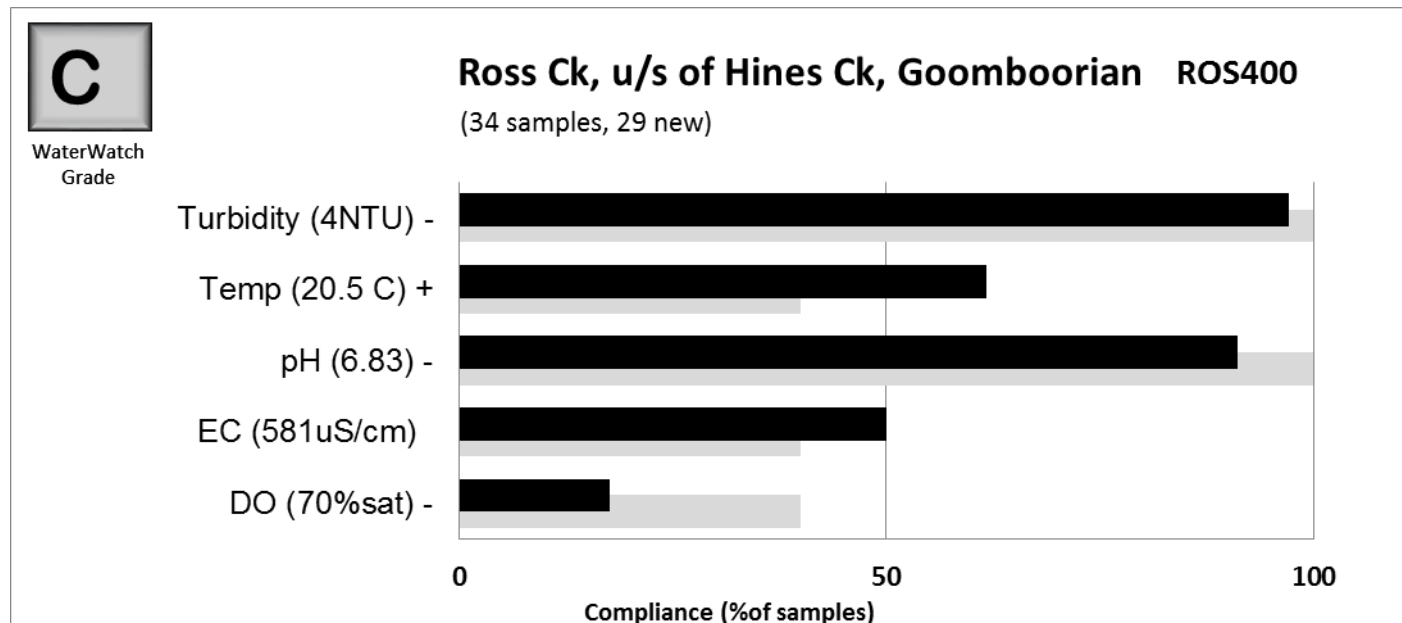
- New site.
- Good sample size.
- Good turbidity and pH compliance.
- EC median value is just above guideline level, which has resulted in a C score compared to the ROS450 which is a B.

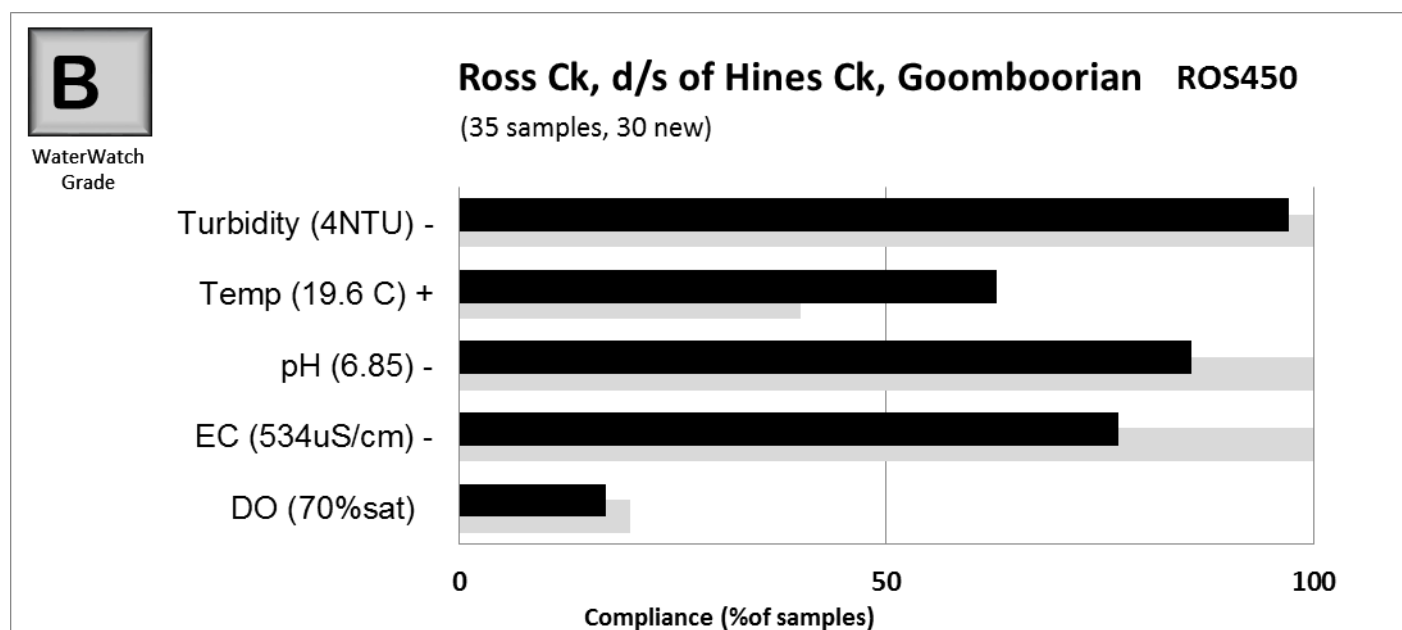
- New site.
- Good sample size.
- Good turbidity compliance.
- Dissolved oxygen compliance is similar to the upstream site.

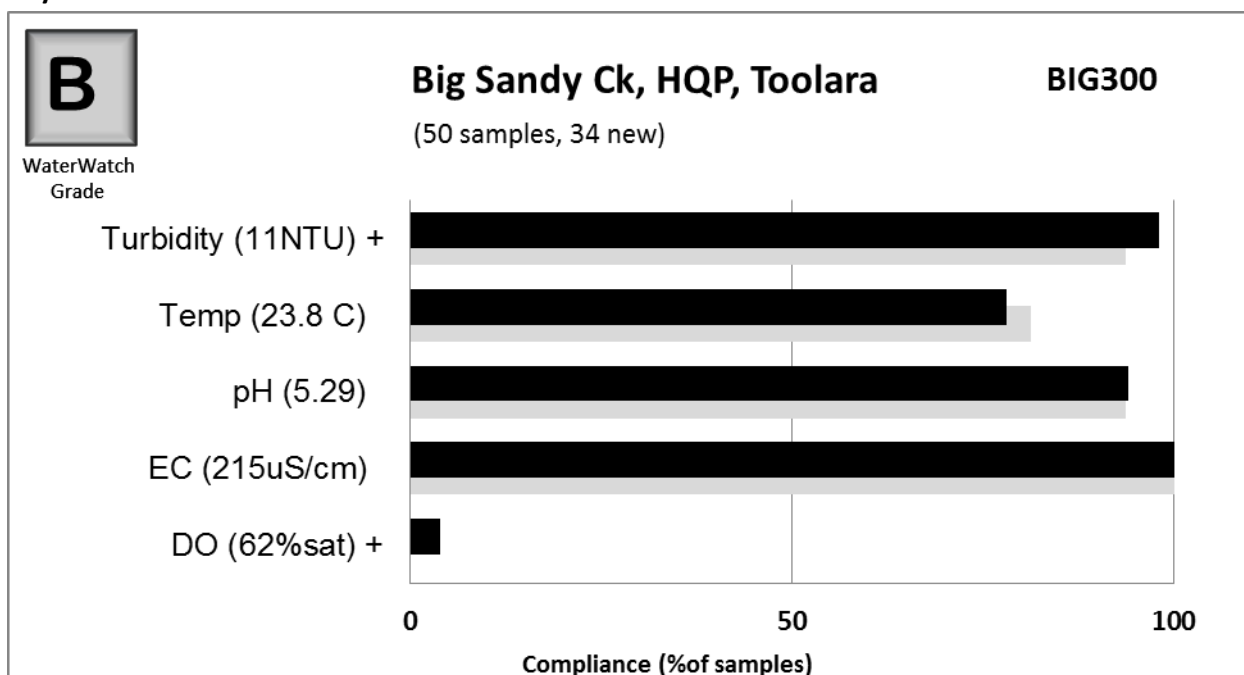
- Good sample size.
- The Big Sandy Creek site displays similar levels of dissolved oxygen compliance to that of the Tinana Creek sites. Big Sandy Creek is a tributary of Tinana Creek.
- pH is naturally low.
- Dissolved oxygen saturation does not comply with guidelines – possibly a natural occurrence.
- Maintaining an overall grade of B (2013 Waterwatch Grade = B) over the past 3 years.

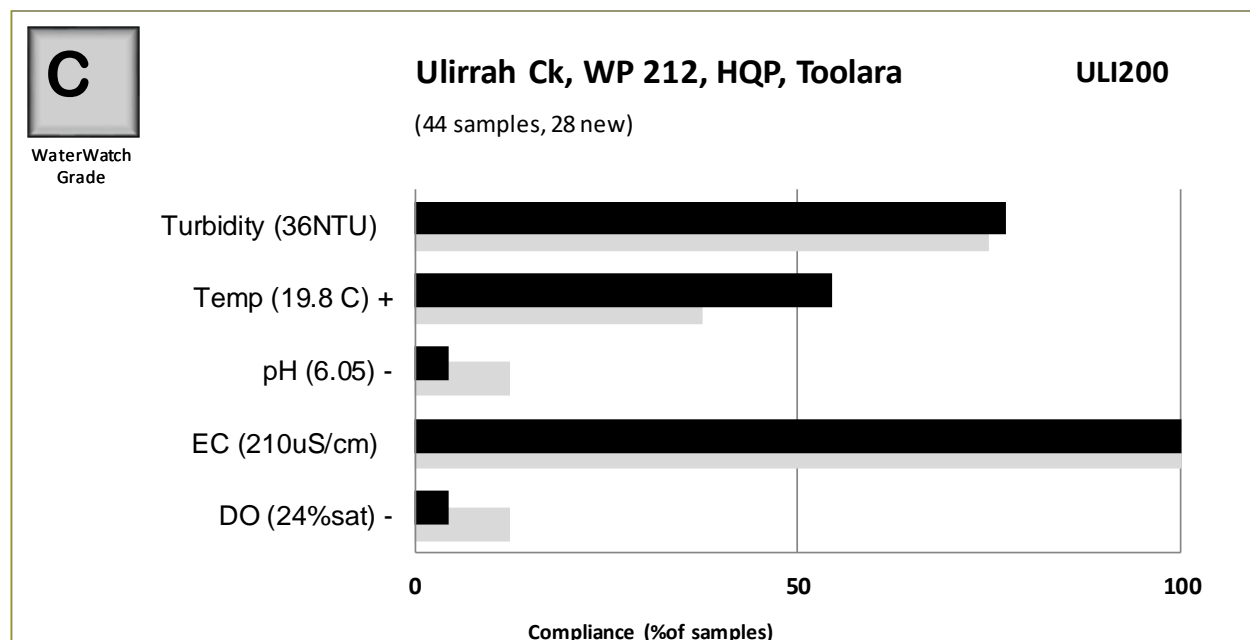
- Good sample size
- Ulirrah Creek displays low pH (acidic) levels, which is consistent with the nature of the sub-catchment.
- Excellent compliance with electrical conductivity (salinity).

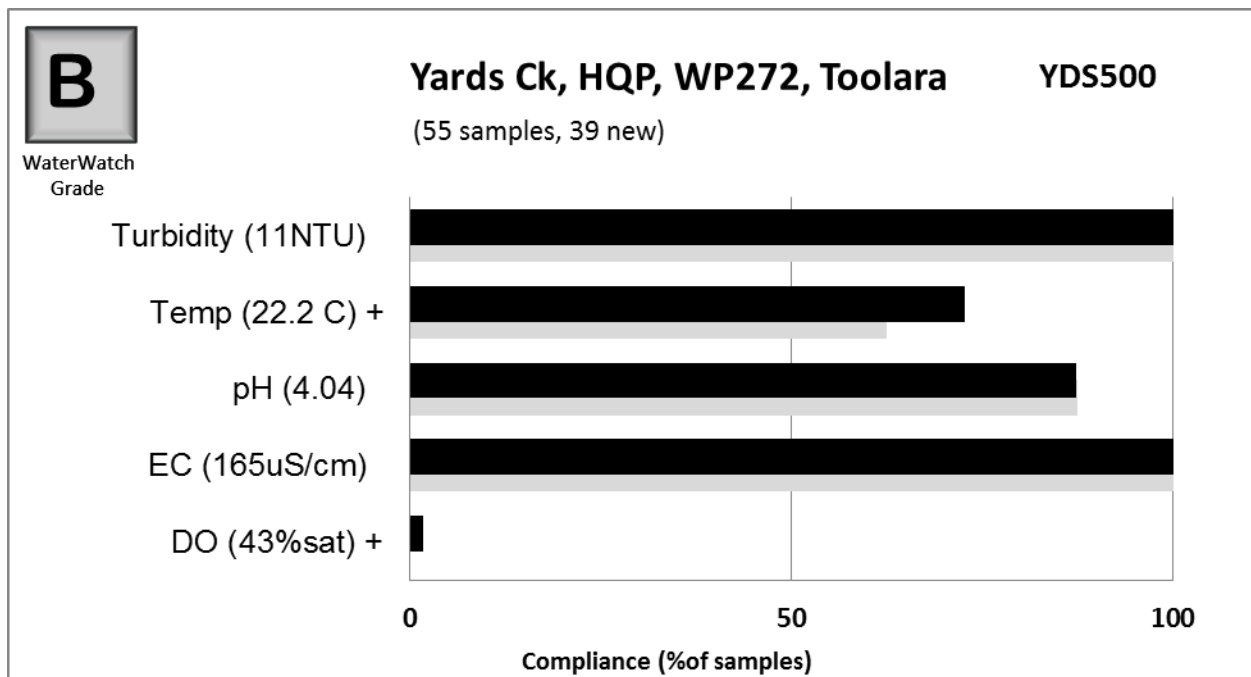
- Good sample size.
- Improvement in temperature compliance of the last three years has improved the grade from C to B.
- pH is naturally low.
- Improved overall grade to B (2013 Waterwatch Grade = C) over the past 3 years.
