Mary River Water Quality Catchment Crawl

2019

8 – 9 October 2019

Mary River Catchment Coordinating Committee
25 Stewart Terrace
Gympie QLD 4570
www.mrccc.org.au
admin@mrccc.org.au

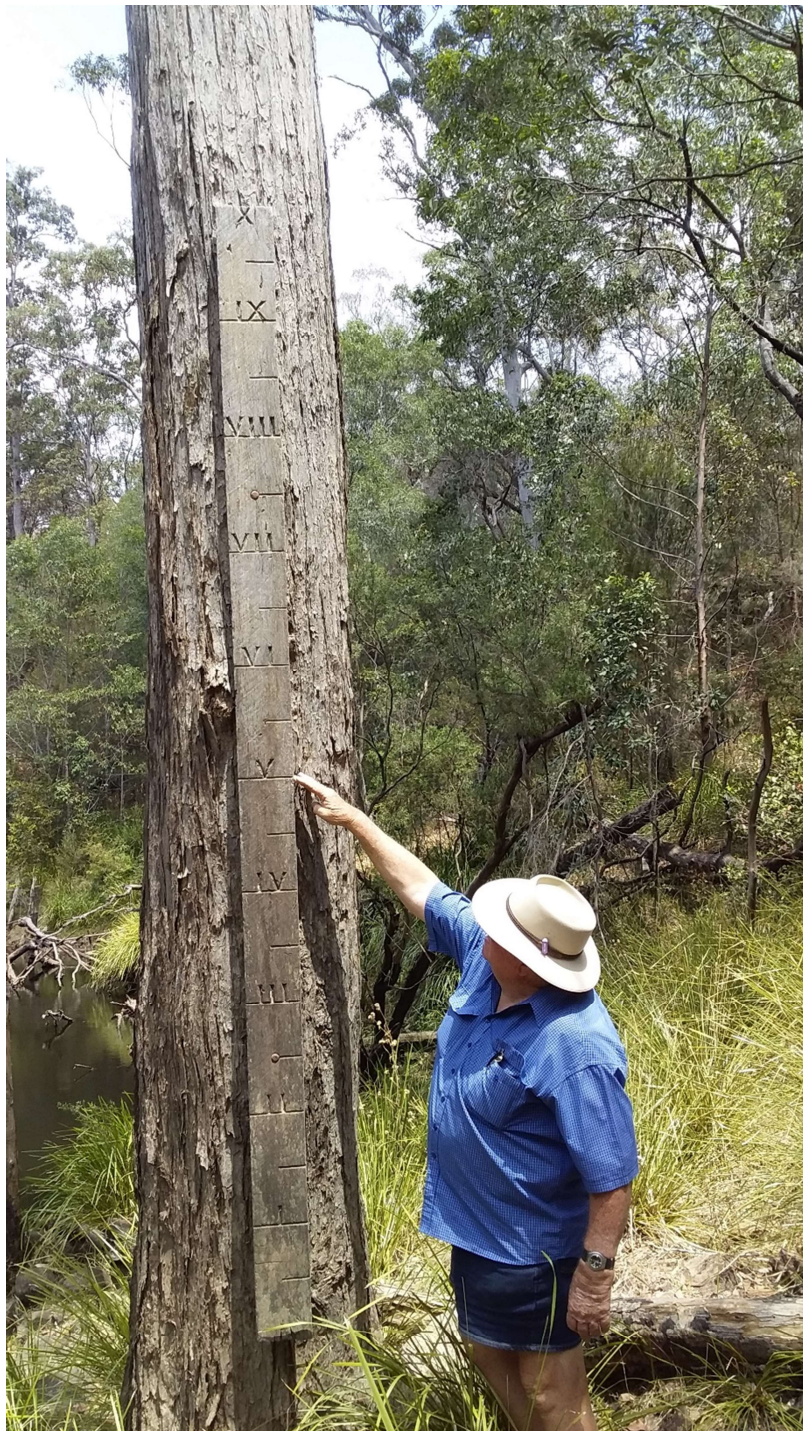
Above: Garth Jacobson looking at flood marker at Tinana Creek, Missings Crossing (TIN800)

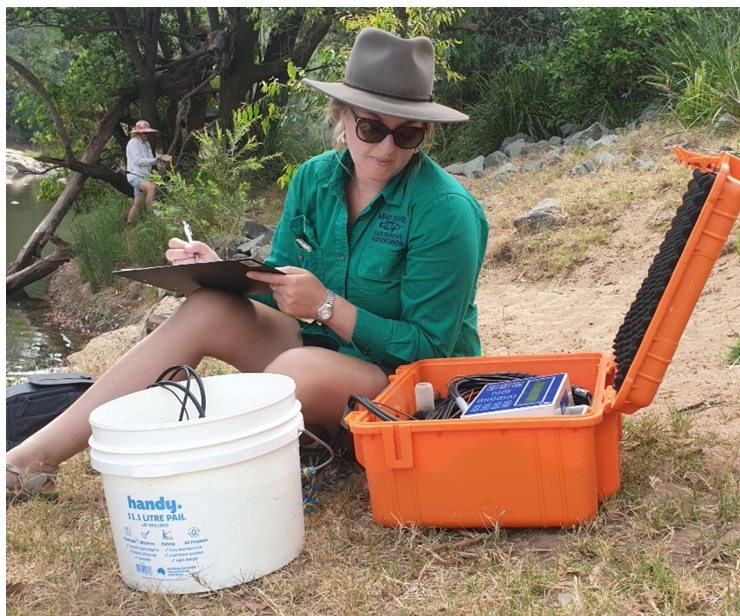
Figure 4 Caitlin Mill recording data from the TPS FLT90 multiprobe

1. FLT 90 multi probe to measure pH, conductivity, salinity, temperature, dissolved oxygen and turbidity (and spare equipment).
2. WP80 and WP81 used to measure pH, conductivity, salinity, temperature, dissolved oxygen.
3. DES sample bottles and sampling equipment (sample pole, gloves, syringes, filters)
4. Esky and portable freezer
5. *E. coli* sample bottles
6. Digital camera
7. Garmin hand held GPS unit
8. Turbidity (clarity) tube
9. 10L bucket
10. Catchment map
11. Hat, sunscreen, first aid kit
12. Folder, data sheets, equipment instructions, itinerary and site hazard analysis assessment sheets

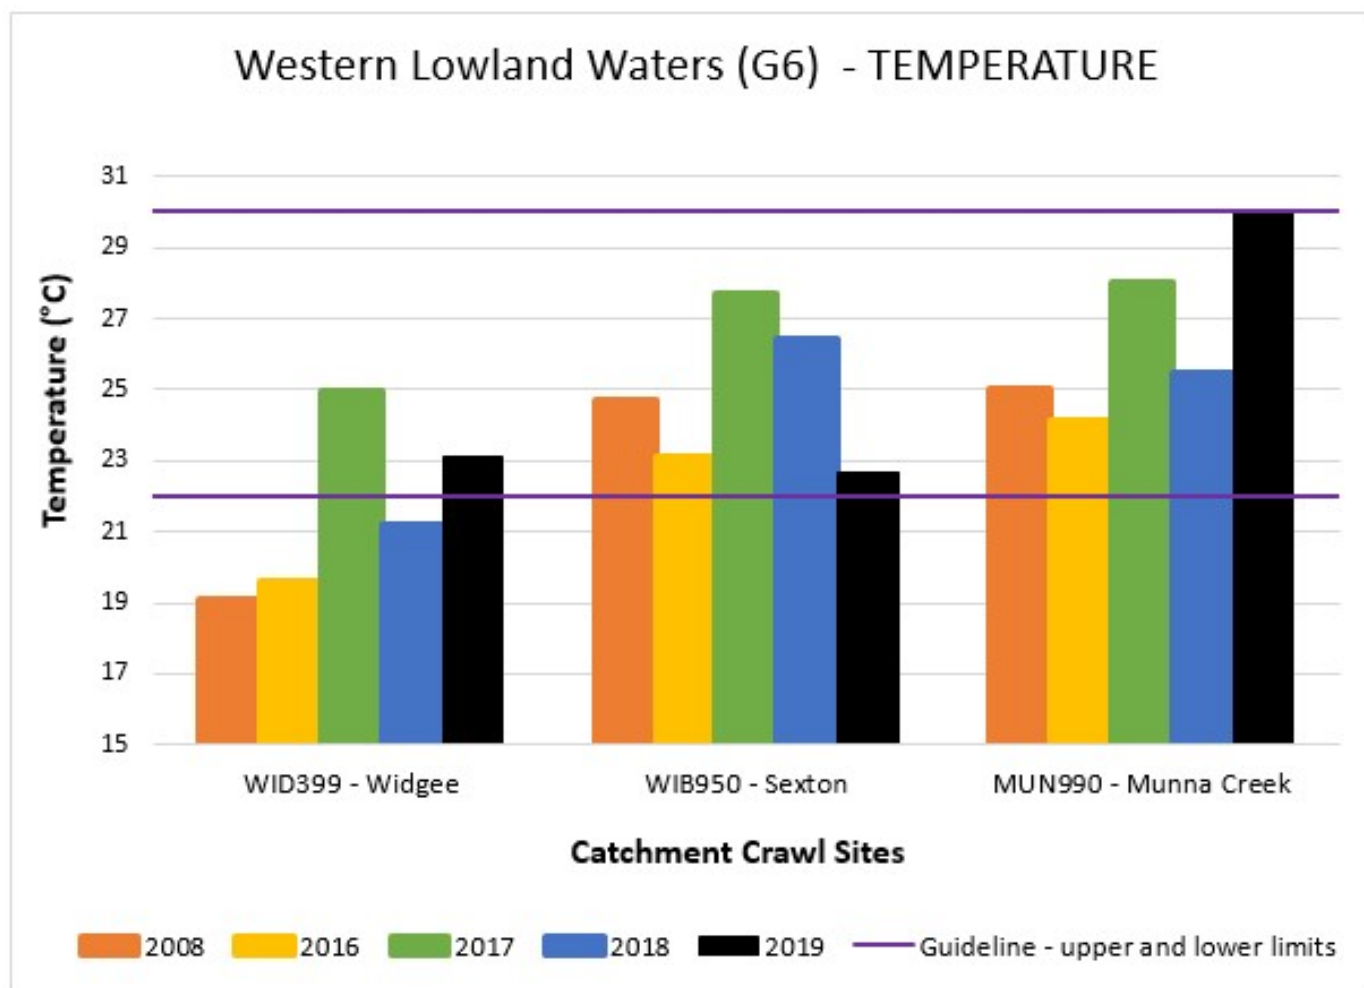
The North Western Lowland Waters tributaries measured during the Catchment Crawl are Munna (MUN990), Wide Bay (WIB950) and Widgee (WID399) Creeks. The temperature guideline for the North western lowland waters is between 22 and 30°C for summer. The horizontal purple lines in Figure 8 show the guideline temperatures. All measurements are within guideline values. Munna Creek (MUN990) fell just below the maximum guideline value and is the warmest G6 site for 2019, at the time of testing it was a stagnant open pool with no flow. Widgee Creek has good temperature compliance and could provide conditions suitable for Mary River Cod spawning. Wide Bay Creek (WIB950) at 22.65 is the coolest record for this site. These temperature records were taken late in the afternoon when high water temperatures are expected, however Widgee Creek appears to have sufficient shading to moderate temperature fluctuations.

Figure 8 Temperature of tributaries in North Western Lowland Waters (G6)

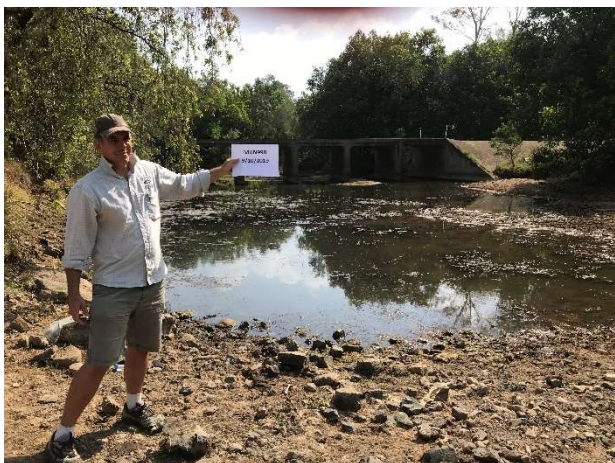
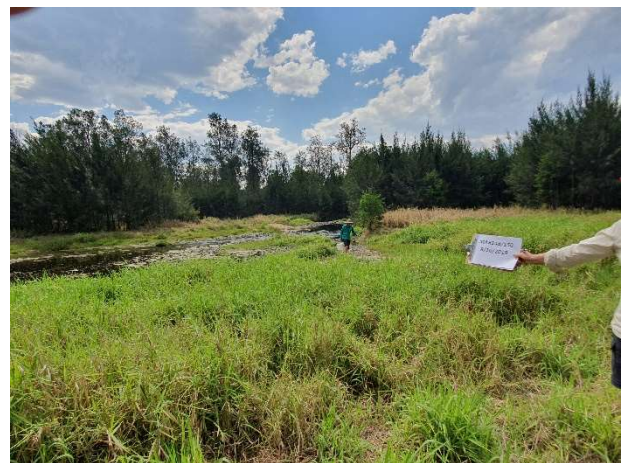
Figure 14 MUN990 (30°C) – hottest tributary site in 2019 (to the left), MAR148 (27.97°C) – hottest Mary site in 2019 (to right)

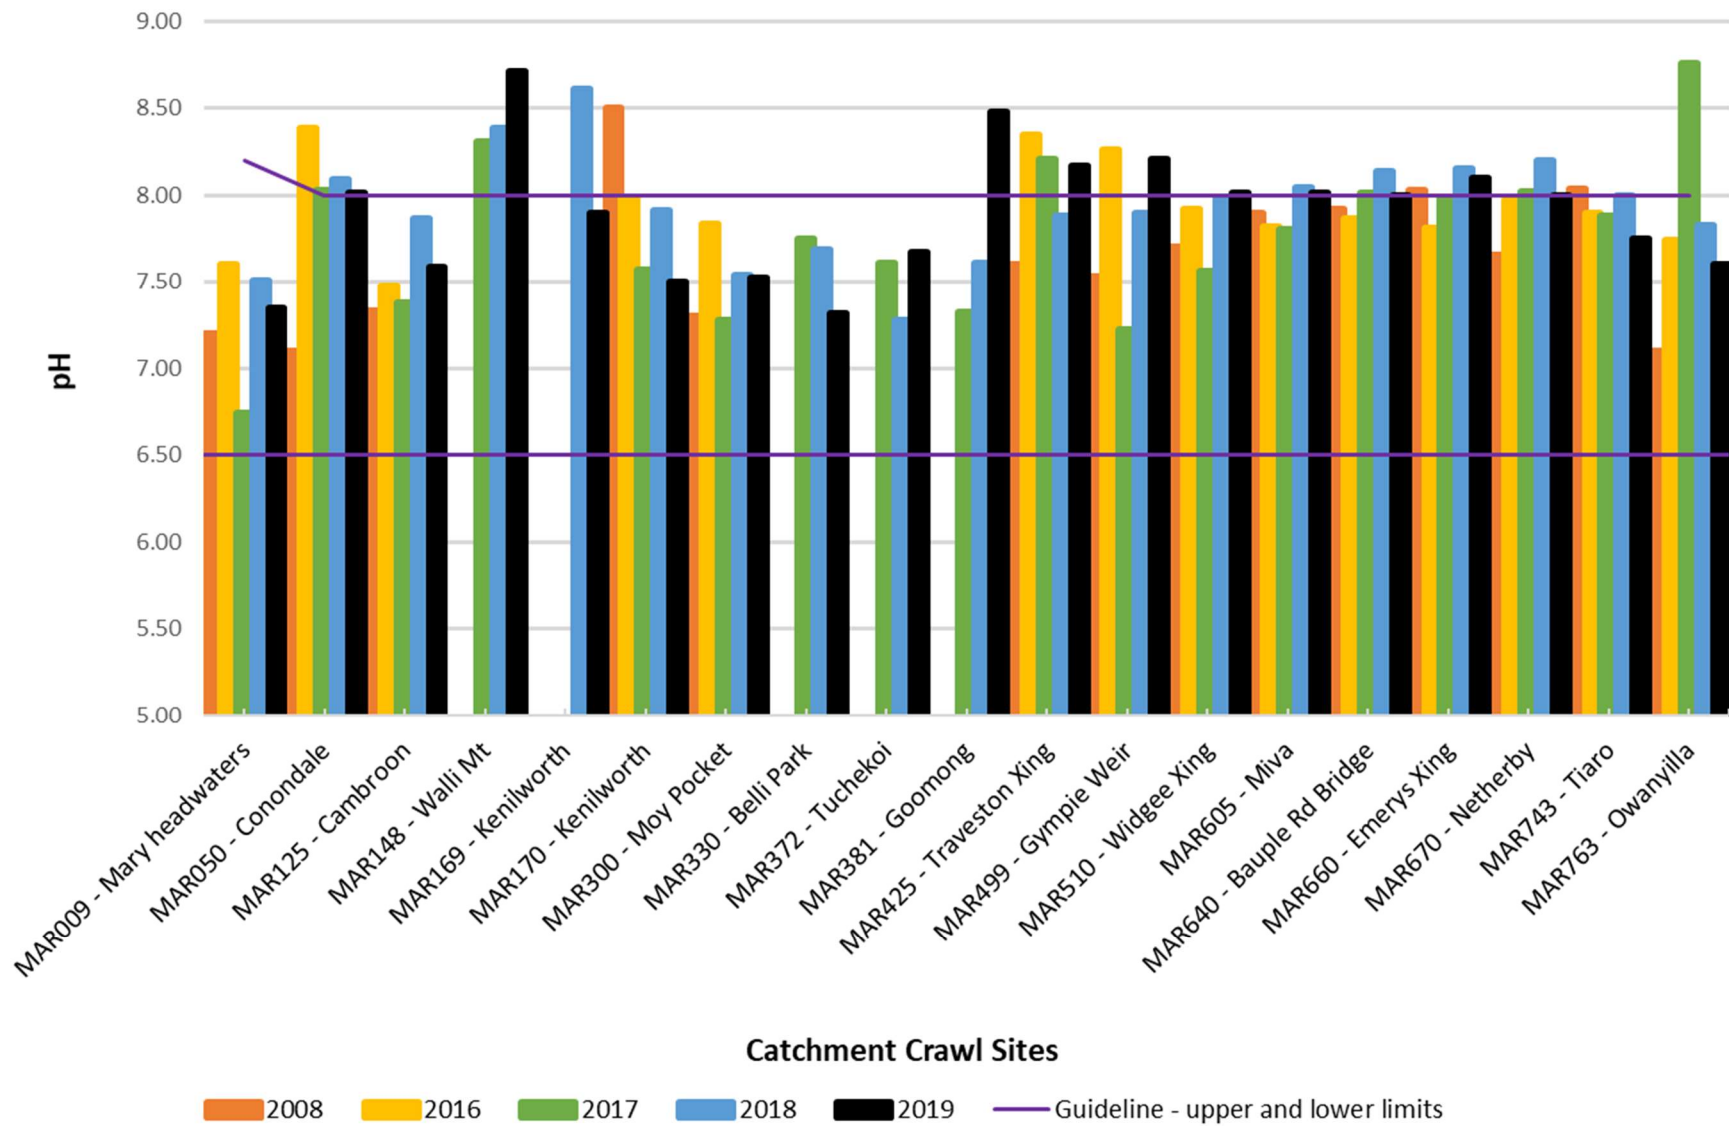
Figure 16 pH of Mary River sites in Southern Lowland waters (G5)

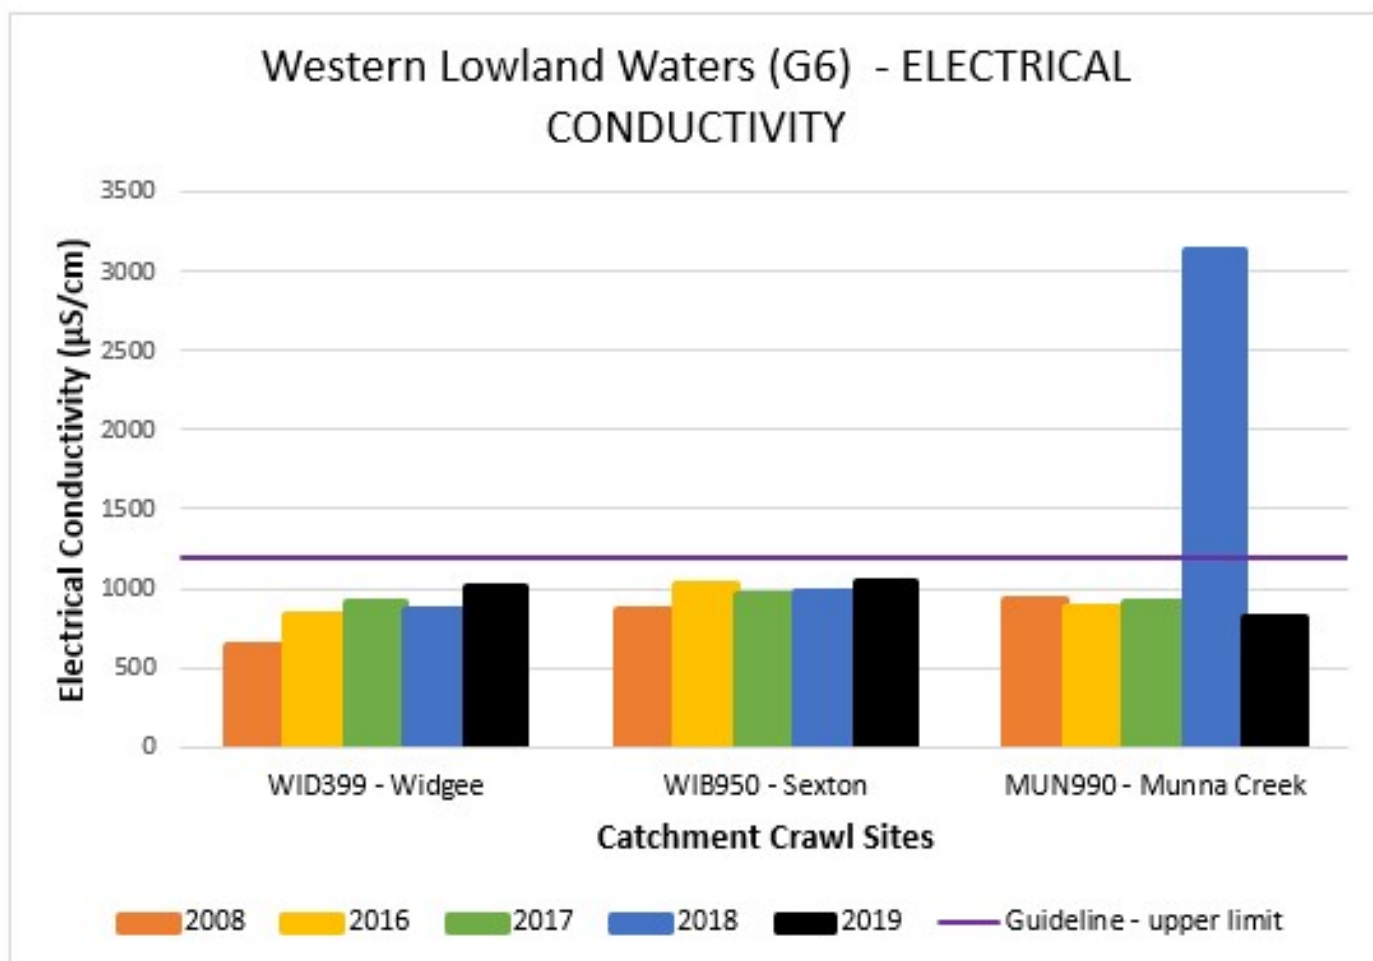
The Electrical Conductivity guideline for the Western tributaries (Southern Lowland Water) (Munna, Wide Bay, Widgee Creeks) is between 0 – 1200 μ S/cm. The higher upper value reflects the naturally more saline geology in these waters. The Widgee (WID399) and Sexton (WIB950) sites complied with the guidelines between 2019 and previous years. However the Munna Creek site (MUN990) showed a significant increase in 2018, recording 3125 μ S/cm (see Figure 25). The high EC value recorded in 2018 could be attributed to high concentrations of salt being flushed through the system with the first rains. Prior to the catchment crawl the Waterwatch sampling for this site recorded EC of 984 μ S/cm on the 29th August 2018, well within guideline values. Historic Waterwatch data shows that while the site usually falls within the guideline for EC, periodic spikes do occur.

Figure 25 Electrical conductivity of tributary sites in North Western Lowland waters (G6)

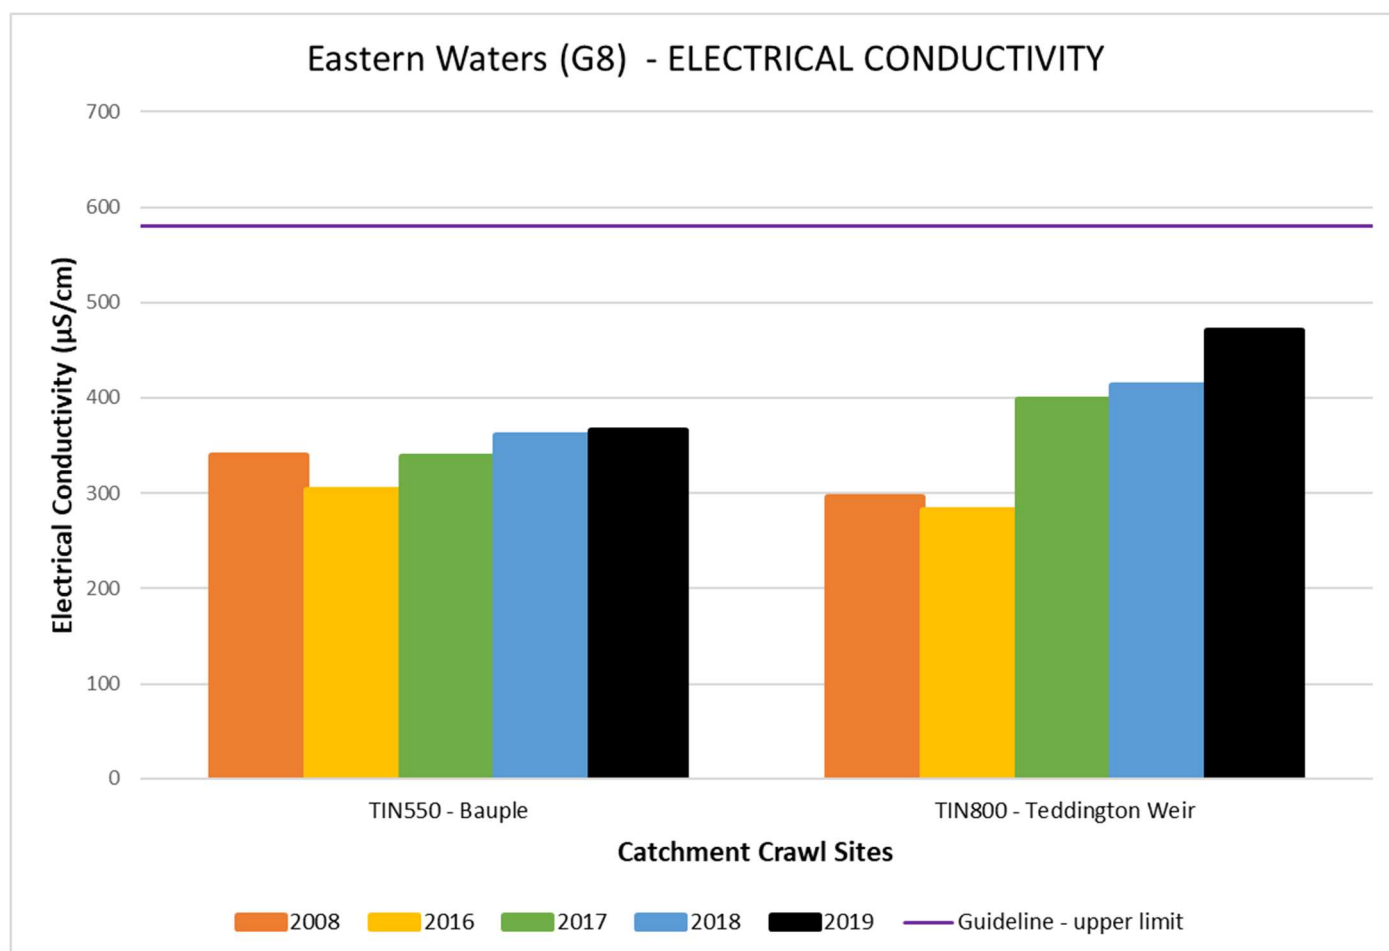
The Electrical Conductivity guideline for the Southern Lowland Waters (Tinana Creek only) is between 0 – 580 $\mu\text{S}/\text{cm}$. The horizontal purple line in Figure 26 shows the maximum guideline value. Data points above the line are outside of the guideline range. All sites sampled comply with the guideline. EC at both sites has shown a gradual increase over the last three years. This could be attributed to the lack of rain and therefore a concentration of salt levels.

Figure 26 Electrical conductivity of tributary sites in North Eastern Lowland waters (G8)

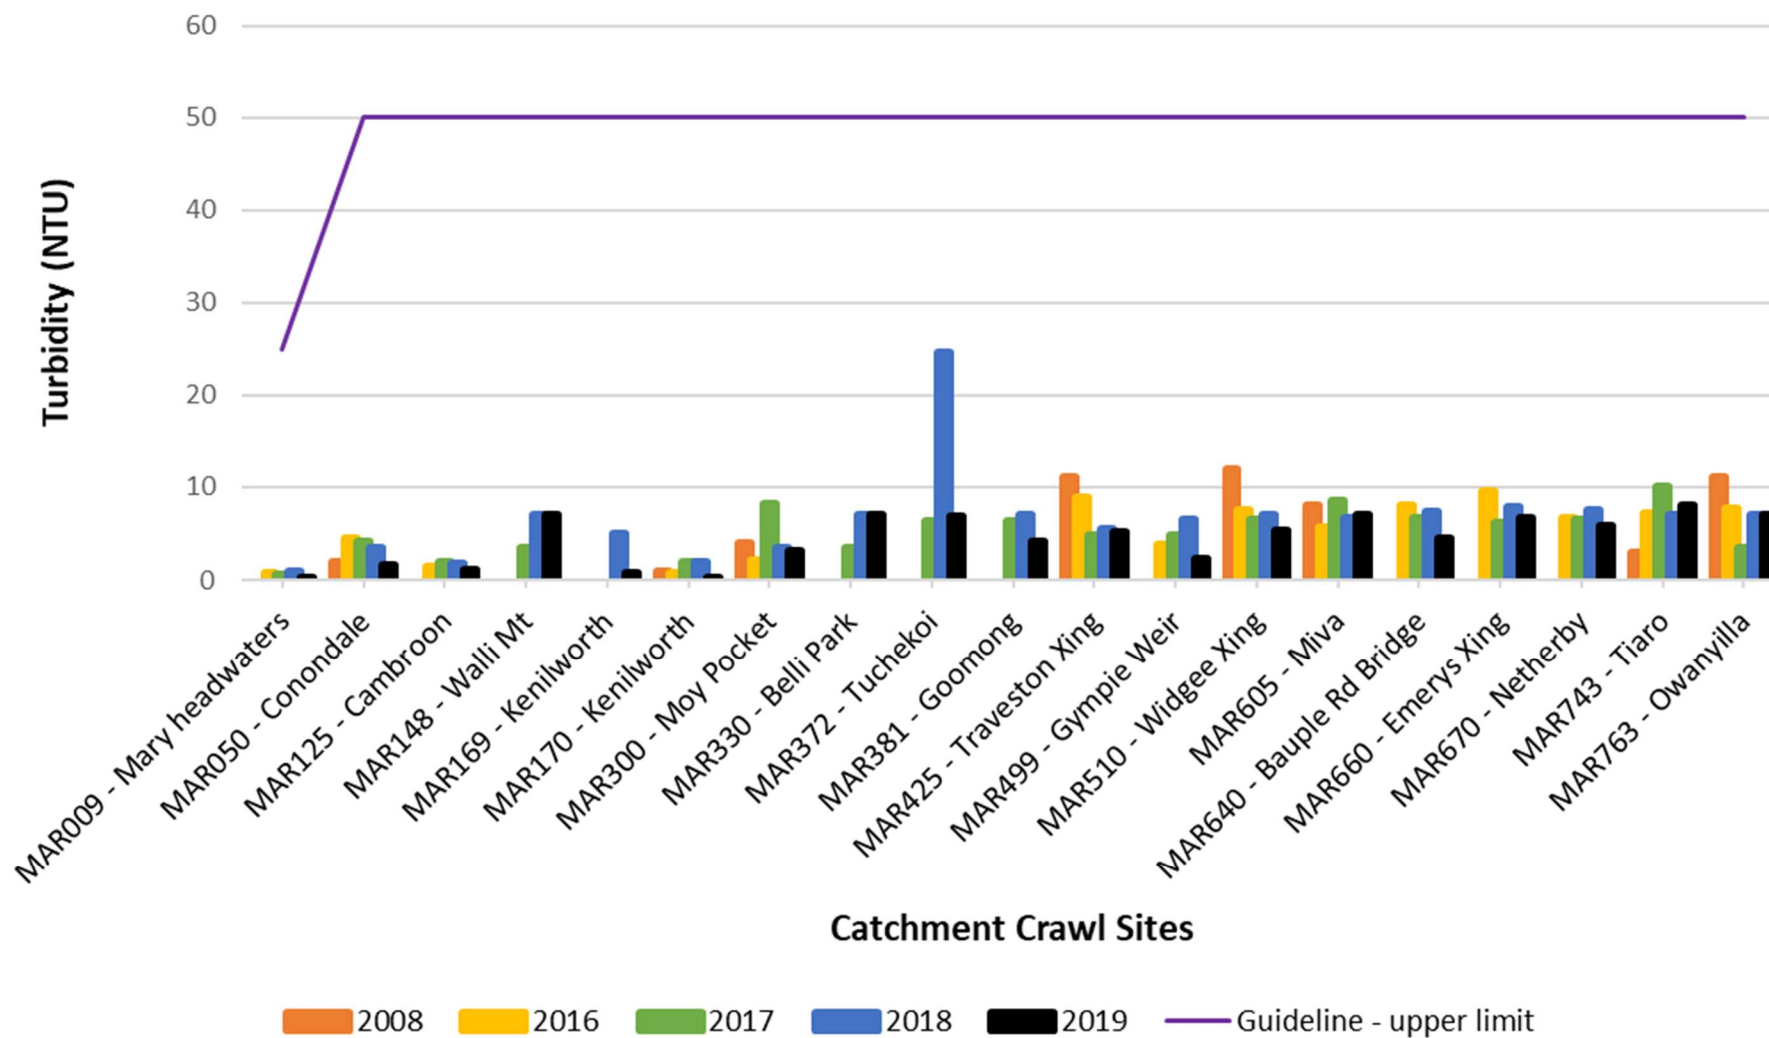
Figure 29 Turbidity of Mary River sites in Southern Lowland waters (G5)

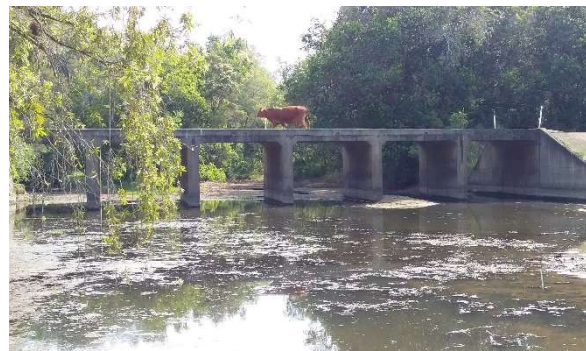
Above: Cow crossing Birt Rd Bridge, Munna Creek (MUN990)

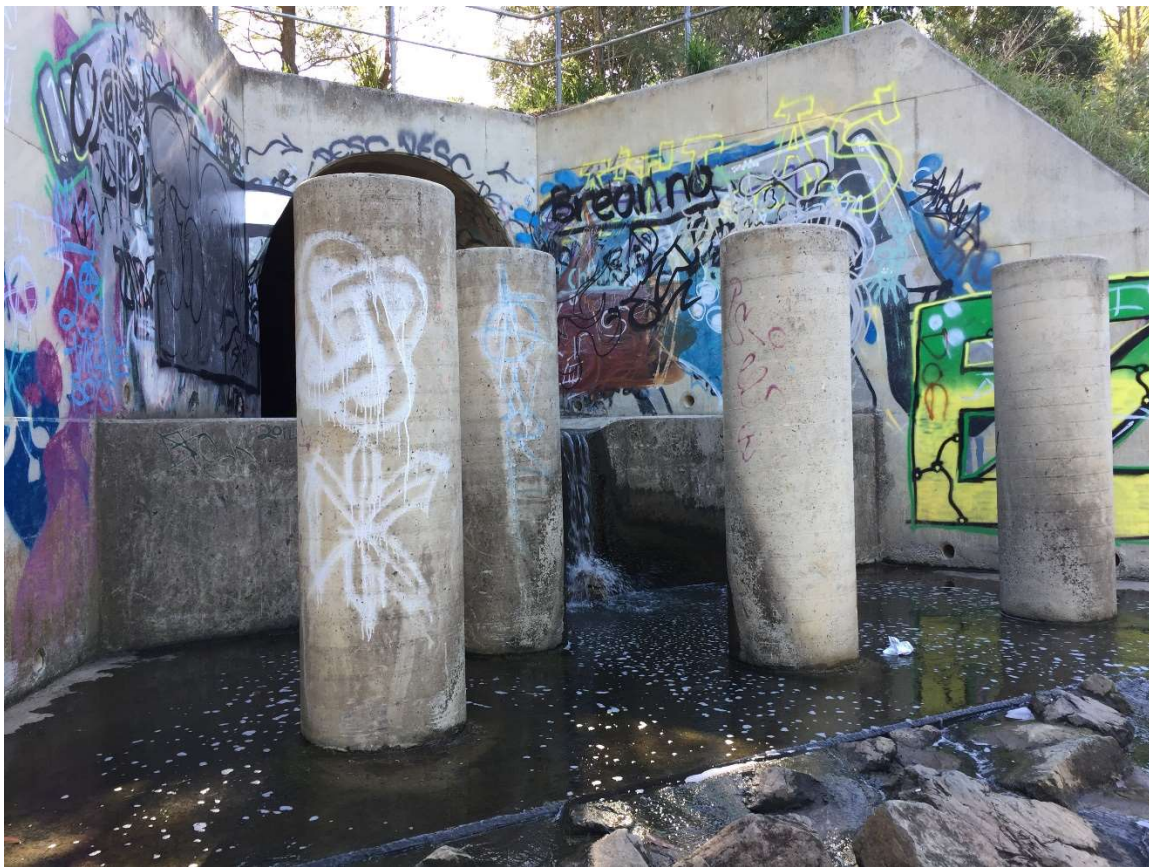
Above: Stormwater drain above Gympie Weir (MAR499)

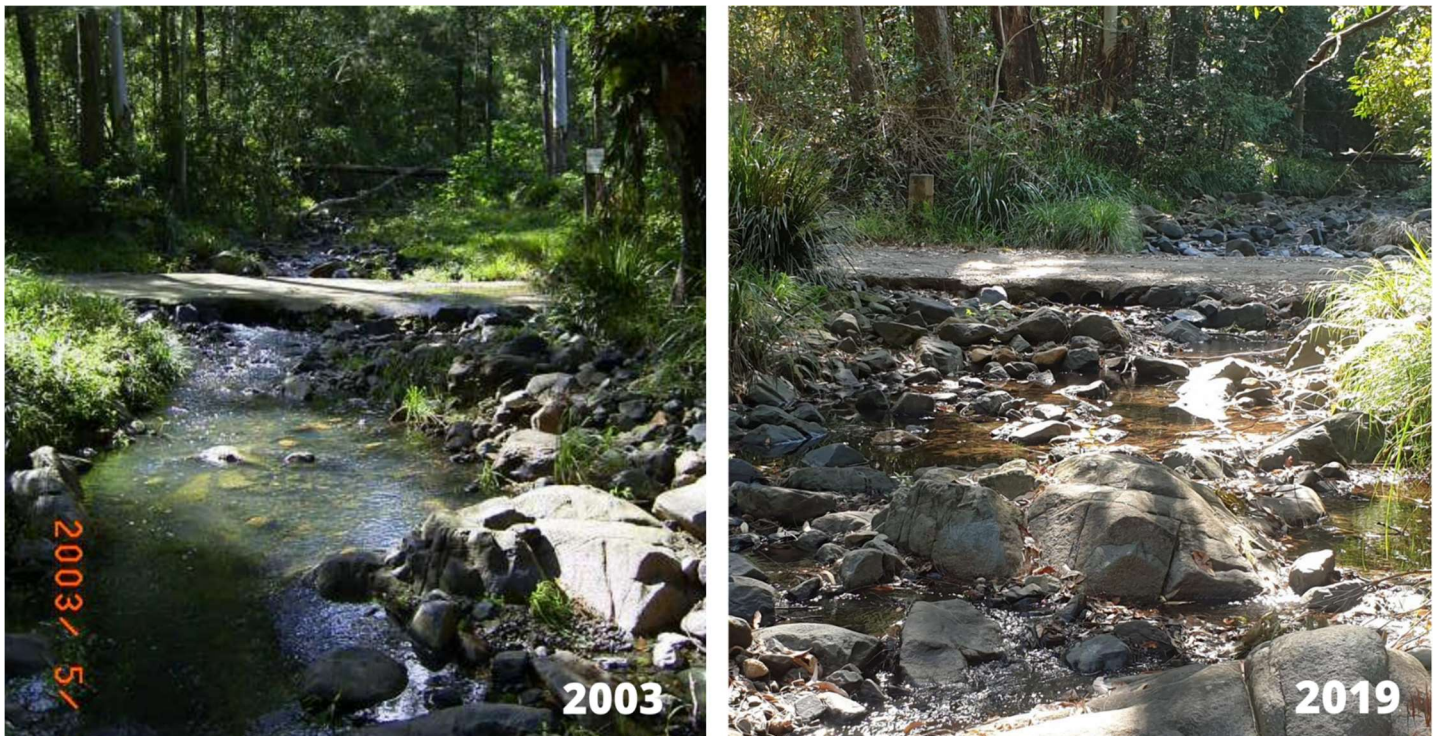
Figure 2 Mary River, McCrae Lane (MAR009)

Figures 89 to 95 below show images from the 2019 Catchment Crawl compared with those taken during past Catchments Crawls. This provides photographic evidence of historical change within the stream and riparian zone. The sites chosen represent the Mary River along its course, starting at the Mary headwaters site (MAR009) and ending at the River Heads site (MAR999), and including the five sites for which long term temperature records exist – Conondale (MAR050), Kenilworth (MAR170), Gympie (MAR510), Miva (MAR605) and Emerys Crossing (MAR660).
