Mary River Water Quality Catchment Crawl

2018

8 – 9 October 2018

*Mary River Catchment Coordinating Committee
25 Stewart Terrace
Gympie QLD 4570
www.mrccc.org.au
admin@mrccc.org.au*

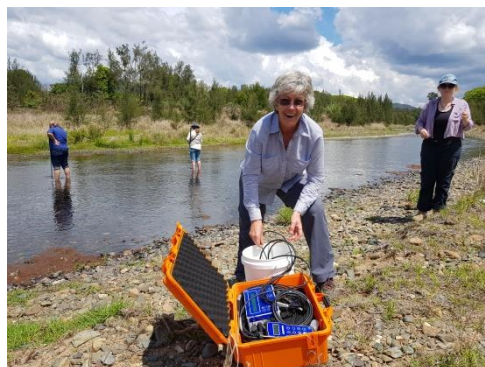
Figure 4 Antoinette Augustinus using the FLT90 multiprobe

1. FLT 90 multi probe to measure pH, conductivity, salinity, temperature, dissolved oxygen and turbidity (and spare equipment).
2. WP80 and WP81 used to measure pH, conductivity, salinity, temperature, dissolved oxygen.
3. DES sample bottles and sampling equipment (sample pole, gloves, syringes, filters)
4. Esky and portable freezer
5. *E. coli* sample bottles
6. Digital camera
7. Garmin hand held GPS unit
8. Turbidity (clarity) tube
9. 10L bucket
10. Catchment map
11. Hat, sunscreen, first aid kit
12. Folder, data sheets, equipment instructions, itinerary and site hazard analysis assessment sheets

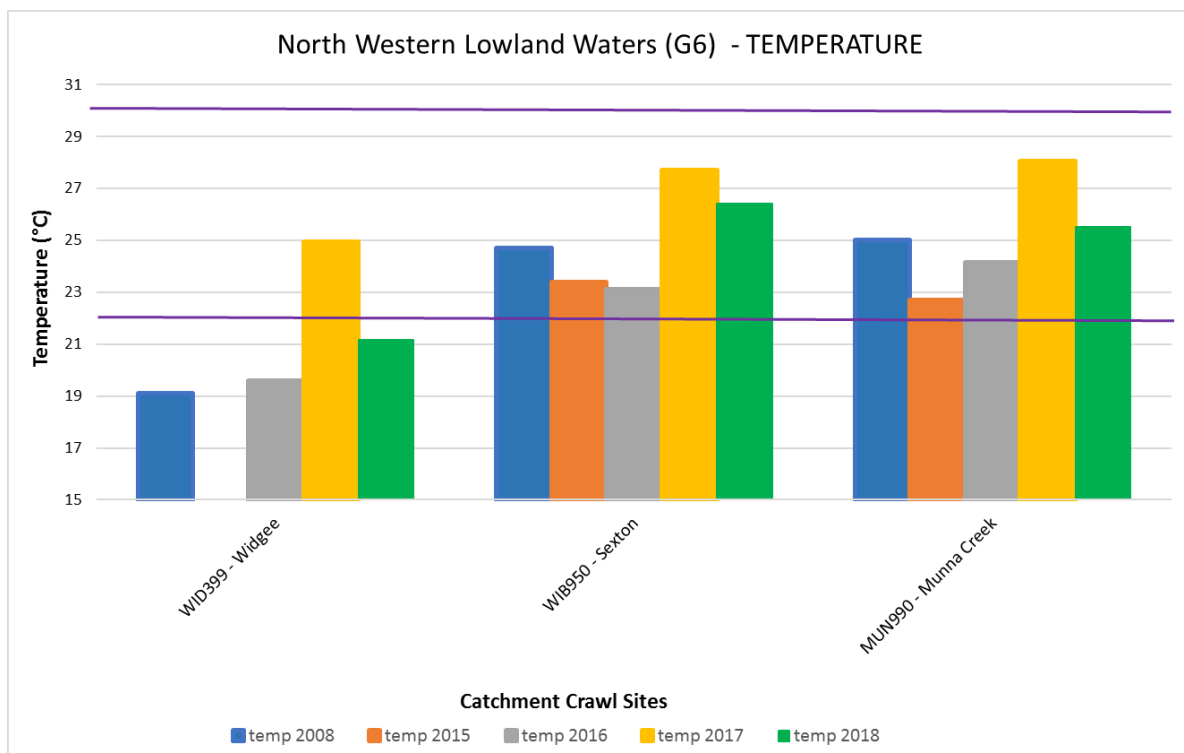
Figure 8 Temperature of tributaries in North Western Lowland Waters (G6)

The North Western Lowland Waters tributaries measured during the catchment crawl are Munna (MUN990), Wide Bay (WIB950) and Widgee (WID399) Creeks. The temperature guideline for the North Western lowland waters is between 22 and 30°C for summer. The horizontal purple lines in Figure 8 show the guideline temperatures. The green line shows the result for 2018. All measurements fell below the maximum guideline value. In 2018 all sites were cooler than in 2017, which had the highest temperature measurements for all three sites. Widgee Creek has good temperature compliance and could provide conditions suitable for Mary River Cod spawning. These temperature records were taken late in the afternoon when high water temperatures are expected, however Widgee Creek appears to have sufficient shading to moderate temperature fluctuations.

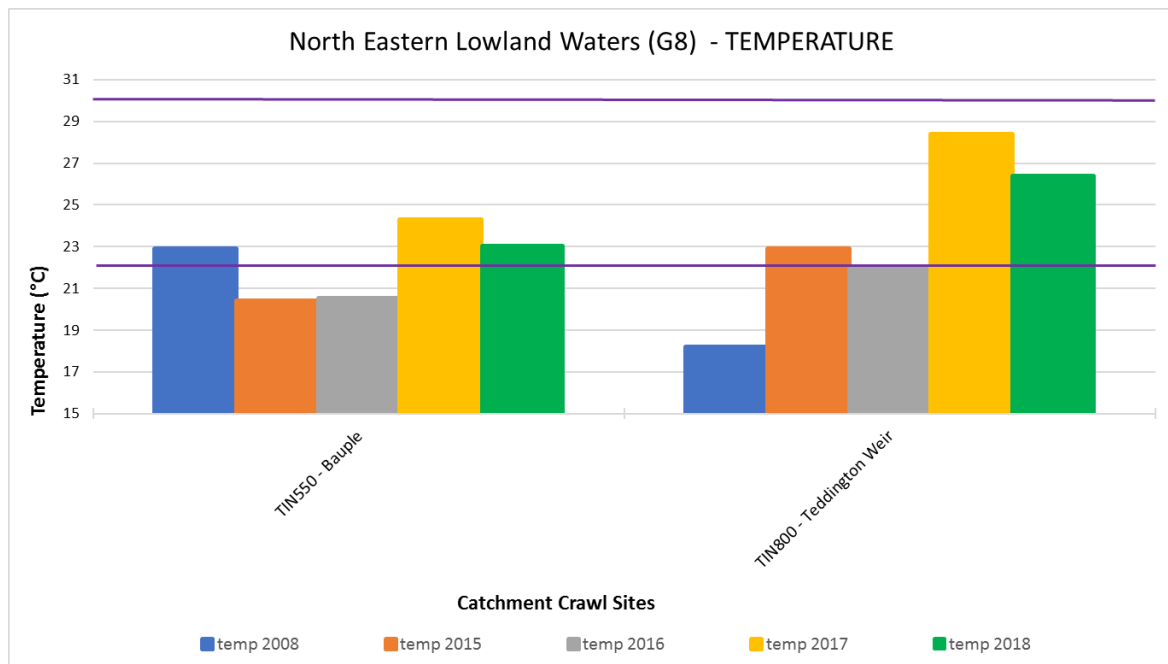
Figure 9 Temperature of tributaries in North Eastern Lowland Waters (G8)

Tinana Creek is the only tributary measured, at two sites. The temperature guideline for the North Eastern Lowland Water is between 22 and 30°C for summer. The guideline range is indicated in Figure 9 by horizontal purple lines, with data points above the upper line or below the lower line outside of the guideline range. The green line shows 2018 measurements. The 2018 temperatures were lower than the 2017 measurements, and TIN800 was 3.5°C warmer than 2015 and 2°C cooler than 2017.

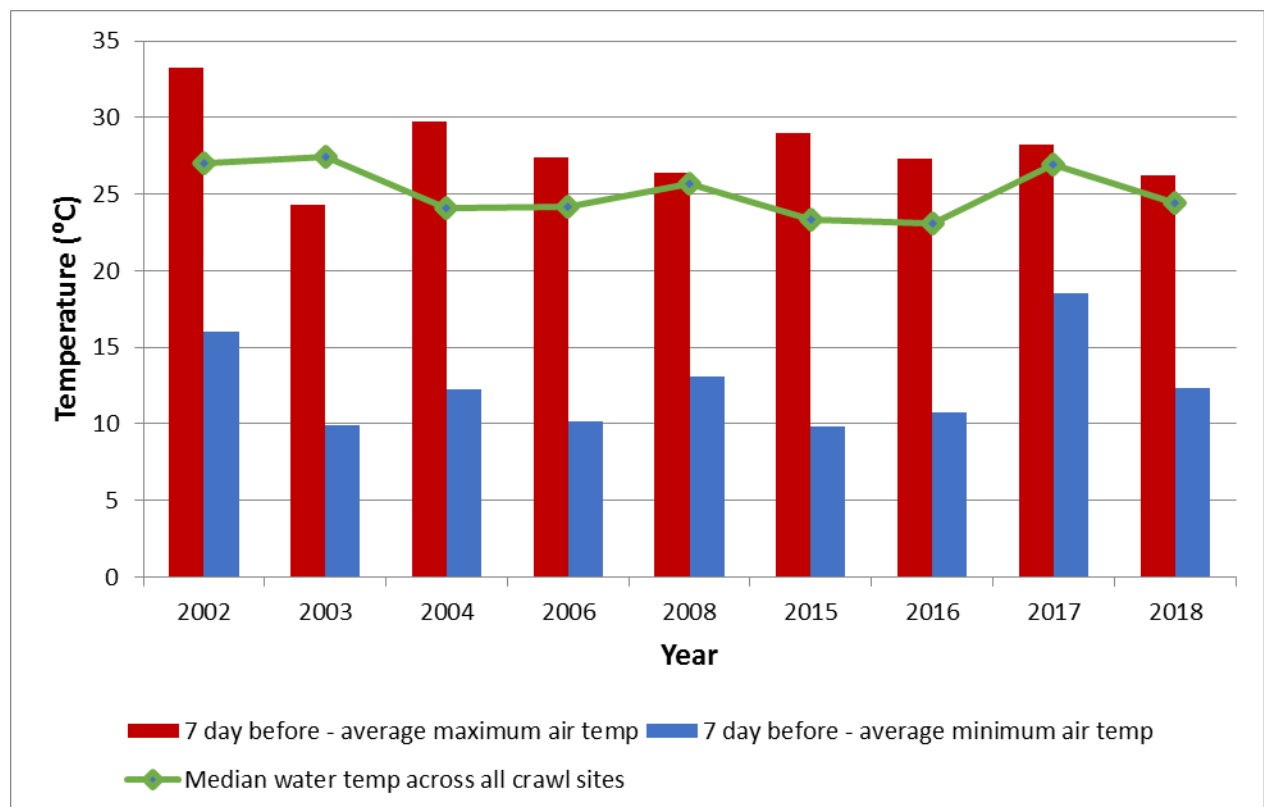
Figure 13 Comparison of average maximum and minimum temperatures for 7 days prior to each catchment crawl

Ambient air temperature is one possible influence on water temperature. To assist with understanding the influence of air temperature, data from the Bureau of Meteorology for the Gympie weather station was downloaded and analysed. Daily maximum and minimums for October were calculated along with the average maximum and minimum for the seven days prior to the Catchment Crawl. The assumption is that the fluctuation in air temperature for several days prior to a sample has an influence on the water temperature. The results of this analysis are presented in Figure 13 which shows the average of the daily maximum and minimum air temperature for seven days prior to the Catchment Crawl together with the median water temperature (from Figure 12).

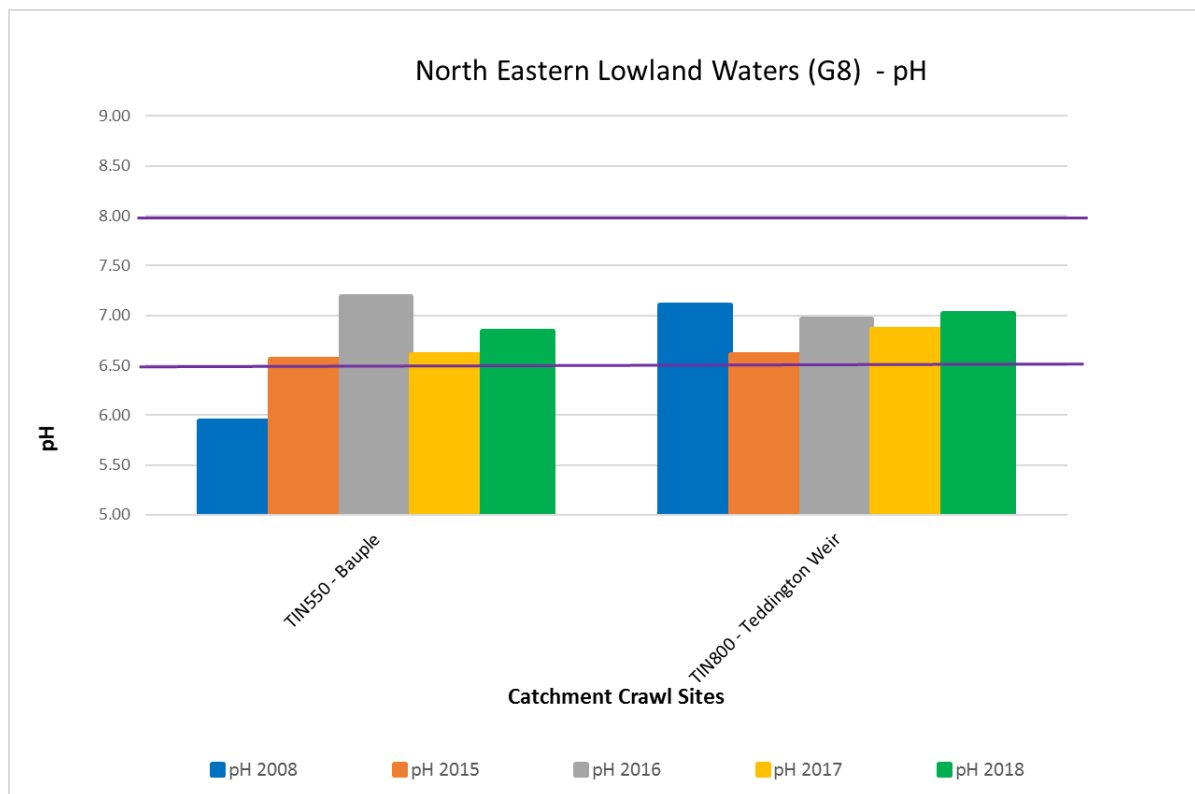
Figure 19 pH of Tributary sites in North Eastern Lowland waters (G8)

The pH guideline for the North Eastern Lowland Water (Tinana Creek only) is 6.5 to 8. The horizontal purple lines in Figure 19 show the guideline range. Data points above the upper line or below the lower line are outside of the guideline range. In 2018 sites sampled on Tinana Creek complied with the guideline.

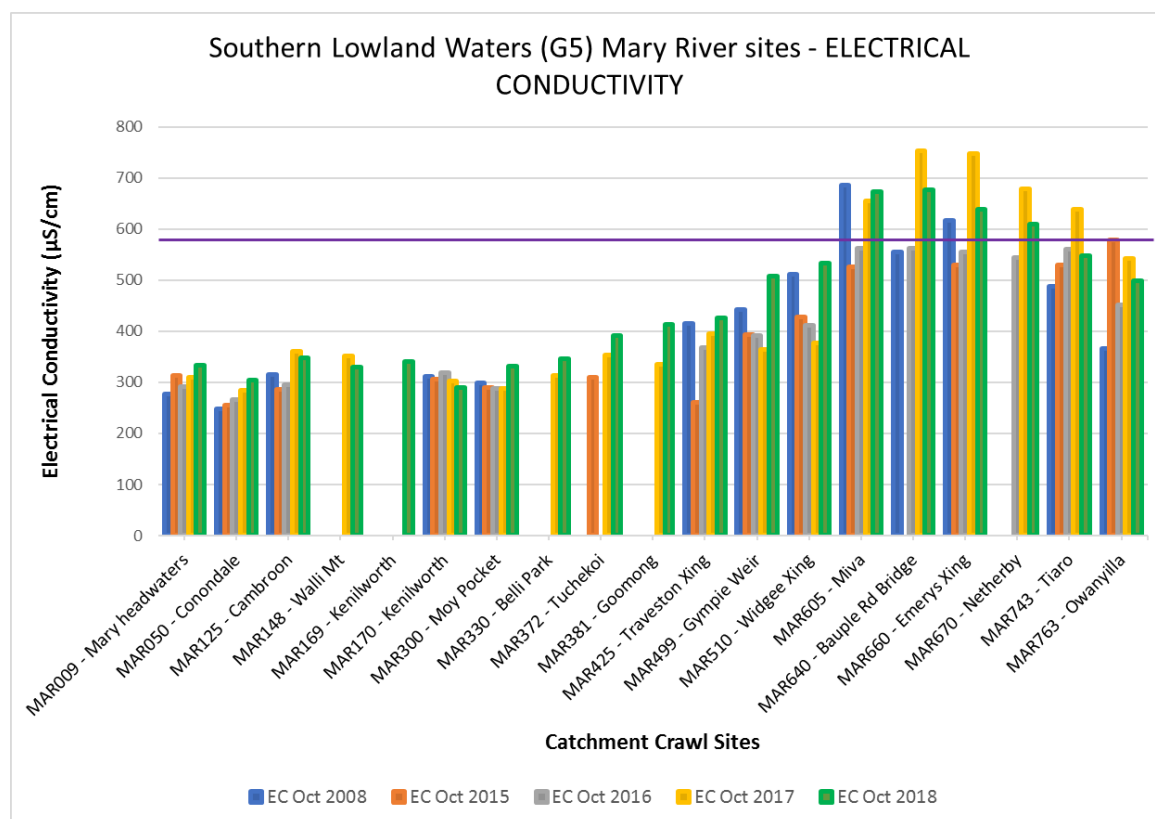
Figure 23 Electrical conductivity of Mary River sites in Southern Lowland waters (G5)

The Electrical Conductivity guideline for the Southern Lowland Waters is between 0 – 580 $\mu\text{S}/\text{cm}$. Results for the Mary River (G5) sites and the guideline range is shown in Figure 23. The horizontal purple line shows the upper guideline limit. Data points above the line are outside of the guideline range. The green line shows the results for 2018.

In the month before the Catchment Crawl most of the Mary River sites experienced very low or cease-to-flow conditions for approximately one week in late September. These conditions, particularly in the river below Gympie, would have contributed to the EC non-compliance.
