**IMPLEMENTING THE MARY RIVER  
& TRIBUTARIES  
REHABILITATION PLAN**

**MONITORING & EVALUATION REPORT  
2003**

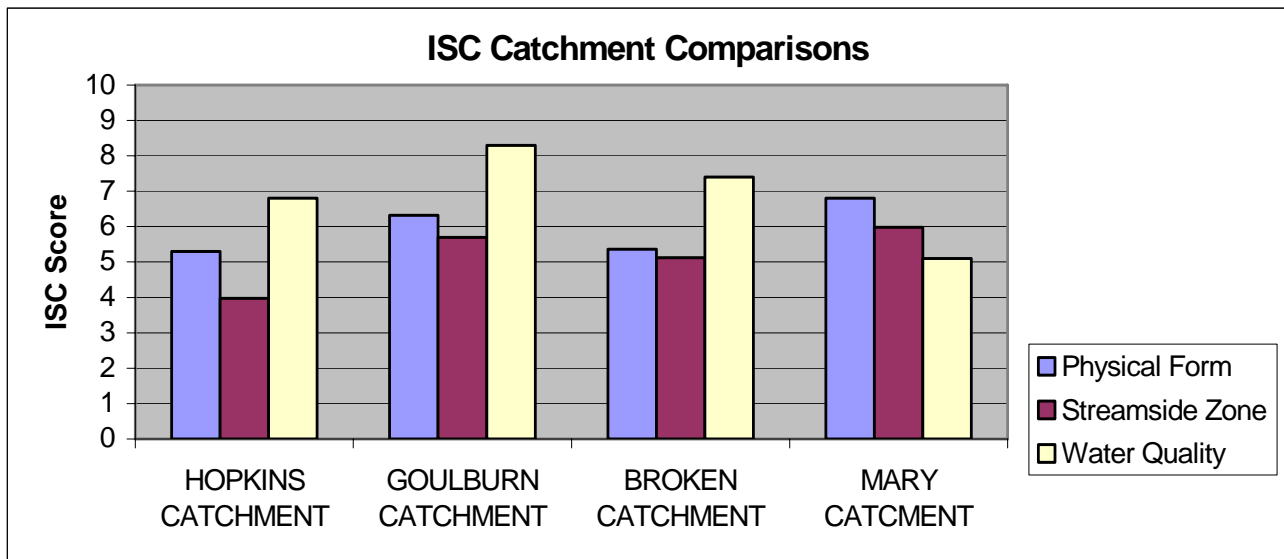
The following Figure 3.1 breaks these average scores into their three components, and shows that the sites monitored within the Mary catchment score the highest for both physical form and streamside zone, however scores the lowest for the water quality component.

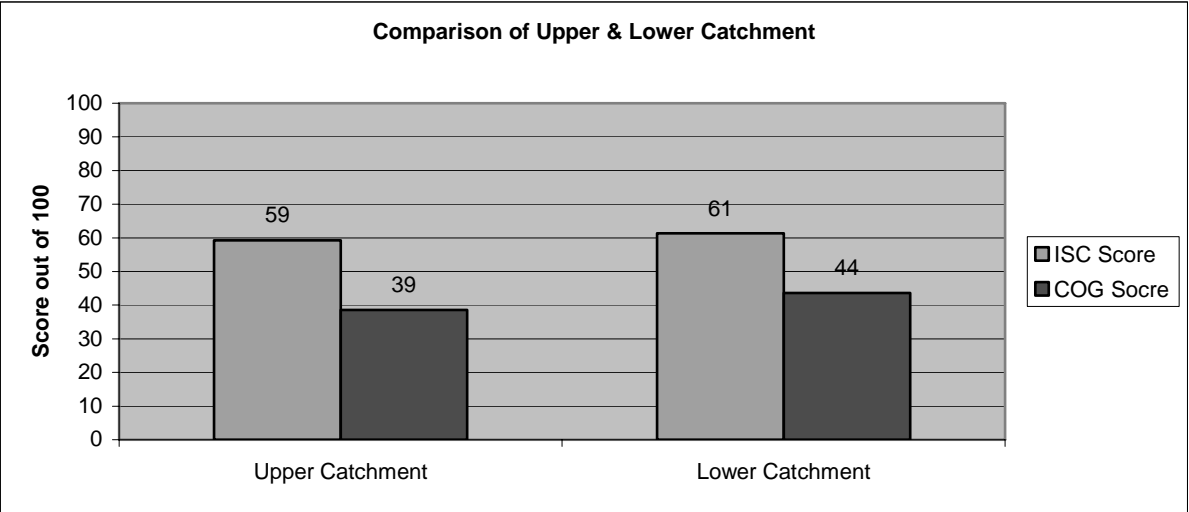
Figure 3.2 presents the mean scores of sites located in the upper Mary River catchment zones and the scores of sites located in the lower Mary River catchment zones. The upper Mary River catchment is defined as the Mary River catchment zone located above the township of Gympie and the lower catchment as below Gympie. There appears to be little difference between the upper and lower catchment for both ISC and Cog scores. It then follows that for the stream reaches monitored for this project, the level of degradation or condition of the sites was very similar in the upper and lower catchments.

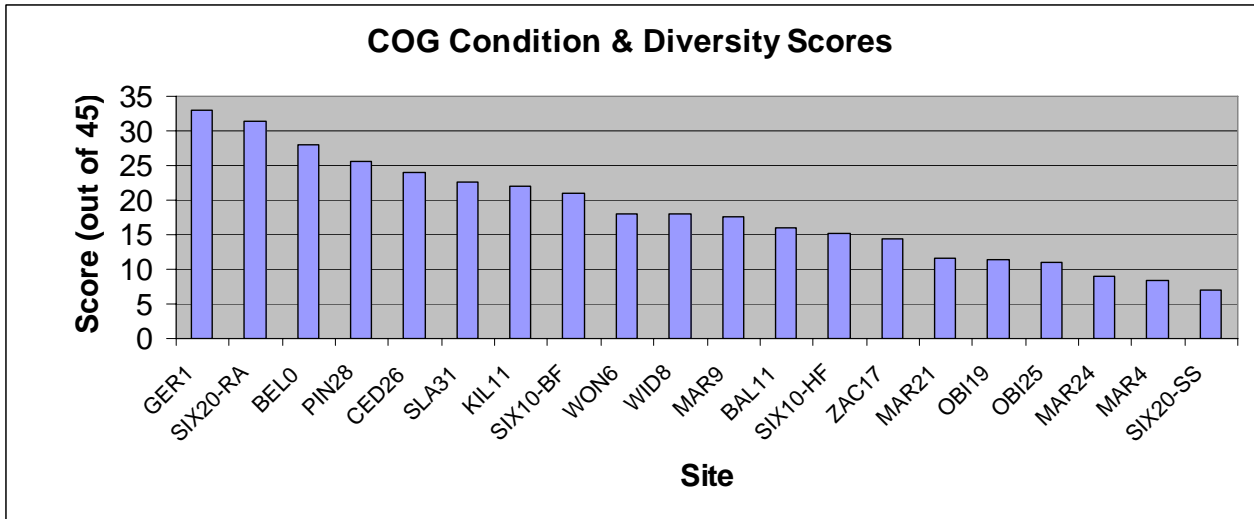
Figure 3.4

The ISC scores of the SIX20-SS site and SIX20-RA (see figure 3.3) may also be used as an example of effectiveness for the COG scores. The SIX20-SS site, which scored a 7 out of 45, represented a monoculture of pasture grass, while the SIX20-RA scored 31 out of 45 was predominately well-established natural regeneration, with a high level of species diversity.

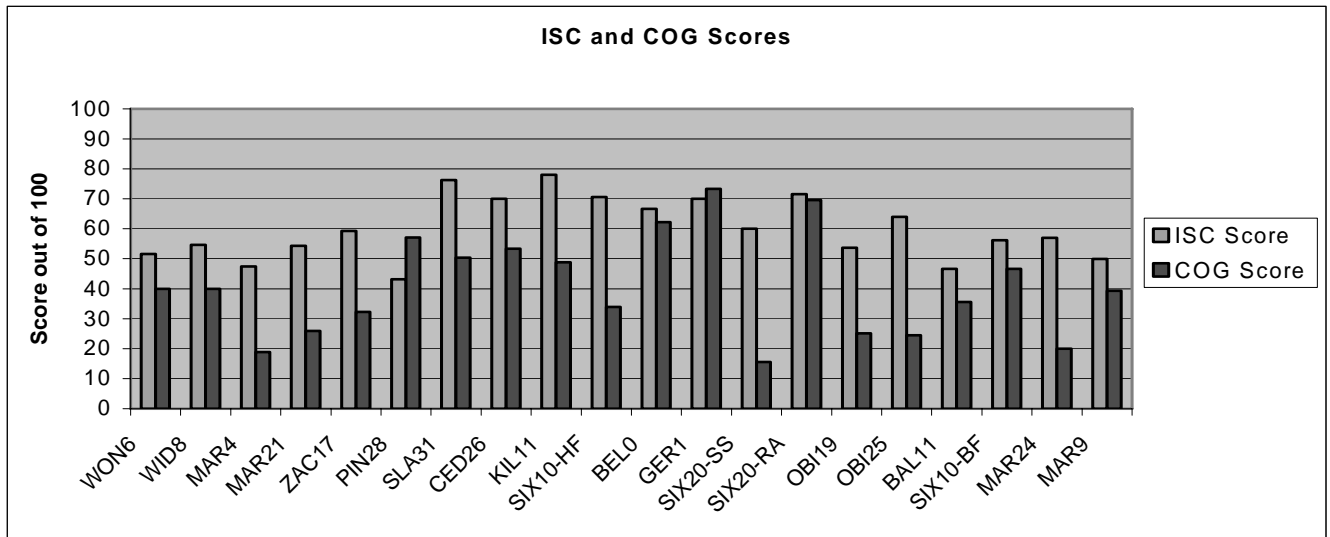
By converting the ISC and COG scores from scores to a percentage value a comparison can be made between these two scoring methods. Figure 3.5 represents this by presenting a bar chart with the converted ISC and COG scores for each site.

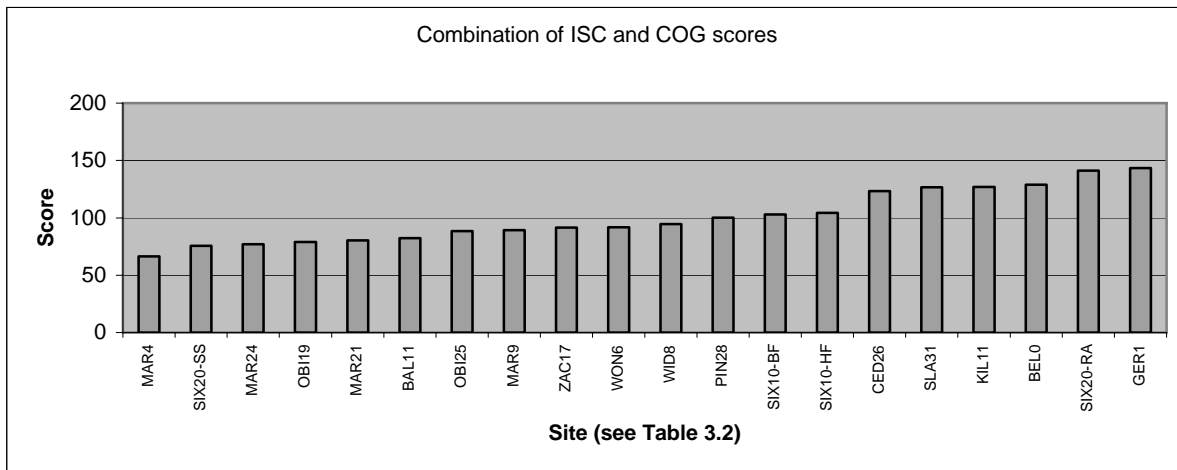
Figure 3.6

By combining the scores in figure 3.6 and obtaining a score out of 200, a comparison can be made between ISC and COG scores. A standard deviation value of 23.2 for these combined scores is most likely due to differences in vegetation types and/or level of degradation.

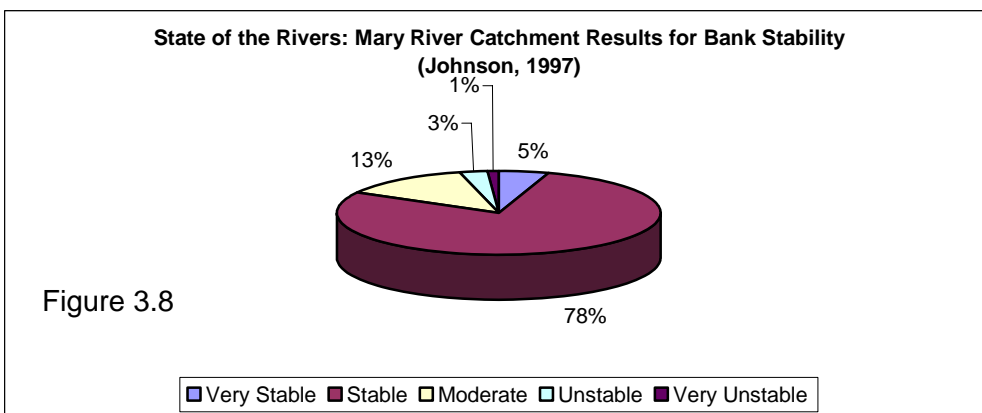
Figure 3.8

these overall results to the Mary River and Major Tributaries: State of the Rivers Report (1997) findings (see figure 3.8) it can be seen that while both exhibit similar results for the three higher levels of erosion, the State of the Rivers shows a greater percent of banks classed as stable, while the ISC monitoring has a far greater occurrence of banks with limited erosion and stable banks.

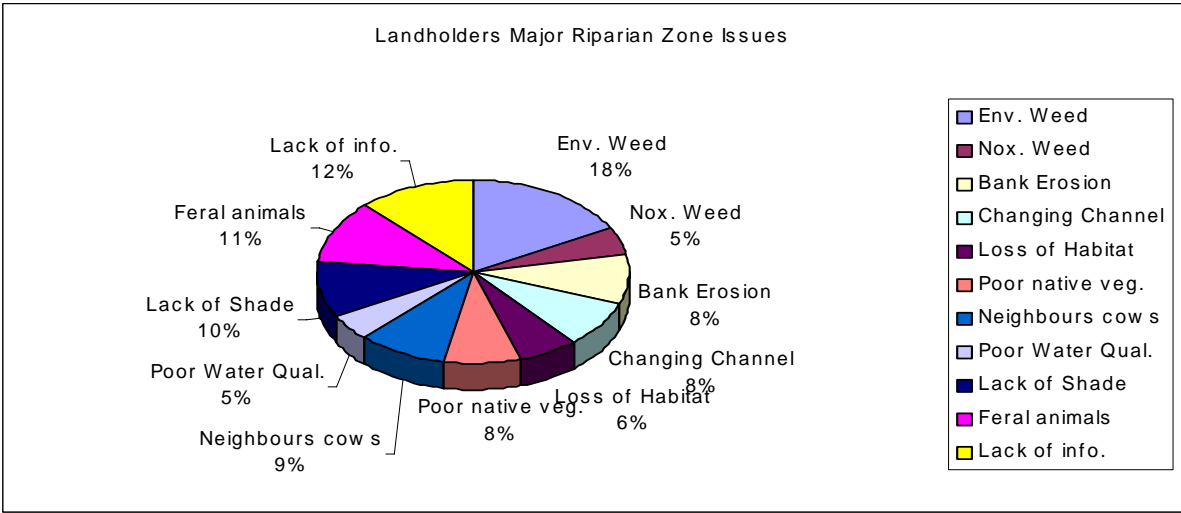
A survey of each landholder was conducted regarding, various topics relating to the Rivercare Grant Scheme. Question four queried the landholders on what they believed to be the major riparian zone issues on their property. Each issue option had a priority rating and a mean for the total points scored for each issue was derived. Figure 3.14 displays the mean score for each issue given in percentage form.

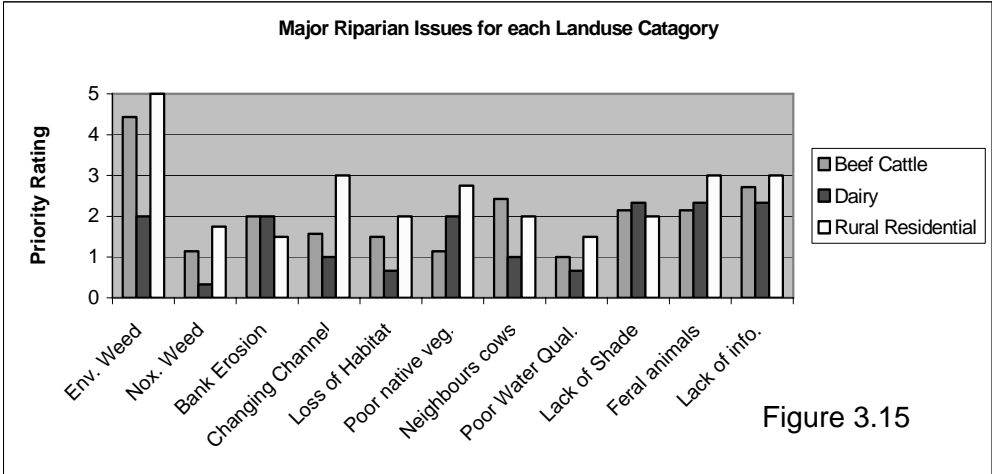
Figure 3.15 uses the same information gathered by the survey (represented in Figure 3.14) but looks at the priority of concerns for each of the three separate land uses. This was performed to investigate any differences in priority riparian issues between the three groups. The figure shows that the Dairy farmers surveyed were least concerned with the issues of environmental weeds and loss of native habitat, but were however, most concerned regarding the issue of lack of shade. Figure 3.15 also suggests that the Rural Residential landholders felt the most strongly about the ecological health of their streams.

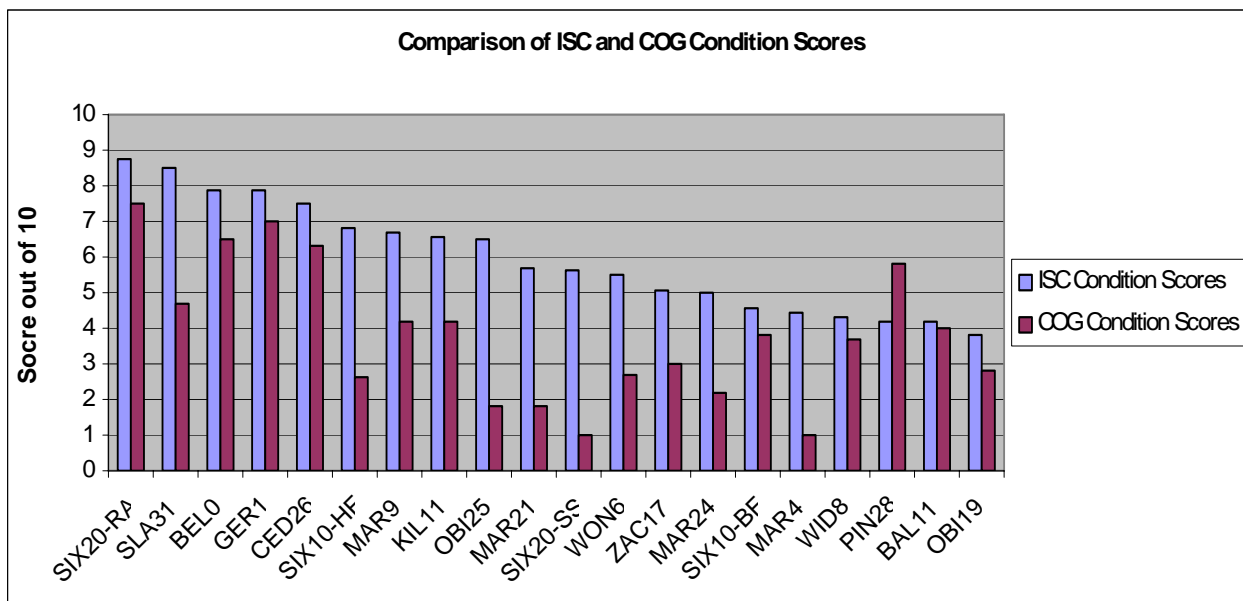
When developing the methodology for obtaining quantifiable scores from the COG data sheets, both a vegetation condition score and a vegetation diversity score (as described above) was used. Figure 3.16 displays a comparison between the condition scores derived from the COG and ISC data (the stream side zone score was used to derive the condition score for the ICS.)
