**IMPLEMENTING THE MARY RIVER  
& TRIBUTARIES  
REHABILITATION PLAN**

**MONITORING & EVALUATION REPORT  
2003**

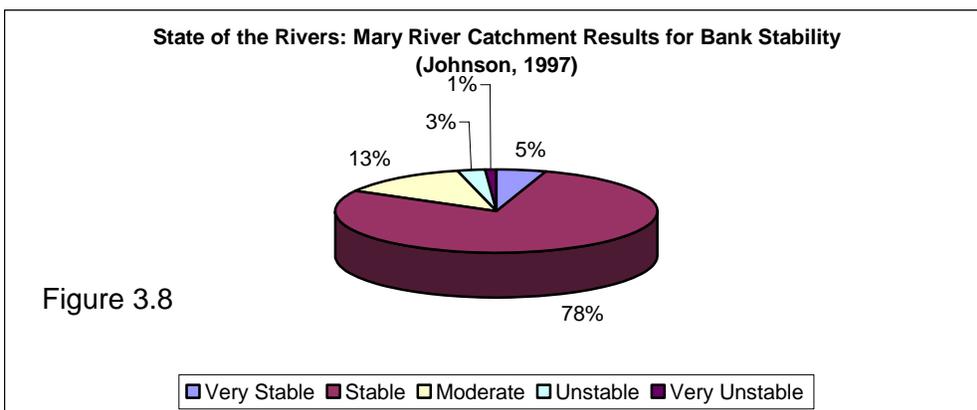
Figure 3.8

these overall results to the Mary River and Major Tributaries: State of the Rivers Report (1997) findings (see figure 3.8) it can be seen that while both exhibit similar results for the three higher levels of erosion, the State of the Rivers shows a greater percent of banks classed as stable, while the ISC monitoring has a far greater occurrence of banks with limited erosion and stable banks.
