Rehabilitation of Erosion Gullies

Adaptations and Learnings from the Mary River Catchment

Mary River Catchment Coordinating Committee

Version 2, July 2022

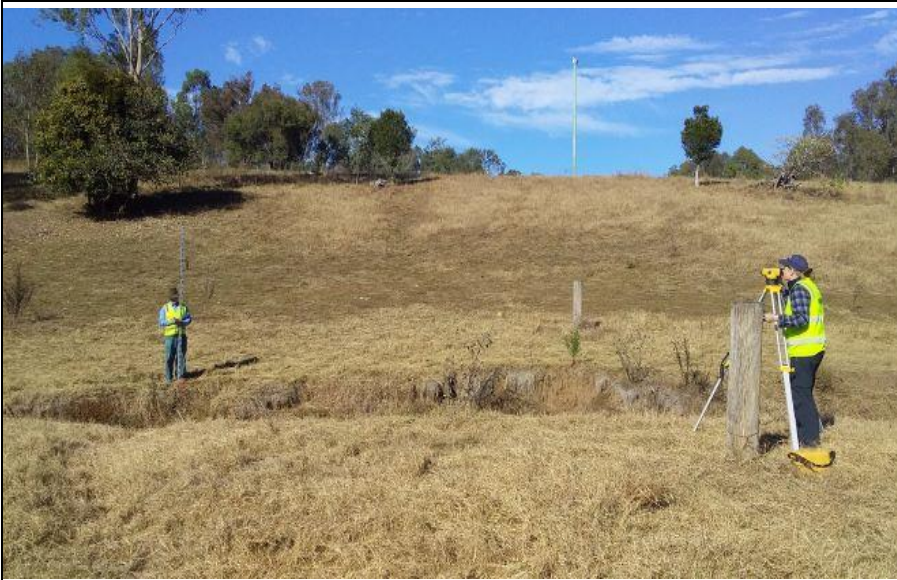
Photo 2

Surveying the level crest

The level 16m uneven crescent shaped crest was surveyed with a dumpy level and marked as the first step.

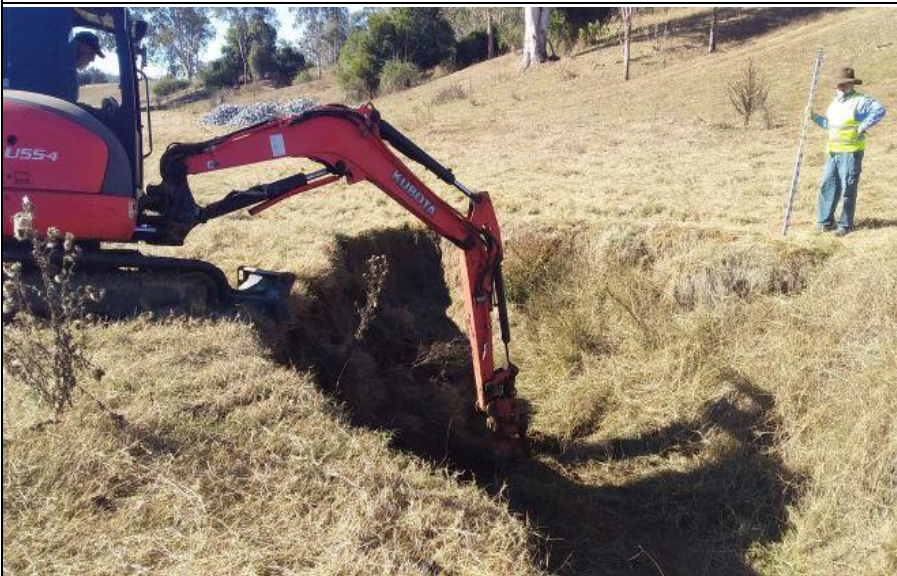
Photo 3

Dig bottom cut off trench

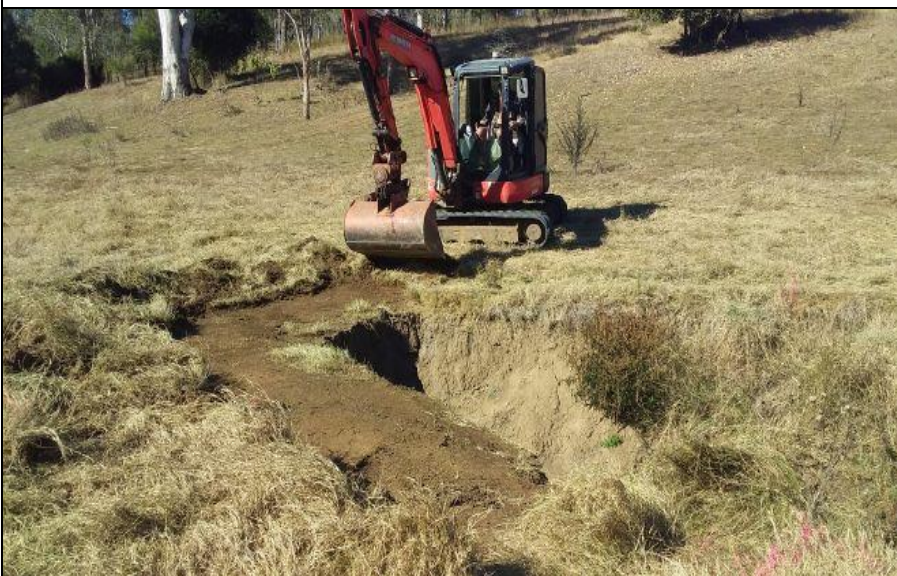
Photo 4

Preparing the crest and gully walls

The gully head was tidied and shaped slightly with overhangs and tunnels collapsed and the topsoil pulled back for 1.5m around the crest before the 0.6m x 0.6m cut off trenches were constructed. Due to access issues with the skid steer for placing the rock, the whole structure was built from the bottom up.

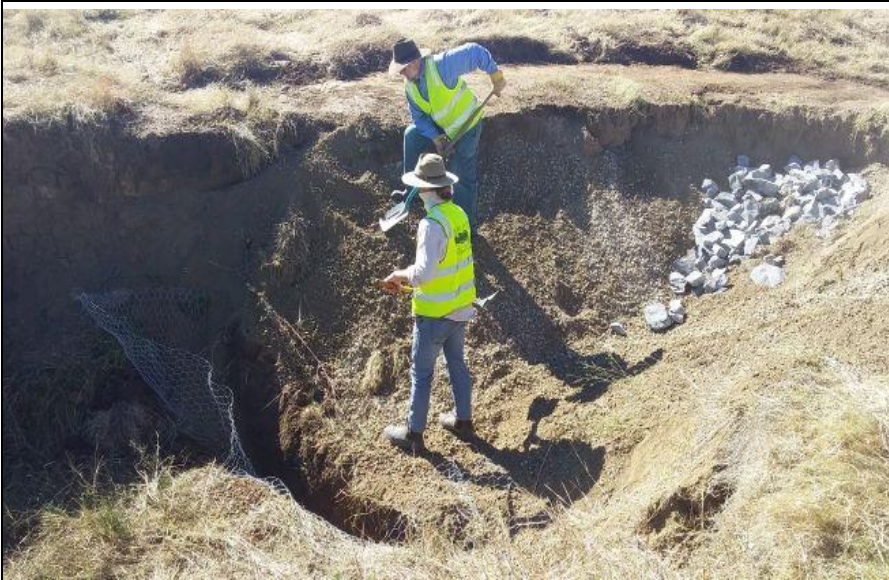
Photo 5

Completed bottom trench inlaid with netting and lined with clay gravel

The bottom cut of trench was built first. It extended across the gully floor approximately 4m from the gully head and up the gully walls to intersect with the top cut of trench, later constructed at the ends of the crescent crest. The bottom cut off trench and the gully floor were lined with 10cm of good gravel and the heavy wire netting was placed in the bottom trench.

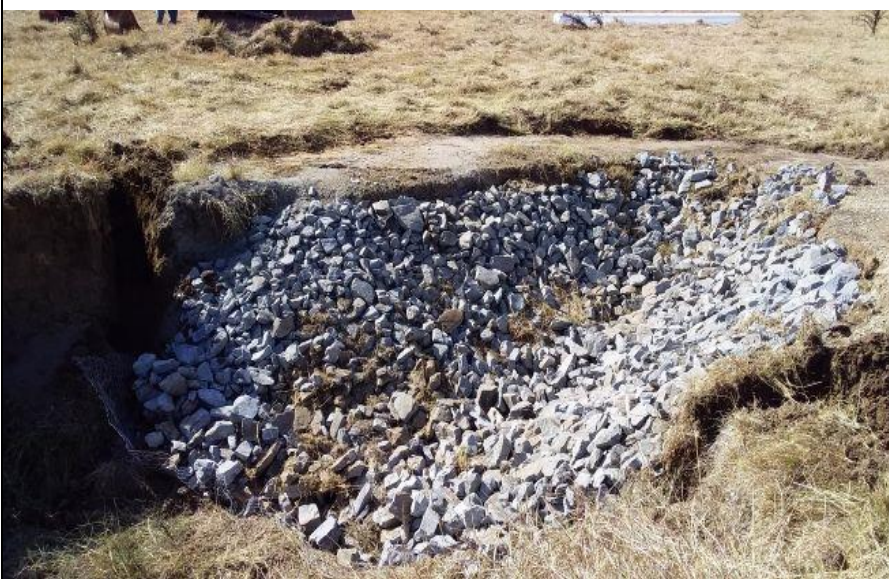
Photo 6

Trench and gully filled with rock 2:1

The trench was then filled with fine rock (100mm to 200mm and gravel), up to half then topped up with the 100mm to 400mm gravel mix, battered at approximately 2:1 so the bottom end of the fill sits on the gully floor approximately 5m from the top cut off trench.

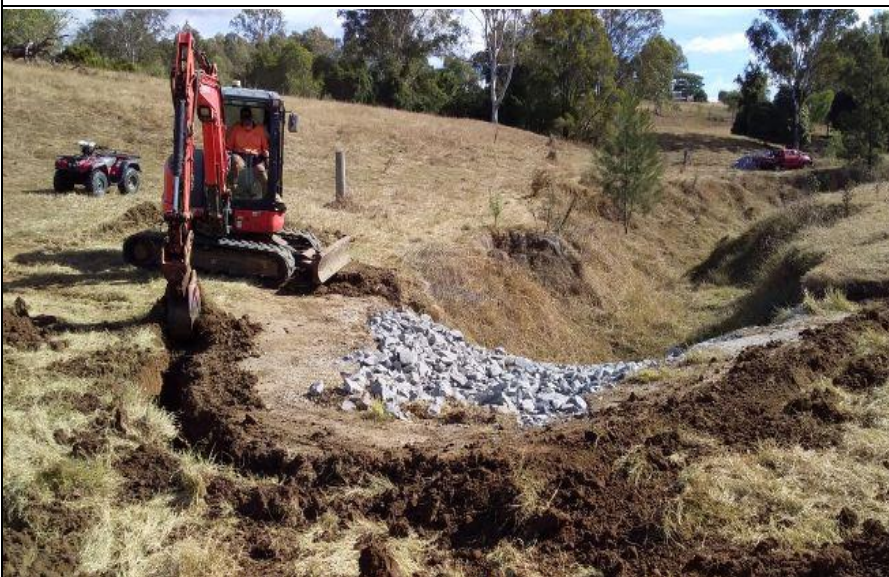
Photo 7

Excavation of top cut off trench

The gully head was filled up to the edge of the 1.5m bench where the topsoil was removed and then the top cut off trench was constructed.

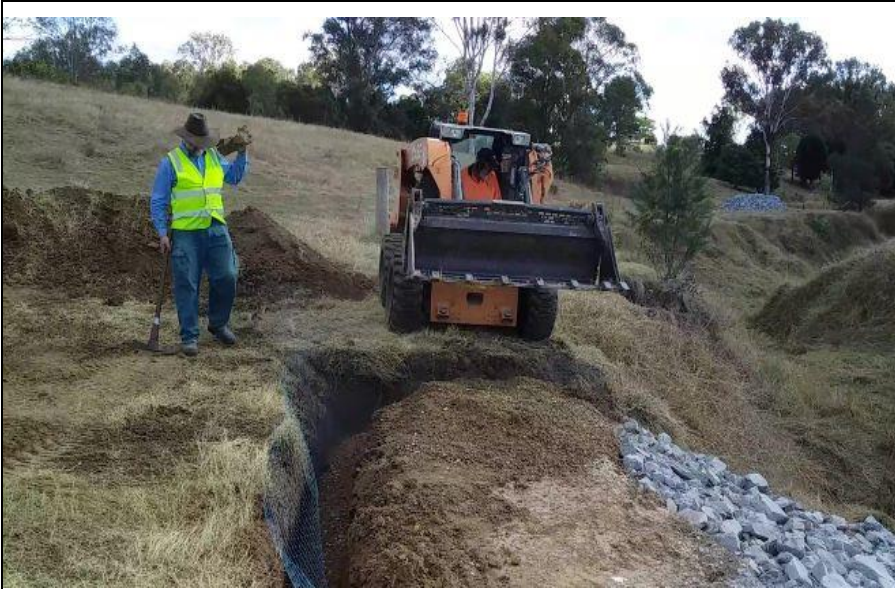
Photo 8

Wire netting and gravel placed in top cut off trench

The wire netting was placed in the top cut off trench. The trench bottom and bench were covered with 10cm of gravel.

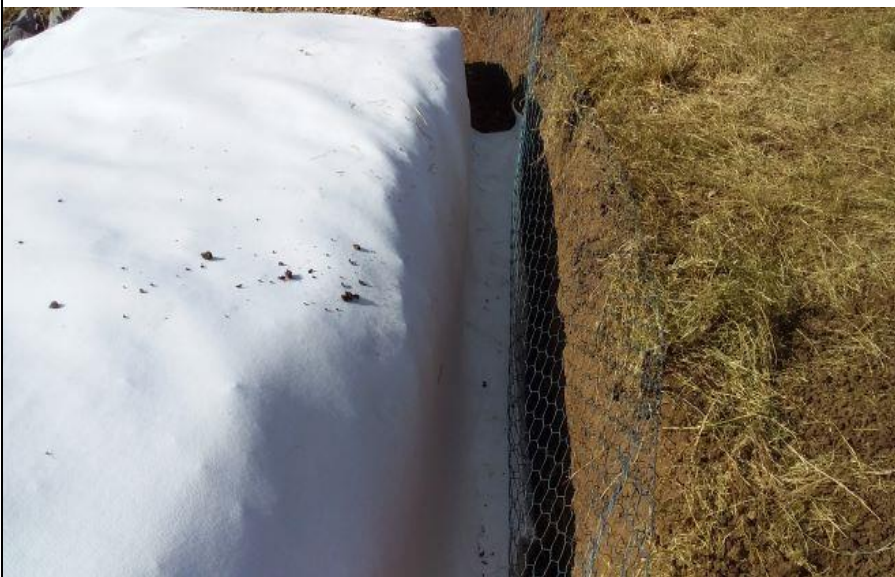
Photo 9

Geofabric Texcel R400 used to line around the full crest and over the bench.

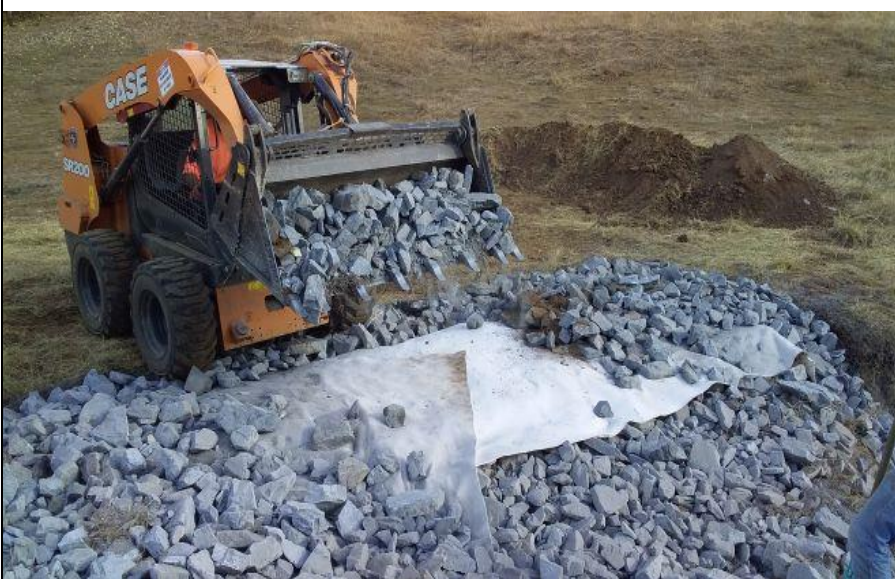
Photo 10

Gravel and rock placed over the fabric

More gravel and rock filled the same as the bottom trench. With lose ends of the geofabric facing down slope, more rock was added to finish the rock cover.

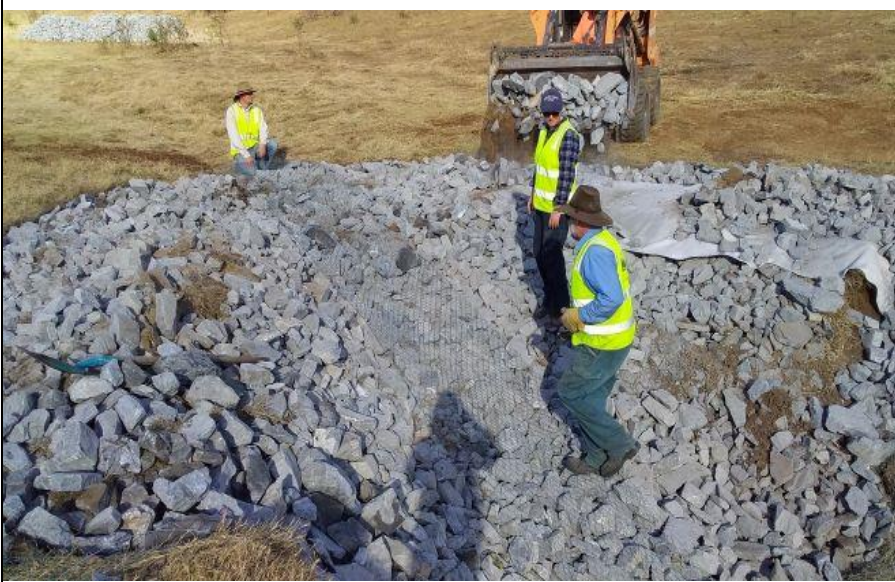
Photo 11

Lengths of wire netting placed over the rock chute and attached to netting in cut off trenches

This process left the wire netting secured and exposed right around the crest and across the bottom of the structure so more netting could be laced across the top securing all of the rock.

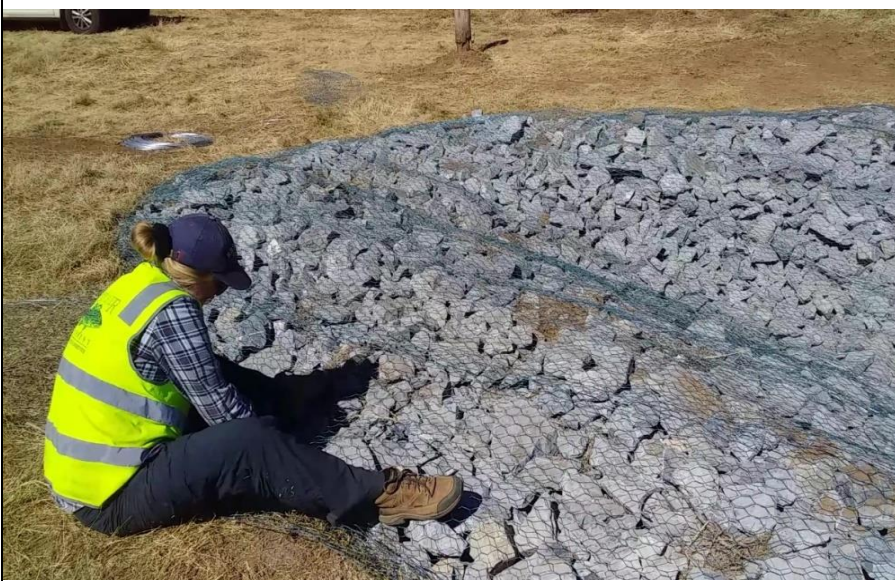
Photo 12

Wire netting laced together with 2.5mm plain wire, to form one single large gabion.

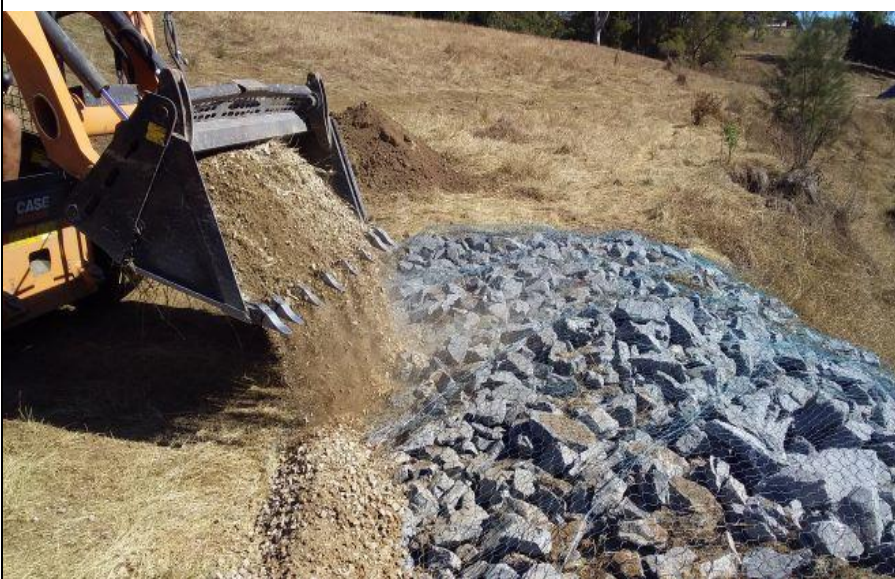
Photo 13

Filling the gaps in the rock with gravel along the crest

Once the wire lacing was complete, the lip of the chute crest was filled with gravel. This ensured the upstream edge of the cut off trench was sealed so no water could flow directly into the trench and fill it quickly. It also provided an environment for the grass to quickly grow over the lip.

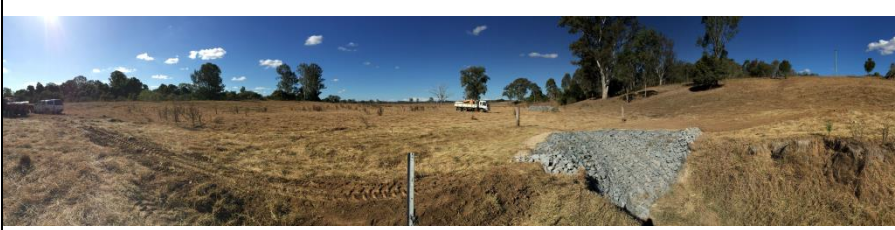
Photo 14

Soil from excavation used for diversion bank construction

The soil taken from the batter, the trenches and any widening or shaping of the gully floor and head was used to construct diversion wing banks on each side of the rock chute, approximately 15m long and 0.6m high constructed, to ensure the water from the catchment is concentrated on the stable rock fill structure. These banks were constructed at approximate right angles to the gully edge heading upslope either side and extended until the end was 0.6m above the rock crest of the rock fill chute. The outlet ends of the banks were rock armoured for 3m up to 0.5m high to ensure they do not erode.

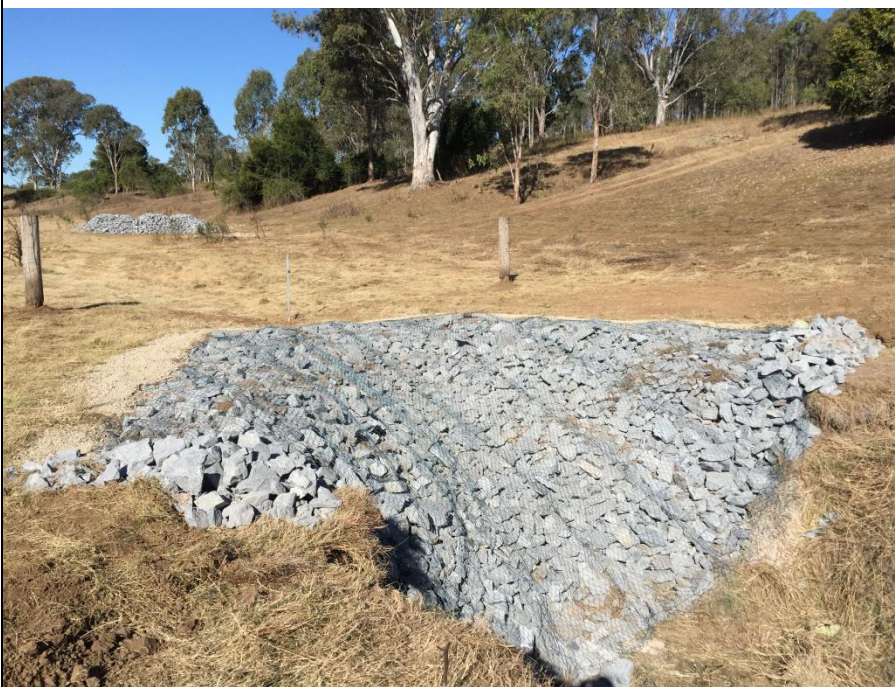
Photo 15

Completed chute with stock exclusion fencing in place – looking upstream

The site was fenced to exclude stock and allow the maximum potential for revegetation of all disturbed areas.

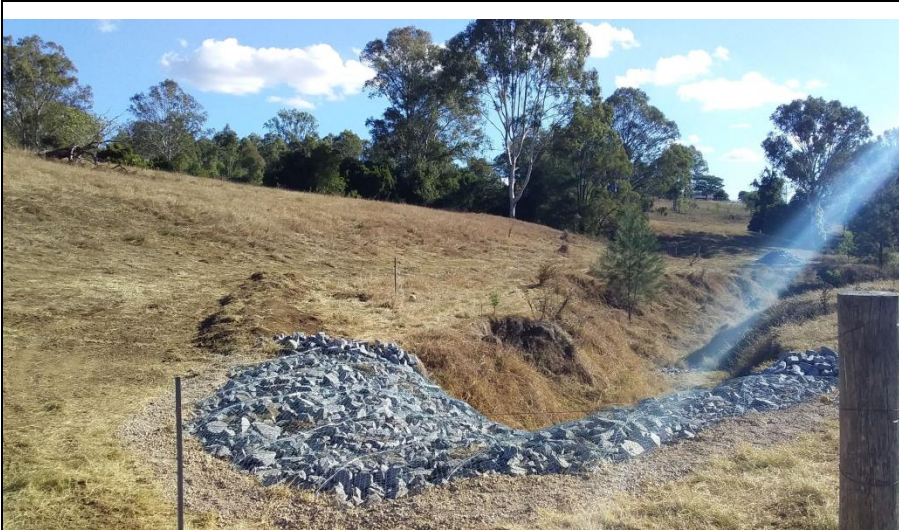
Photo 16
Looking downstream at completed chute

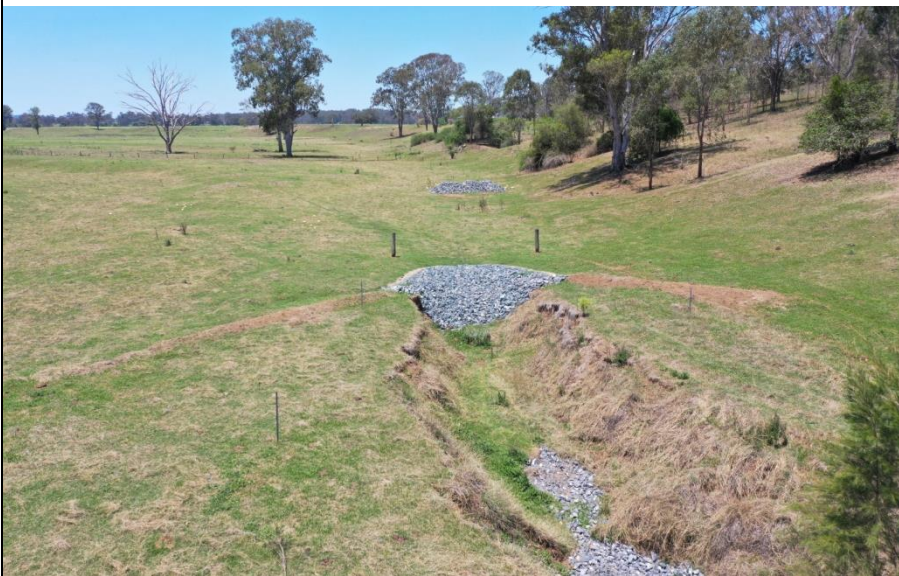
Photo 17
3 months post-construction
October 2020 at beginning of first wet-season

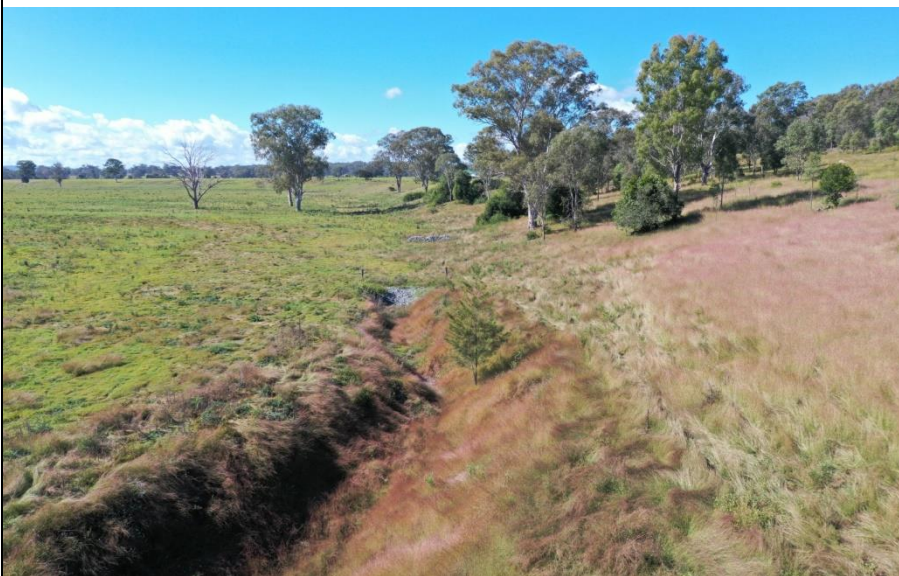
Photo 18
10 months post-construction, post first wet season
May 2021

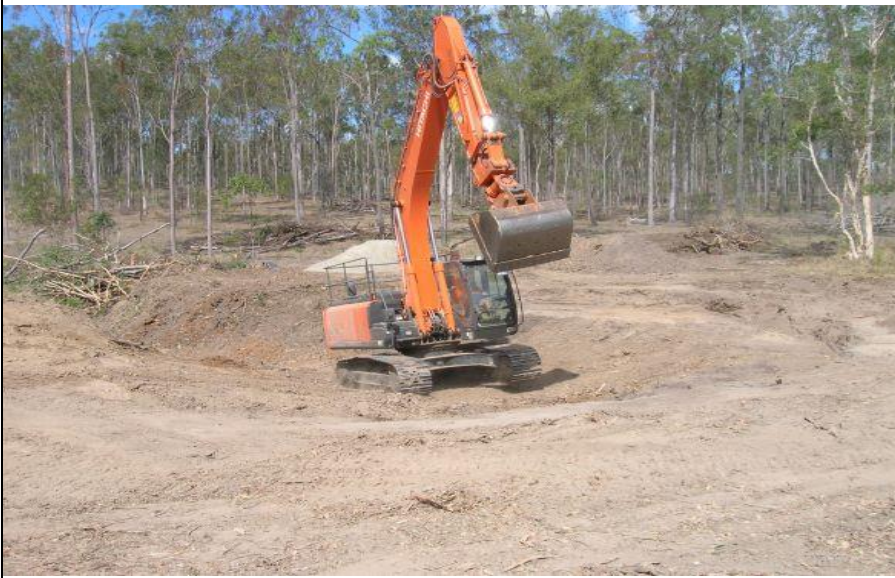
Photo 20

Chute shaped to capture both gully heads.

The chute level crest was designed at 35m around the top and the gully head was battered to 3:1. This meant the chute batter was approximately 8m long, with an additional 2m apron length constructed with large rock to dissipate the energy.

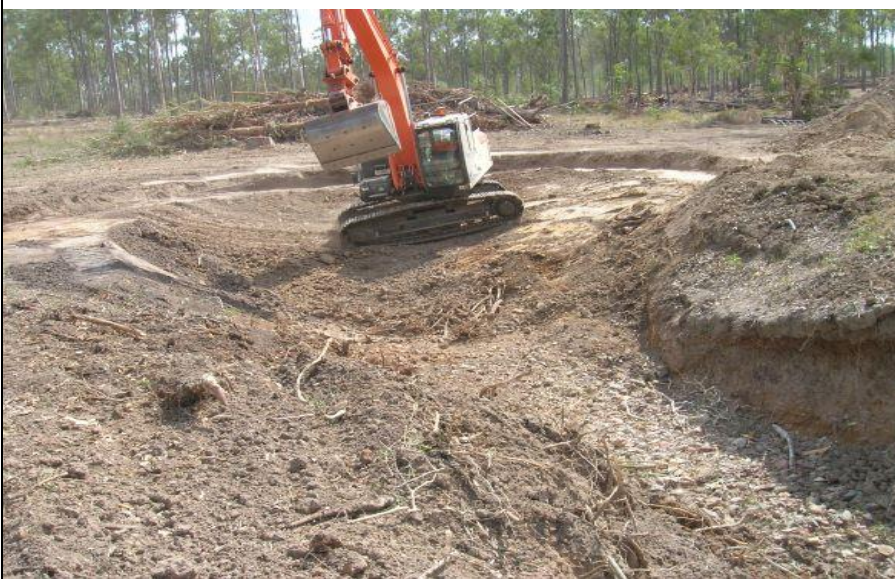
Photo 21

Chute level crest constructed to design width

The chute level crest was designed at 35m around the top and the gully head was battered to 3:1 so the chute batter is approximately 8m long.

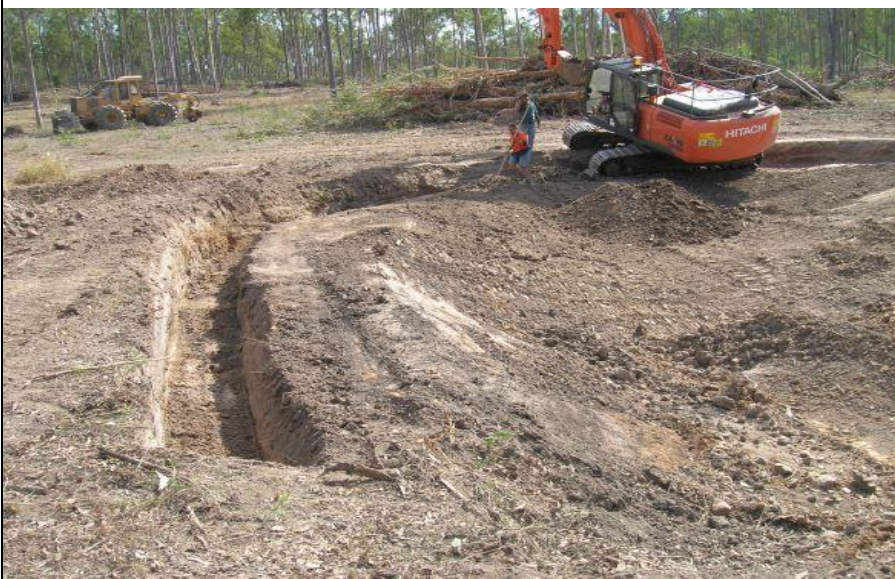
Photo 22

Top cut off trench going in

A cut off trench approximately 0.8m wide x 0.6m deep was constructed around the top of the chute crest 1m up slope from the start of the batter at the top. Another trench was constructed at the bottom at the end of the rock apron.

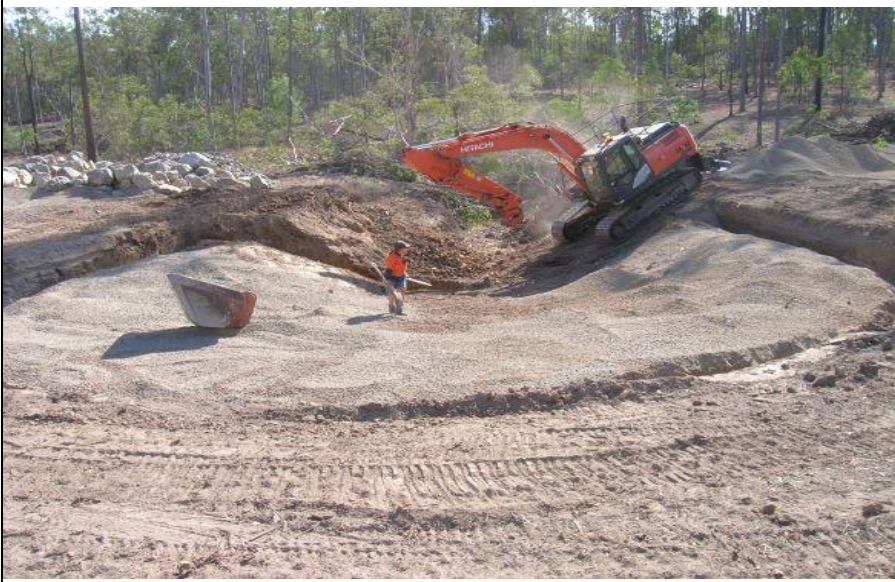
Photo 23

Excavation of bottom cut off trench and gravel placed on chute batter

The batter of the chute and the bottom of the cut off trenches was covered with approximately 10cm of high clay content gravel.

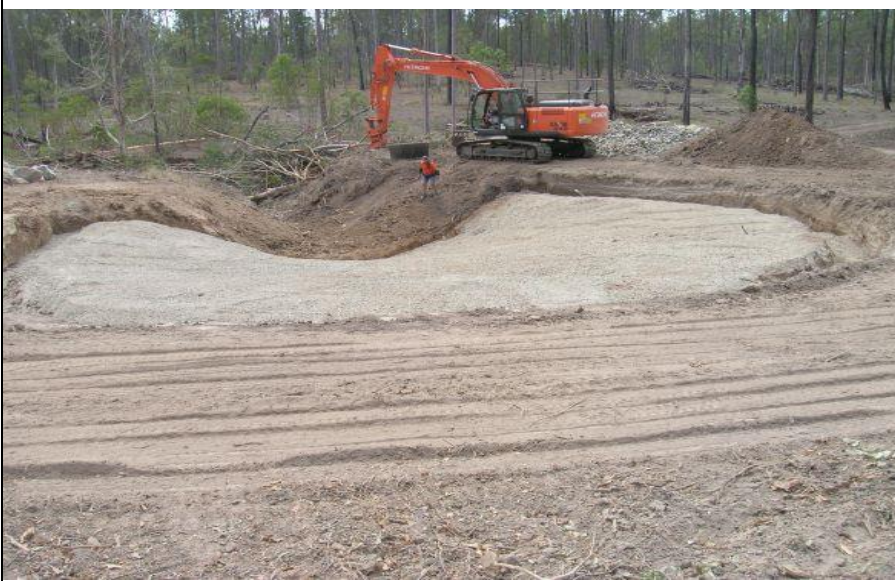
Photo 24

Cut off trenches completed and gravel placed batter and trenches with site ready for geofabric

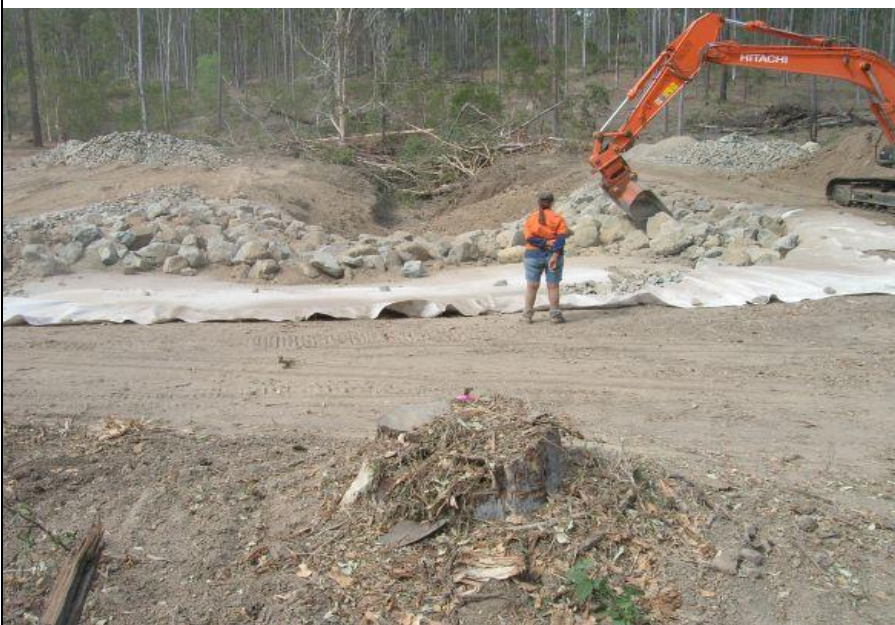
Photo 25

Geofabric laid over the chute, rock placed from the bottom cut off trench to the top - due to size of chute

The cut off trenches were filled with gravel and smaller rock mix up to a third of the trench depth.

A rock mix of 150mm to 700mm was placed and compacted on the geofabric covered batter and top and bottom cut off trenches.

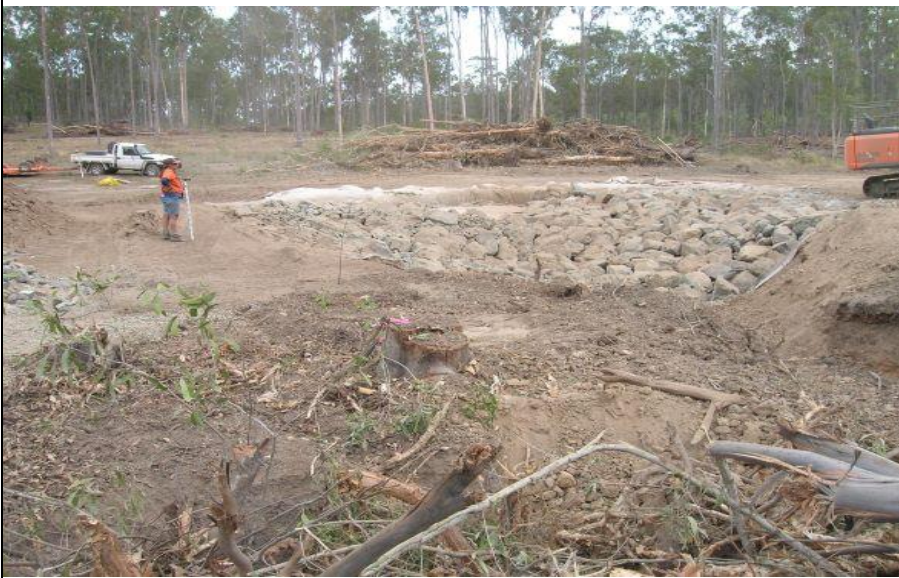
Photo 26

Rock fill on the chute close to finished

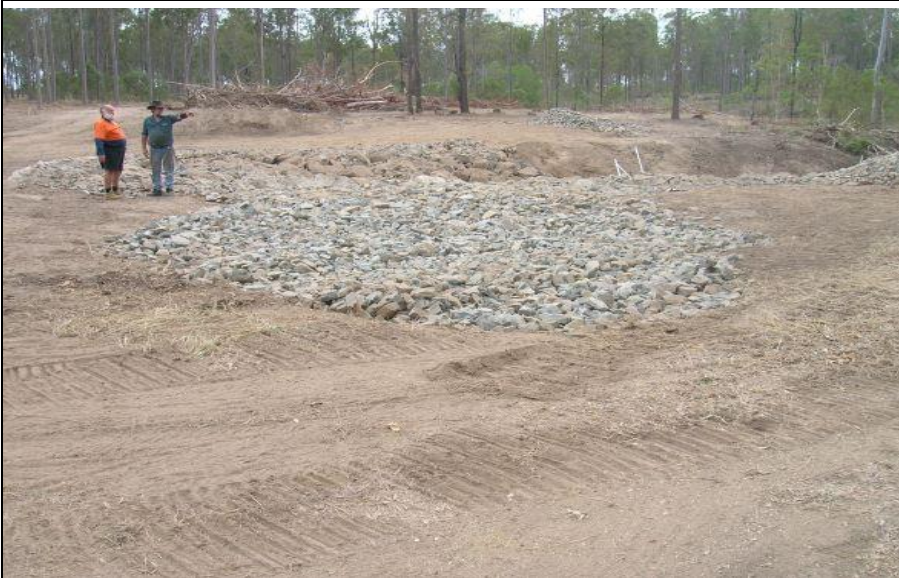
Photo 27

The depressions in gully above the crest filled with small rock and compacted

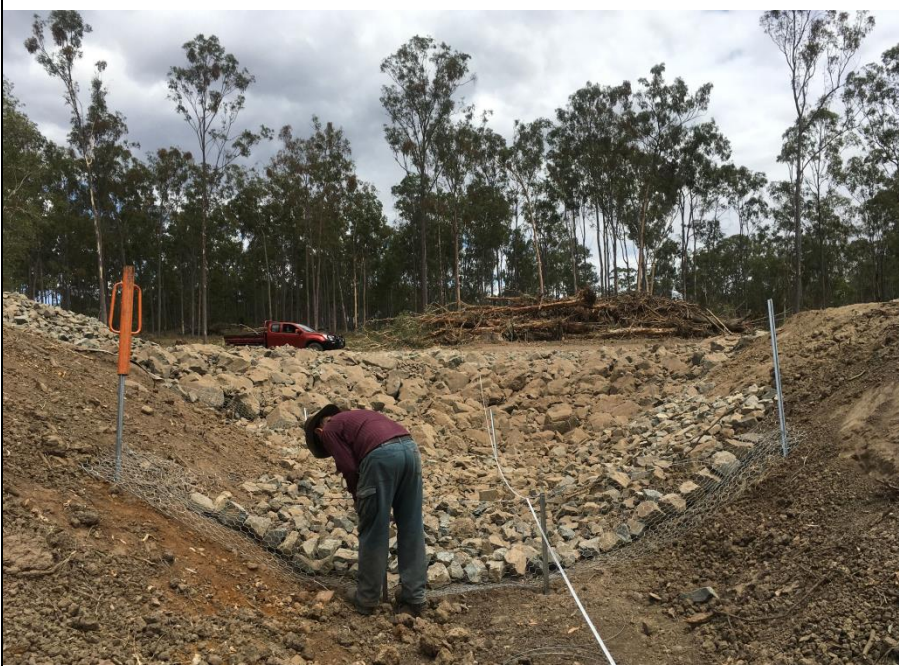
Photo 28

Rock on chute finished and fence in at the bottom

1.6mm galvanised netting mesh was placed in the length of the bottom trench and up each adjacent gully wall. This was fixed in place using the rock and galvanised star pickets. This fence was designed to capture any 'rolling' rock during events.

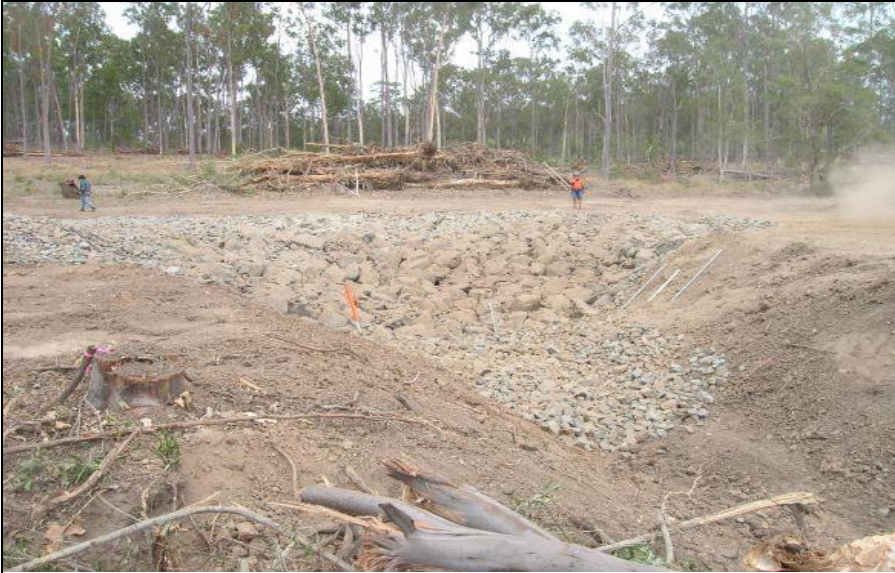
Photo 29

Some excess rock placed downstream of the apron and the fence.

Some of the larger rock (700mm) was concentrated for the apron end and at the base of the chute to assist energy dissipation. There was some surplus rock which was spread below the apron and fence to help stabilise the gully floor. A second short netting fence was constructed below this rock to hold it in place and act as a silt trap.

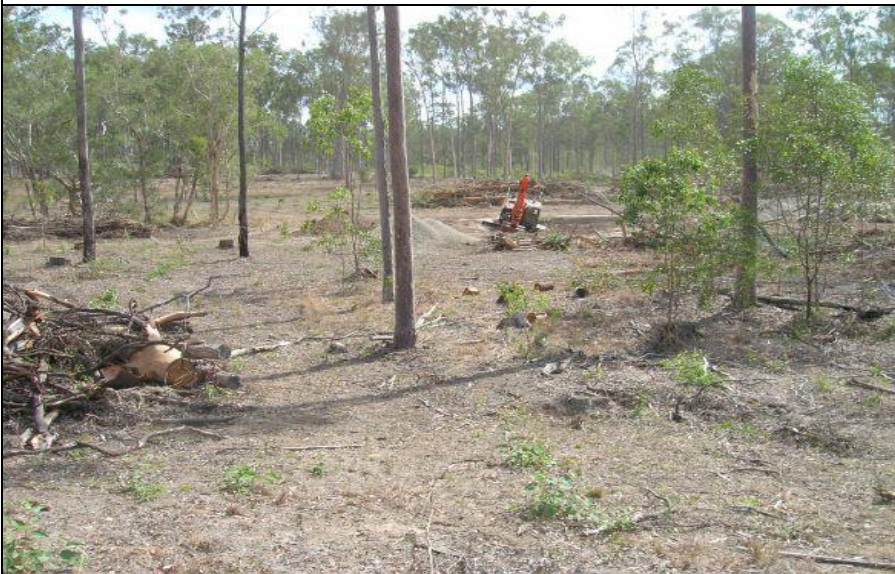
Photo 30

Survey line for wing wall

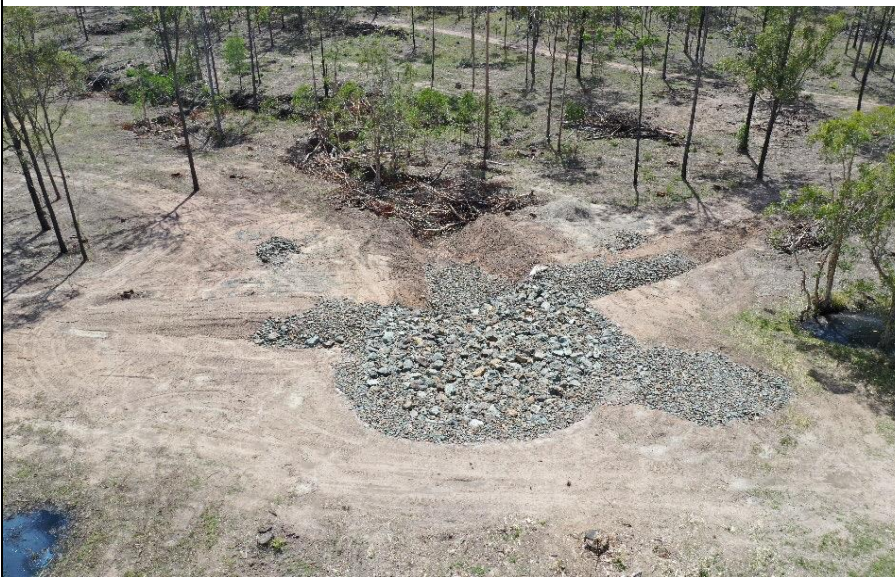
Photo 31

Wing walls completed with rock armouring

During construction, any excess soil from the battering and shaping process was retained and used to help construct diversion wing banks at each side of the chute to direct flows over the rock chute. Using over burden avoided exposing the fragile subsoil. The wing banks were constructed to 1m high and aligned at approximate right angles on a surveyed line at 0.4% slope on either side. The banks were turned up at the ends until the ends at ground level were at least 0.75m above the weir crest height.

The ends of the diversion banks were also rock armoured up to 0.6m high for a distance of 3m, using the smaller rock from the 150 – 700mm rock mix, to ensure the ends do not erode.

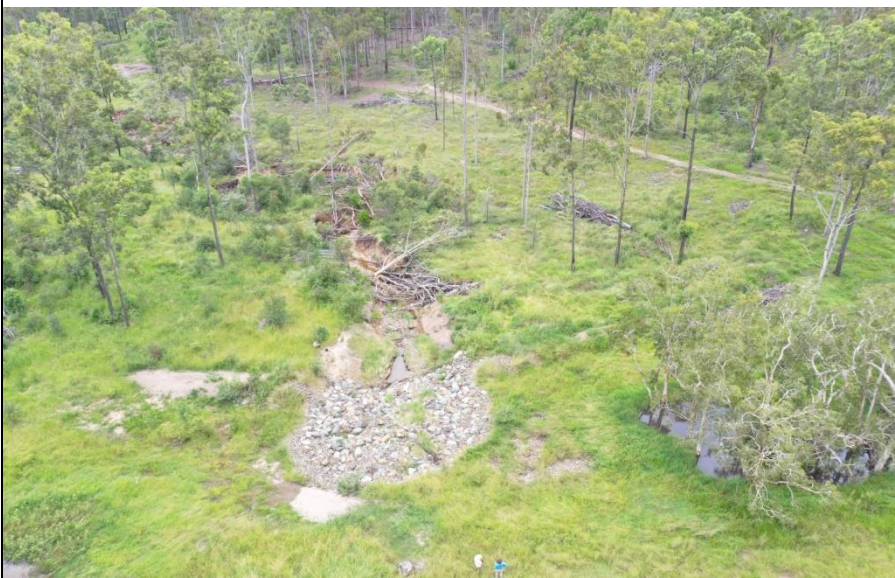
Photo 32

February 2022 after major floods in the area. 24 hour rain totals exceeded 600mm for the area.

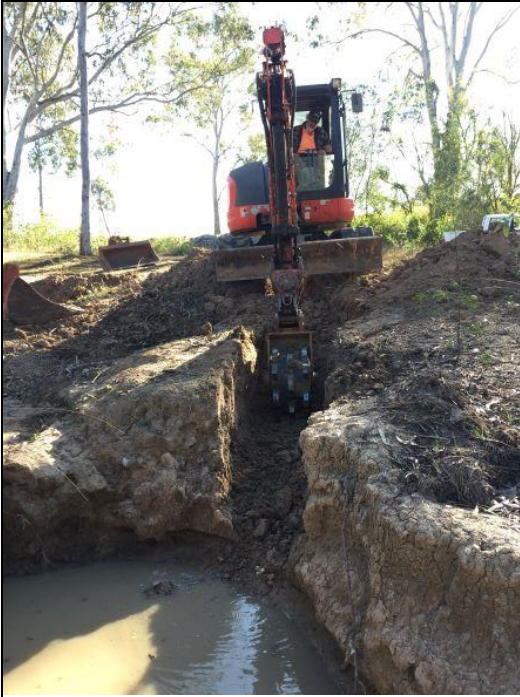
Photo 34

Exposing tunnels and compacting

At the erosion site, all material from the failed porous check dams was removed.

All tunnel erosion on the eastern fork was exposed and compacted.

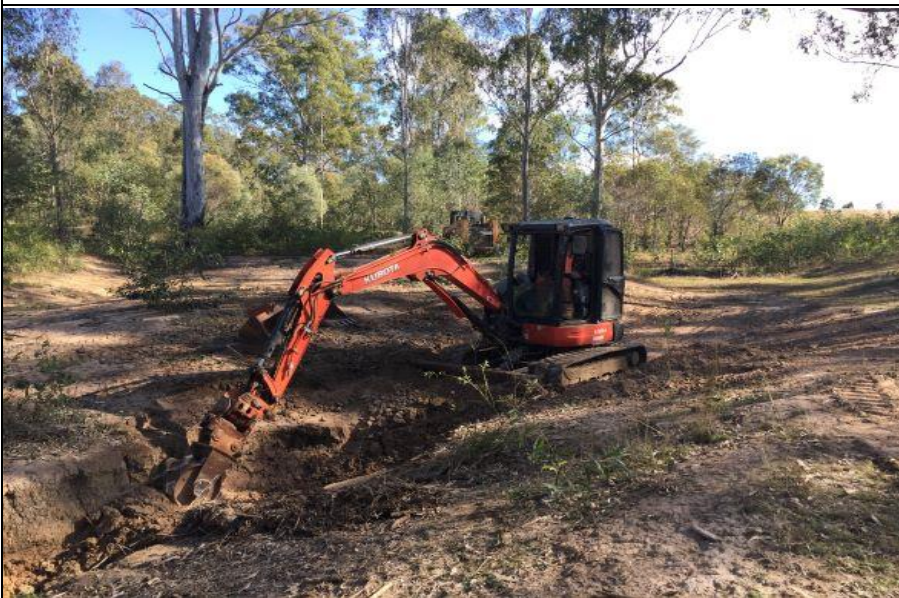
Photo 35

Filling, shaping and compacting the gully

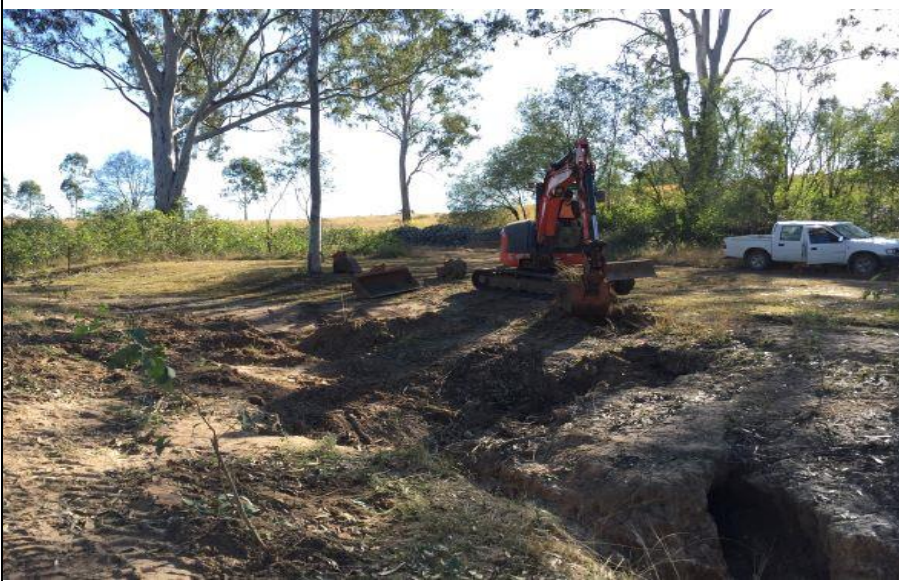
Photo 36

Another tunnel before it was collapsed

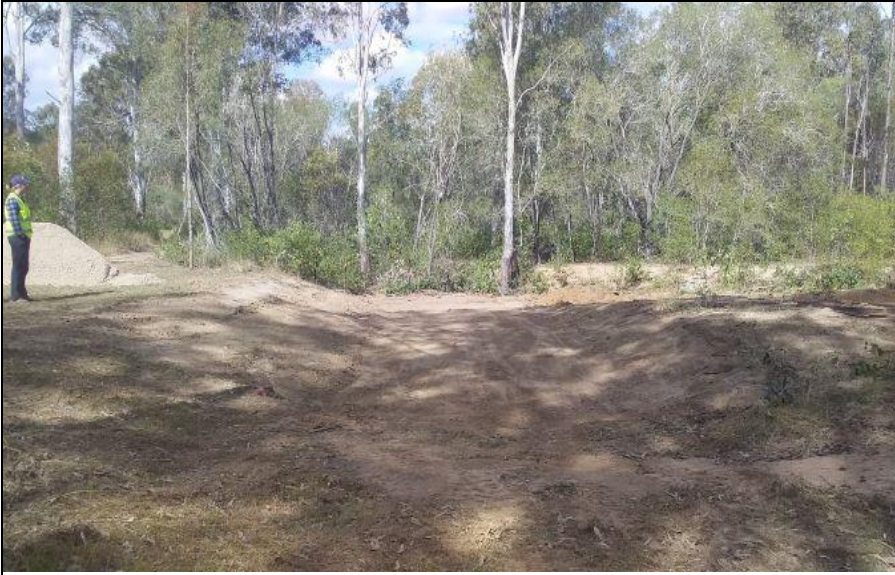
Photo 37

Gully shaped ready for gravel and rock

The beds were widened and shaped into a trapezoidal shape, 3m wide for the short side, 4m wide for the long side and 0.4m deep. 3:1 batters were used on the sides of the channel for the full length of both sections. Once shaped and compacted, a 10cm layer of high clay content road gravel was spread over the two gully floors and batters and compacted.

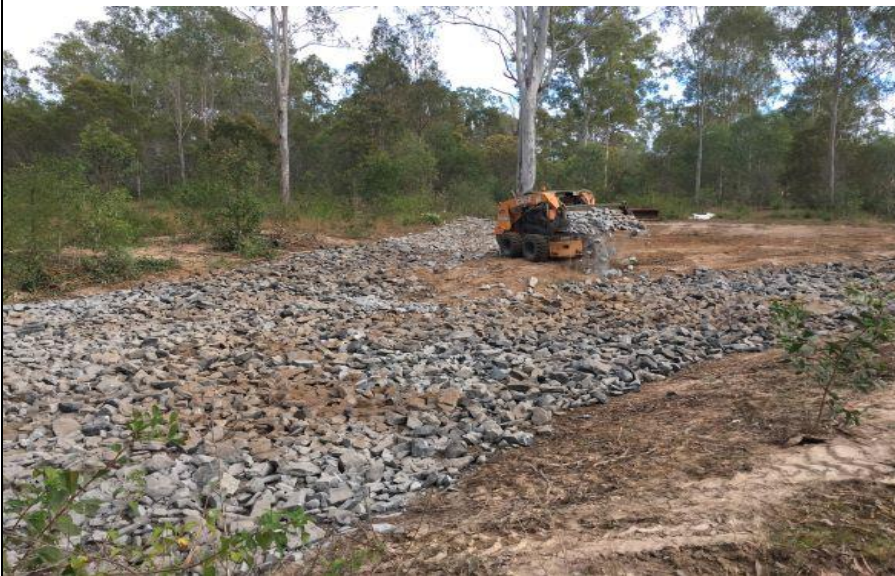
Photo 38

Finishing the rock mattress

After the gravel a layer of 100mm to 200mm mixed rock was spread over both gullies and up the batters.

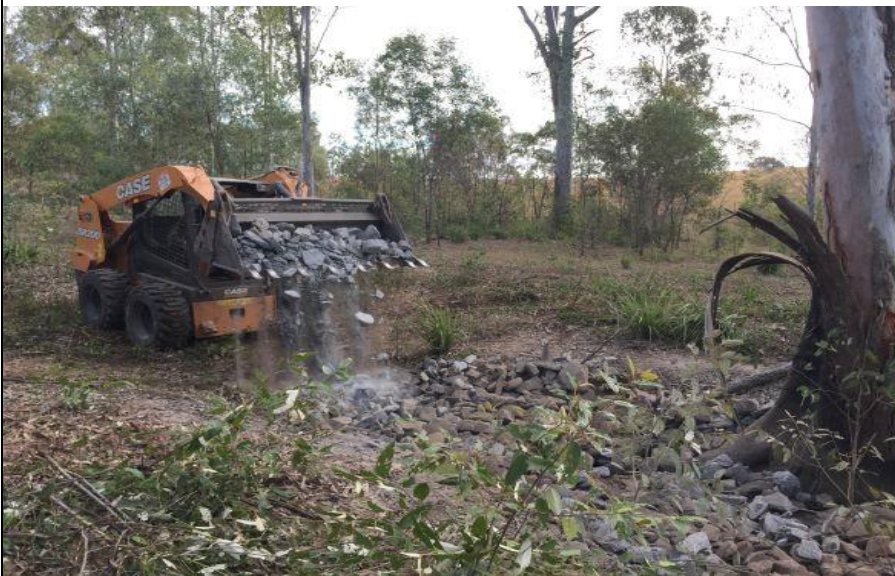
Photo 39

Fill gully head above tree

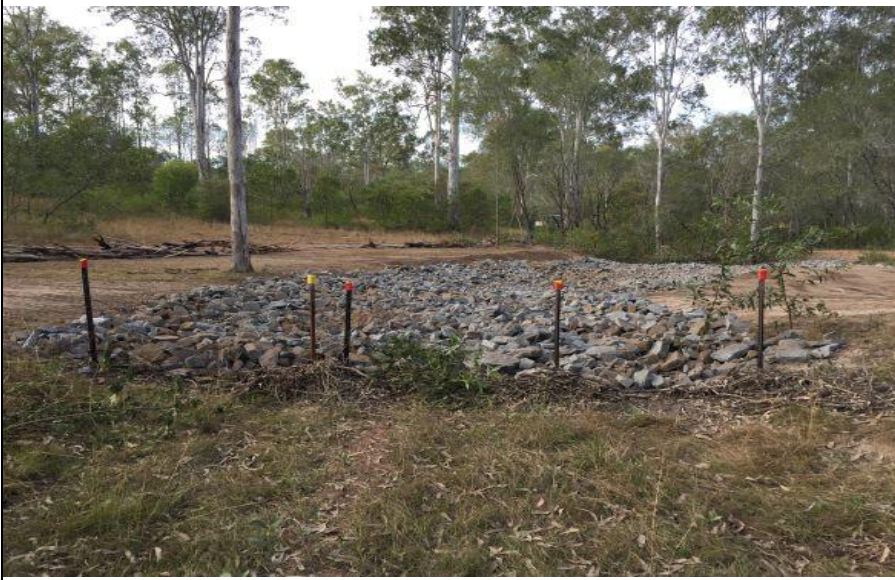
Photo 40

Rock finished on both sides.

A silt trap weir installed prior to works had performed well during the rain event and was left to continue trapping silt. As the silt drops out, it provides a growing medium for grasses to colonise – an essential step in the landscape recovery process and for slowing the water moving across the landscape.

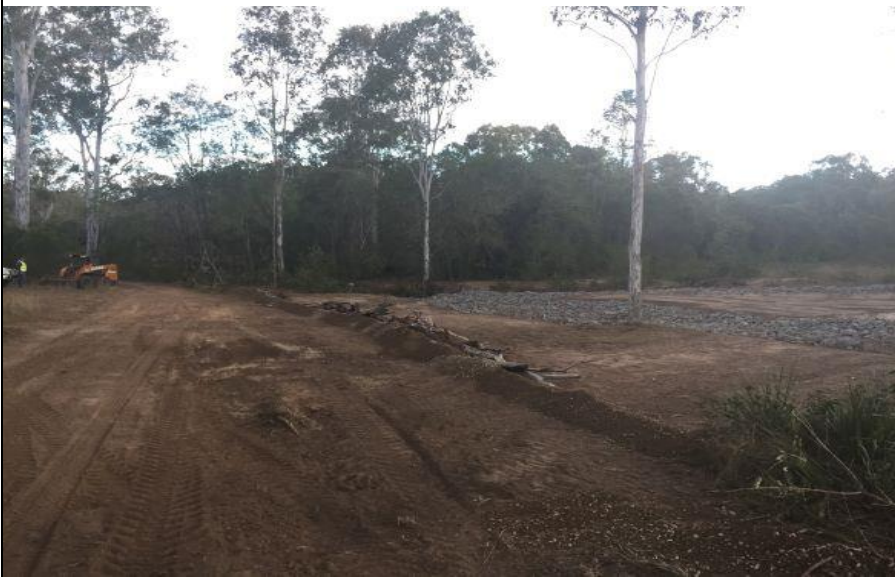
Photo 41

Log and gravel line along roadside to divert water away from the completed structure

A diversion log line and gravel barrier was constructed parallel to the gully and road edge to divert run off from the road and neighbours paddock to a safe flat location downstream.

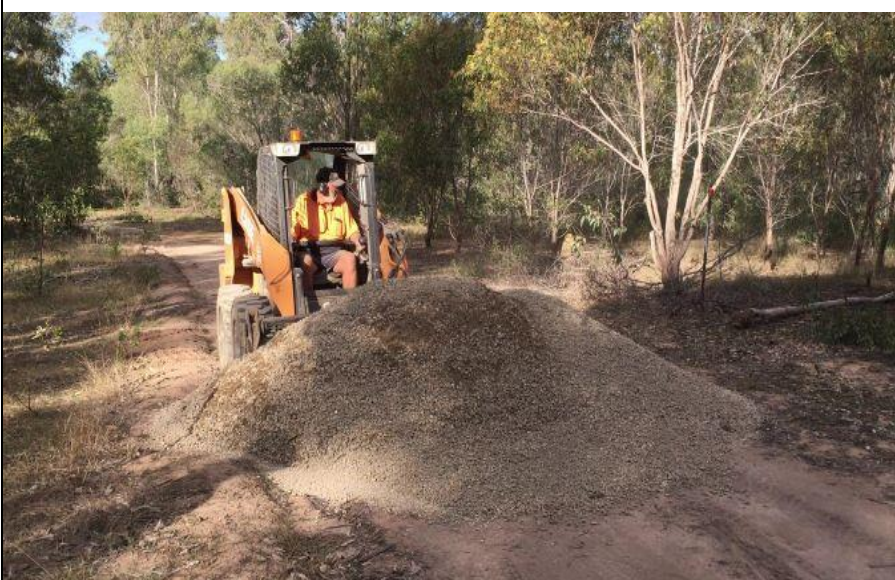
Photo 42

Gravel road base dumped in position on the driveway ready to be shaped into a whoa boy

If possible, dumping material in position will save machine time later on.

Whoa boys surveyed with 10cm fall across the width of the road. The slope was steep at 7%.

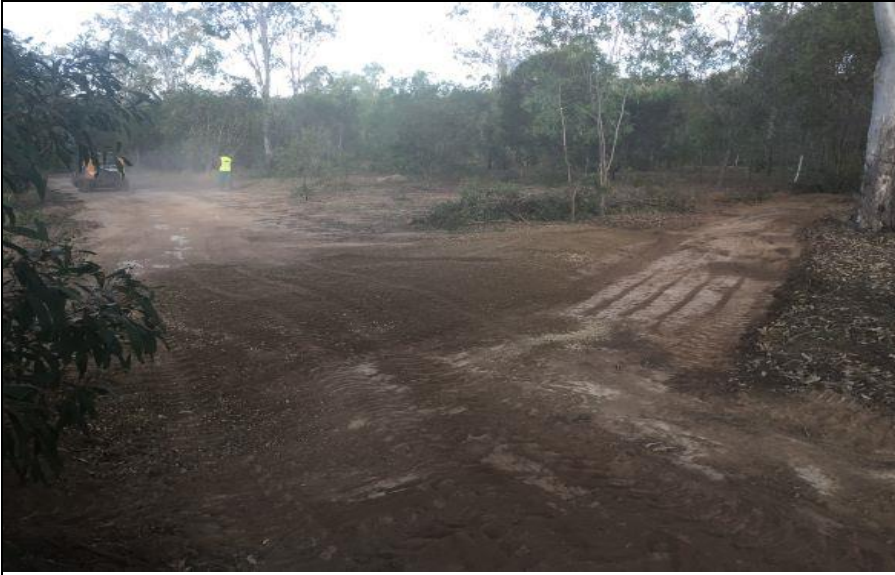
Photo 43

Whoa boys completed

Lines of logs, dead timber and mulch at the end of each whoa boy were used to carry water at least 20m away from the driveway and out of the gully catchment. Log lines were surveyed with 10cm fall over 25m, or 0.4%.
