Rehabilitation of Erosion Gullies

Adaptations and Learnings from the Mary River Catchment

Mary River Catchment Coordinating Committee

Version 2, July 2022

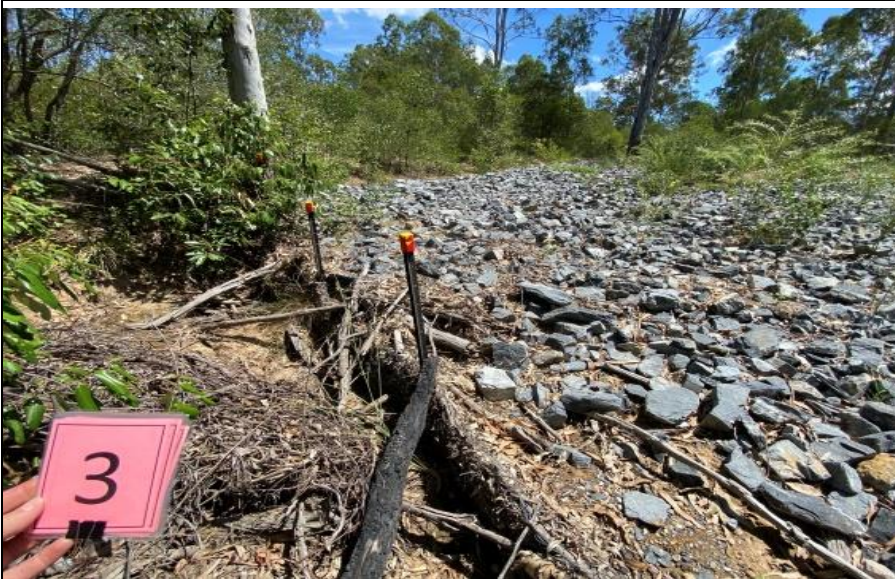
Photo 44

Ongoing maintenance of silt trap weirs below rock mattress

A netting weir at the confluence of the fork worked perfectly and was full of silt. Another netting weir was constructed about 10m downstream from that one so the crest of the new weir was high enough to back water approximately 0.3m up the wall of the existing netting weir. This was done to stop some potential undermining which was starting below the existing weir.

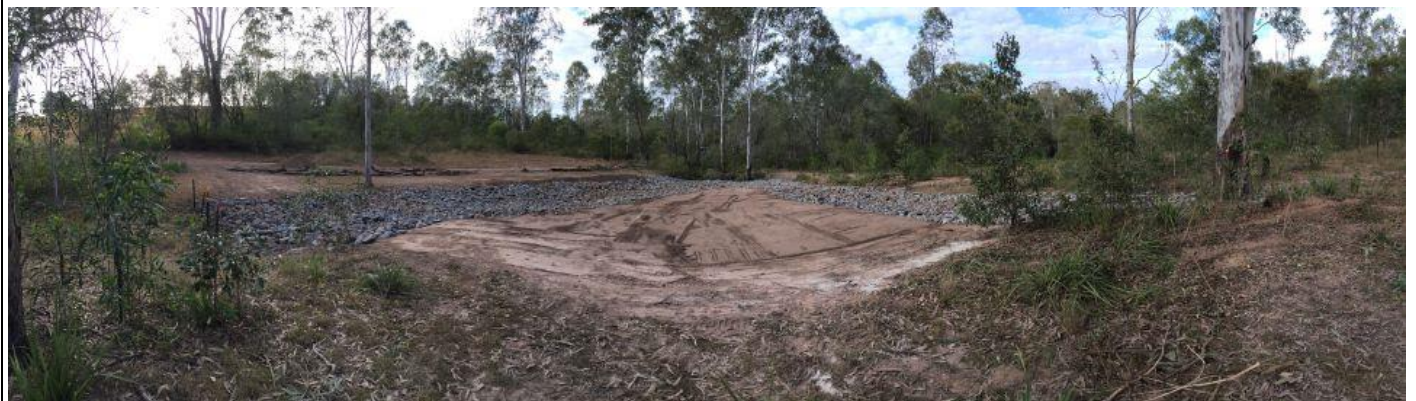
Photo 45

Looking downstream – completed project

Rock mattress on either side and topsoil spread in the middle to provide favourable conditions for regeneration of ground cover.

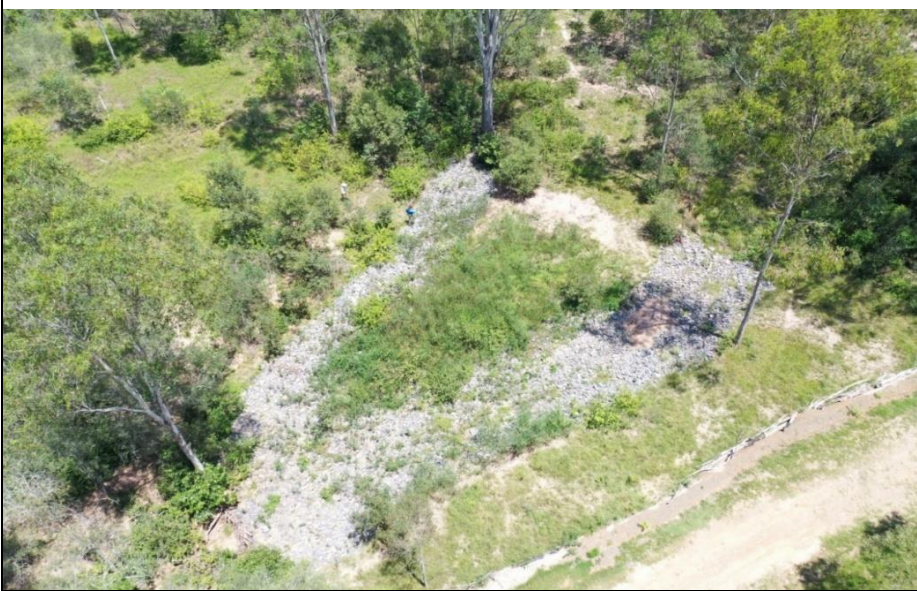
Photo 46

February 2022 after major flooding in the area

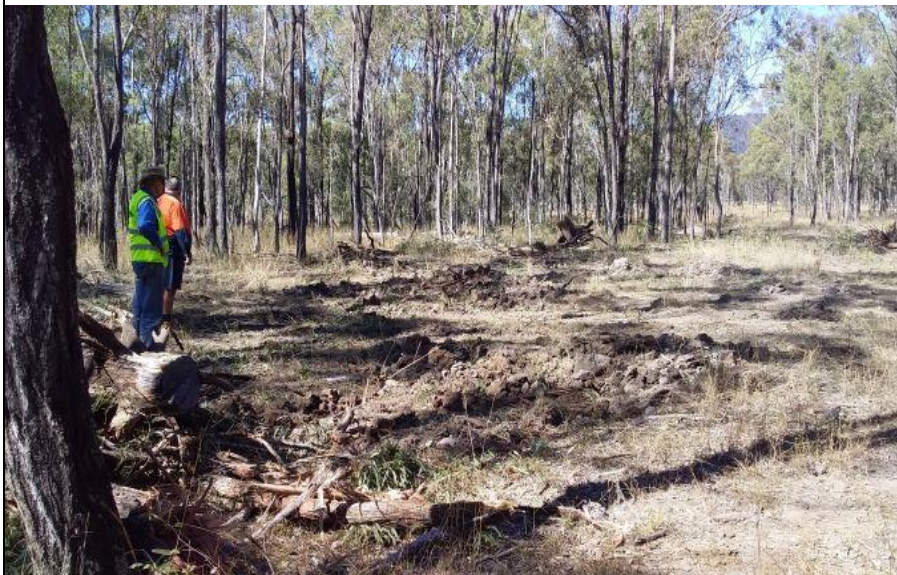
Photo 49

Minimal trees cleared for detention basin

The site of the detention dam at the end of the historic diversion bank outlet.

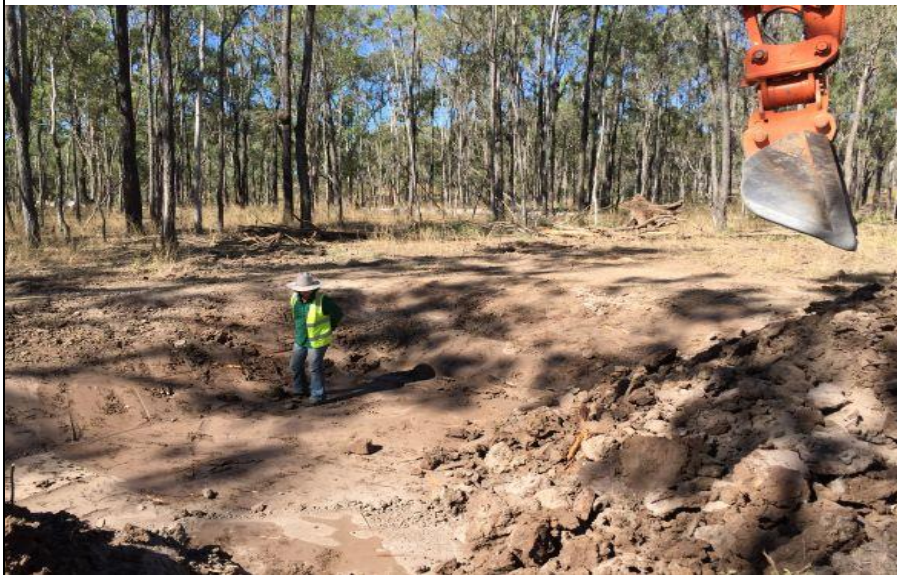
Photo 50

Detention basin taking shape

To reduce the volume and slow water reaching the slope above the gully head, a detention basin approximately 25m long and 10m wide and 1m deep, was constructed at the end of the historical diversion bank delivering the water from the contour system on the adjoining slope.

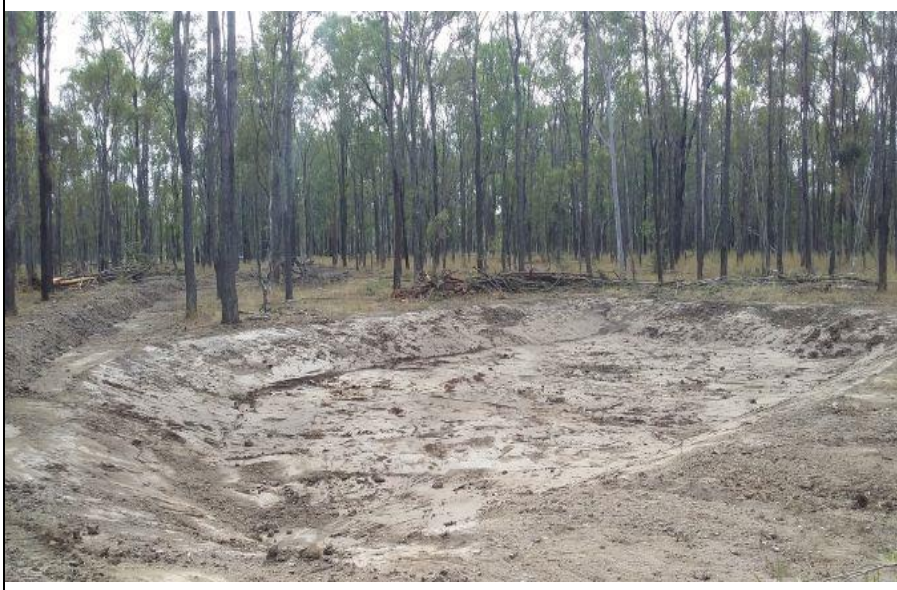
Photo 51

Detention dam complete with by-wash surveyed along ridge line

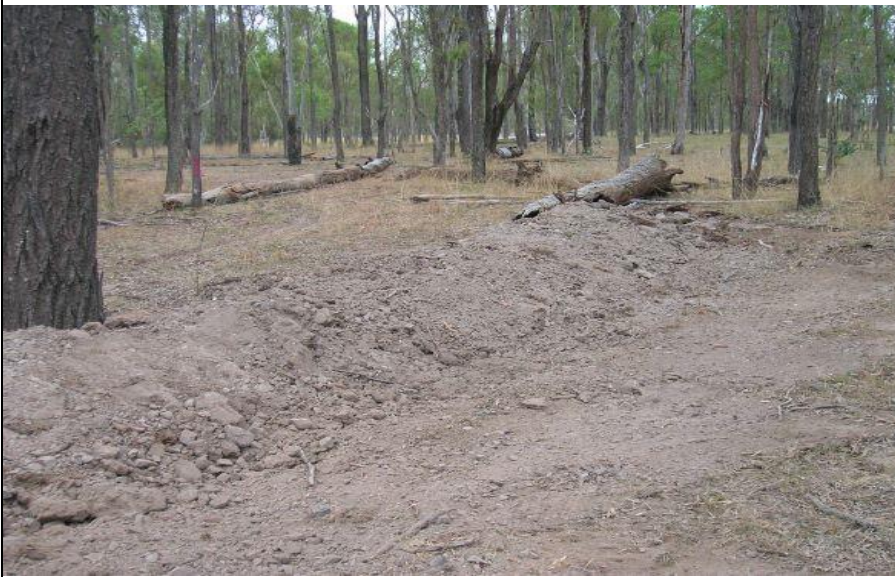
Photo 52

Detention dam by wash surveyed almost level, with log lines in place

The ridge top was quite flat at the site of the detention dam so the by-wash was surveyed almost level to retain more water and to take the water along the ridge line with the outlet approximately in the middle of the ridge. The by-wash placement and outlet was extensively surveyed and planned before work was started. Cascading stick rake or log lines approximately 25m long were positioned about 2m and 10m below the dam by-wash outlet to slow and spread water. A slight grade of 0.2%, or 5cm every 25m, was surveyed in the log lines to lead and spread the water along the slope.

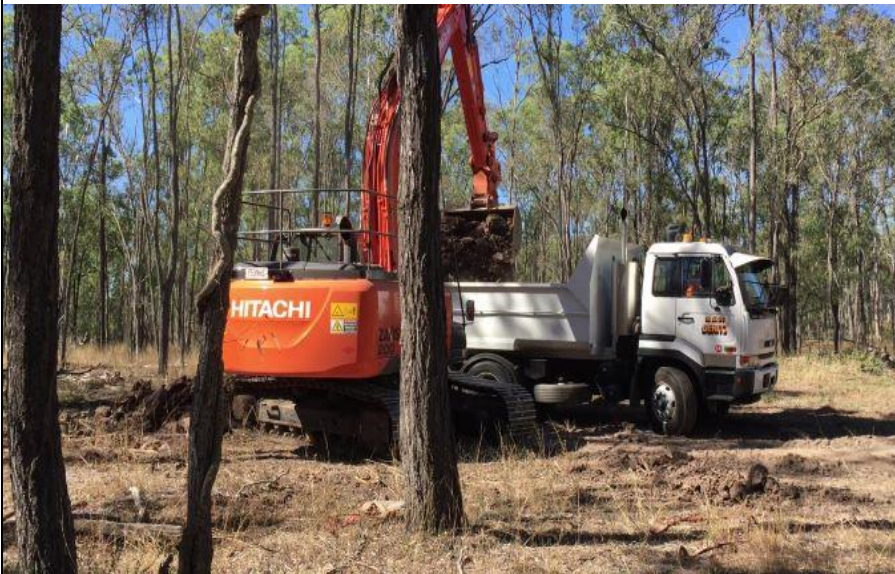
Photo 53

Excess clay soil was trucked from the detention basin site to the gully head downslope

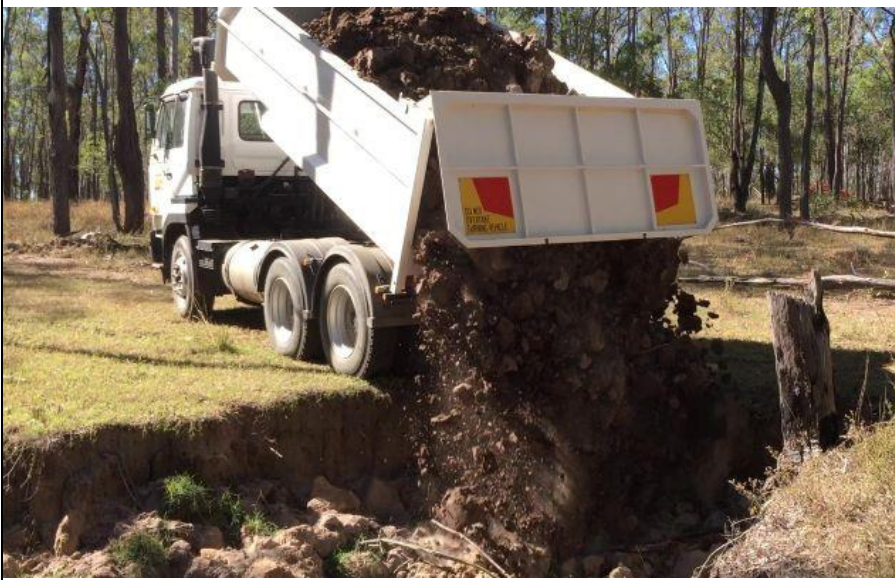
Photo 54

Spoil used to fill gully head

Clay soil from the detention basin was used to fill the gully head.

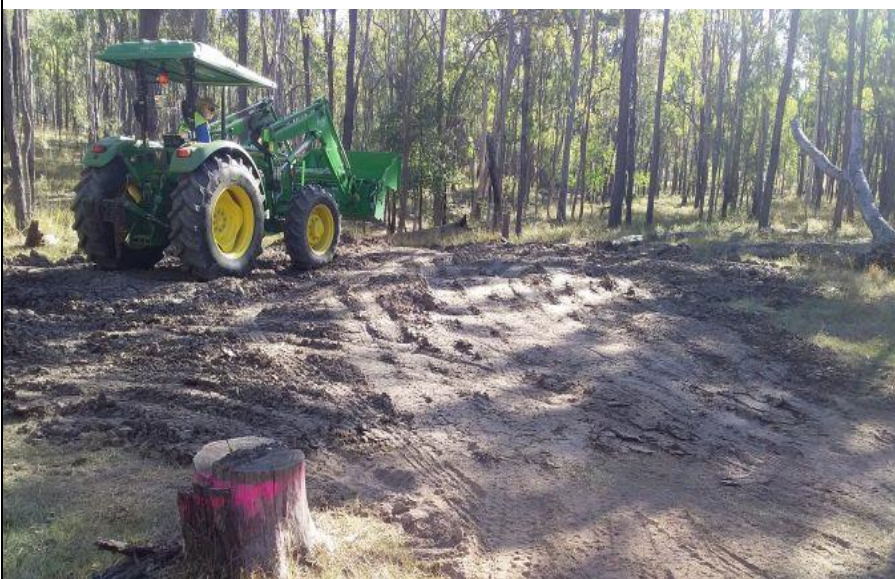
Photo 55

Filled gully head

The farm tractor was used to level and compact the fill.

Excess clay soil was placed along a by-wash bank and other small side gully heads below the main gully head cut.

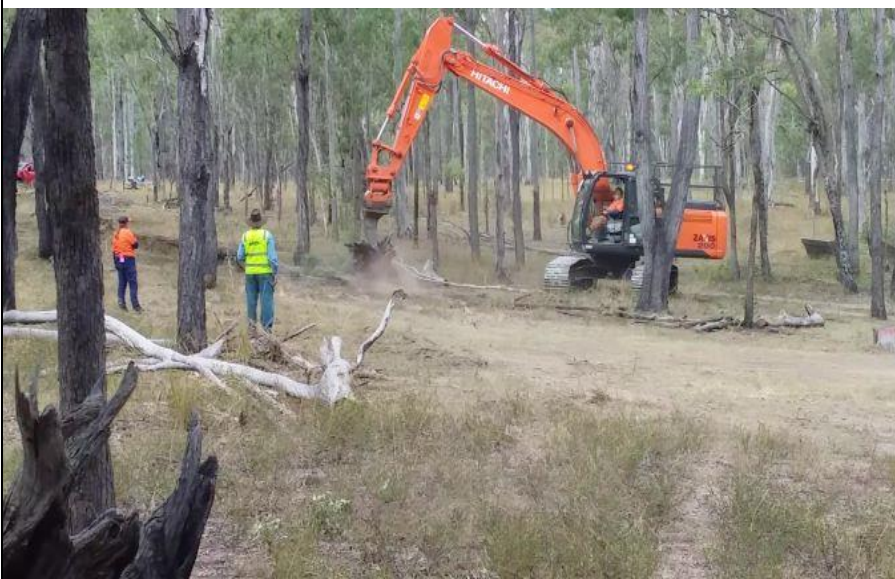
Photo 56

Clearing survey line for the main diversion bank above the gully fill

A diversion bank was surveyed so that it captured any water coming from the detention dam outlet and any other run off from the slope.

The line was cleared with the excavator which reduced the number of trees removed. The level sill and bank were constructed on the way back for time efficiency.

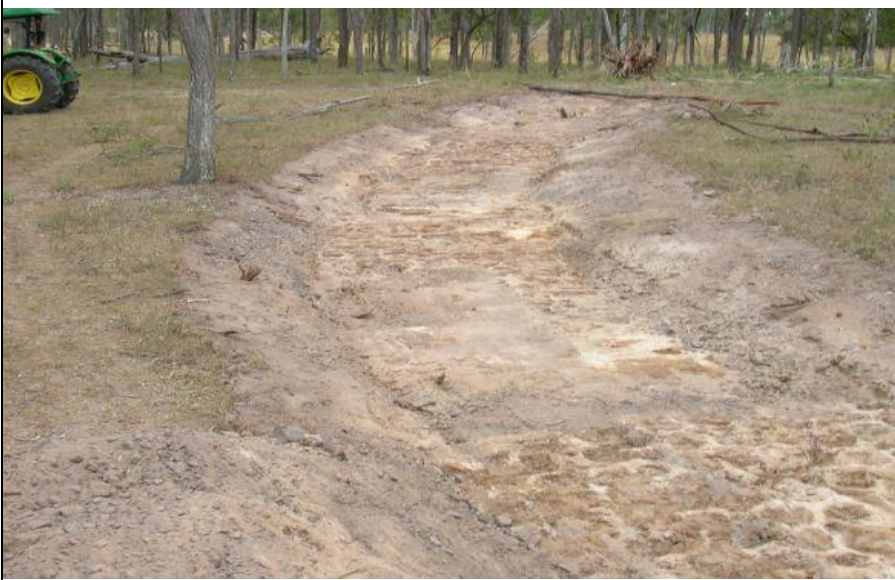
Photo 57

Main diversion bank level sill outlet

A level sill outlet was constructed to spread the water at the outlet. The level sill excavation was 20m long, 3m wide and 0.3m deep.

A series of three, 50m long level log lines were surveyed and placed below the level sill approximately 10m apart to further slow and spread the water from the outlet.

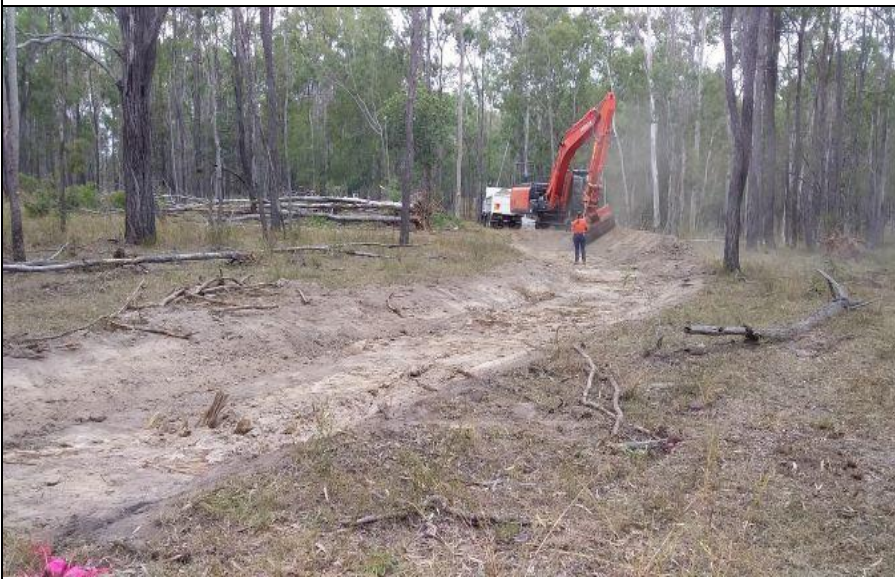
Photo 58

Levels taken consistently along the channel floor during construction using a laser level

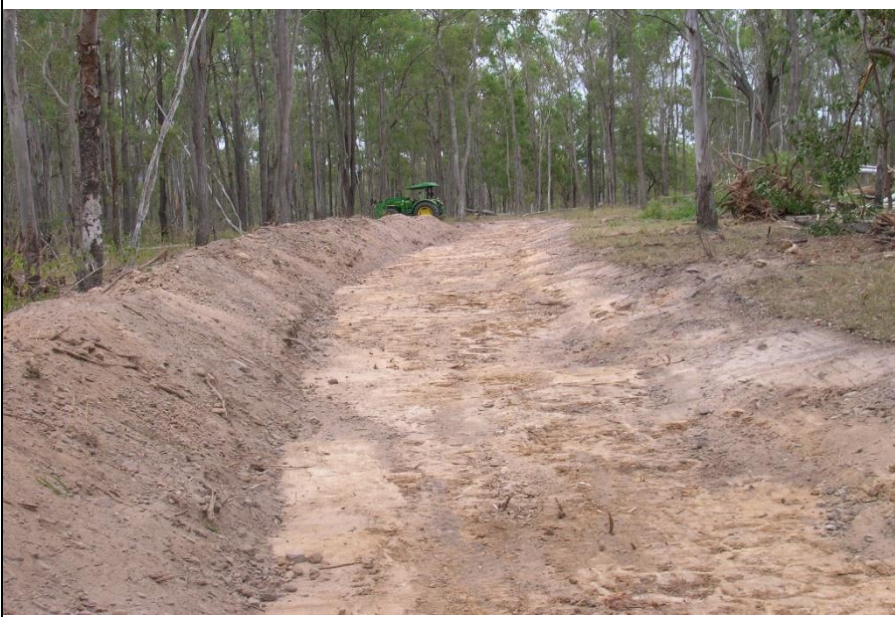
Photo 59

Completed bank looking towards level sill outlet

The bank was designed for a 1 in 20 year event and surveyed at 0.4% grade with a 3m wide flat channel and a 1m high bank at construction.

The bank took the water around the hillside to a well grassed area with a much gentler slope.

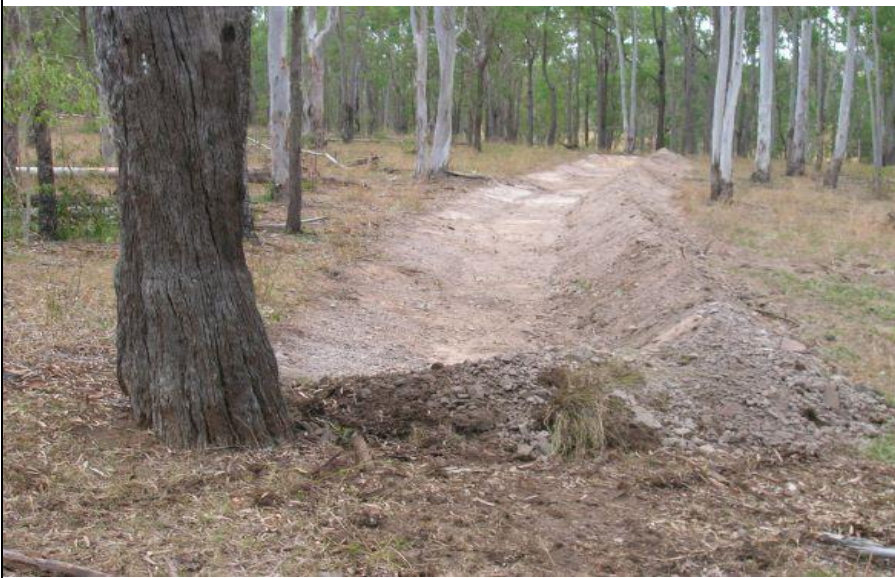
Photo 60

Short top diversion bank above the start of the main diversion bank

A short diversion bank was placed above the start of the main bank to take the top water from the natural drainage line out to a ridge line to further reduce the pressure on the depression which had gullied. This bank had a very small catchment size (<1ha). The 25m bank with 0.2% slope was constructed to 0.8m with a 1m wide channel.

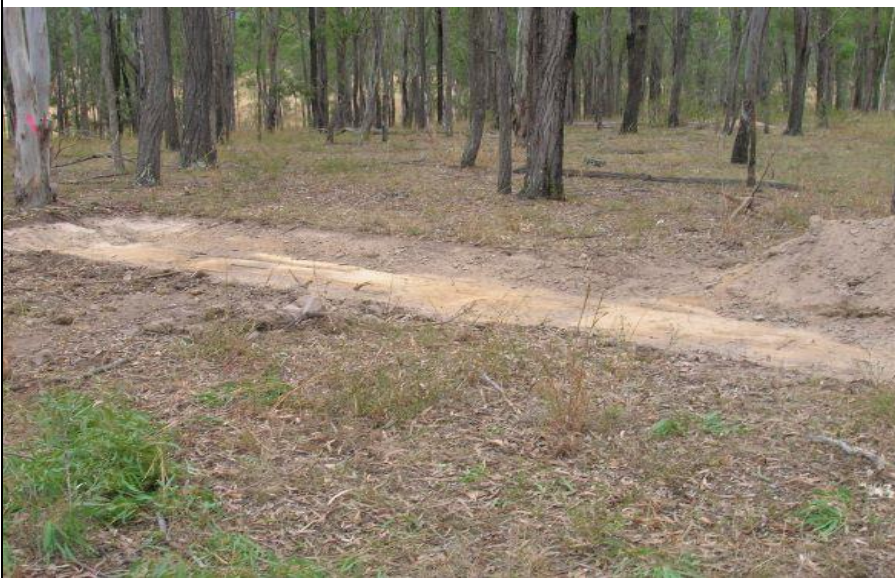
Photo 61

Short top diversion bank level sill outlet showing the grassed slope where water spreads

A level sill was constructed at the end of the short top diversion bank to spread water over the grassy slope below. The level sill outlet was constructed to 10m long x 1m wide x 0.3m deep.

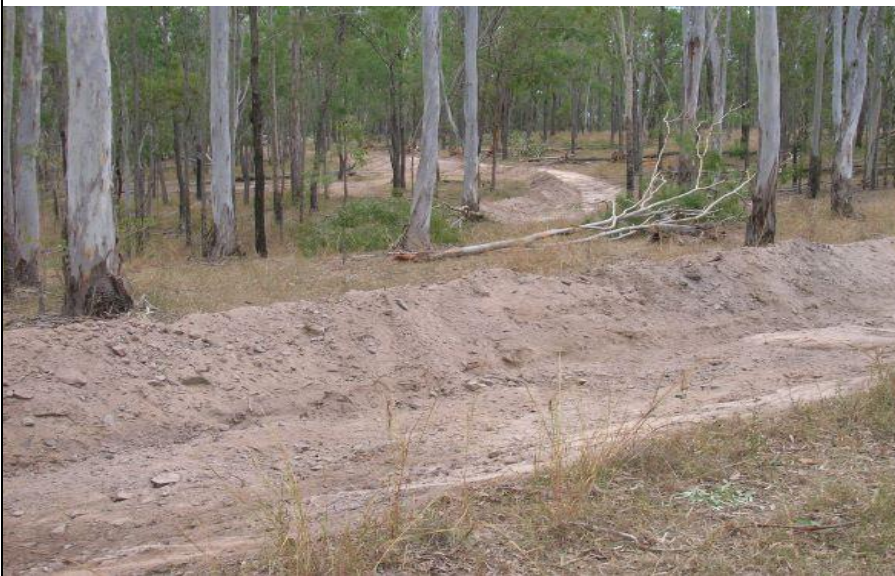
Photo 62

Background: Main diversion bank looking along the channel towards the outlet end

Foreground: Short diversion bank above the main bank

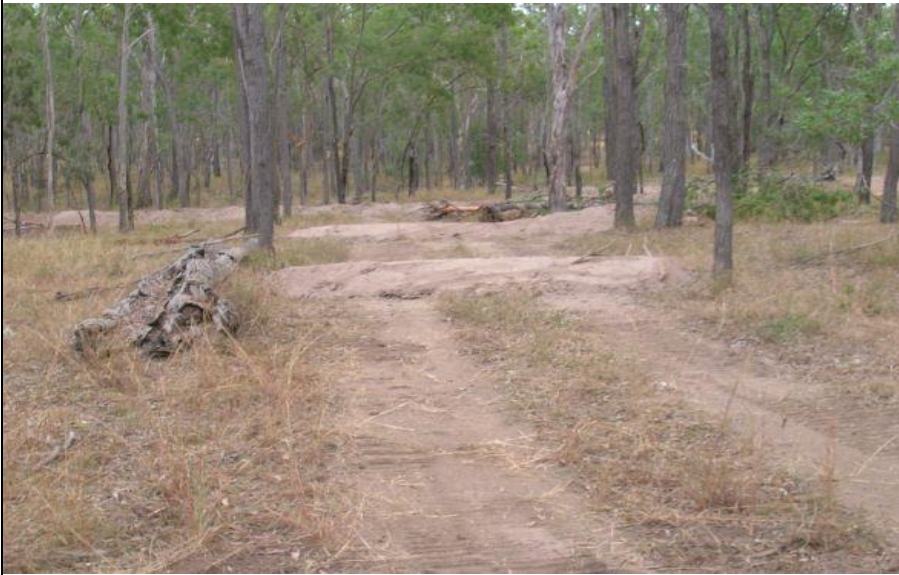
Photo 63

Whoa boys constructed on the way out to prevent erosion of the track exposed during construction

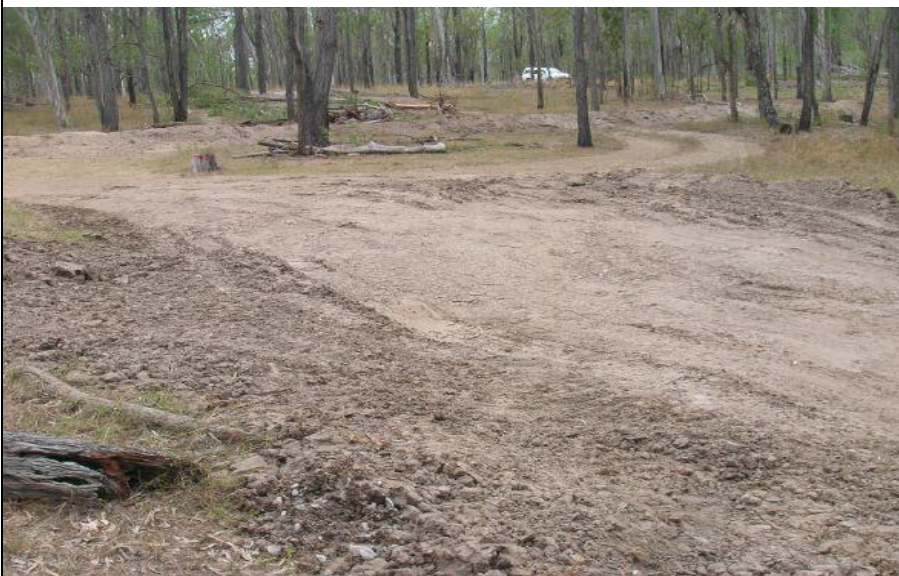
Photo 64

Completed July 2020

Looking upslope towards diversion banks from what was the gully head.

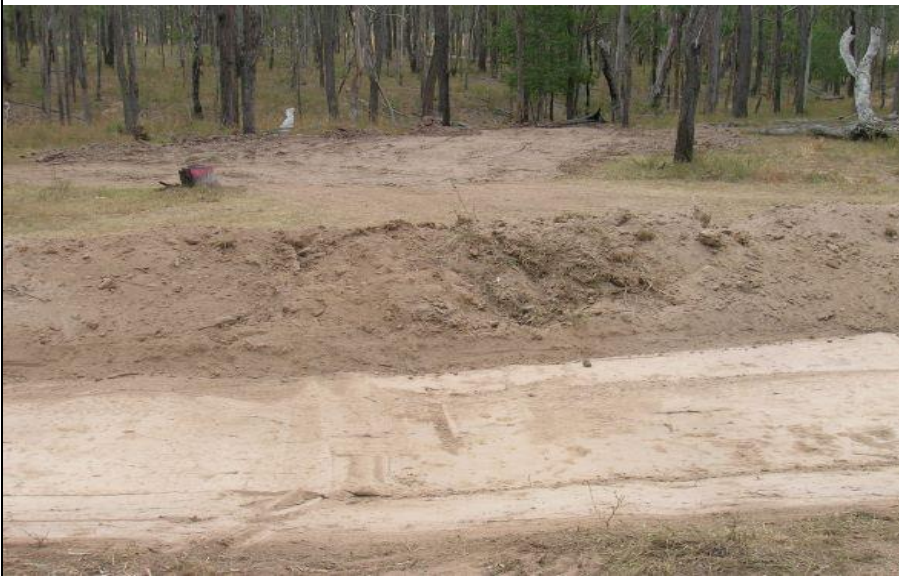
Photo 65

Completed July 2020

Looking downslope over diversion bank towards filled gully head.

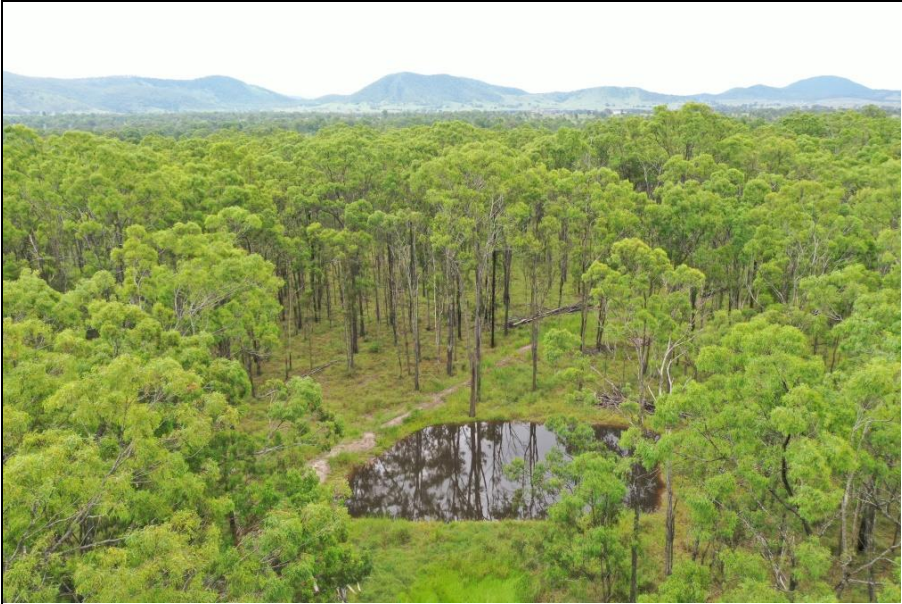
Photo 66

Feb 2022 post flood

Detention basin full and ground cover has improved significantly.

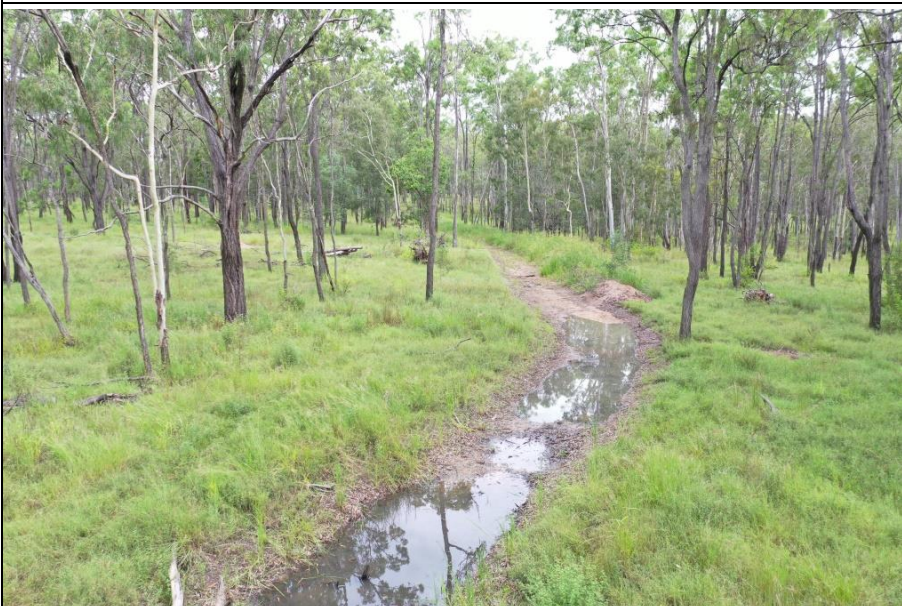
Photo 67

Feb 2022 post flood

Level sill at outlet still holding some water following the flood.

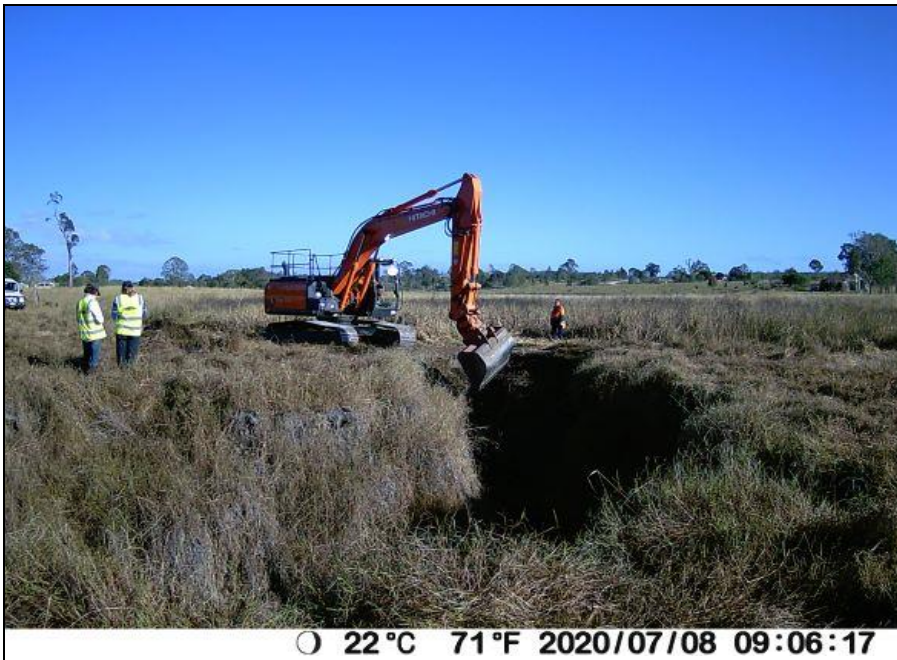
Photo 70

Beginning of the shaping

The rock chute crest was skewed to the south to reduce the amount of earthworks in forming the batter and apron.

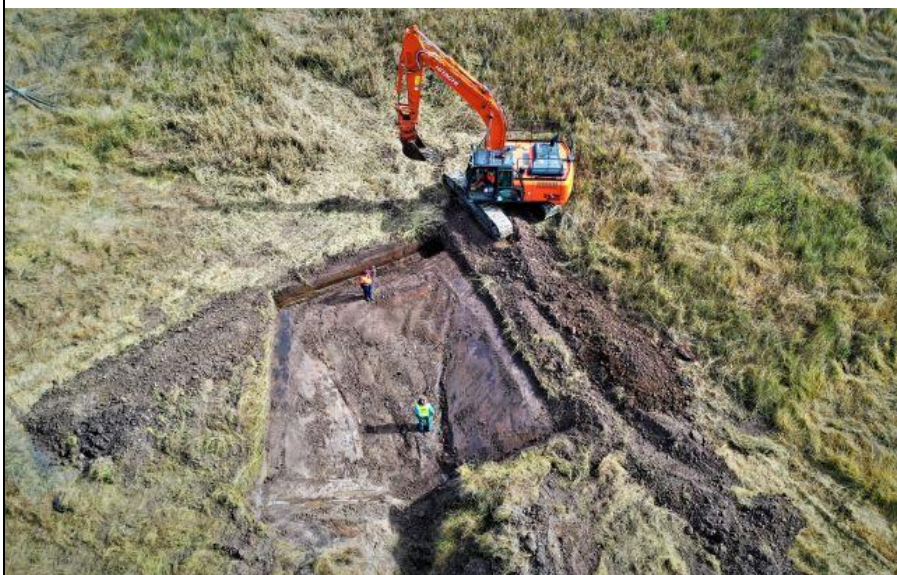
Photo 71

Gully head chute shaping completed

A cut off trench approximately 0.6m wide x 0.6m deep was placed across the top of the chute crest 1m up slope from the start of the batter. A second 0.6m deep V shaped cut-off trench was constructed across the bottom of the batter and up both sides of the shaped gully.

A 1m wide x 0.3m deep ledge on either side joined the top and bottom cut-off trenches, providing a flat surface where rock could hold the geofabric in place during construction.

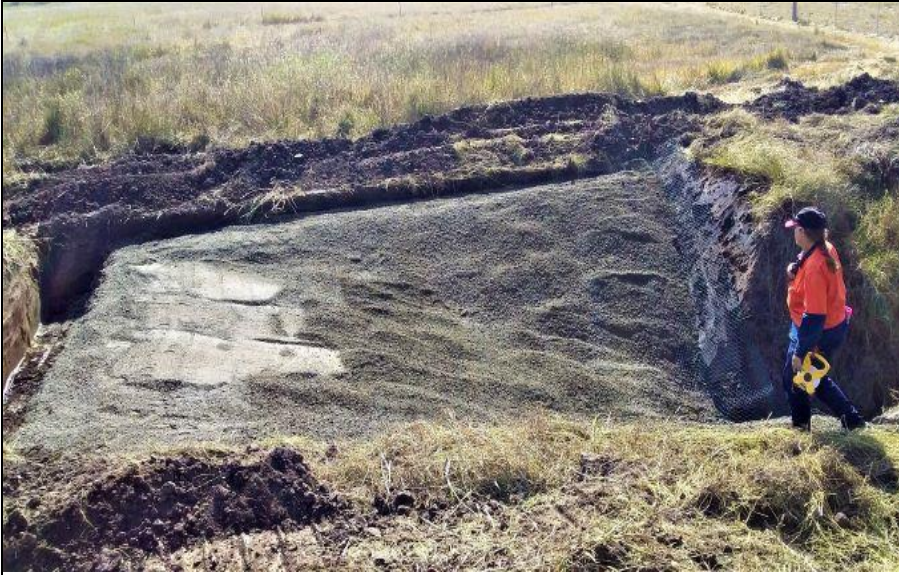
Photo 72

Chute covered with high clay gravel

The batter of the chute and the bottom of the cut-off trenches were covered with 10cm of high clay gravel.

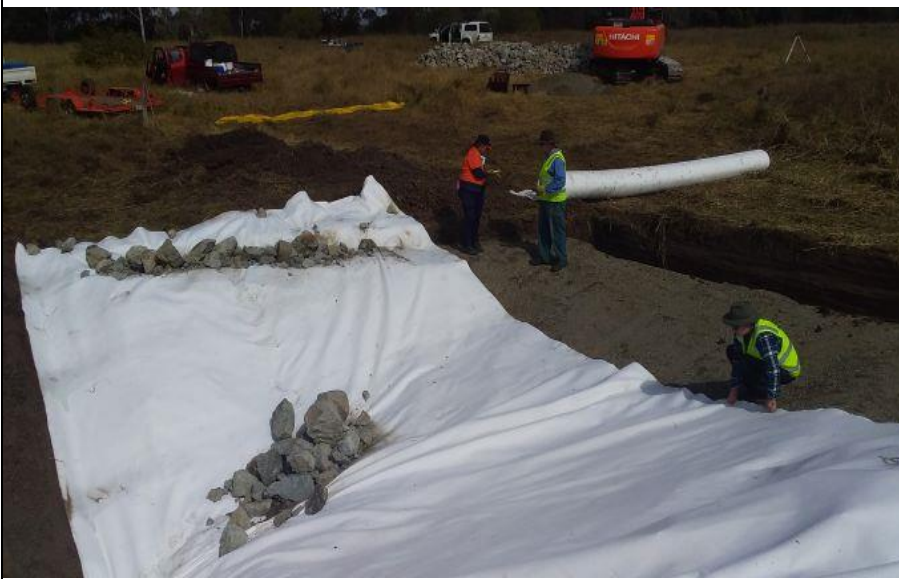
Photo 73

Geofabric placed to cover entire structure

Geofabric (Texel 400R) was placed over the whole chute area and into the cut-off trenches top and bottom. Geofabric was held in place with small amounts of rock.

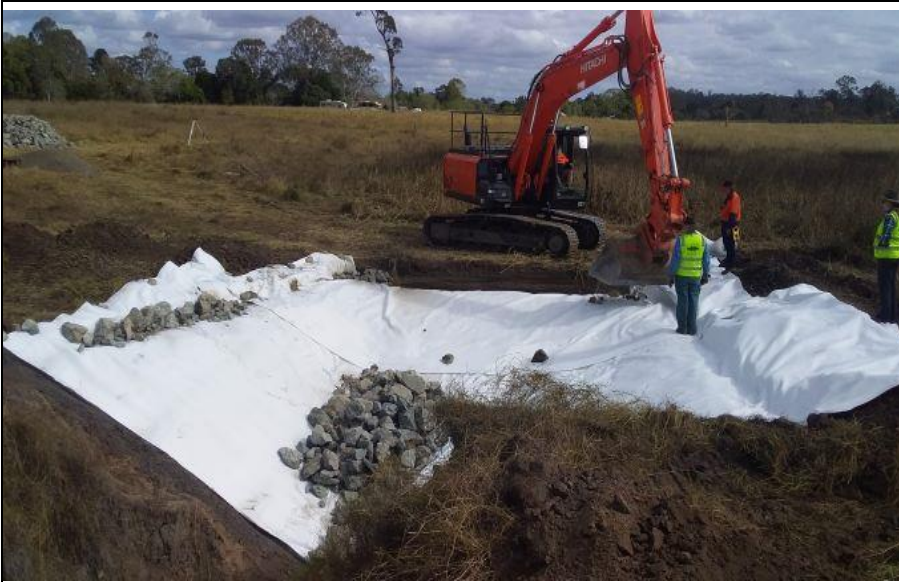
Photo 74

Geofabric completed and rock goes on

The cut off trenches were filled with a gravel and smaller rock mix to 200mm over the geofabric first. A rock mix of 100mm to 400mm was carefully placed and compacted on the geofabric covered batter and cut off trenches top and bottom. The bottom of the batter had a higher component of the large 400mm rock arranged to assist energy dissipation.

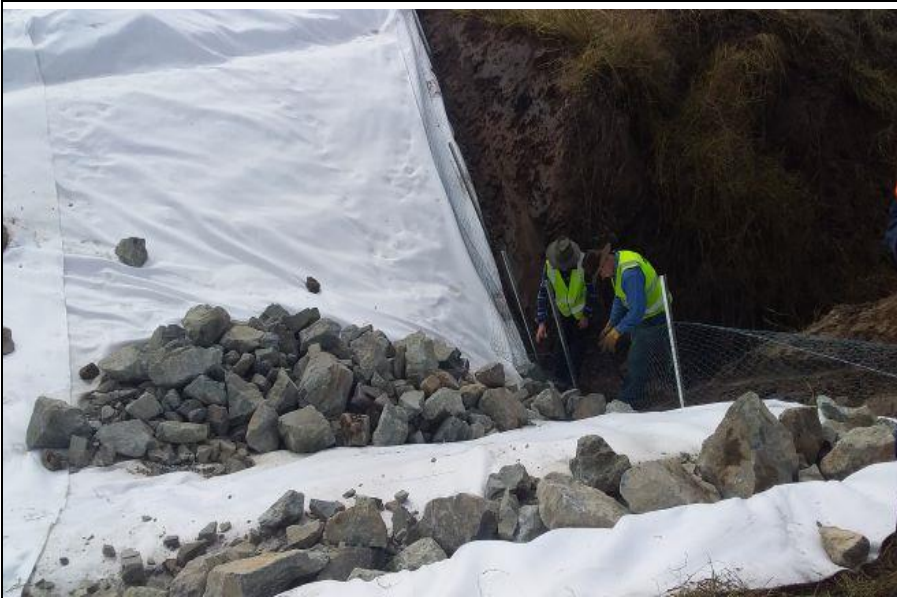
Photo 75

Netting fence constructed in bottom cut-off trench

Heavy wire netting was secured in the bottom cut off trench to be used later as a weir across the bottom of the structure to hold the last rocks on the batter in place during any large flow or flood events.

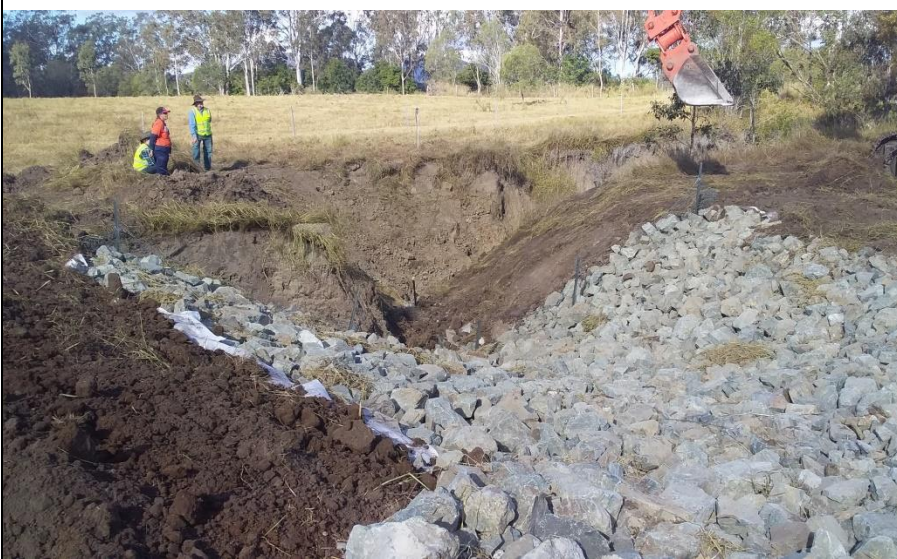
Photo 76

Batter gully walls to encourage grass growth

Both edges of the gully below the structure were battered at 1:1 for approximately 15m to allow grass regeneration. The topsoil and grass sod was scalped back and reserved then replaced following shaping. All tunnels were excavated, back filled and compacted before the battering and bank construction was completed.

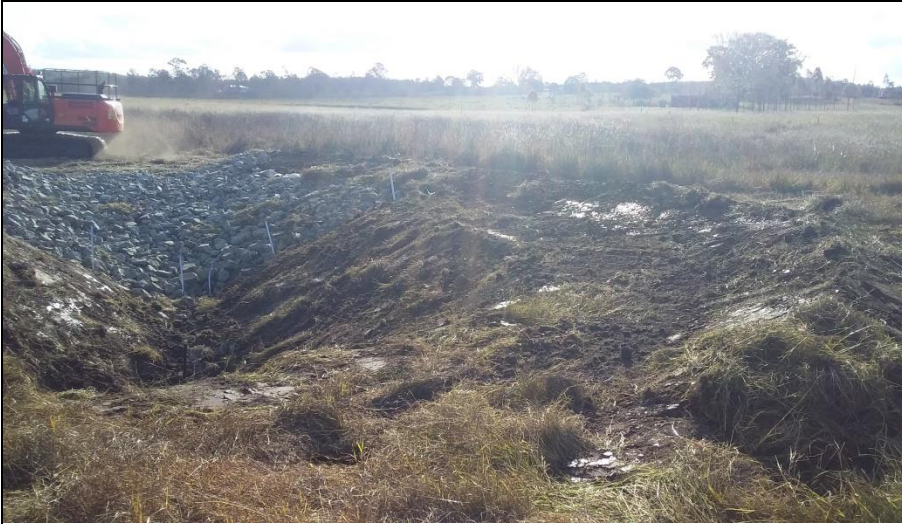
Photo 77

Construct wing banks to direct flow over rock chute and to prevent creation of new tunnels

Excess soil was retained and used to construct diversion wing banks at each side of the chute to direct flows over the rock chute. These banks were constructed to 1m high. The bank closest to the river continued upslope until the end at ground level was at least 0.6m above the weir crest height. The bank on the other side curved around the gully and captured water from the neighbour's paddock which was creating tunnels along that side of the gully wall. The end of the bank was again 0.6m above the weir crest height. To prevent banks eroding at the rock chute entry, banks were rock armoured for a distance of 3m and height of 0.5m.

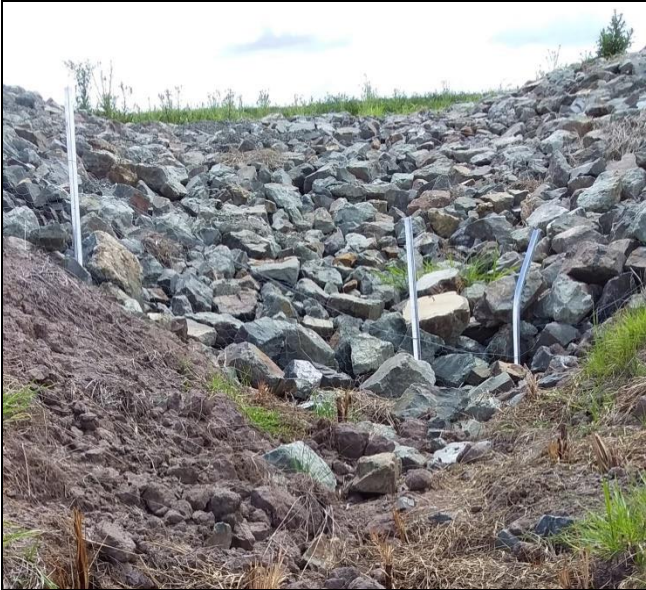
Photo 78

Place large rocks at the base of the chute for energy dissipation

Due to the steep narrow gully, it was impossible to construct a conventional 2m wide energy dissipater at the bottom. Larger rock was placed in the narrow gully bed below the netting fence for approximately 5m to reduce the 'waterfall effect' below the netting and provide some more energy dissipation.

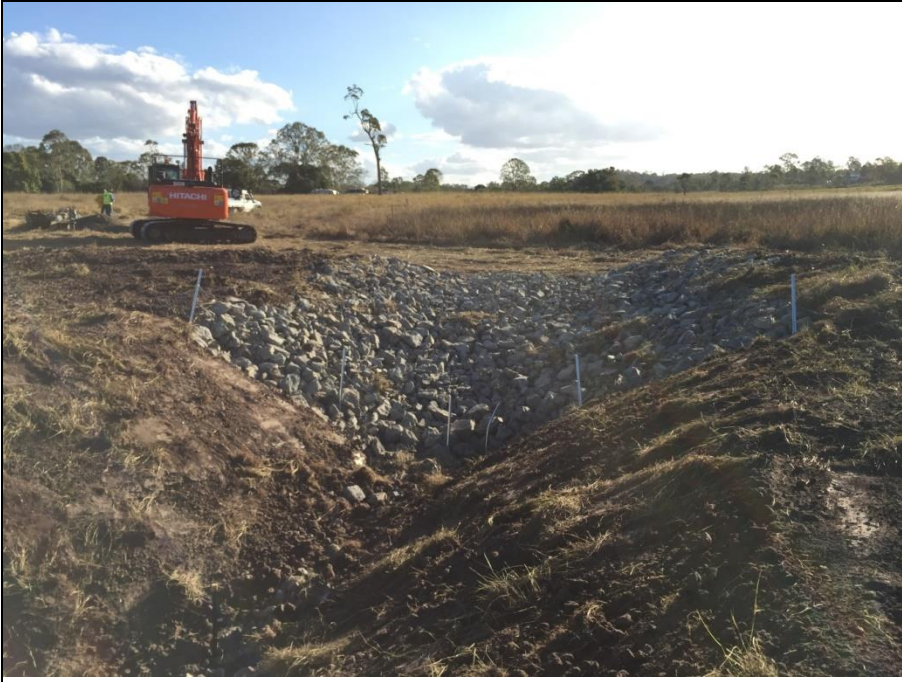
Photo 79

Rock chute complete July 2020

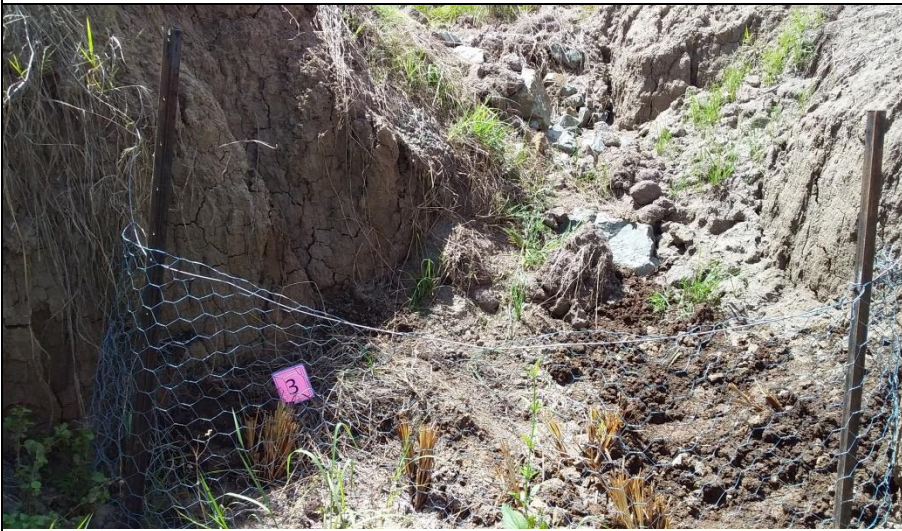
Photo 80

Construct silt trap weirs in gully floor and plant para grass sods

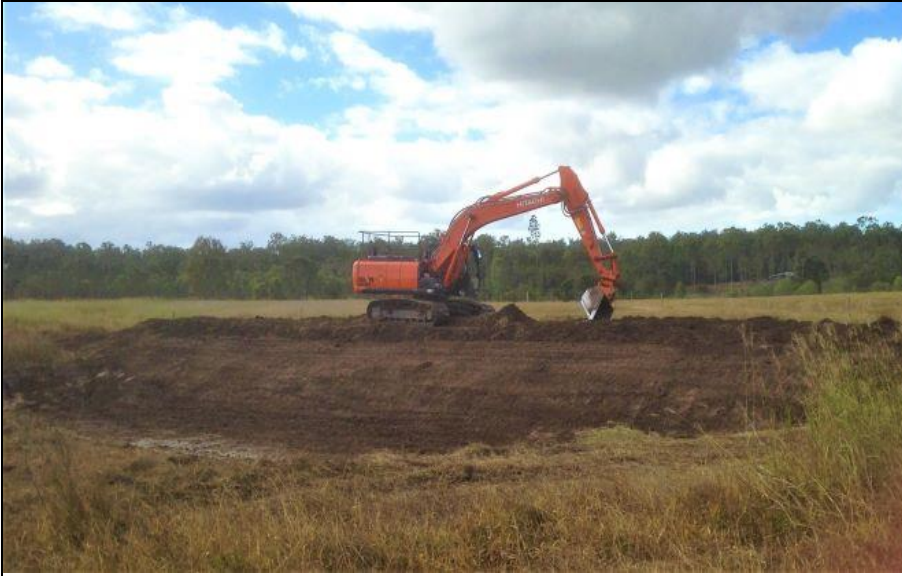
Photo 81

Detention dam construction

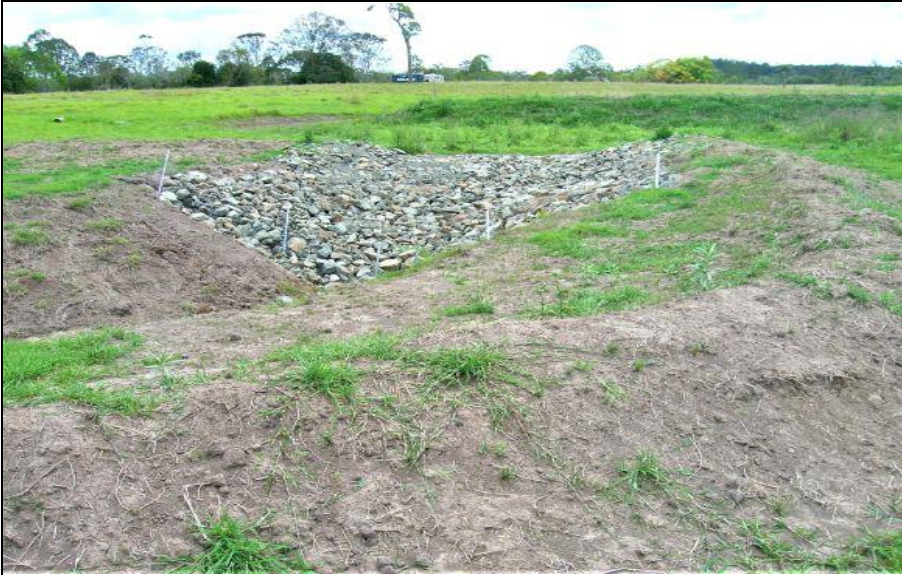
Photo 82

Rock chute and dam wall looking upstream after rain

Ground cover is starting to establish.

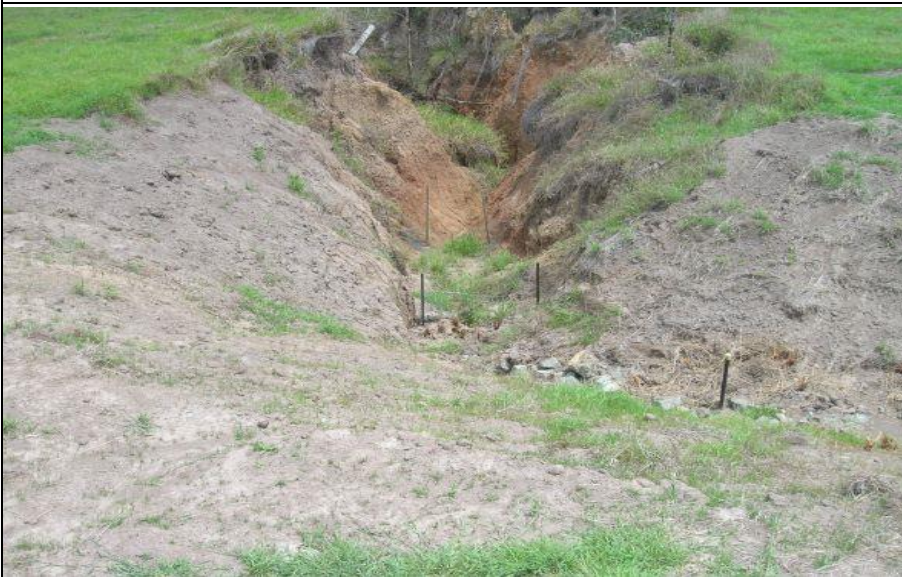
Photo 83

Gully below chute after rain, showing netting weirs

Two additional netting silt trap weirs were spaced at approximately 0.4m vertical drops down the gully floor to assist with siltation and revegetation.

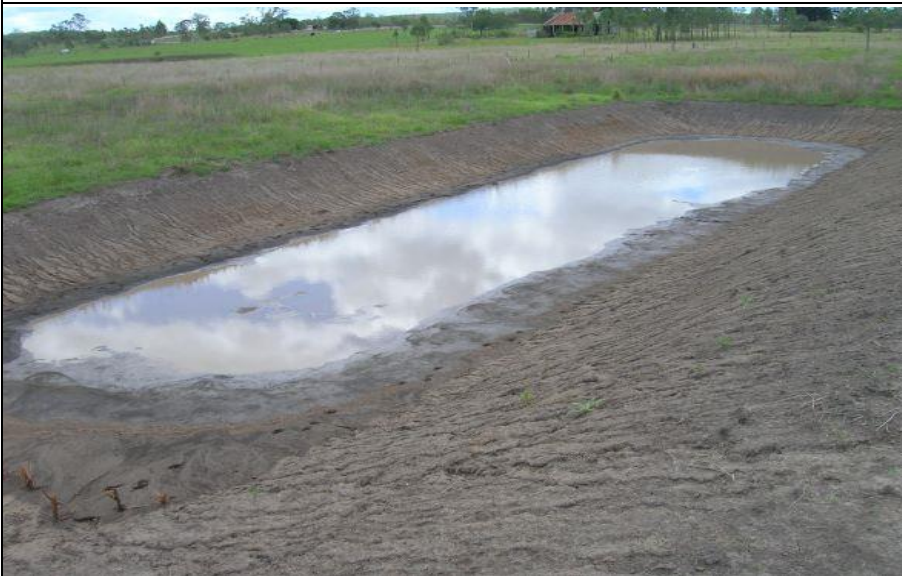
Photo 84

Detention dam after first rain event

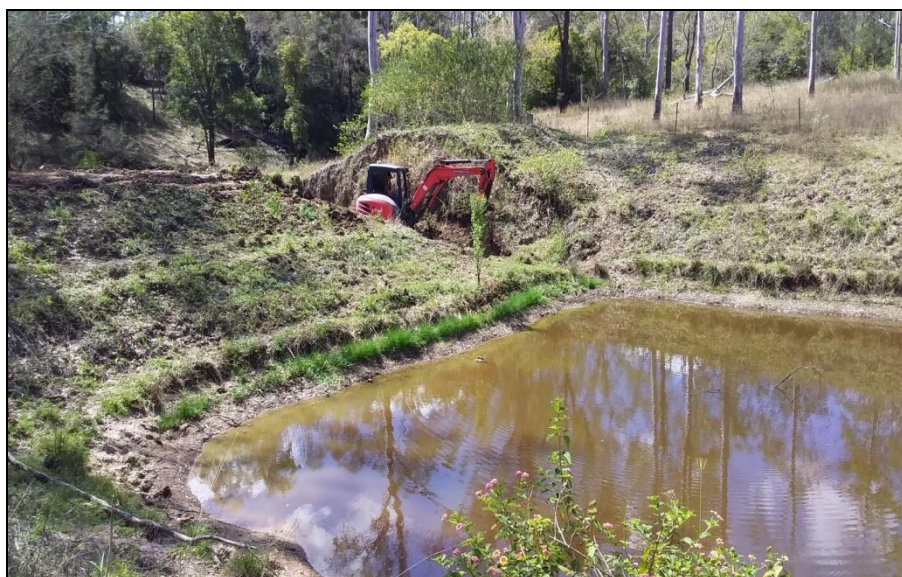
Photo 89

Excavation of crest

The first step was to fill and compact the gully while widening the gap in the broken wall to the design width of 25m. During construction this width was reduced to 20m to manage the costs and to complement the original shape and width of the stream bed. The rock chute was constructed longer and flatter to compensate for the width reduction.

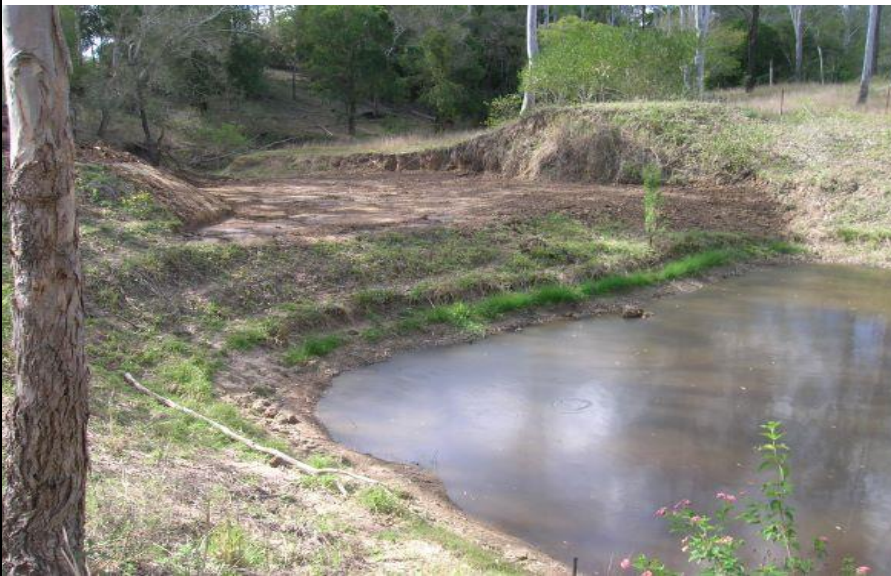
Photo 90

Dam wall cut completed to design width

The constructed gap was approximately 20m at the upstream end narrowing to 10m at the downstream end of the gully cut. The remaining wall either side of the cut was battered back at 1:1. During this process there was a lot of soil which had to spread along the stream bank up out of normal flow depth. This was done with the skid steer very efficiently.
