Rehabilitation of Erosion Gullies

Adaptations and Learnings from the Mary River Catchment

Mary River Catchment Coordinating Committee

Version 2, July 2022

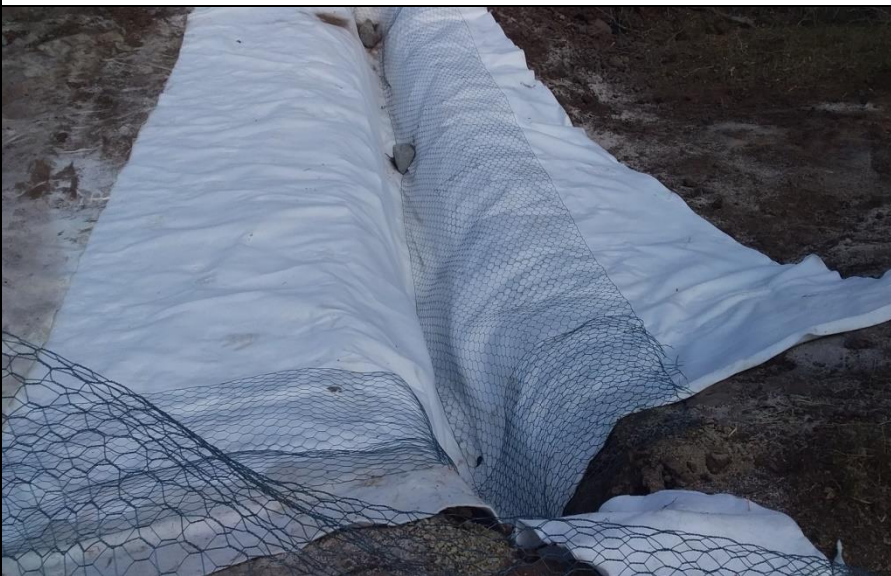
Photo 91

Completed upstream cut off trench with geofabric and inlaid with mesh – which will secure the top mesh

Cut off trenches at least 0.5m wide and 0.7m (depth and width of bucket) were constructed on both ends of the levelled cut through the dam wall. Bentonite was broadcast at 10kg/m² over the top of the whole levelled foundation to provide an impervious base layer to the structure.

Geofabric was laid into the trench allowing 2m overlap and inlaid with 1.6mm galvanised mesh. Trench was half filled with smaller rock to ensure good tight compaction and reduced space for running water.

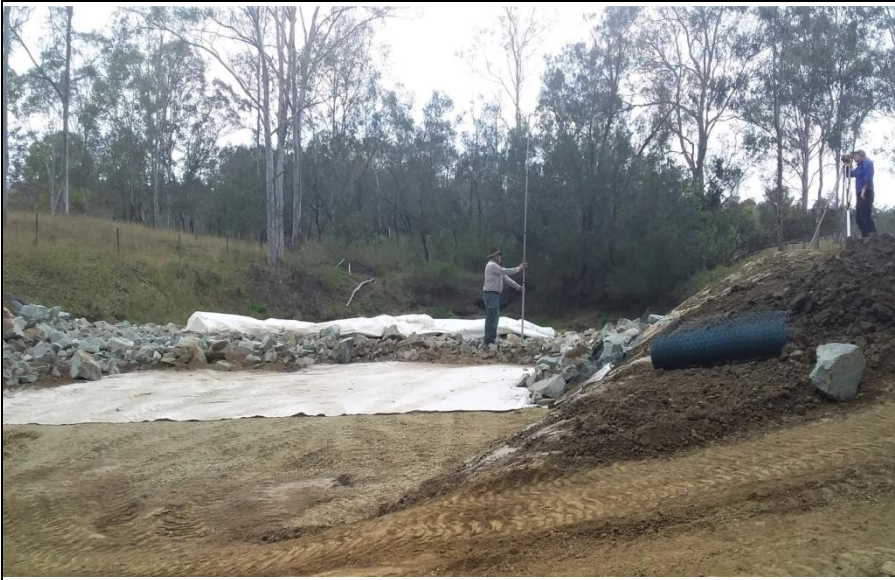
Photo 92

Illustrates the layering – first bentonite, gravel, Texcel 400R fabric then rock. Continuous surveying done to ensure rock mattress was level across the width.

The layering was done starting with the upstream section working downstream so preventing excavator travelling over the geofabric.

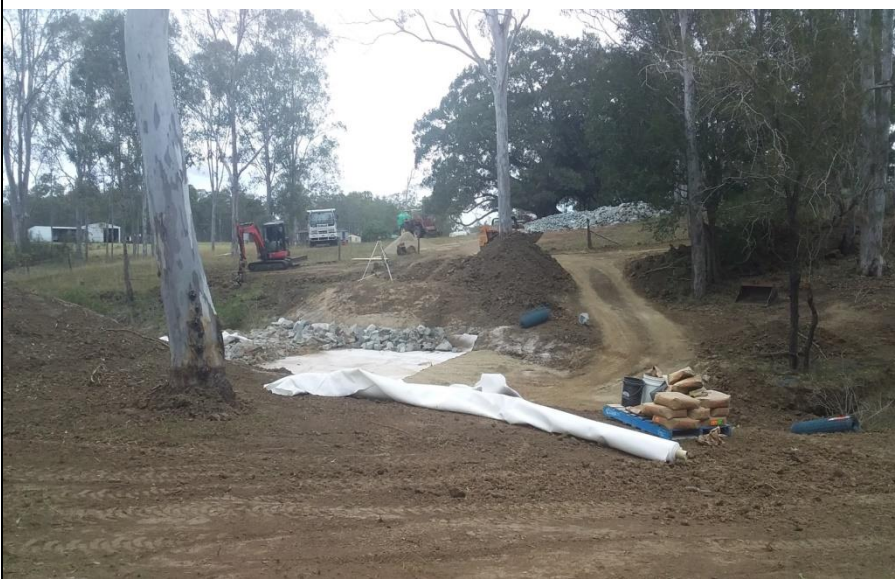
Photo 93

Work site illustrating placement of materials

The rock used was a mix of 100mm to 400mm which was mixed on site as it was laid in. The larger rock first with the gaps filled with the smaller rock.

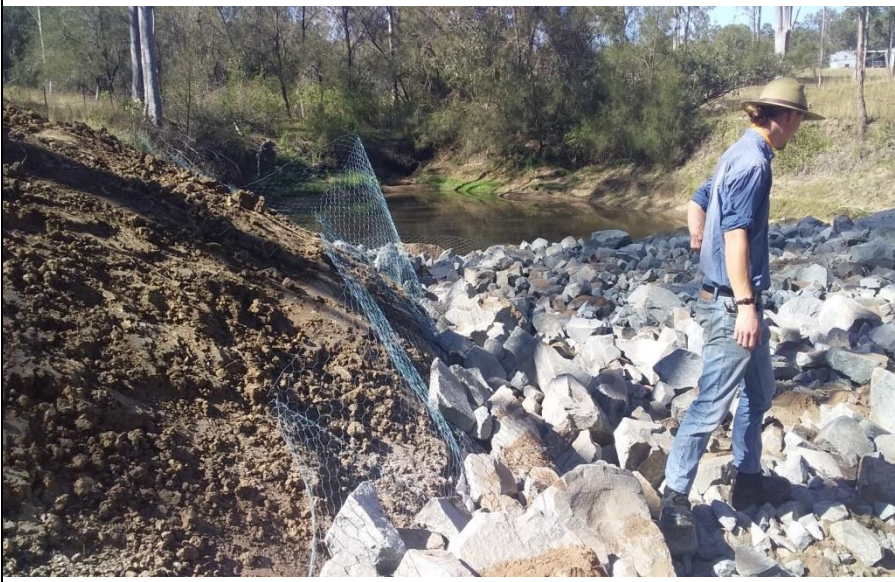
Photo 94

Netting placed along batter before rock added to hold it in place

Secured netting along batters provides the anchor point for attaching the final netting.

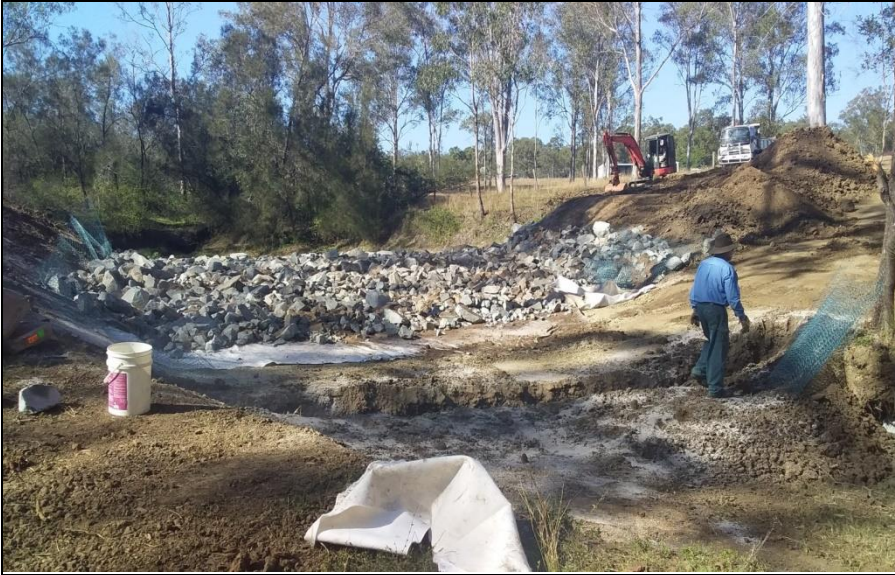
Photo 95

Looking upstream illustrating position of netting and rock mattress

Netting and rock was laid so it extended 1.5m up the walls of the battered sides to ensure the exposed soil was covered by rock should a deep flow pass through the structure.

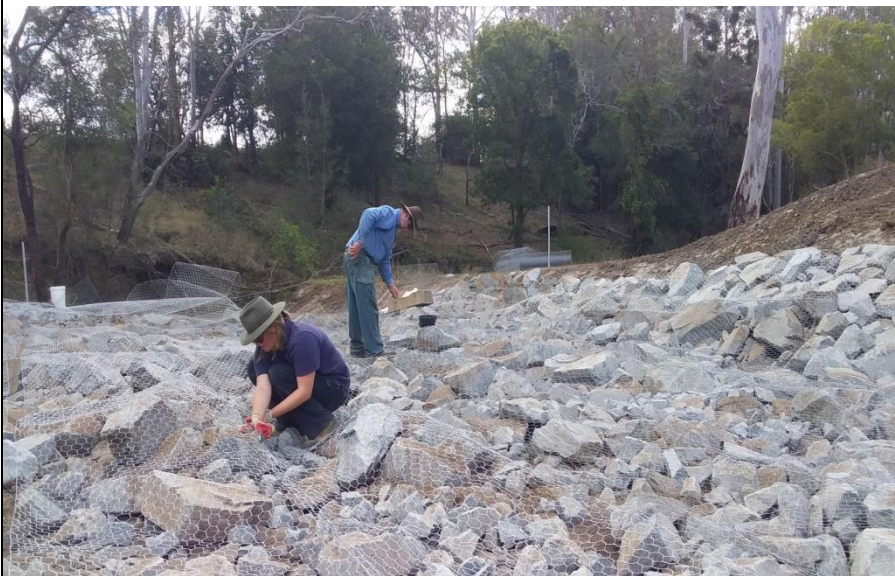
Photo 96

Covering the rock mattress with netting and stitching overlapping lengths together from upstream to downstream

Once the rock was laid in and a length of netting placed in the bottom cut off trench the whole structure was covered with netting strips. The strips were placed from up to downstream with a half meter overlap. Soft 2.5mm plain wire was used to lace each end for 6m tying off the wire to netting secured in the trenches and along the batter. The remaining distance (10m) was clipped to save time. Clipping alone has failed at other sites.

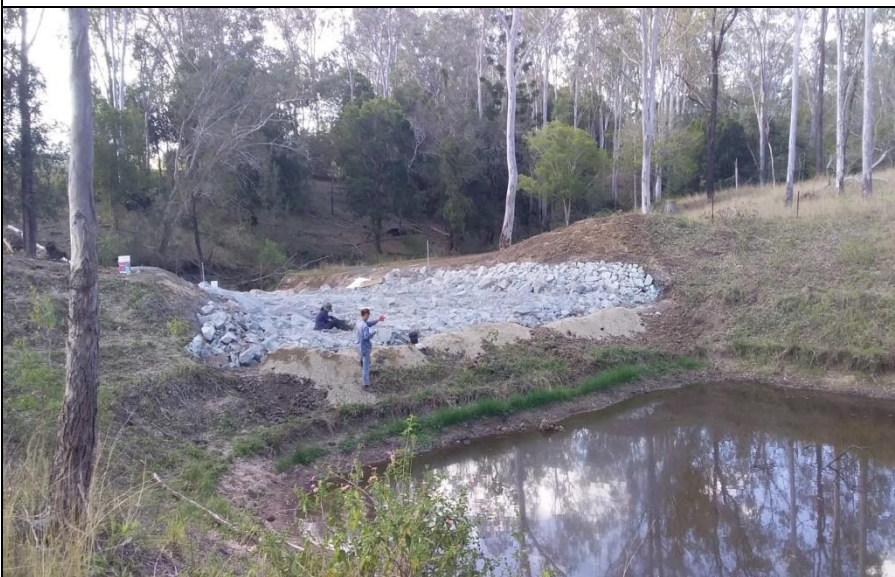
Photo 97

Gravel placed along the top cut off trench was then shovelled by hand into the trench to fill cavities.

The secured laced netting provides a robust and secure entry and exit points to the structure where the erosivity is greatest.

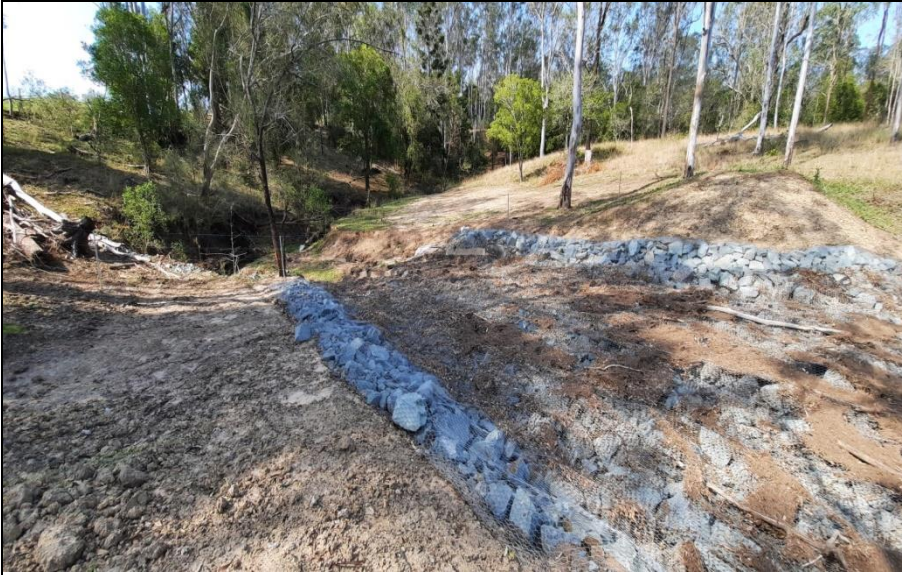
Photo 98

October 2020 after the first rain event

No damage observed to the structure and some organic deposition – a critical first step in rehabilitation

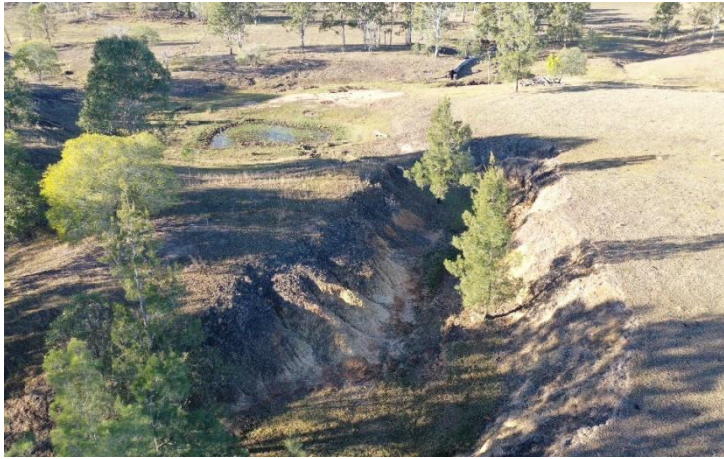
Photo 103 Looking upstream along the eroded by-wash

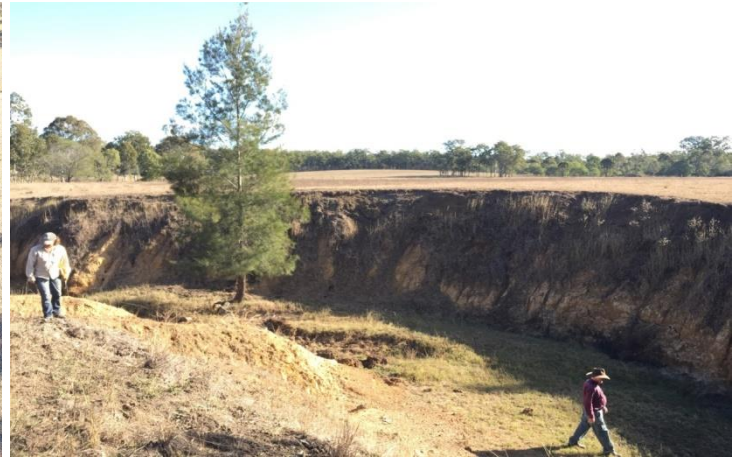
Photo 104 Standing on the dam wall looking into the by-wash, for size perspective

The dam was constructed in the 1980s and the by-wash started to erode badly with the first filling rains. The large floods of 2010, 2011 and 2013 completely emptied the dam except for a small excavation which became a bog hazard for stock. The site had very deep and active erosion as a result of a poorly designed and constructed by-wash for the large dam.

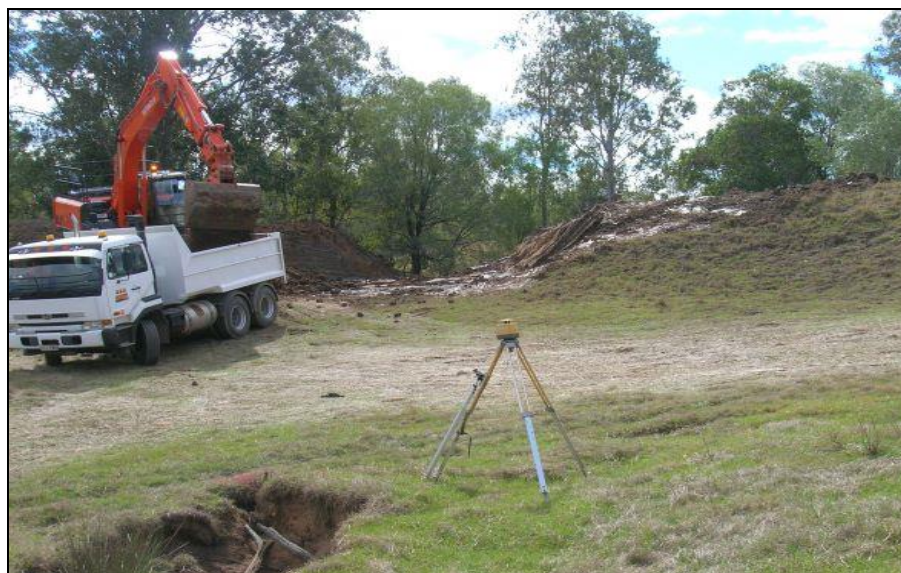
Photo 105

Excavation through wall half completed.

Surveyed to ensure water will flow through the level sill and not pond upstream.

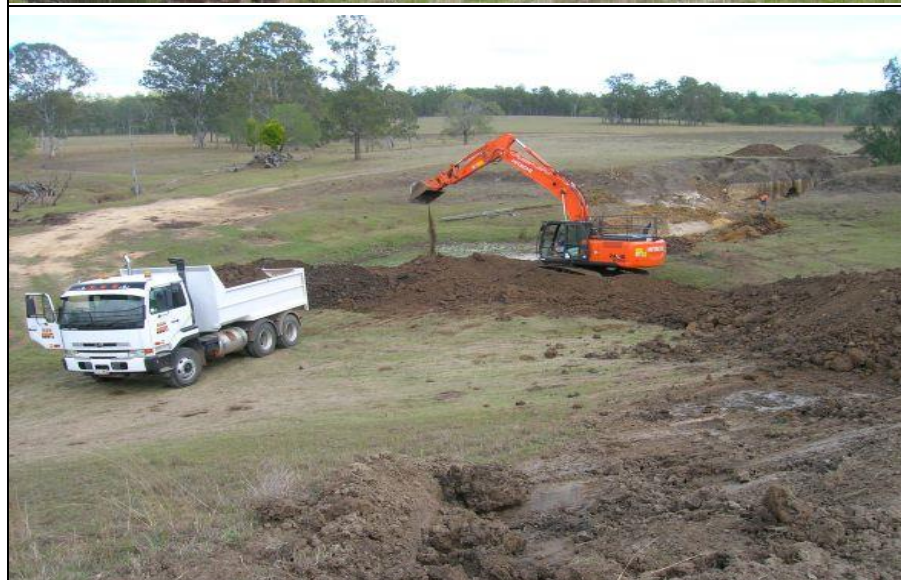
Photo 106

Draining the waterhole and backfilling with excavated material from the dam wall.

A small channel was excavated from the waterhole to the by-wash. Material from the dam wall excavation was used to fill the waterhole, pushing the water out through the excavated channel.

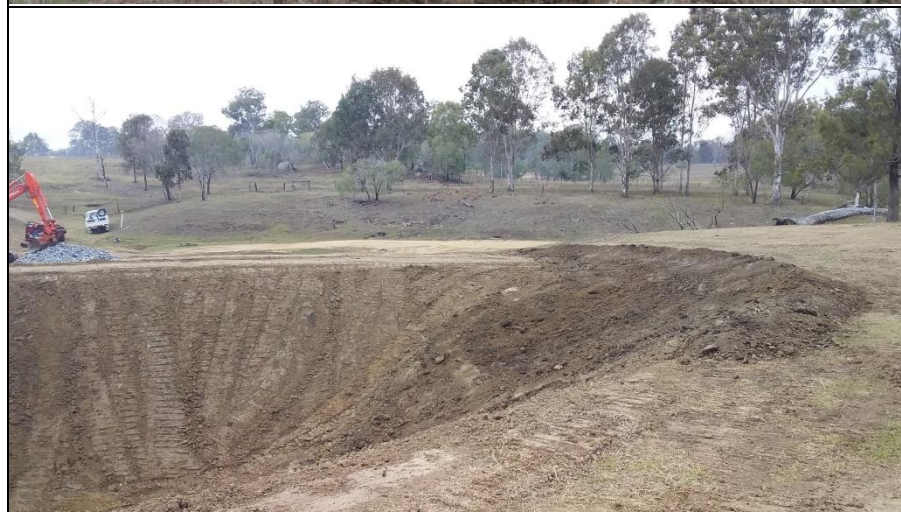
Photo 107

By-wash end sealed, creating an extension to the old dam wall. Diversion bank constructed to redirect overland flow.

Soil was then transported to form a bund wall across the failed by-wash. All water is diverted back into original drainage line through the constructed dam wall break. A diversion bank was also constructed to 0.6m high which runs parallel with the by-wash on the western side. This aims to redirect overland flow from the flats to a small rock chute.

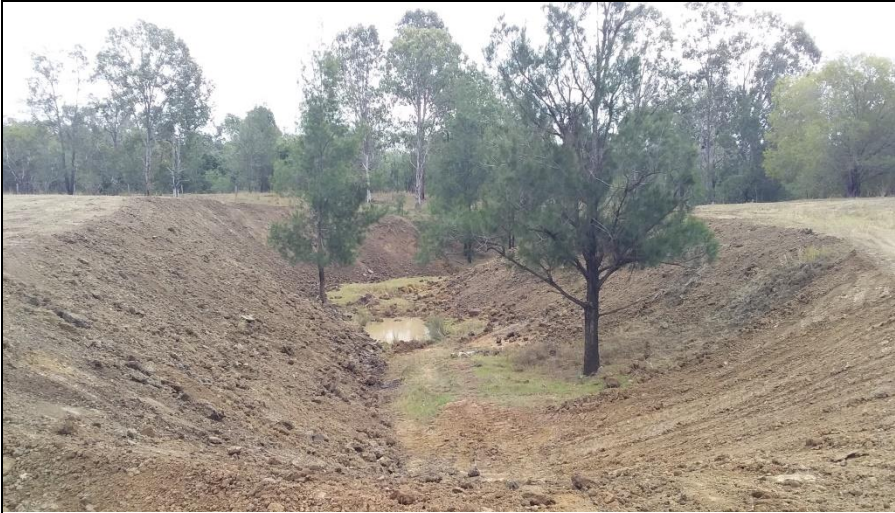
Photo 108

By-wash gully walls battered, top soiled.

The vertical edges of the gullied by-wash were battered to 1:1 and then spread with the topsoil which was removed during battering.

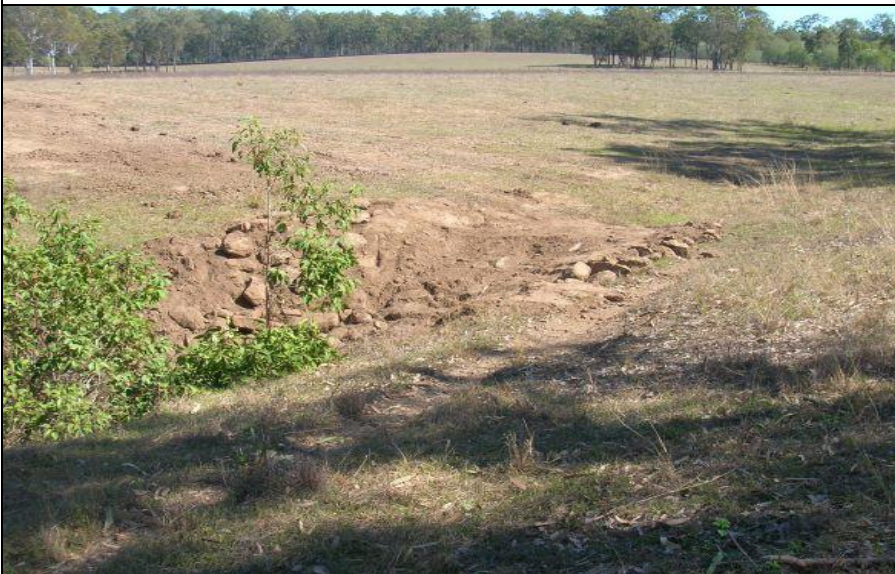
Photo 109

Small gully on the end of the by-wash stabilised with rock fill chute (using locally sourced larger rock and gravel).

A small gully on the north-western end of the gullied by-wash was also filled with rock and top soiled so all erosion sites around the gullied area were stabilised during the construction.

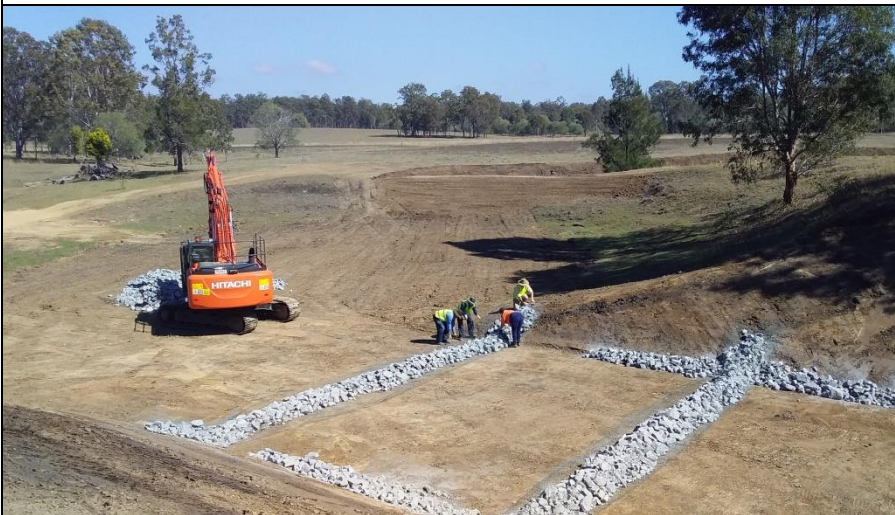
Photo 110

Rock groynes evenly spaced along the excavated site

4 rock groynes were positioned evenly along the excavated channel. They were 30m in length extending 1.5m up the batter and 1m wide. Rip rap rock (100mm – 200mm) was used. Each groyne was wrapped in galvanised wire netting to hold the small rock in place during flow events.

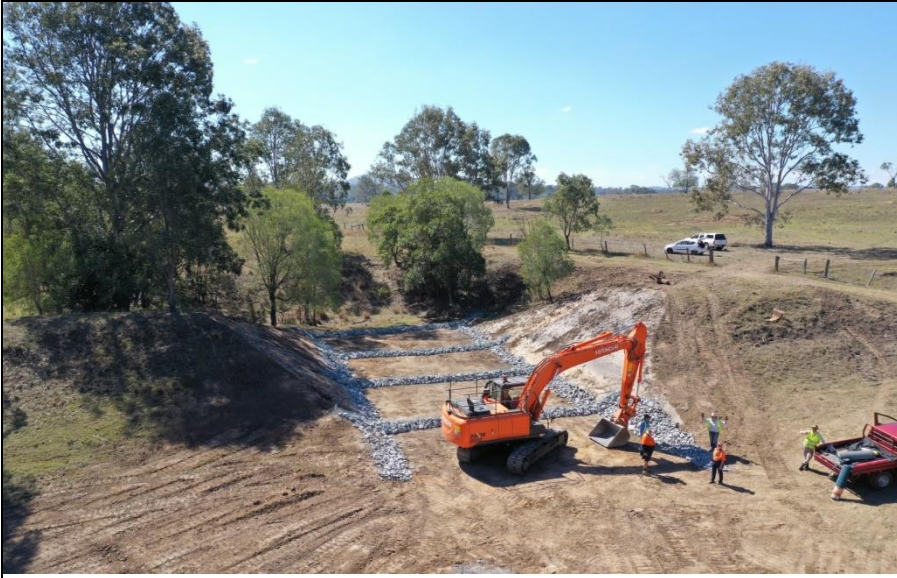
Photo 111

Completed: Looking downstream on cut through the dam wall.

Batters at approximately 1:1. Cut through dam wall is dead level back to front and side to side. Rock armouring to 1.5m on the batter inlet edges and extensions of the groyne ends up the batter, to reduce the chance of erosion during high flow events.

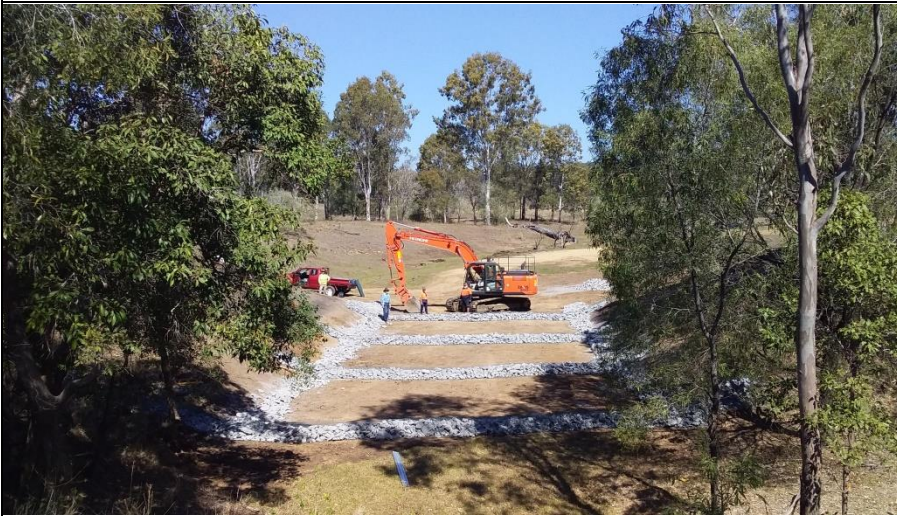
Photo 112

Completed: Looking upstream through the cut in the dam wall, which reinstates the original flow path.

Note retention of grass below the rock groynes to ensure as much stability as possible as the flow concentrates again to join the narrower stream below.

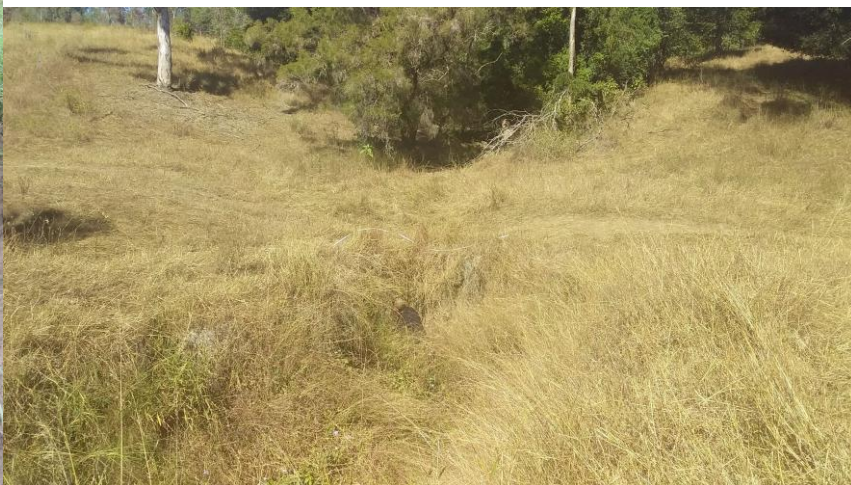
Photo 120 Gully head prior to rehabilitation in 2020

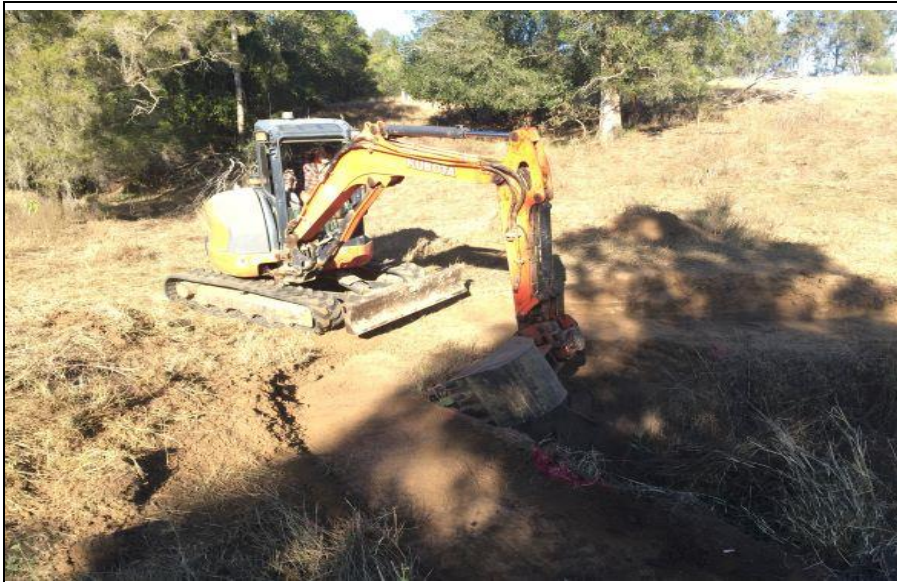
Photo 121

Shaping the gully head and cleaning any overhangs and removing grass

The crest was levelled to a width of 1.5m while removing the topsoil, any overhangs and the grass from the gully head and walls below the crest.

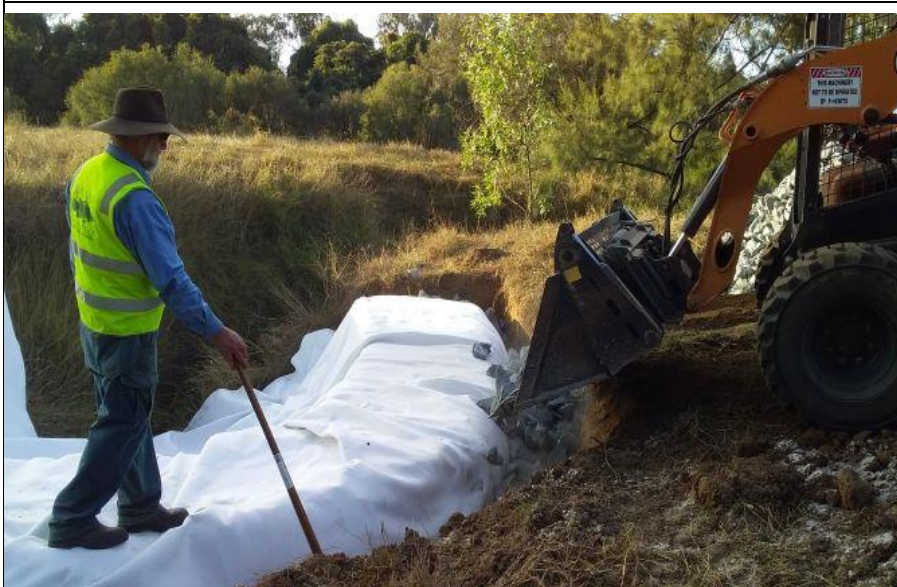
Photo 122

Excavated top cut off trench and geofabric shaped over the gully head

A cut off trench was constructed 0.5m x 0.5m, 1m upstream from the lip of the gully head. A similar cut off trench was constructed across the gully bottom and up the sides to meet with the ends of the top trench.

The top trench, the exposed subsoil lip around the level crest and the gully floor and bottom cut of trench were lined with the geofabric Texcel 400R. A single sheet of 6m wide geofabric was stretched and arranged to create a smooth curtain over the gully head and walls.

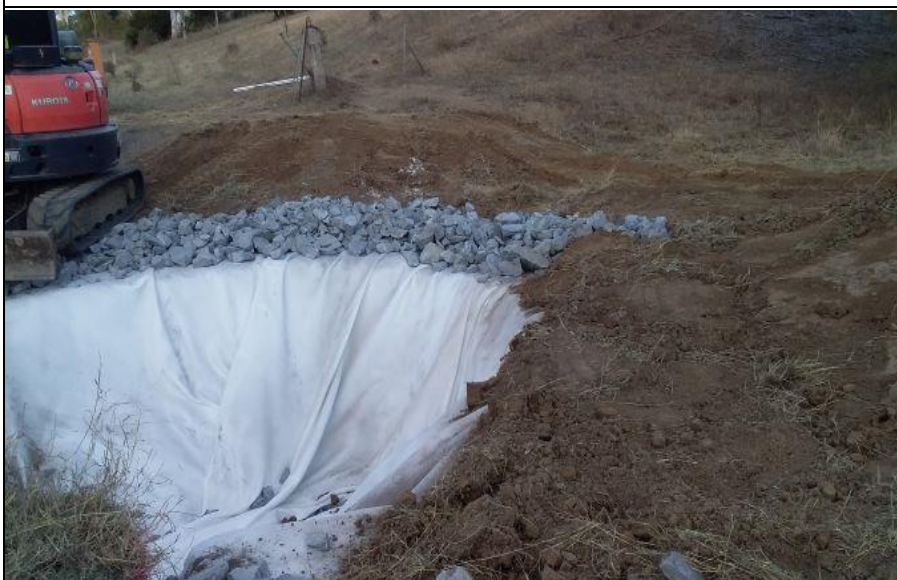
Photo 123

Top cut off trench filled with rock

The trenches were then filled with fine rock 100mm to 200mm and compacted to secure the geofabric in place.

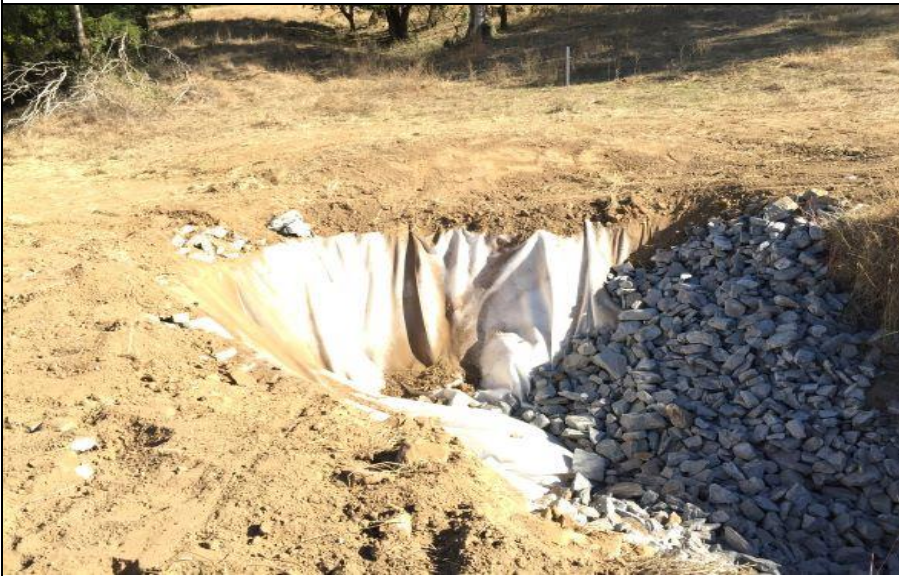
Photo 125

Covering the cut off trench rock fill with topsoil to encourage revegetation

At this site there was excess rock available, so this was spread over the gully floor and walls over and below the bottom cut off trench.

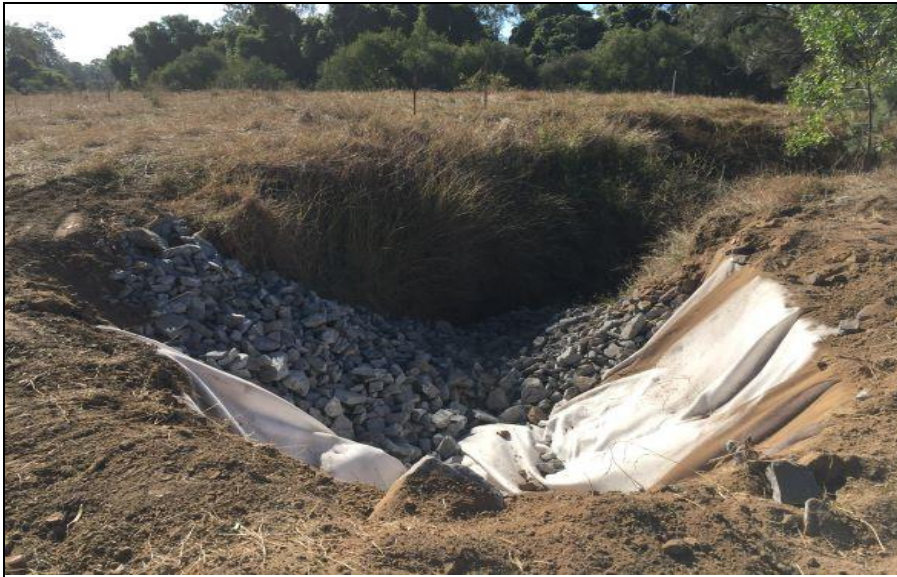
Photo 127

Drop structure completed looking downstream

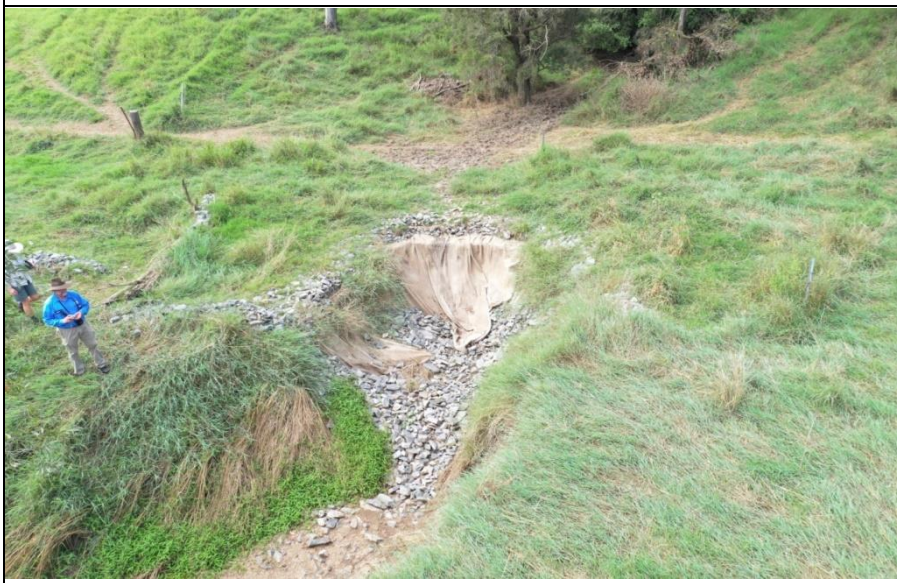
Photo 128

February 2022 after major flooding in the area

Note the wing wall on the left of gully image. This was repaired using logs and worked well following observations taken following significant flooding in 2022.

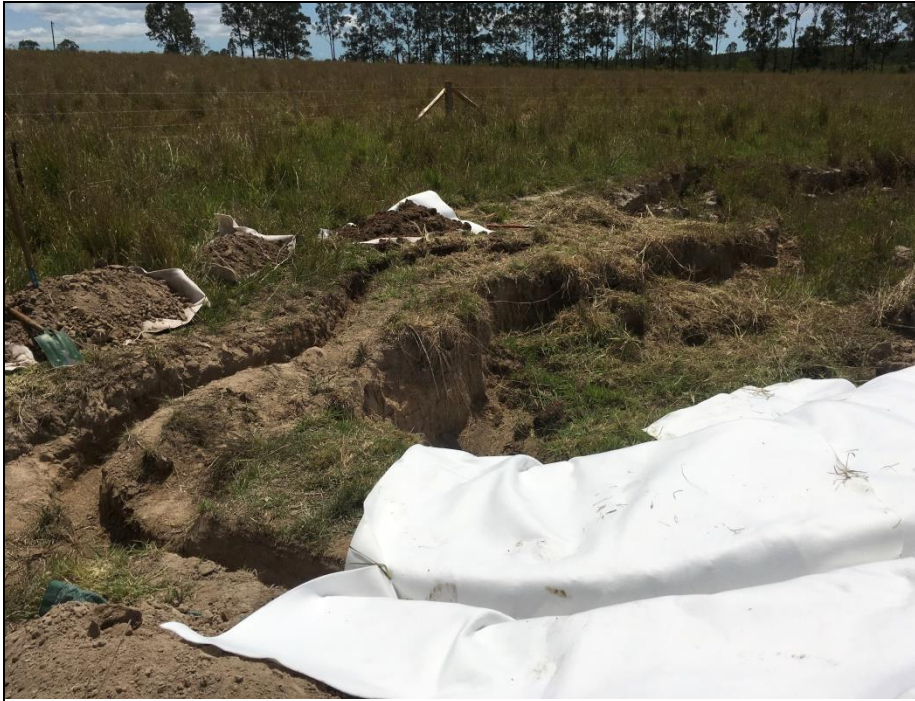
Photo 130

Dig cut-off trench; follow the natural shape of gully head and include the cattle tracks

Mark out the position of the structure considering concentrated flow paths, including cattle tracks etc. Dig trench 1m away from the crest edge, to the depth of the spade (approx. 30cm).

Place the fill on geofabric offcuts – this makes for easy retrieval later.

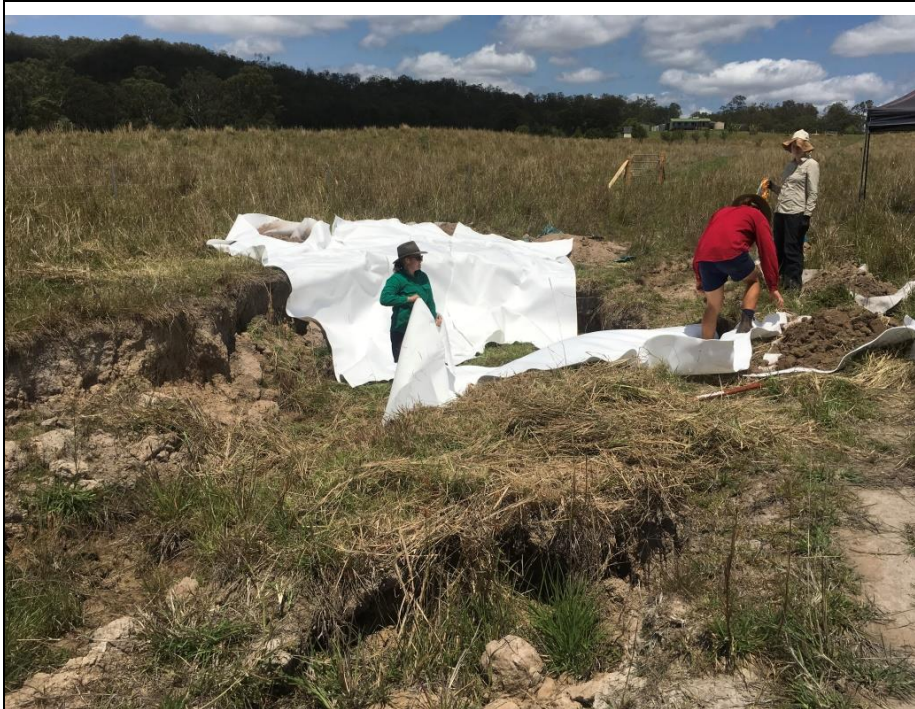
Photo 131

Geofabric cut and placed over trench and into gully bed

Cut the geofabric to length – the fabric should start almost at the centre of the gully floor and extend up the walls and into the trench. Cut the geofabric approximately 1m past the trench. This is to allow enough fabric to double back over the trench section once filled.

Overlap the fabric starting with the outside layer first, working to the middle. The final middle section should cover the ends of side pieces and cover the length of the gully floor to tie it all together.

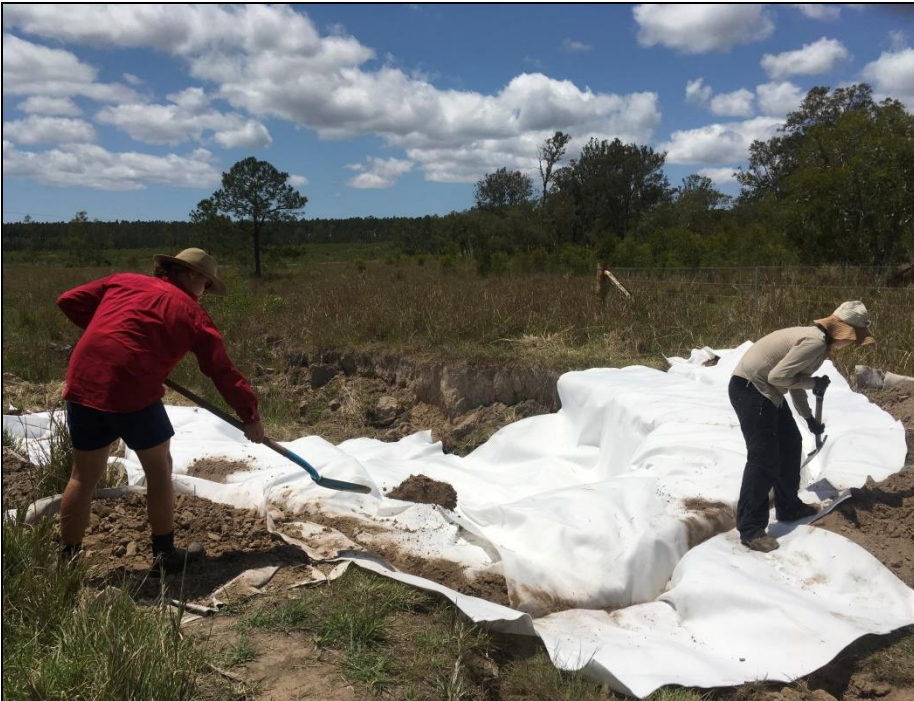
Photo 132

Backfill the trench with spoil and compact

Back fill the trench with spoil and compact as much as possible. Make sure to not overfill as this could create a diversion.

Fold the fabric back over the trench section, facing downstream.

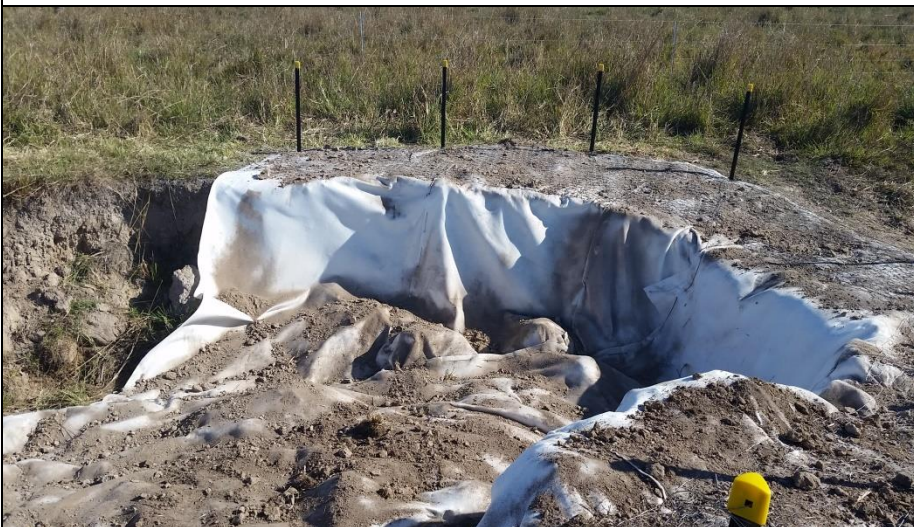
Photo 133

Mesh secured along the crest and joins stitched

Drive star pickets through the edge of the mesh and fabric, into the trench, every 1-2m.

Stich all the joins of the geofabric with soft wire, securing to the mesh at the top and a tent peg at the

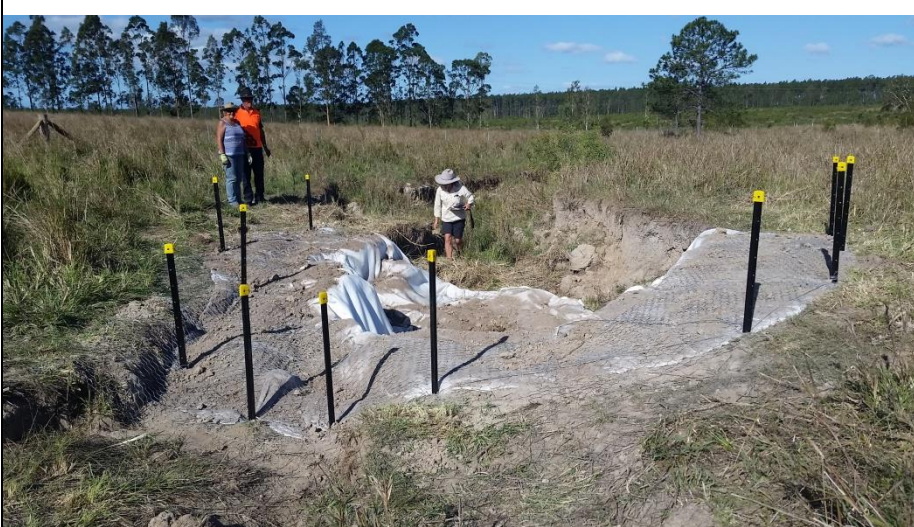
Photo 134

Tension wire around the crest. Spread soil and seed over the fabric and bare areas.

Thread a stronger gauge plain wire through the pickets and secure to the picket at each end. Carefully hammer in the star pickets to tension the wire. Without care, the wire can snap easily.

Lightly spread the remainder of the soil onto the fabric and seed with annual grass – millet in summer, rye in winter. Plant pangola runners in any areas of moisture holding pools / low points in the gully bed.

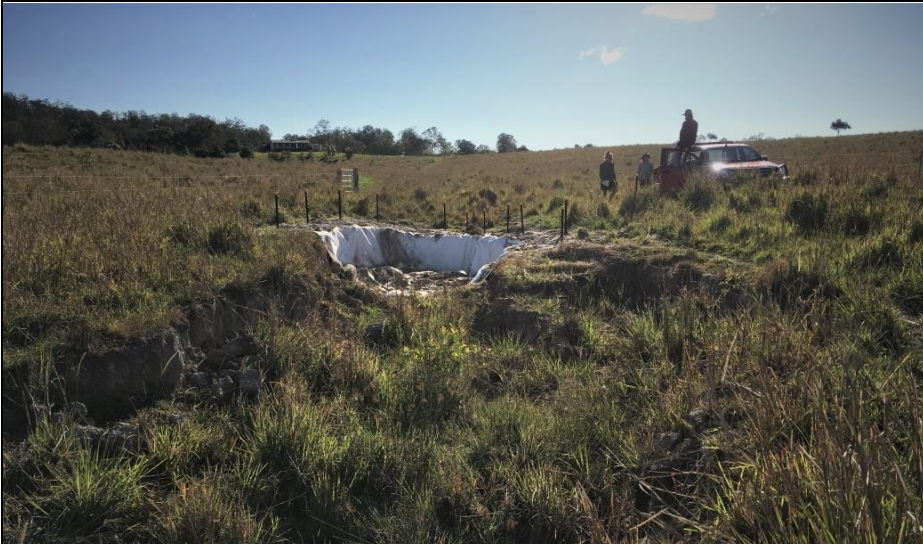
Photo 135

Completed October 2019

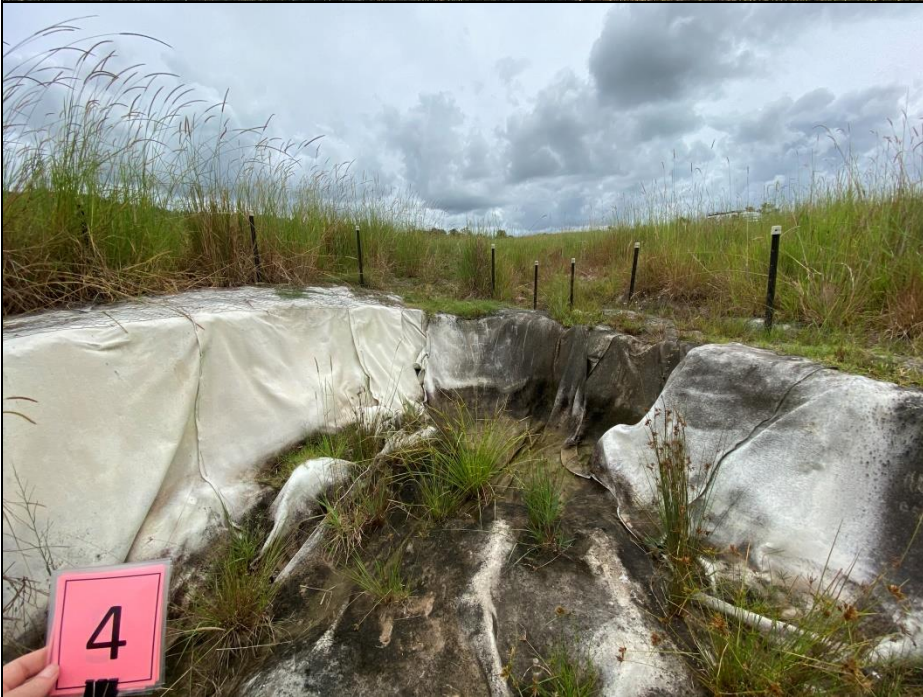
Photo 136

**February 2021 monitoring,
following 2 wet seasons**

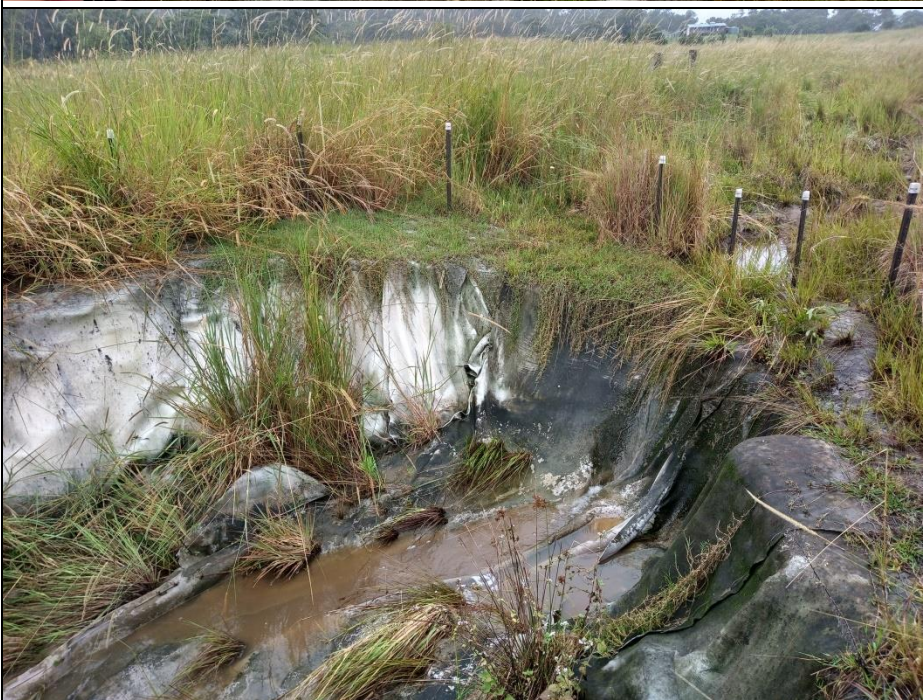
Photo 137

As a note of confidence, this example received significant rain in excess of 650mm over five days in an already saturated catchment during 2022. The structure held in place and prevented advancement of the gully head.

Feb 2022 post floods
