# Erosion gully rehabilitation

Adaptations and learnings from sites in the Mary River Catchment

By John Day, Becky Watson and Caitlin Mill  
Mary River Catchment Coordinating Committee

July 2023

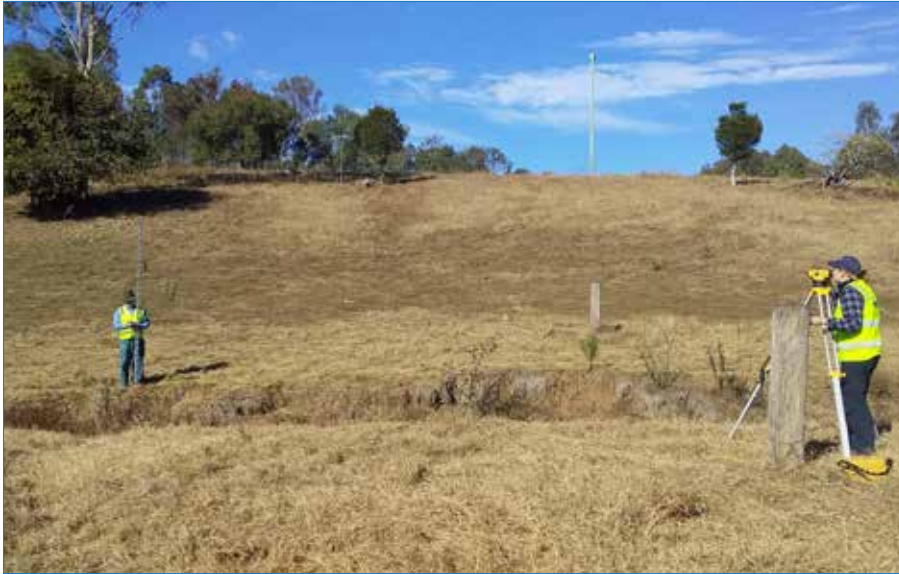
**Photo 2** Survey the level crest.

The level 16m uneven crescent shaped crest was surveyed with a dumpy level and marked.

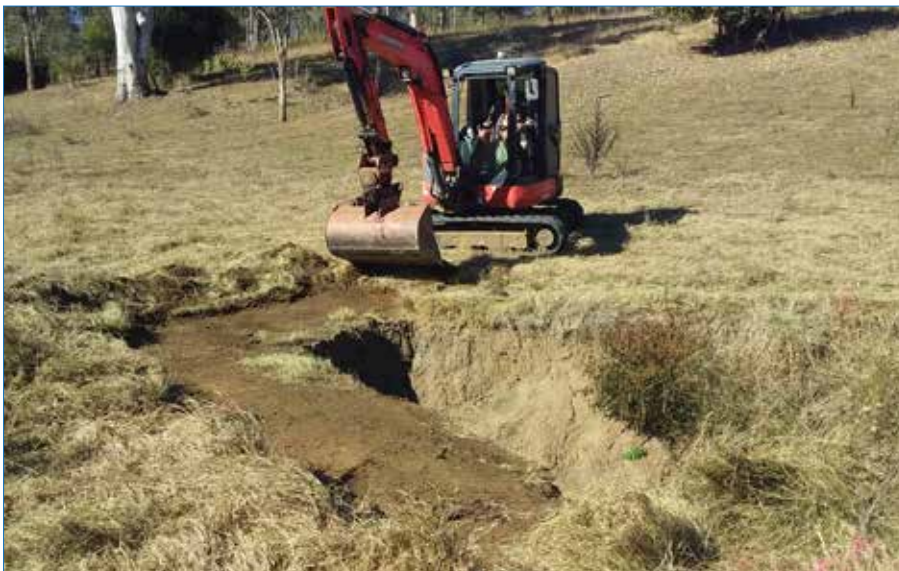
**Photo 4** Prepare the crest and gully walls.

The gully head was tidied and shaped slightly to collapse overhangs and tunnels and pull back the topsoil for 1.5 m around the crest before constructing the 0.6 m x 0.6 m cut-off trenches. Due to access issues with the skid steer for placing the rock, the whole structure was built from the bottom up.

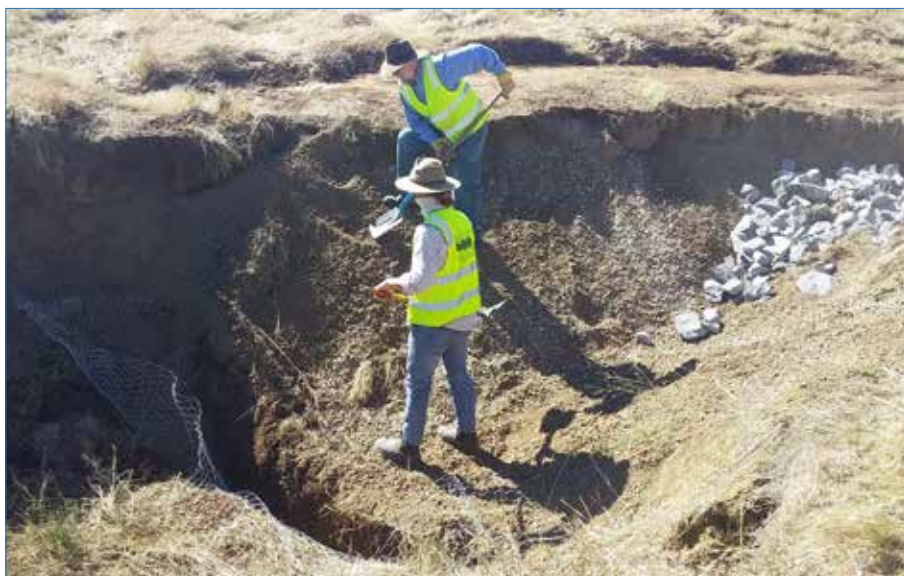
**Photo 5** Bottom trench inlaid with netting and lined with clay gravel.

The bottom cut-off trench was built first. It extended across the gully floor approximately 4 m from the gully head and up the gully walls to intersect with the top cut-off trench, later constructed at the ends of the crescent crest. The bottom cut-off trench and the gully floor were lined with 10 cm of clay gravel and the heavy wire netting was placed in the bottom trench.

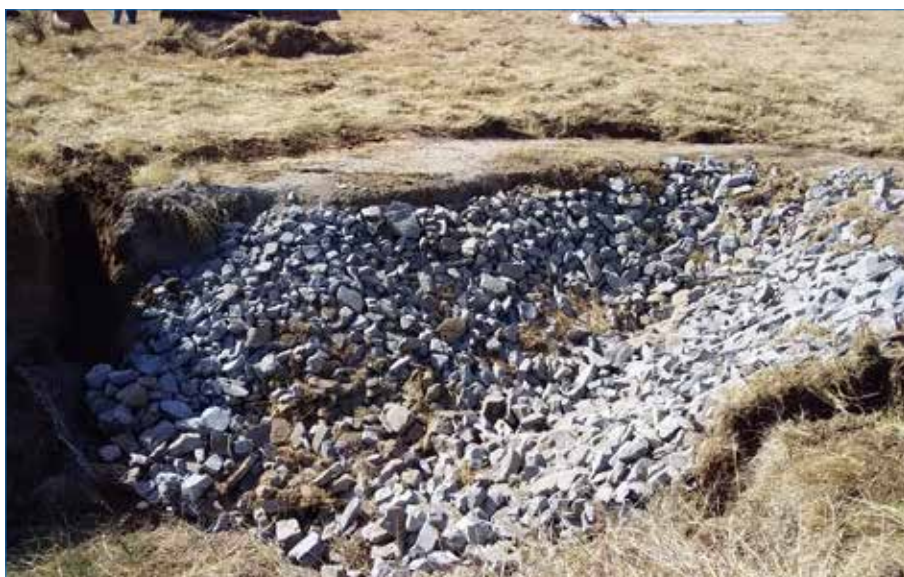
**Photo 6** Trench and gully batter filled with rock.

The trench was half filled with fine rock (100–200 mm) and gravel, then topped up with 100–400 mm gravel mix, battered at approximately 2:1 so the bottom end of the fill sits on the gully floor approximately 5 m from the top cut-off trench.

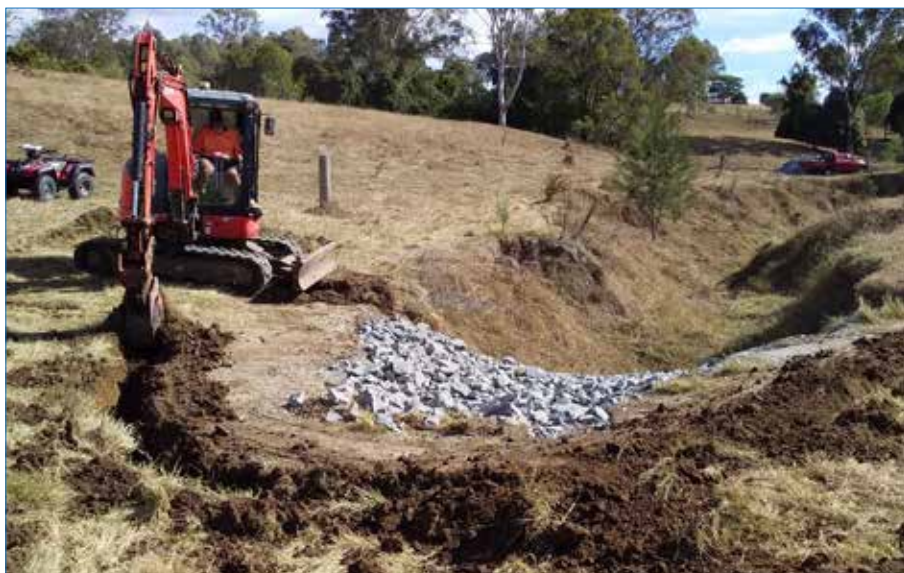
**Photo 7** Excavation of top cut-off trench.

The gully head was filled up to the edge of the 1.5 m bench where the topsoil was removed and then the top cut-off trench was constructed.

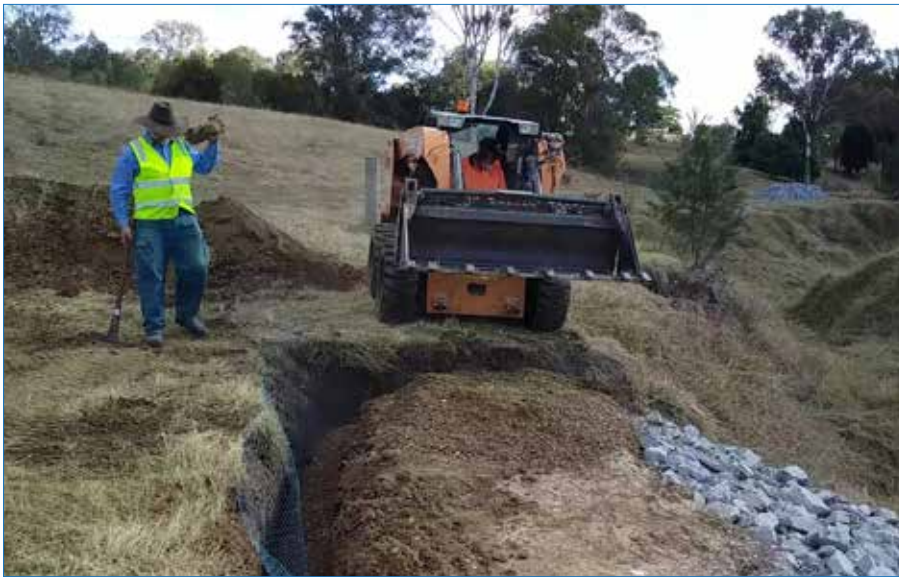
**Photo 8** Wire netting and gravel placed in top cut-off trench.

The wire netting was placed in the top cut-off trench, similar to the bottom cut-off trench. The trench bottom and bench were covered with 10 cm of gravel.

This process left the wire netting secured and exposed right around the crest and across the bottom of the structure so more netting could be laced across the top to secure all of the rock

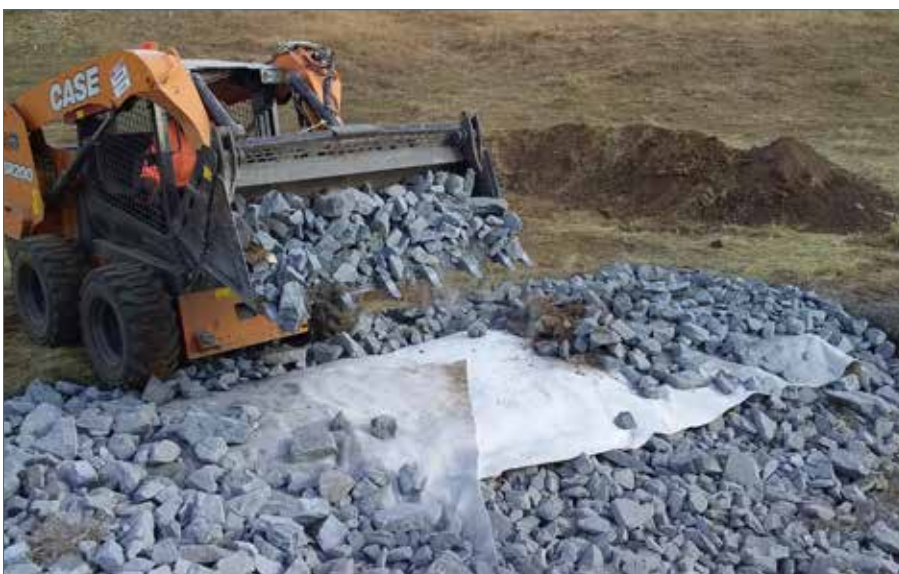
**Photo 10** Gravel and rock placed over the fabric.

The fabric was covered with a 20 cm layer of gravel and rock ensuring loose ends of the geofabric facing downslope were covered.

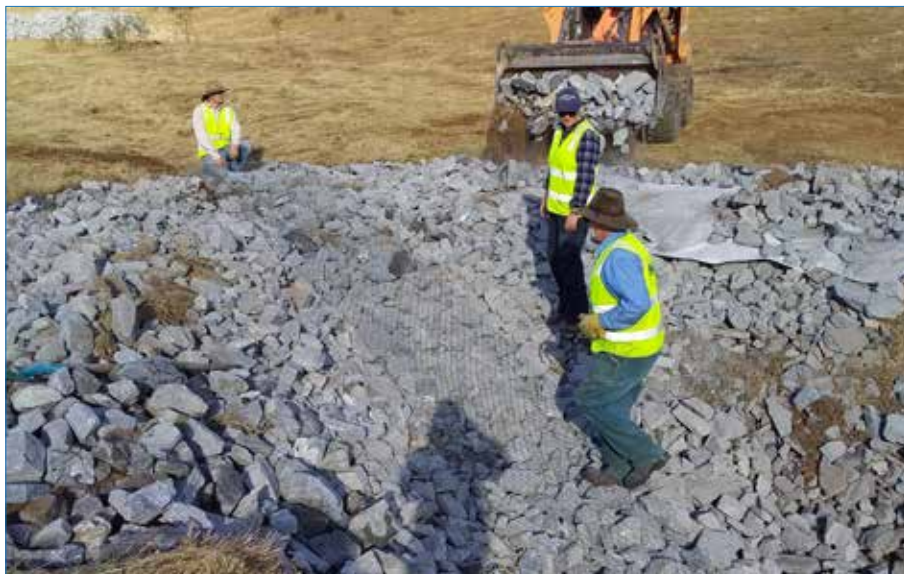
**Photo 11** Lengths of wire netting placed over the rock chute and attached to netting in cut-off trenches.

Wire netting strips connected to the netting in the bottom trench, stretched up and connected to the netting in the top trench ensuring the netting is tight and the strips are close enough together to lace with plain wire.

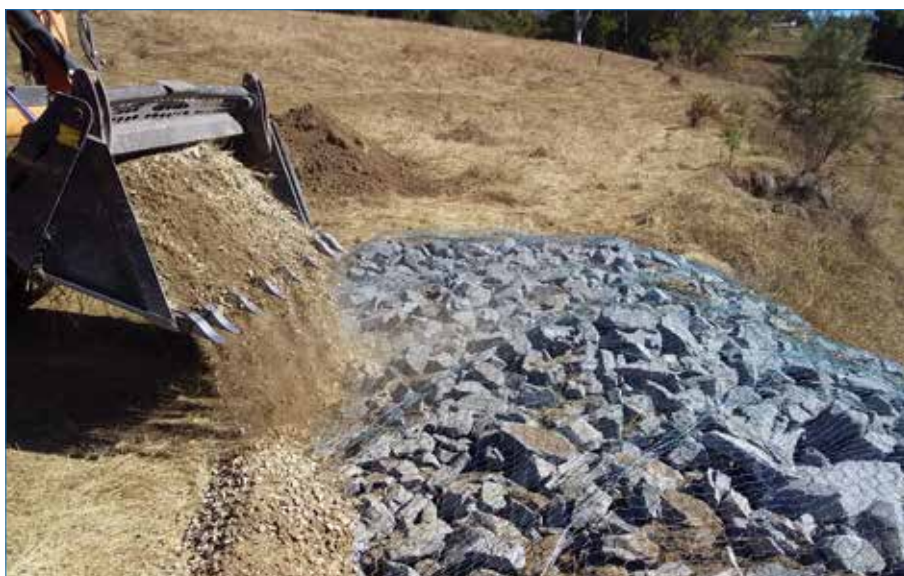
**Photo 13** Filling the gaps in the rock with gravel along the crest.

Once the wire lacing was complete, the lip of the chute crest was filled with gravel. This ensured the upstream edge of the cut-off trench was sealed so no water could flow directly into the trench and fill it quickly. It also provided an environment for grass to quickly grow over the lip.

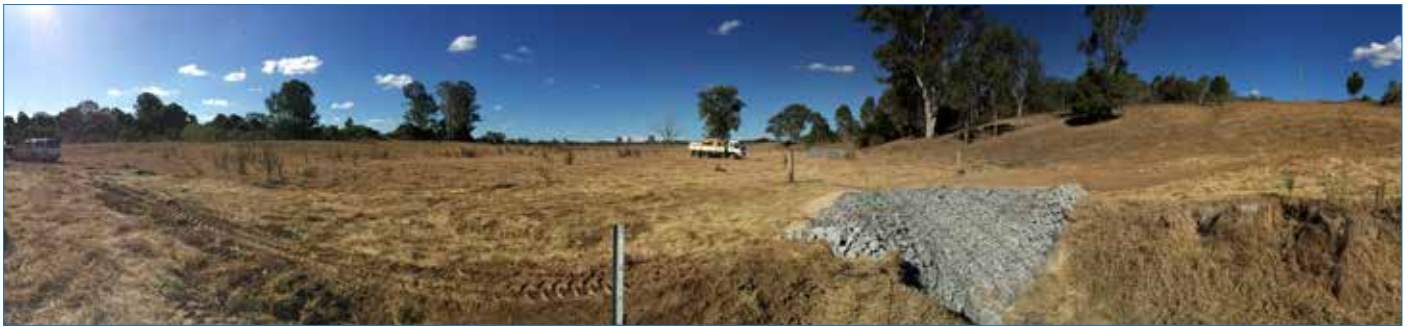
**Photo 14** Soil from excavation used for diversion wing bank construction.

The soil taken from the batter, the trenches and any widening or shaping of the gully floor and head was used to construct diversion wing banks on each side of the rock chute, approximately 15 m long and 0.6 m high constructed, to ensure the water from the catchment is concentrated on the stable rock fill chute structure. These banks were constructed at approximate right angles to the gully edge heading upslope either side and extended until the end was 0.6 m above the rock crest of the rock fill chute. The outlet ends of the banks were rock armoured for 3 m to a height of up to 0.6 m to ensure they do not erode.

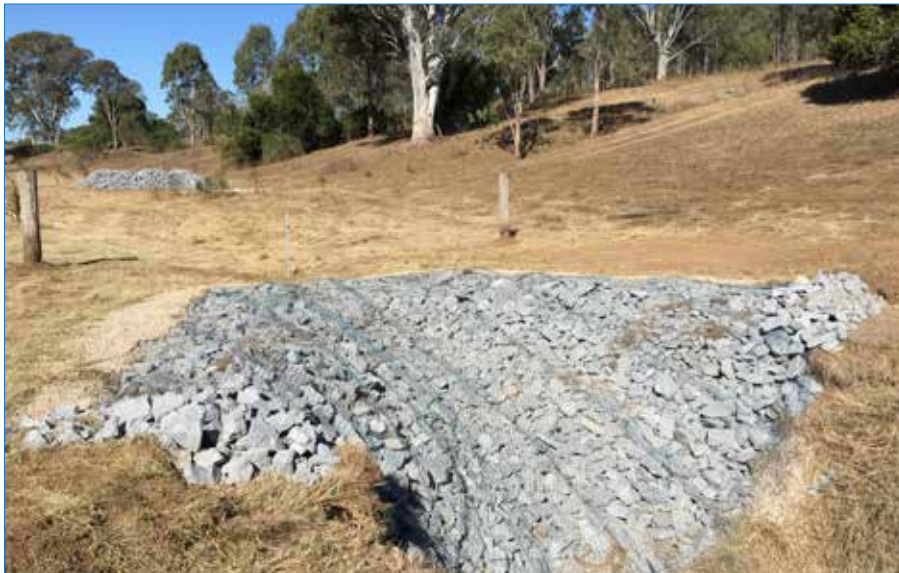
**Photo 15** Completed chute with stock exclusion fencing in place – looking upstream.

The site was fenced to exclude stock and allow revegetation of all the disturbed areas.

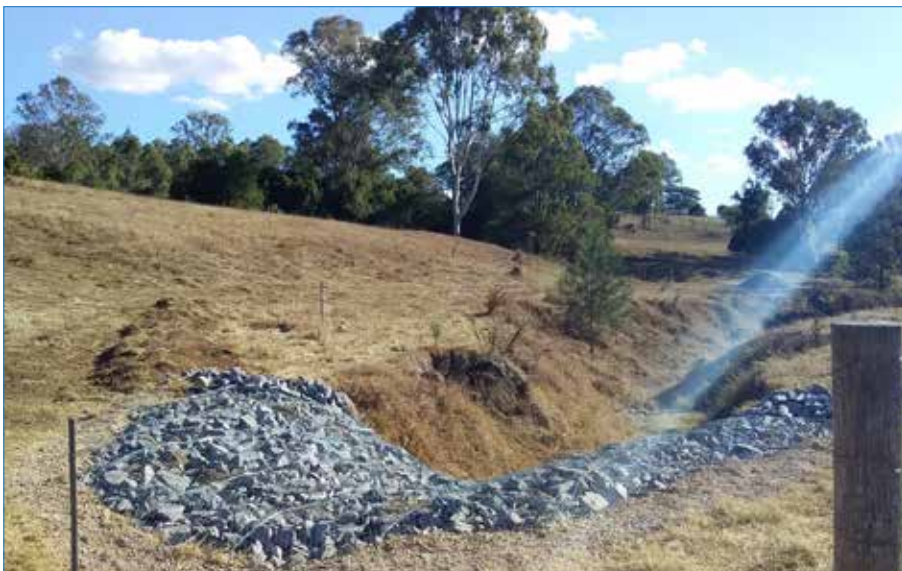
**Photo 16** Looking downstream at completed chute.

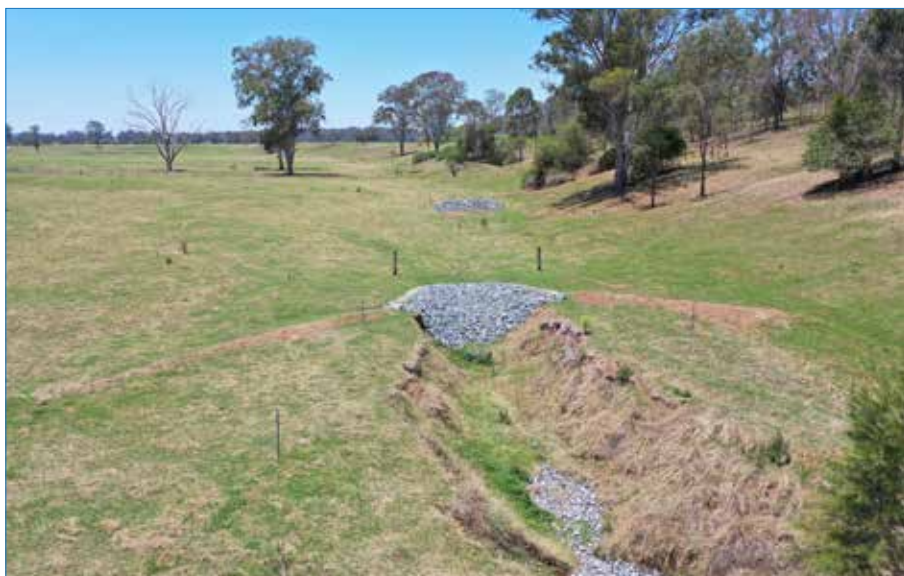
**Photo 17** Three months post-construction.  
October 2020 at the beginning of first wet season.

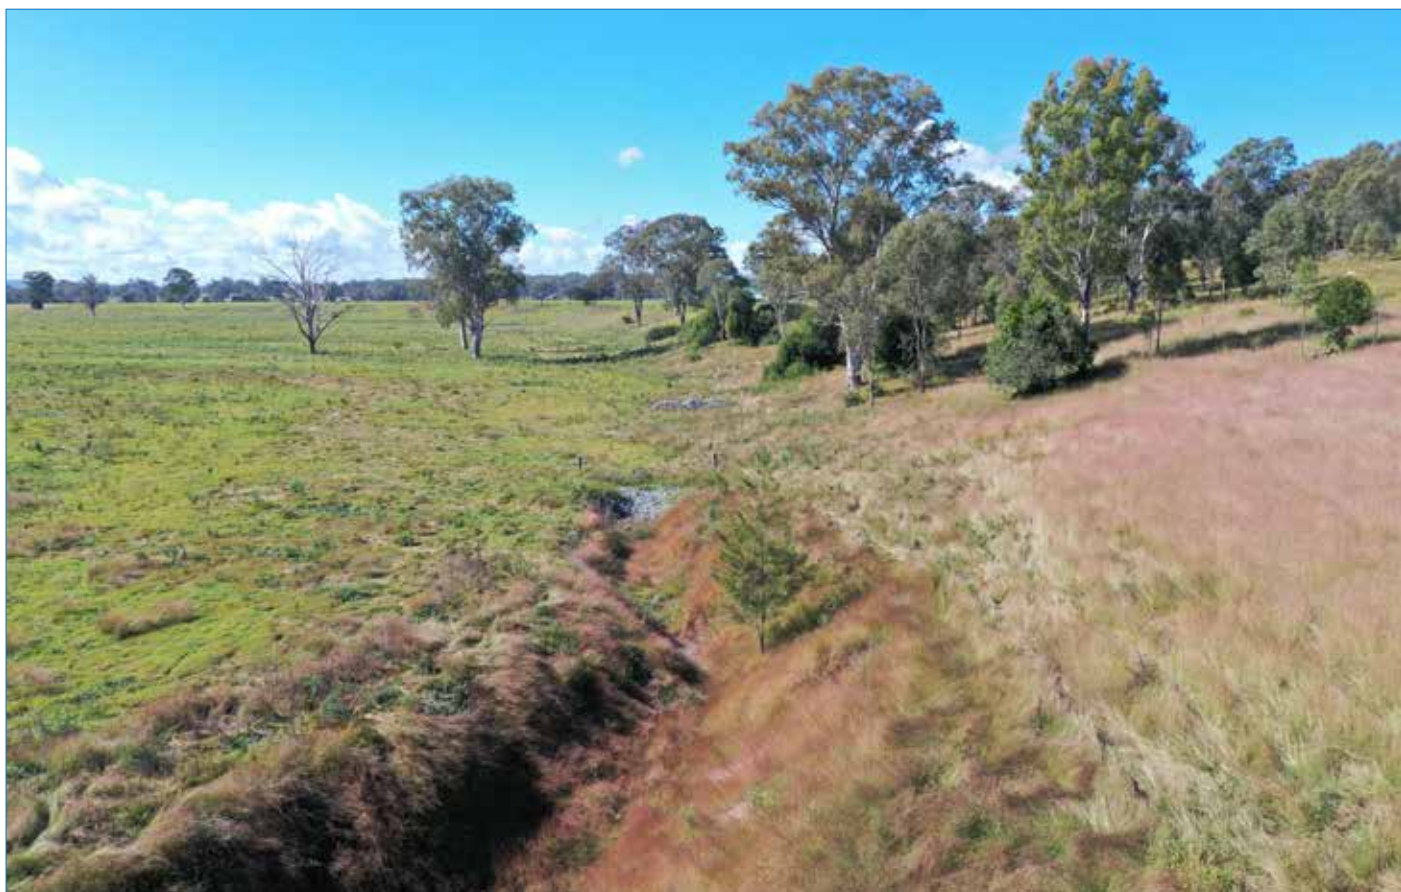
**Photo 18** Ten months post-construction.  
May 2021 after the first wet season.

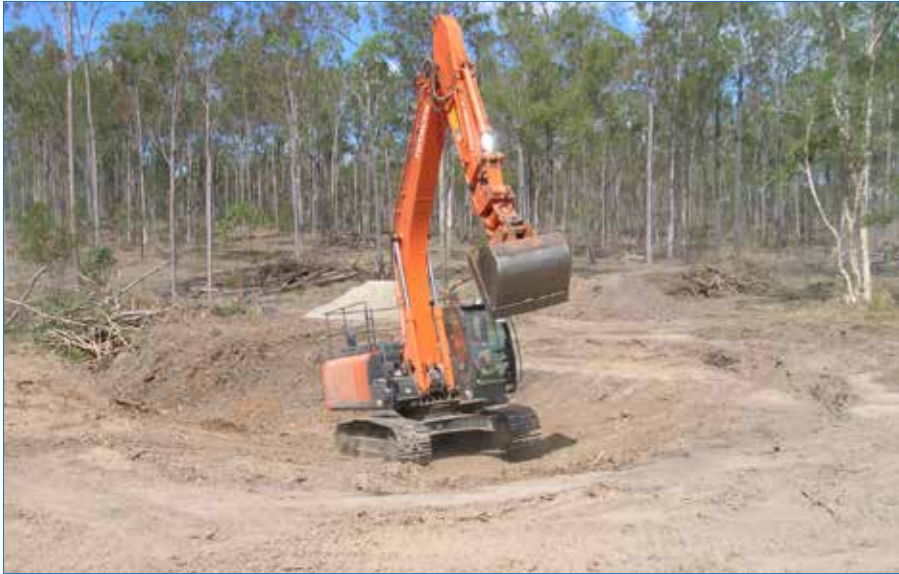
**Photo 20** Chute shaped to capture both gully heads.

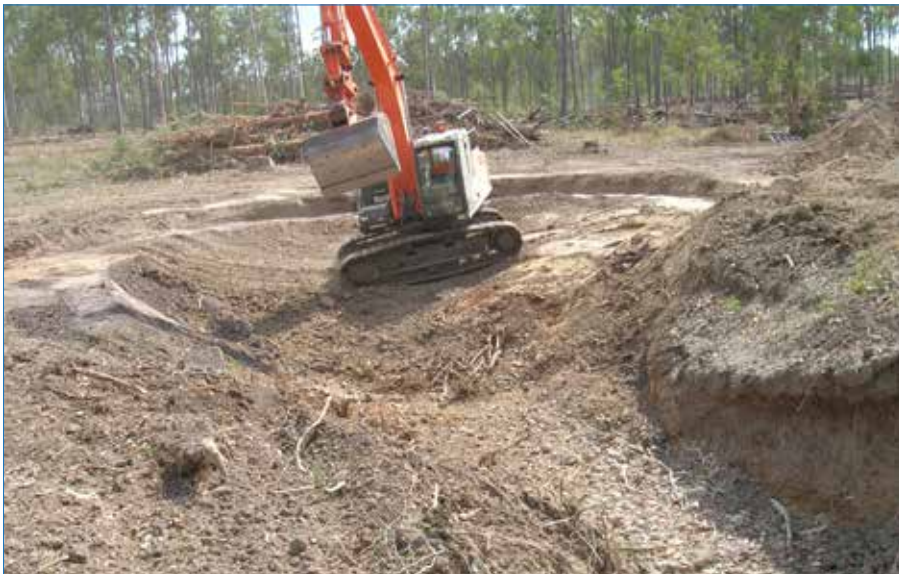
**Photo 21** Chute level crest constructed to design width.

The chute's level crest design length was 35 m around the top and the gully head was battered to 3:1. The chute batter is approximately 8 m long.

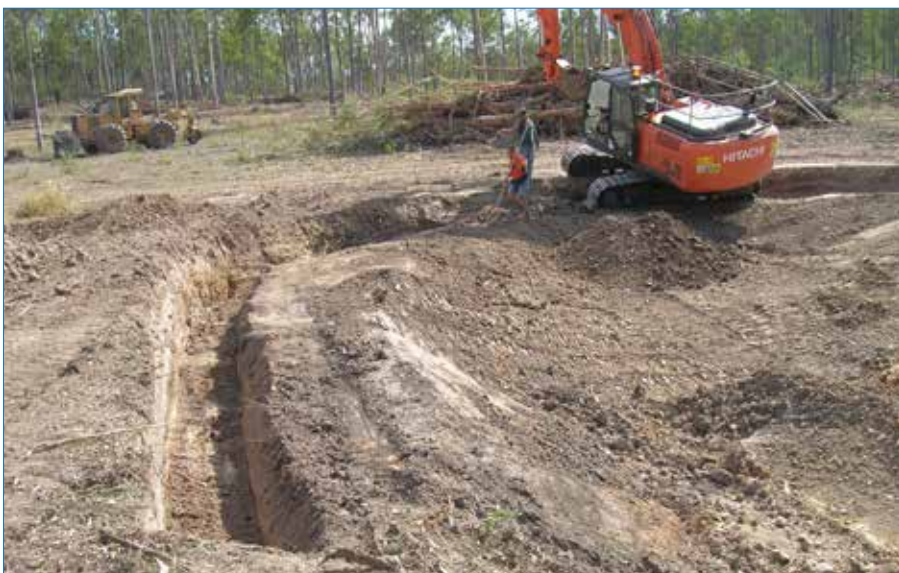
**Photo 22** Top cut-off trench construction.

A cut-off trench approximately 0.8 m wide x 0.6 m deep was constructed around the top of the chute crest, 1 m upslope from the top of the batter. Another trench was constructed downstream of the rock apron.

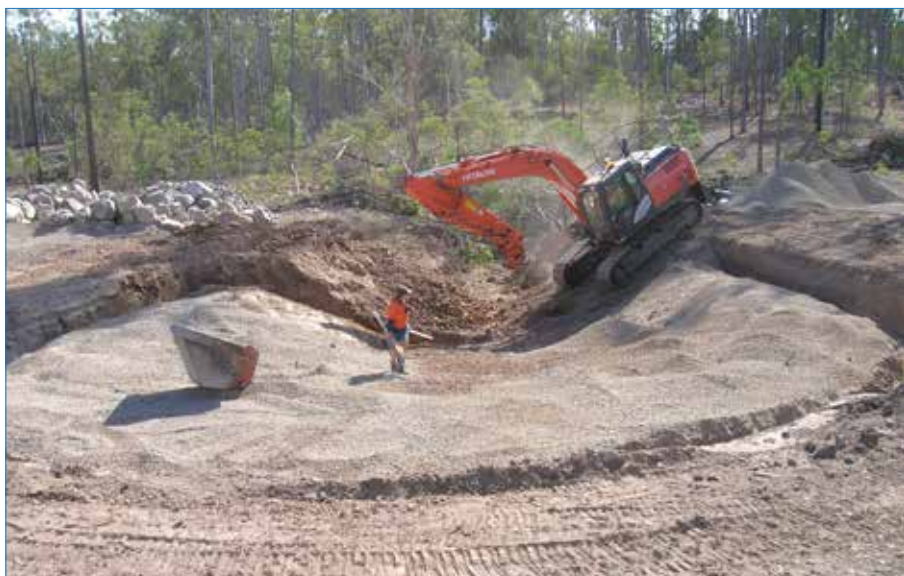
**Photo 23** Excavation of bottom cut-off trench and gravel placed on chute batter.

The batter of the chute and the bottom of the cut-off trenches were covered with approximately 10 cm of gravel with high clay content.

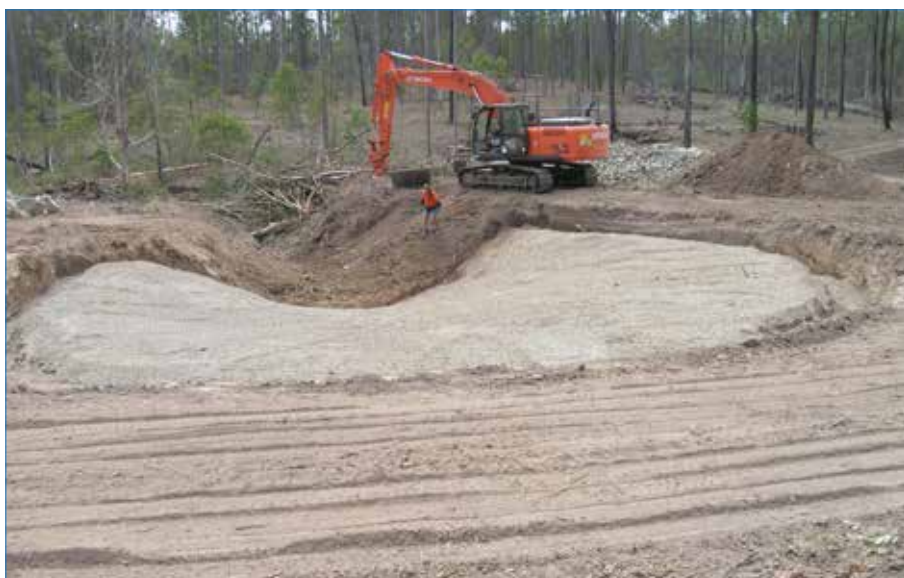
**Photo 24** Cut-off trenches completed and gravel placed on batter and in trenches.

Site is ready for geofabric.

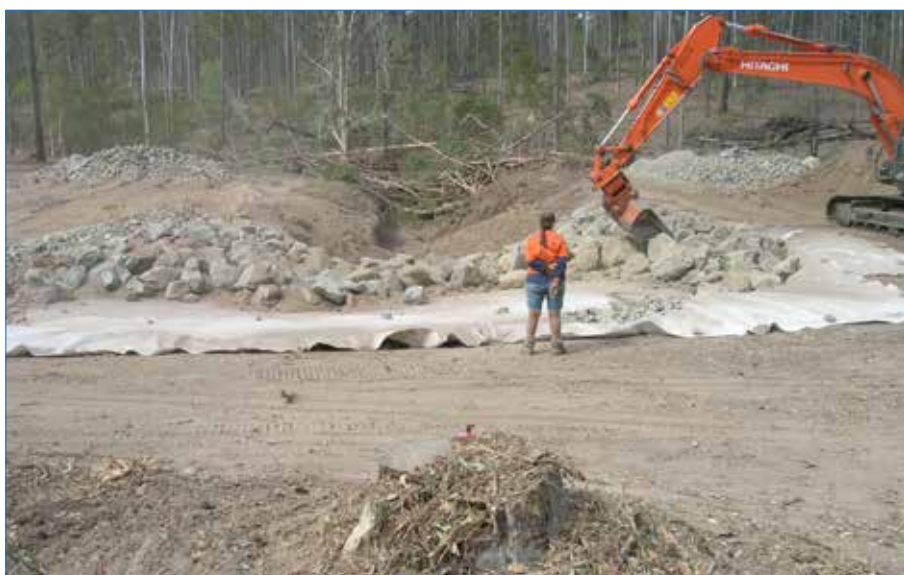
**Photo 25** Geofabric laid over the chute. Rocks placed from the bottom cut-off trench to the top – due to size of chute.

Starting from the bottom and working towards the top, geofabric Texel 400R was laid over the clay gravel. Each strip of fabric was laid with a 0.5 m overlap of the previous strip. This ensures water flows over the sheet and not under (similar in principle to roof tiling).

The lower one-third of the cut-off trenches were filled with gravel and smaller rocks. A rock mix of 150–700 mm was placed and compacted on the geofabric covered batter. The same sized rocks were used to fill the top and bottom cut-off trenches.

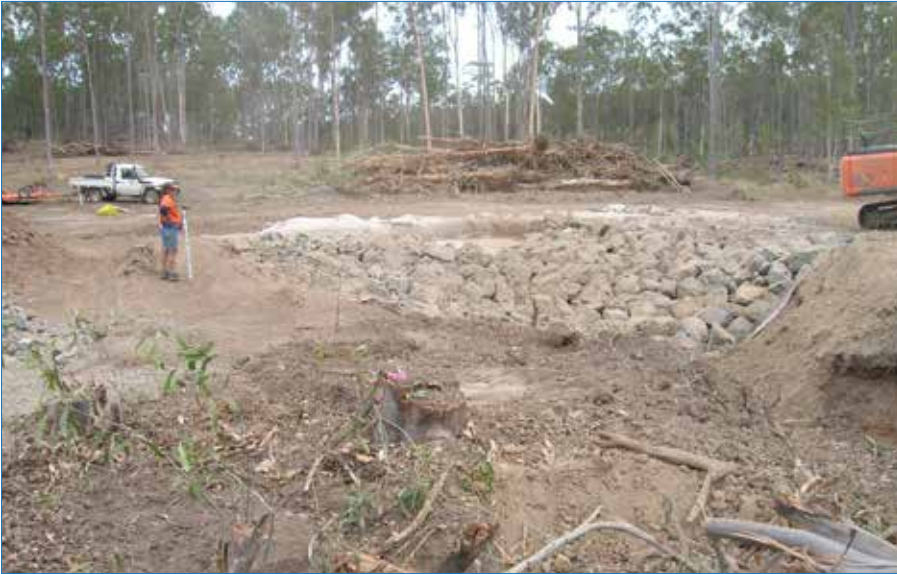
**Photo 26** Rock-fill on the chute close to finished.

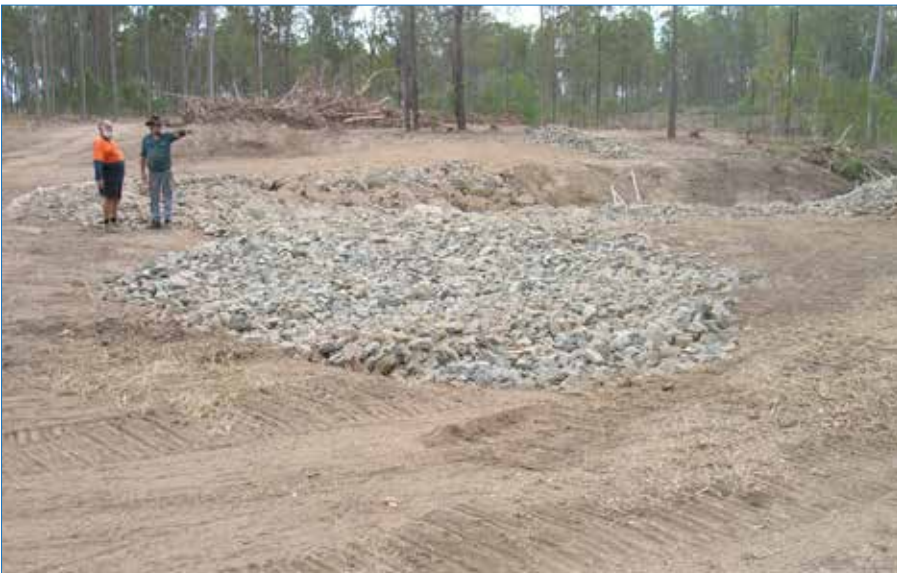
**Photo 27** The depressions in the gully above the crest were filled with small rock and compacted.

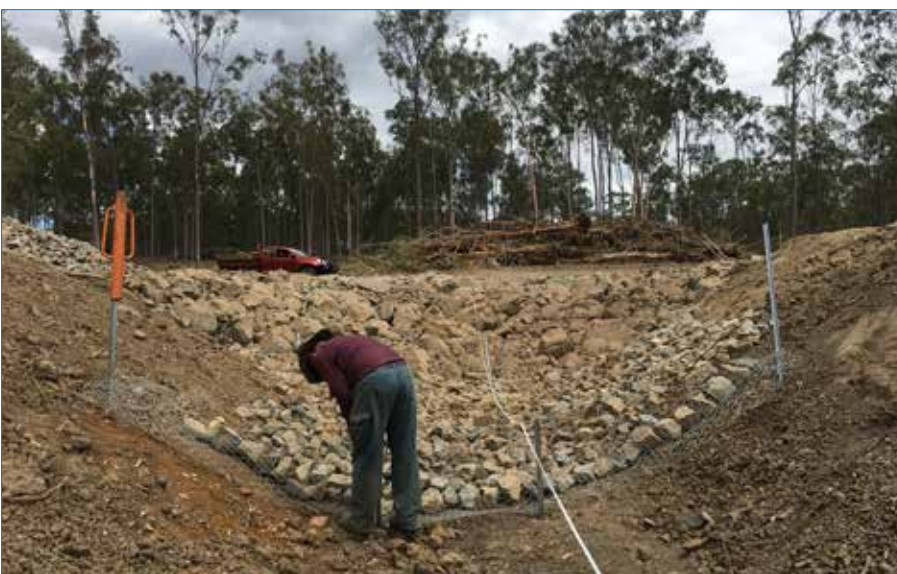
**Photo 28** Completed rock chute. Fence constructed at the bottom end of the structure to stop rocks rolling away during rainfall events.

Galvanised wire mesh (1.6 mm gauge) was placed along the length of the bottom trench and up the gully walls. The mesh was fixed in place using rocks at the base and galvanised star pickets. This fence was designed to capture any 'rolling' rocks during events.

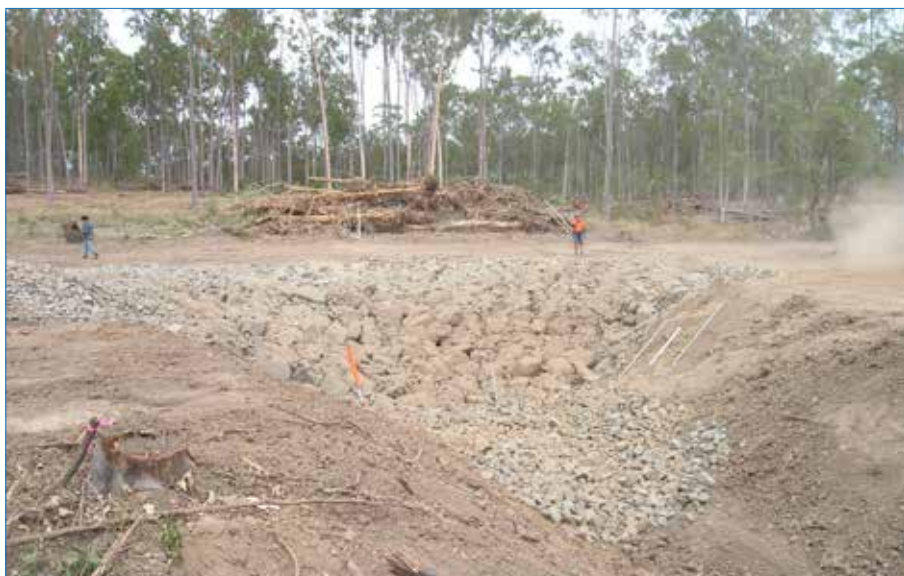
**Photo 29** Some excess rock placed downstream of the apron and the fence.

Some of the larger rocks (700 mm) were placed at the end of the apron and at the base of the chute to assist with energy dissipation. Some surplus rocks were spread below the apron and fence to help stabilise the gully floor. A second short wire mesh fence was constructed below this to prevent the rocks from rolling away and to act as a silt trap.

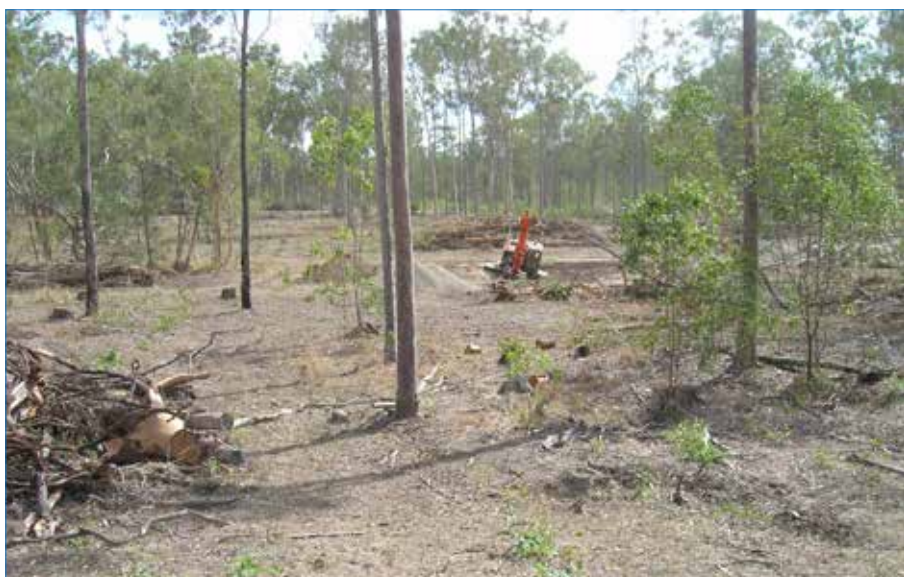
**Photo 30** Survey line for wing wall.

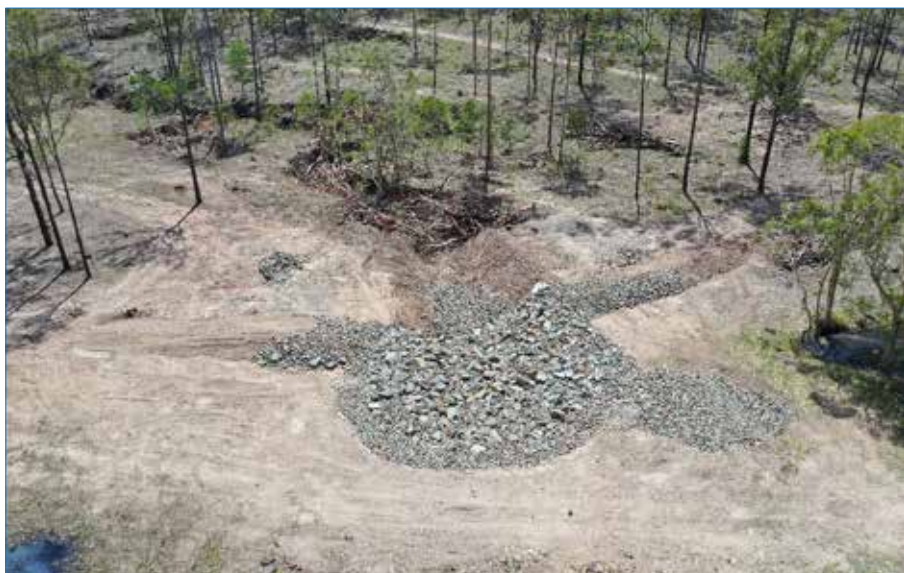
**Photo 31** Wing walls with rock armour.

During construction, any excess soil from the battering and shaping process was retained. This soil was used to help construct diversion wing banks at each side of the chute to direct water over the rock chute. Using overburden avoided exposing any additional fragile subsoil. The wing banks were constructed to 1 m high and aligned at approximate right angles on a surveyed line at 0.4% slope on either side. The banks were turned up at the ends until the ends at ground level were at least 0.75 m above the chute's crest height.

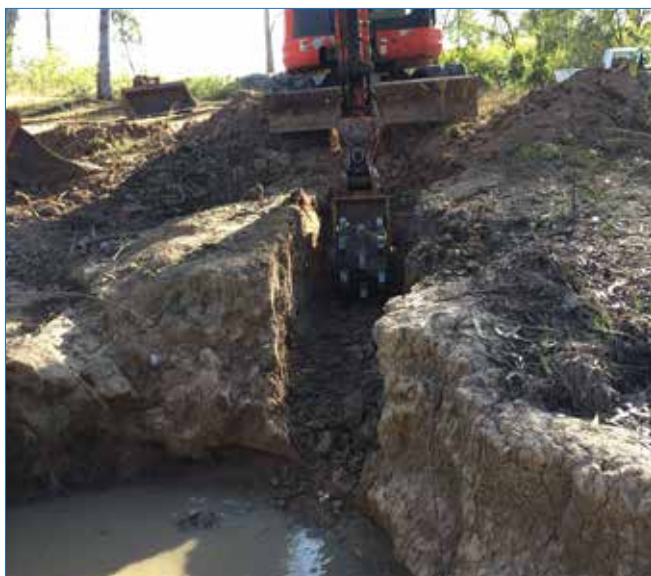
**Photo 34** Exposing and compacting tunnels.

At the erosion site, all material from the failed porous check dams was removed.

All tunnel erosion on the eastern fork was exposed and compacted.

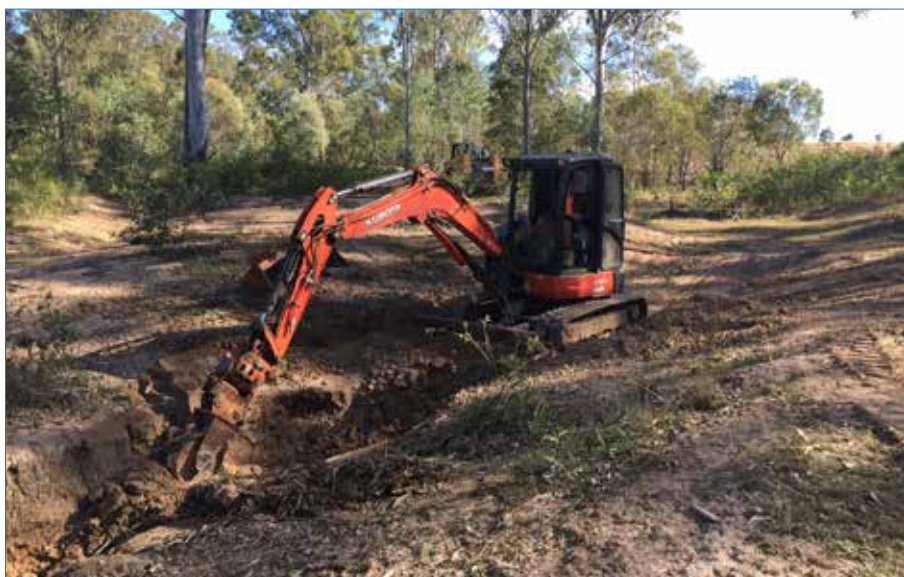
**Photo 35** Filling, shaping and compacting the gully.

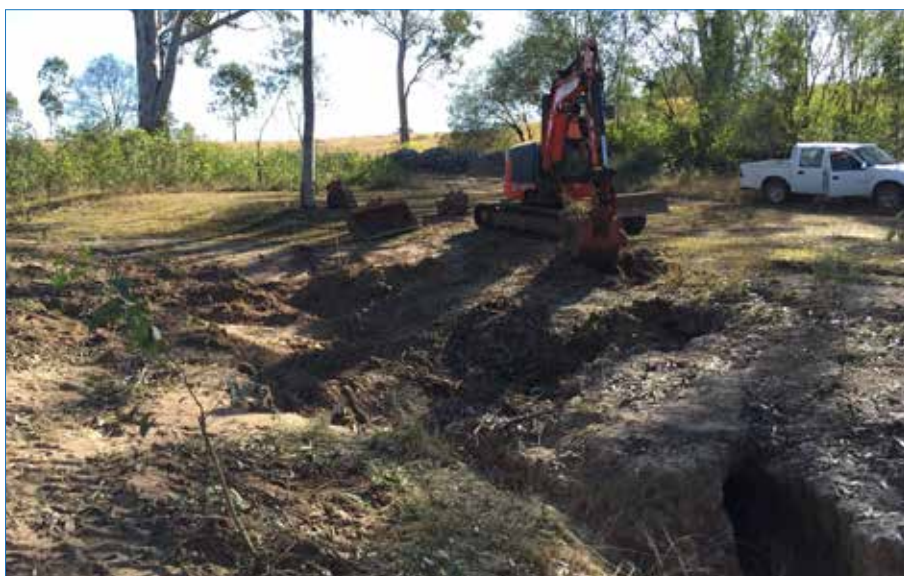
**Photo 36** Another tunnel before it was collapsed.

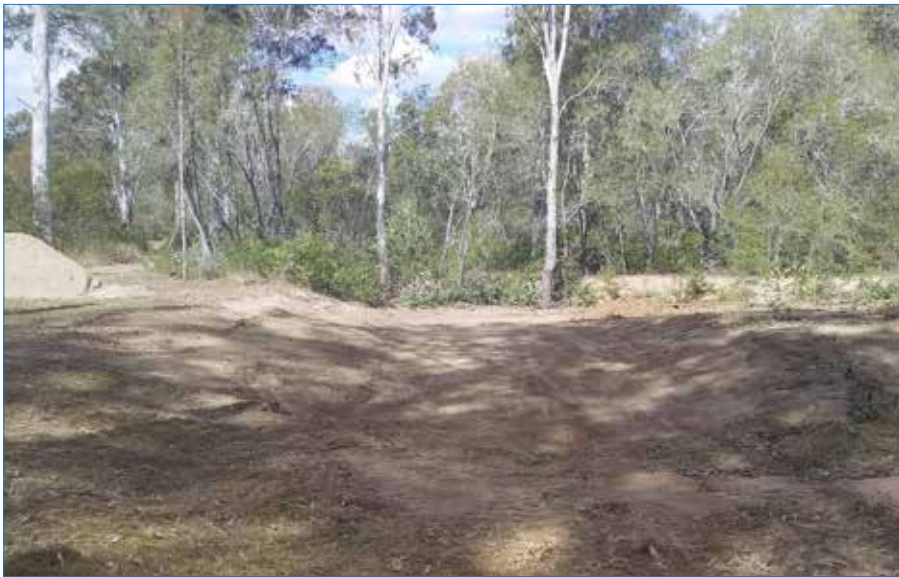
**Photo 37** Gully shaped ready for gravel and rock.

The beds were widened and shaped into a trapezoidal shape, 3 m wide for the short side, 4 m wide for the long side and 0.4 m deep. 3:1 batters were used on the sides of the channel for the full length of both sections. Once shaped and compacted, a 10 cm layer of high clay content road gravel was spread and compacted over the two gully floors and batters.

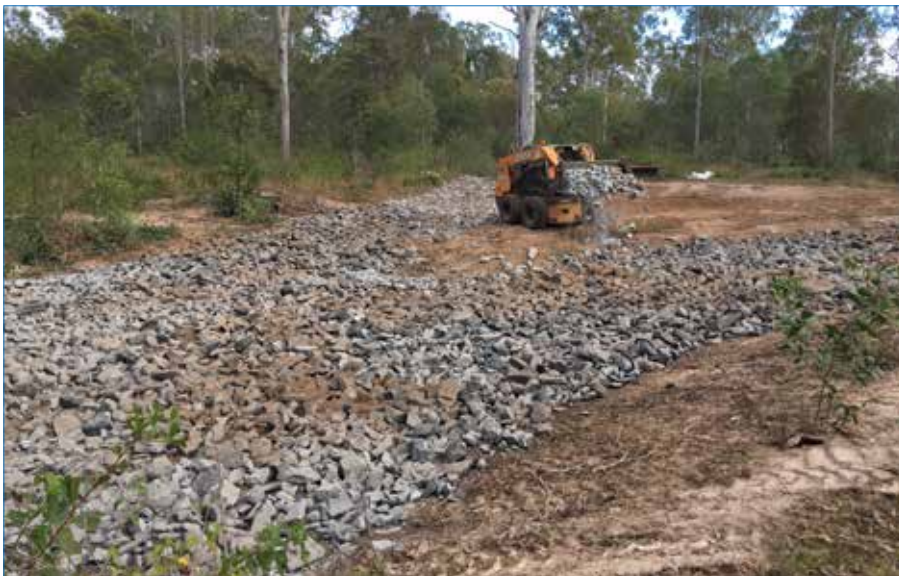
**Photo 38** Finishing the rock mattress.

After the gravel a layer of 100–200 mm mixed rock was spread over both gullies and up the batters.

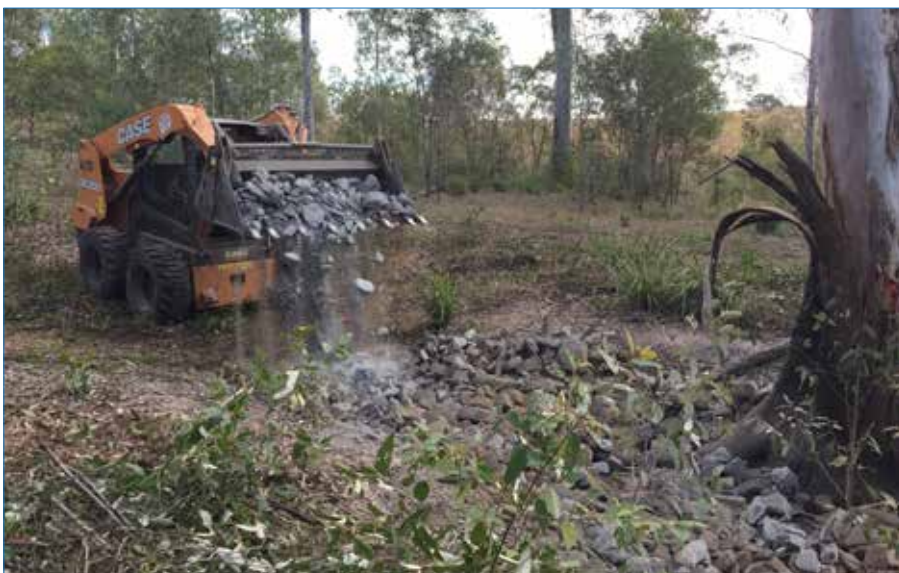
**Photo 39** Fill gully head above tree.

A small gully head at the top of the short gully was also filled with a layer of gravel and rock then compacted, like the rest of the gully. Shaping was not necessary for this small feature due to the small catchment area.

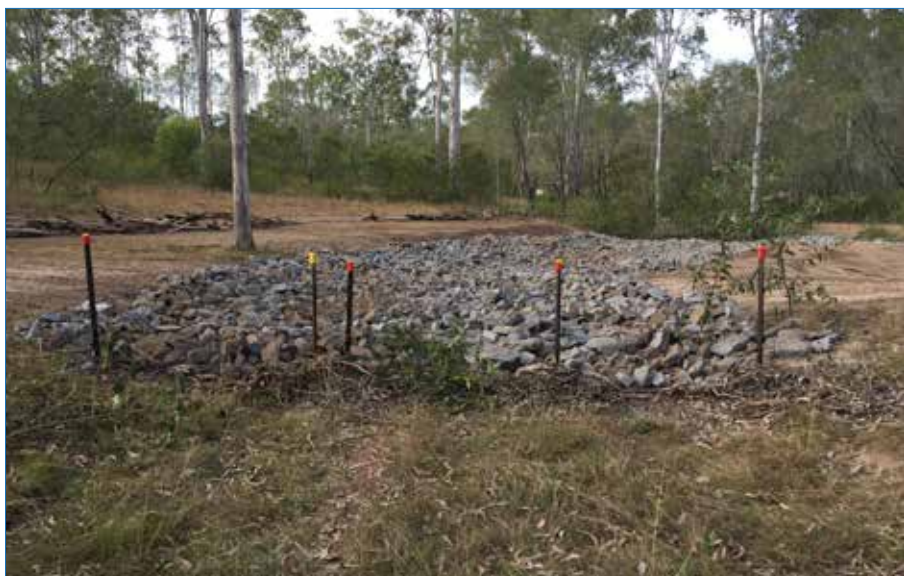
**Photo 40** Rock finished on both sides.

A silt trap weir installed prior to works had performed well during the rain event and was left in place. As the silt drops out, it provides a growing medium for grasses to colonise – an essential step in the landscape recovery process and for slowing the water moving across the landscape.

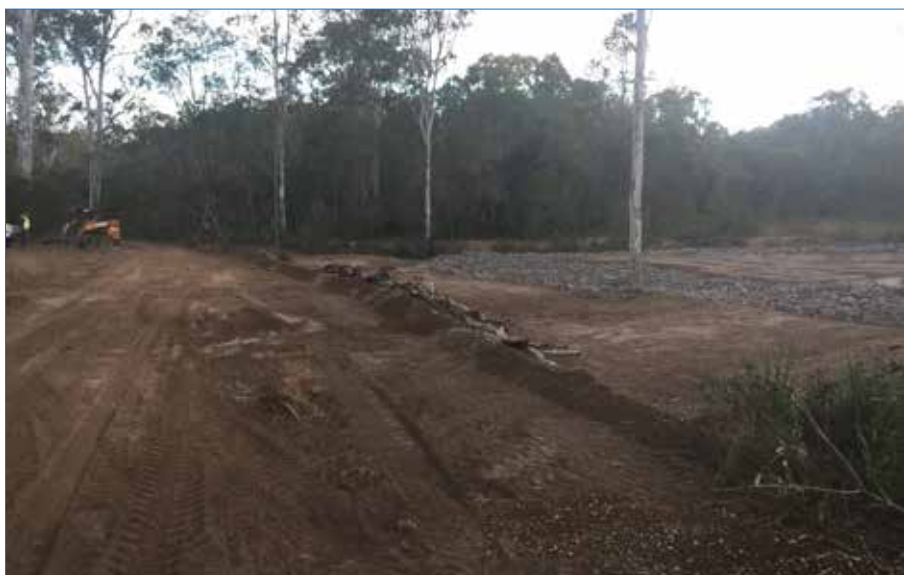
**Photo 41** Log and gravel line along roadside to divert water away from the completed structure.

A diversion log line and gravel barrier was constructed parallel to the gully and road edge to divert run off from the road and the neighbour's paddock to a safe flat location downstream.

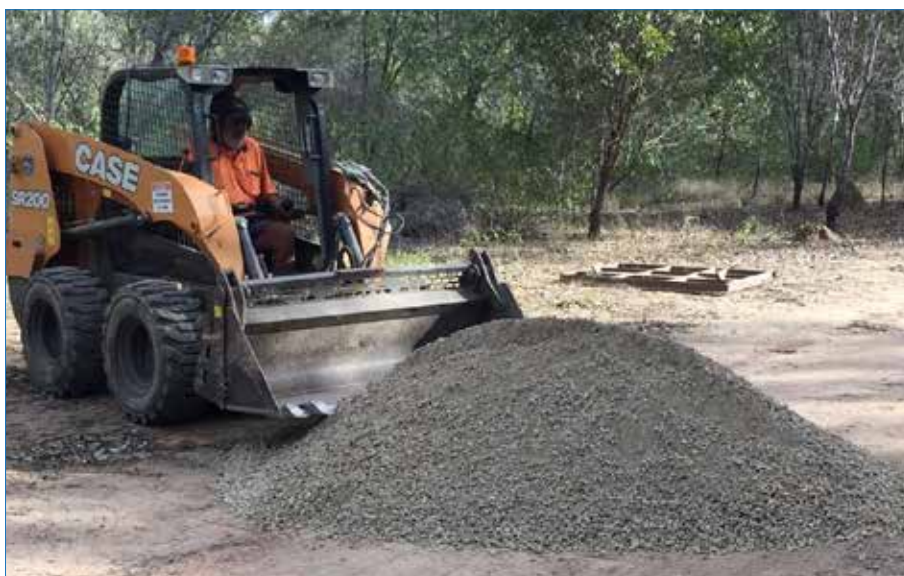
**Photo 42** Gravel road base dumped in position on the driveway ready to be shaped into a whoa boy.

Dumping material in position saves machine time later on.

Whoa boys surveyed with 10 cm fall across the width of the road. The road slope was steep at 7%.

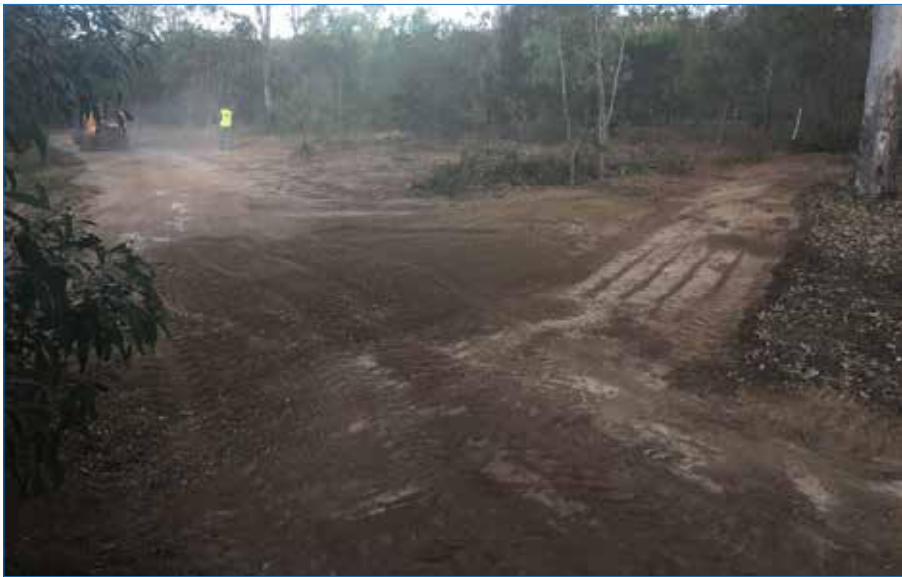
**Photo 43** Whoa boys completed.

Lines of logs, fallen timber and mulch placed at the end of each whoa boy carry water at least 20m away from the driveway and out of the gully catchment. Log lines were surveyed with 10cm fall over 25 m, or a grade of 0.4%.

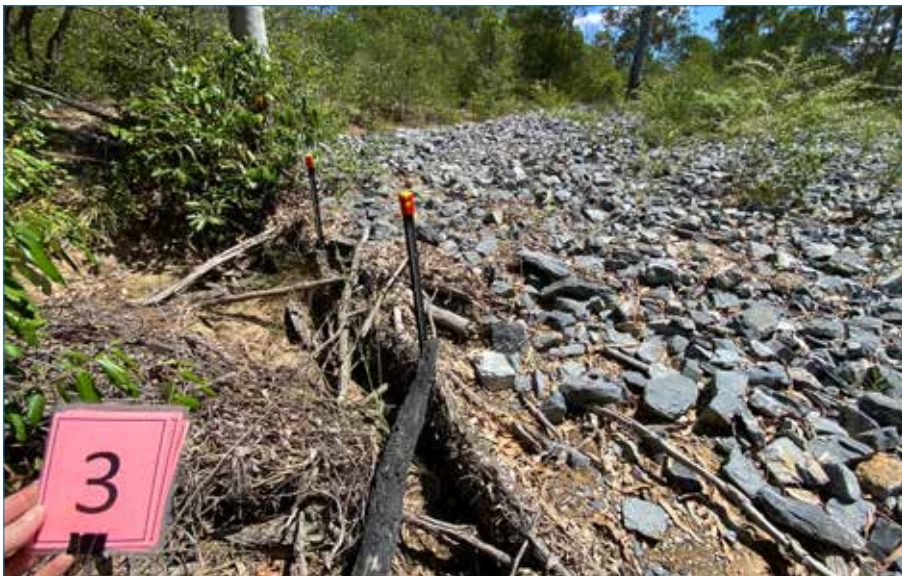
**Photo 44** Ongoing maintenance of silt trap weirs below rock mattress.

A netting weir at the confluence of the fork worked perfectly and was full of silt. Another netting weir was constructed about 10m further downstream so the crest of the new weir was high enough to back water approximately 0.3 m up the wall of the existing netting weir. This was done to stop the undermining that was evident below the existing weir.

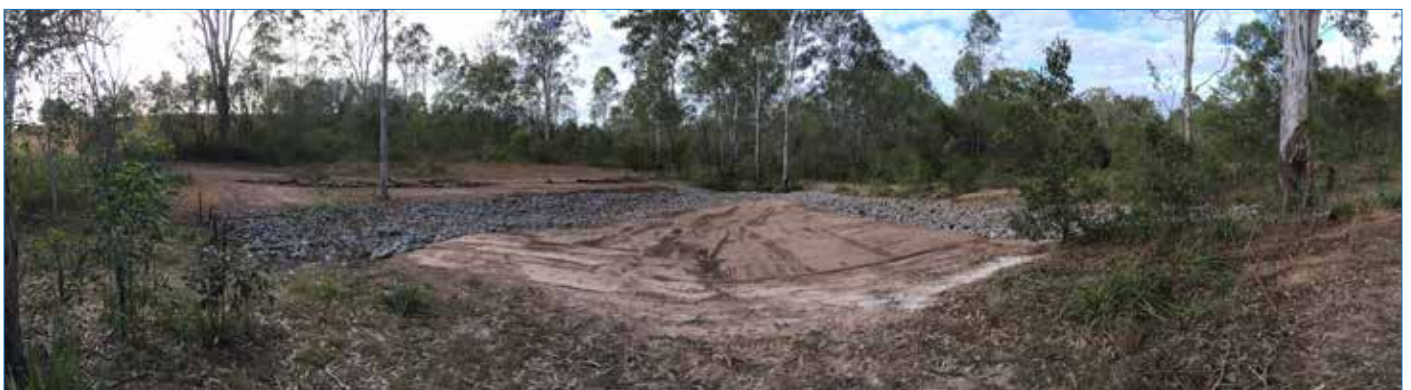
**Photo 45** Looking downstream – completed project.

Rock mattress on either side and topsoil spread in the middle to provide favourable conditions for regeneration of ground cover.
