# Erosion gully rehabilitation

Adaptations and learnings from sites in the Mary River Catchment

By John Day, Becky Watson and Caitlin Mill  
Mary River Catchment Coordinating Committee

July 2023

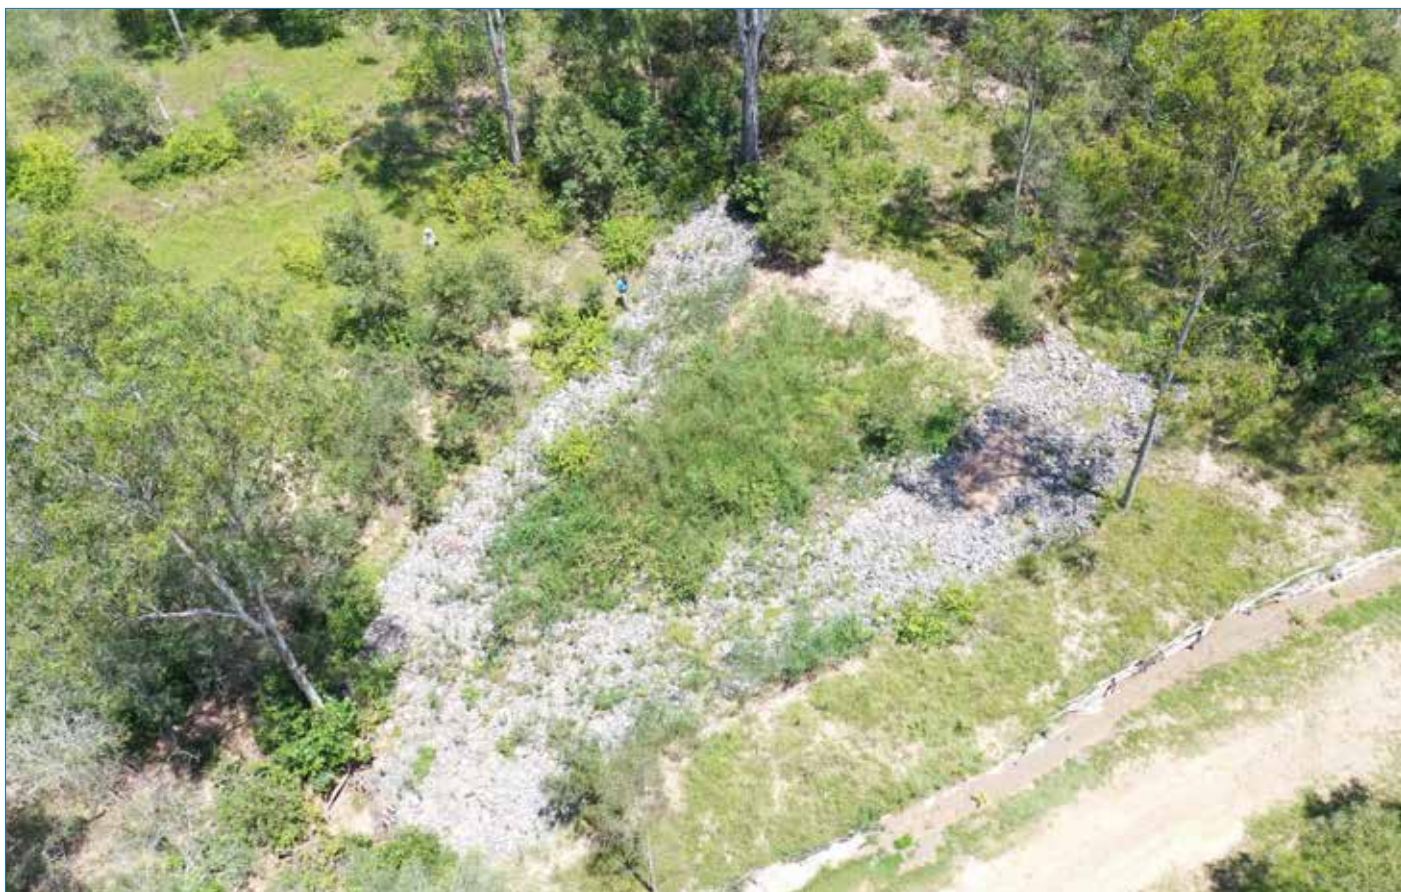
**Photo 46** February 2022 after major flooding in the area.

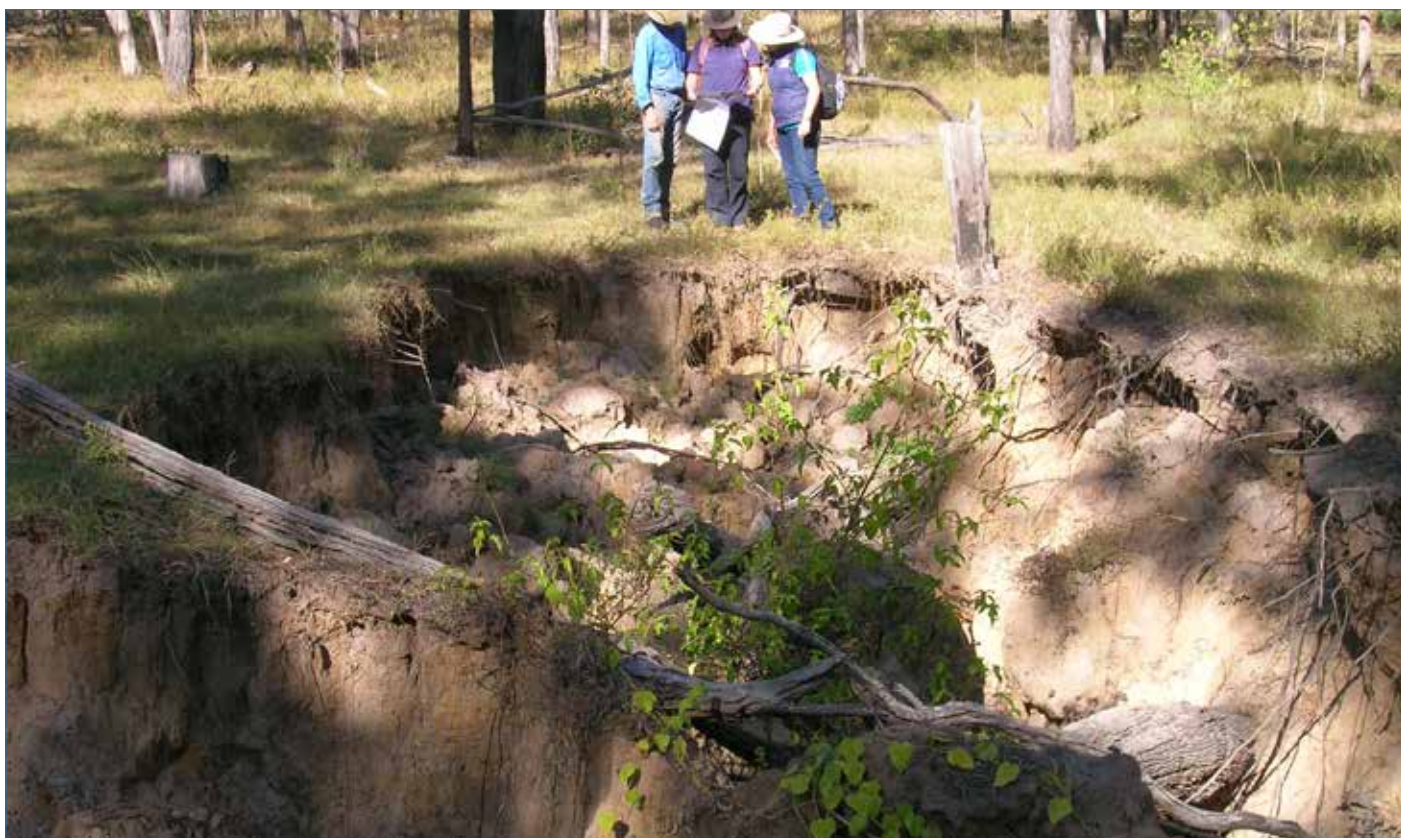
This gully erosion site is due to the diversion of water from a historic 15 ha contoured catchment onto an adjacent ridge top rather than into the eroded natural drainage line. Diverting water away from an erosion site is a common strategy, and the system worked quite well for many years. The contour system to the ridge design was suitable for normal rainfall conditions up to the 1-in-10 rainfall event. However, during the 2011 and 2013 flood events, the increased flow on the receiving catchment resulted in a new gully, which advanced rapidly up the slope.

**Photo 48** Iron bark and Box ridge gully prior to rehabilitation.

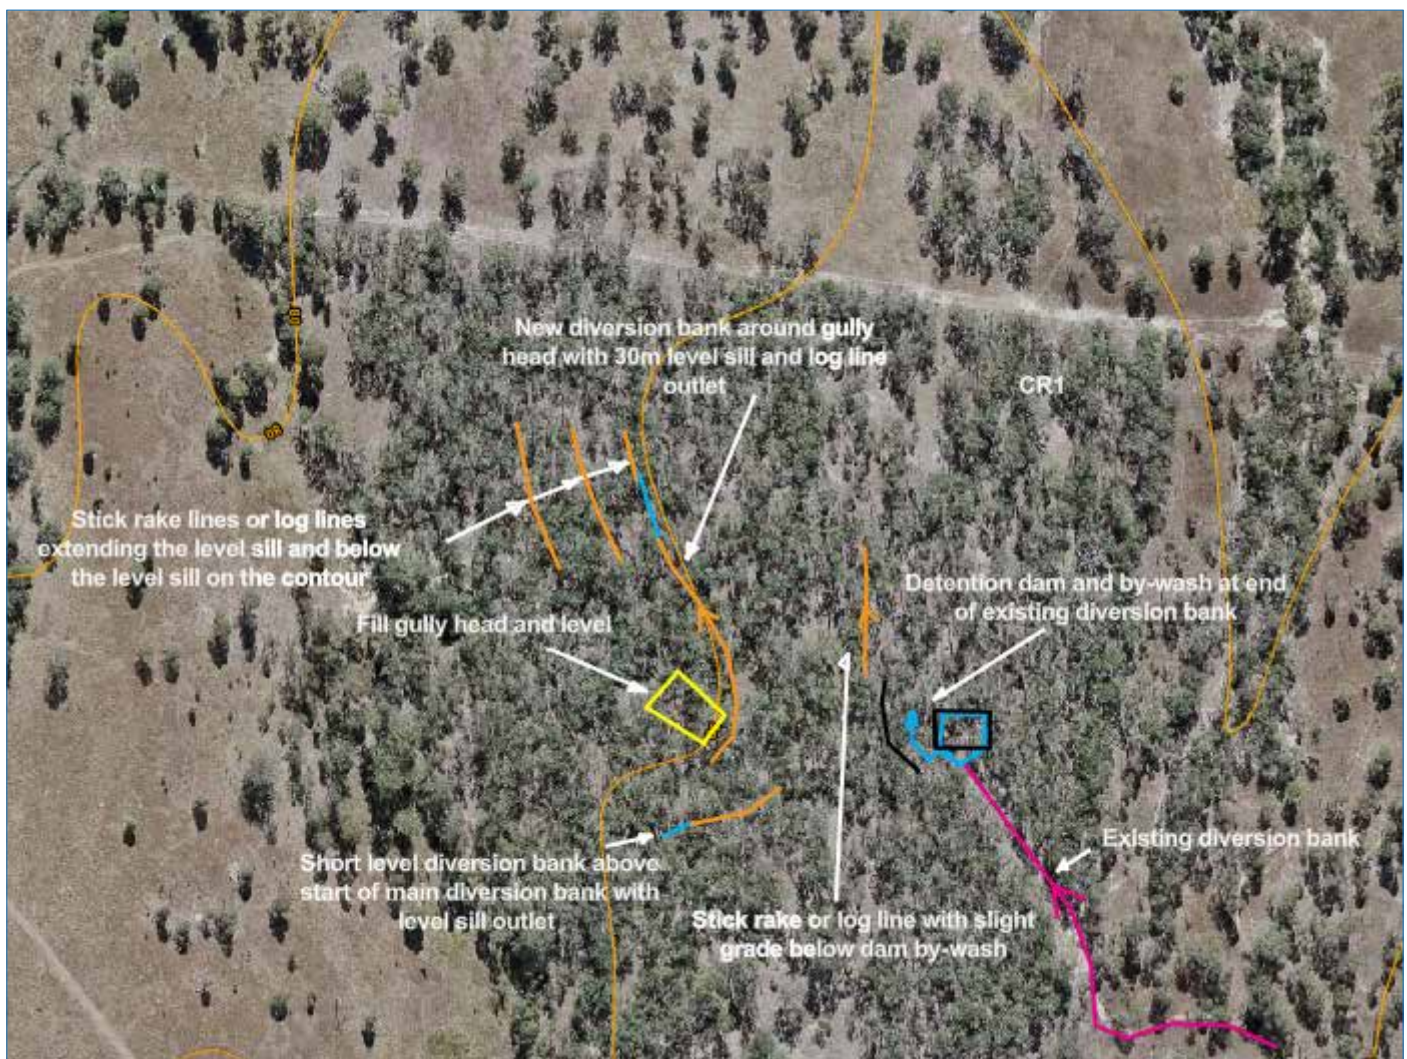
**Figure 5** Suite of gully rehabilitation methods working to slow and spread the flow of water across the ridge at this site.

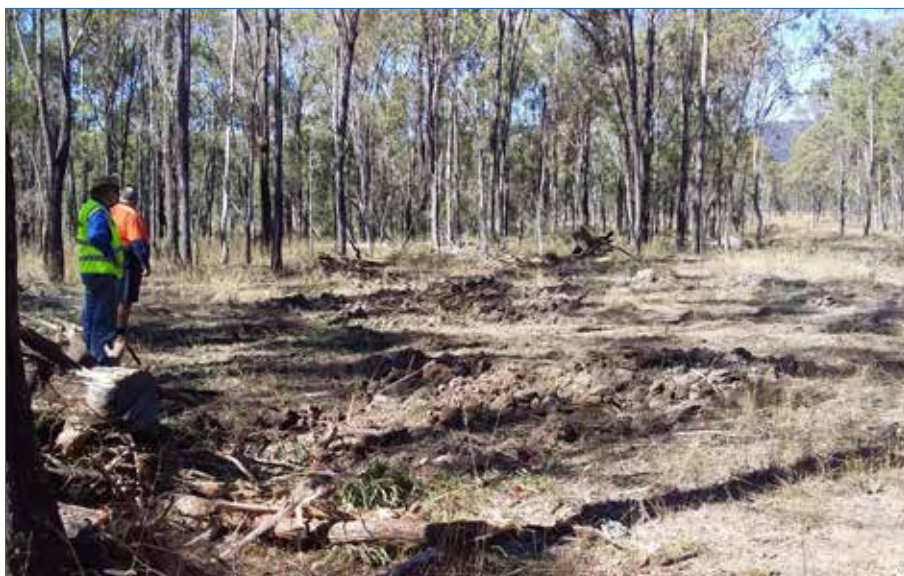
**Photo 49** Minimal trees cleared for detention basin.

The site of the detention dam at the end of the historic diversion bank outlet.

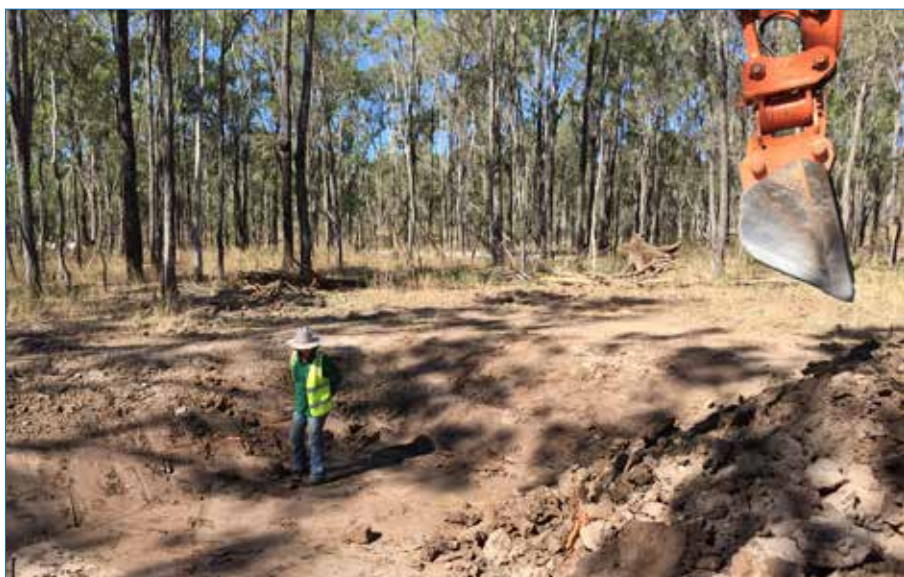
**Photo 50** Detention basin taking shape.

To reduce the volume and speed of water reaching the slope above the gully head, a detention basin approximately 25 m long, 10 m wide and 1 m deep, was constructed at the end of the historical diversion bank delivering the water from the contour system on the adjoining slope.

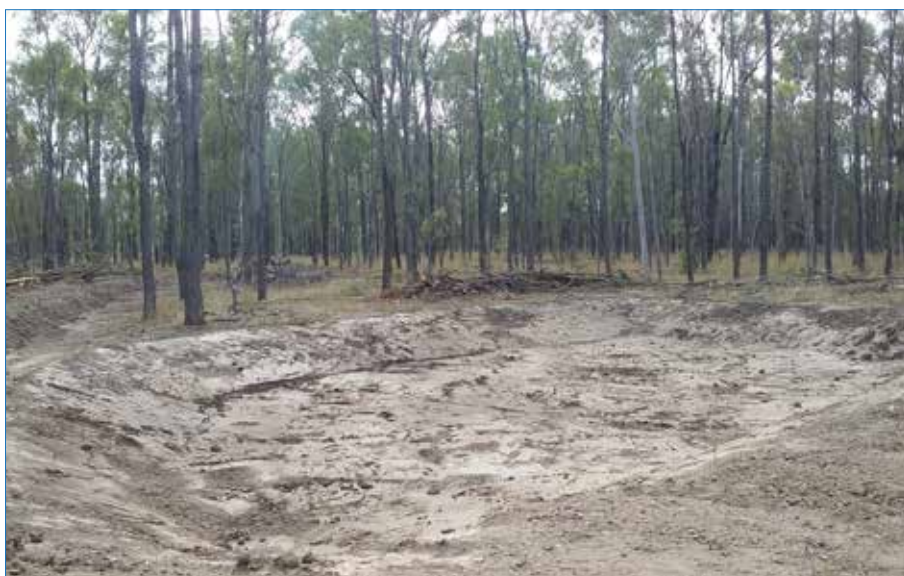
**Photo 51** Detention dam, complete with by-wash, surveyed along ridge line.

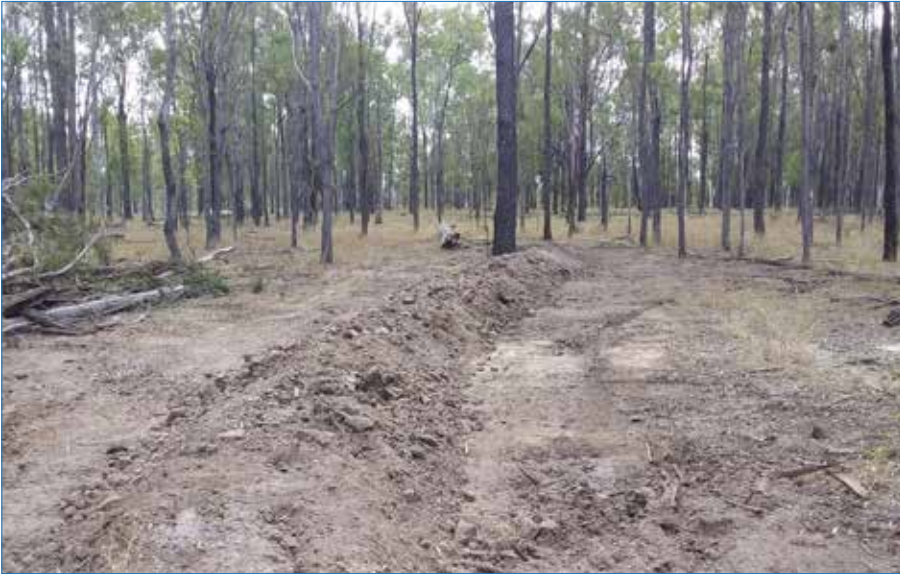
**Photo 52** Detention dam by-wash surveyed almost level, with log lines in place.

The ridge top was quite flat at the site of the detention dam so the by-wash was surveyed almost level to retain more water and to take the water along the ridge line with the outlet approximately in the middle of the ridge. The by-wash placement and outlet was extensively surveyed and planned before work was started. Cascading stick rake or log lines approximately 25 m long were positioned about 2 m and 10 m below the dam by-wash outlet to slow and spread water. A slight grade of 0.2%, or 5 cm every 25 m, was surveyed in the log lines to lead and spread the water along the slope.

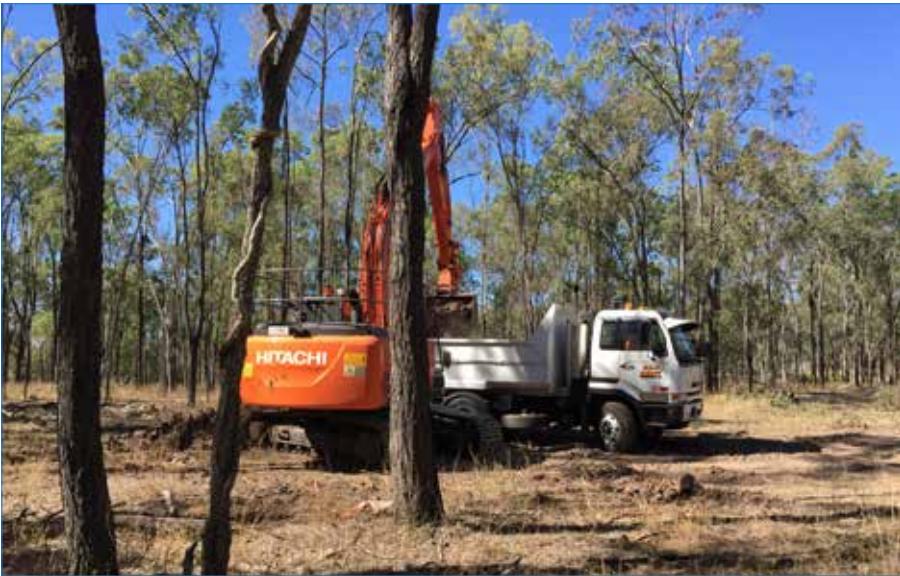
**Photo 53** Excess clay soil was trucked from the detention basin site to the gully head downslope.

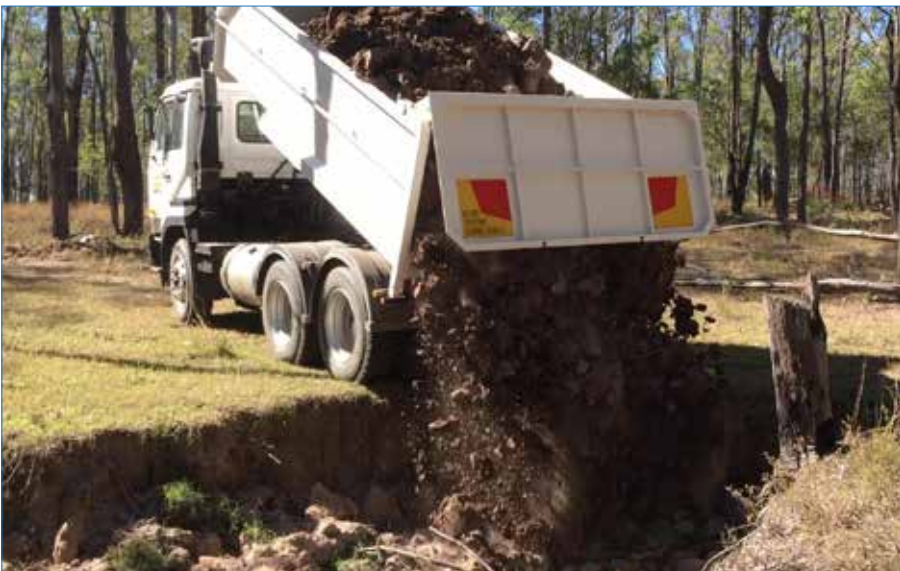
**Photo 54** Spoil used to fill gully head.

Clay soil from the detention basin was used to fill the gully head.

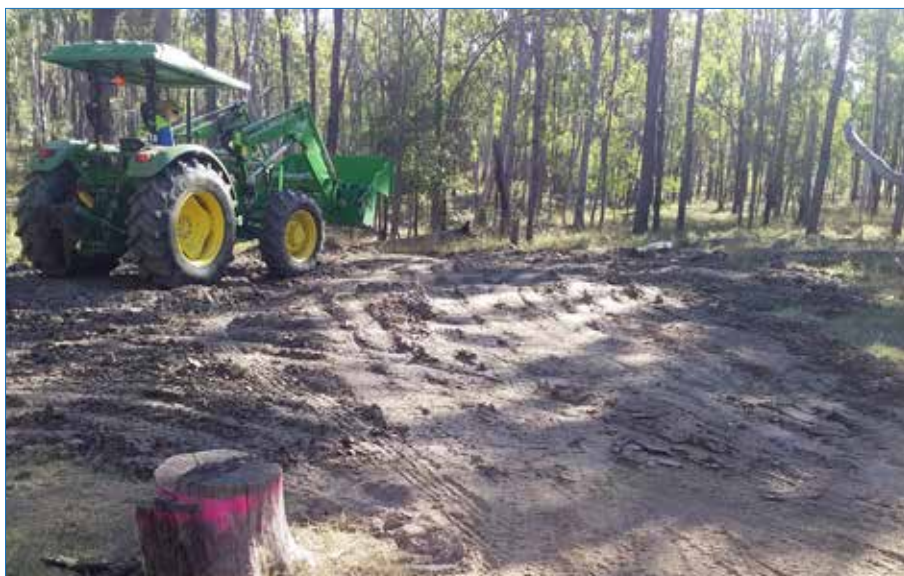
**Photo 55** Filled gully head.

The farm tractor was used to level and compact the fill.

Excess clay soil was placed along a by-wash bank and other small side gully heads below the main gully head cut.

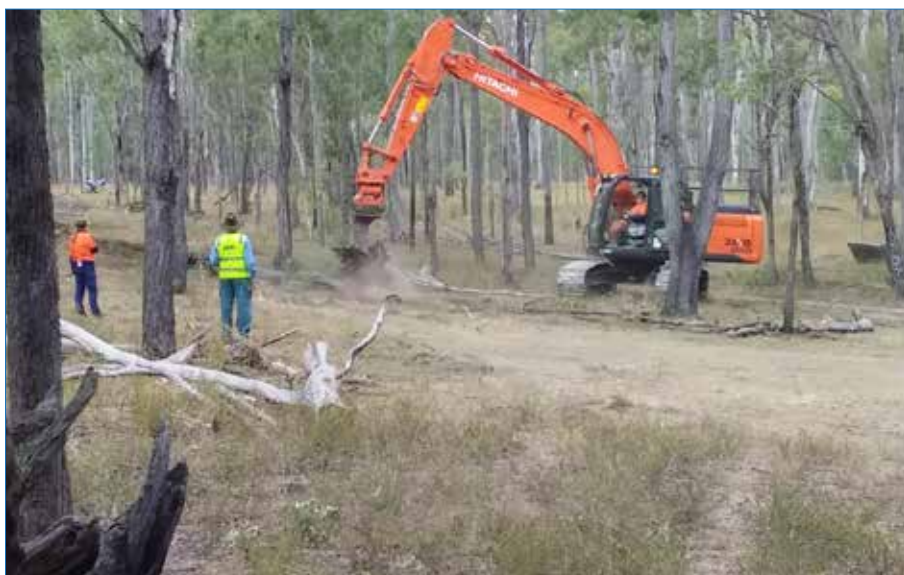
**Photo 56** Clearing survey line for the main diversion bank above the gully fill.

A diversion bank was surveyed so that it captured any water coming from the detention dam outlet and any other run-off from the slope.

The line was cleared with the excavator, which reduced the number of trees removed. The level sill and bank were constructed on the way back for time efficiency.

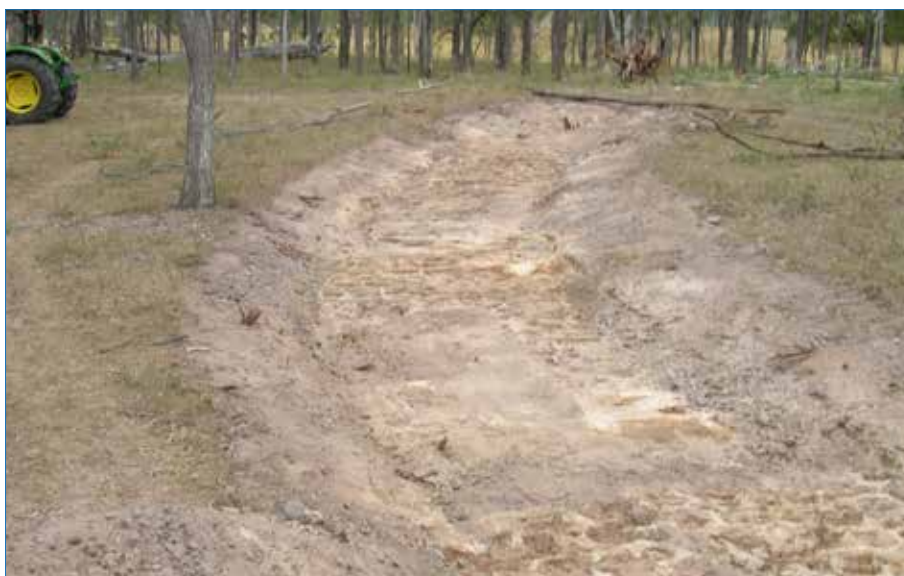
**Photo 57** Main diversion bank level sill outlet.

A level sill outlet was constructed to spread the water at the outlet. The level sill excavation was 20 m long, 3 m wide and 0.3 m deep.

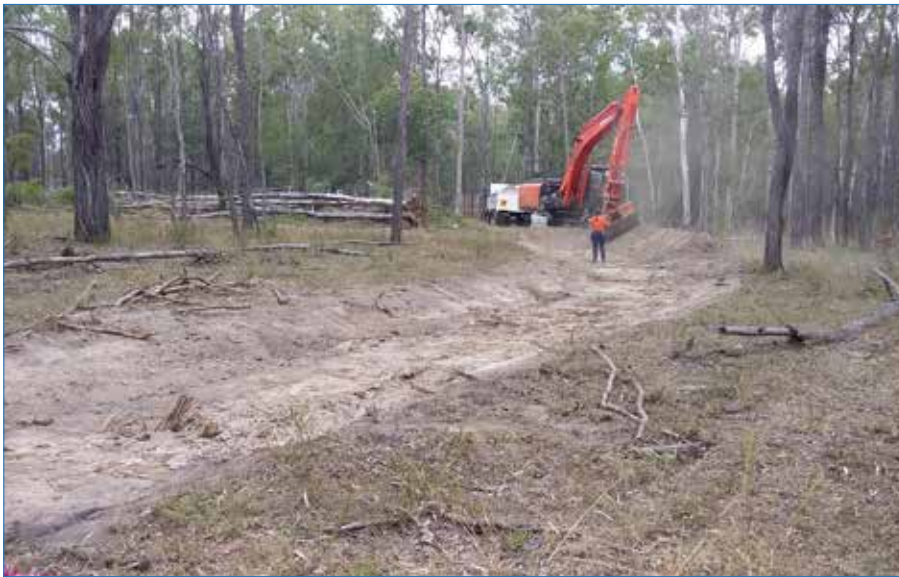
**Photo 58** Levels were taken consistently along the channel floor during construction using a laser level.

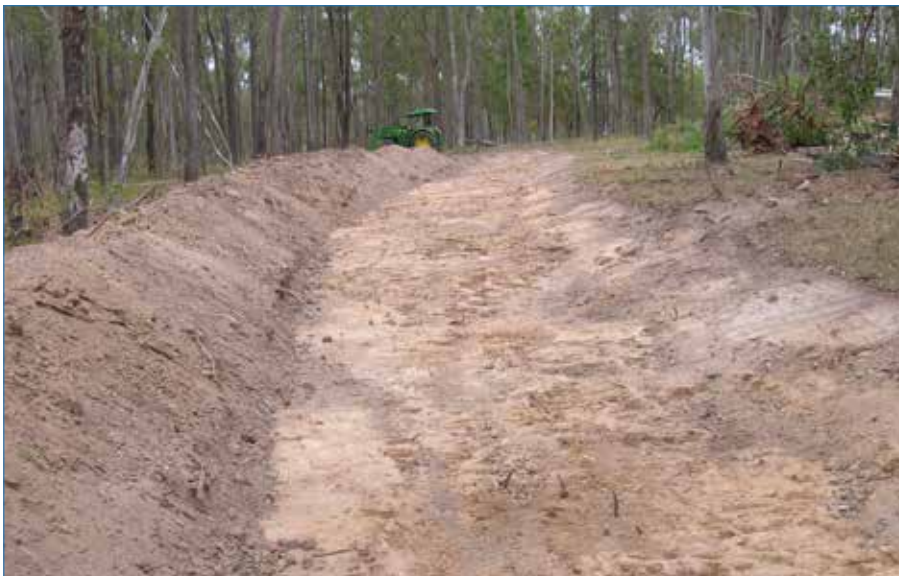
**Photo 59** Completed bank looking towards level sill outlet.

The bank was designed for a 1-in-20 year event and surveyed at 0.4% grade with a 3 m wide flat channel and a 1 m high bank at construction.

The bank took the water around the hillside to a well-grassed area with a much gentler slope.

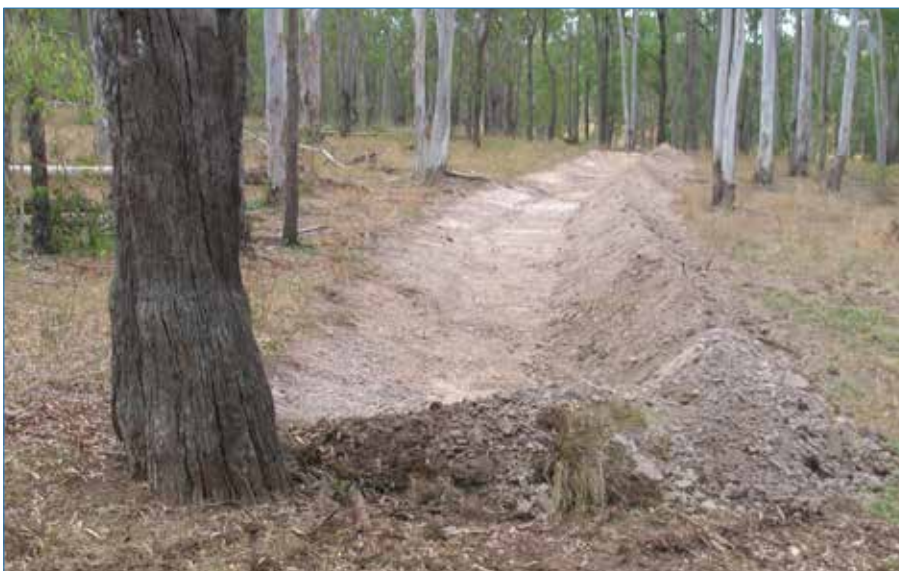
**Photo 60** Short top diversion bank above the start of the main diversion bank.

A short diversion bank was placed above the start of the main bank to take the top water from the natural drainage line out to a ridge line to further reduce the pressure on the depression that had gullied. This bank had a very small catchment size (<1 ha). A 25 m bank with 0.2% slope was constructed to 0.8 m with a 1 m wide channel.

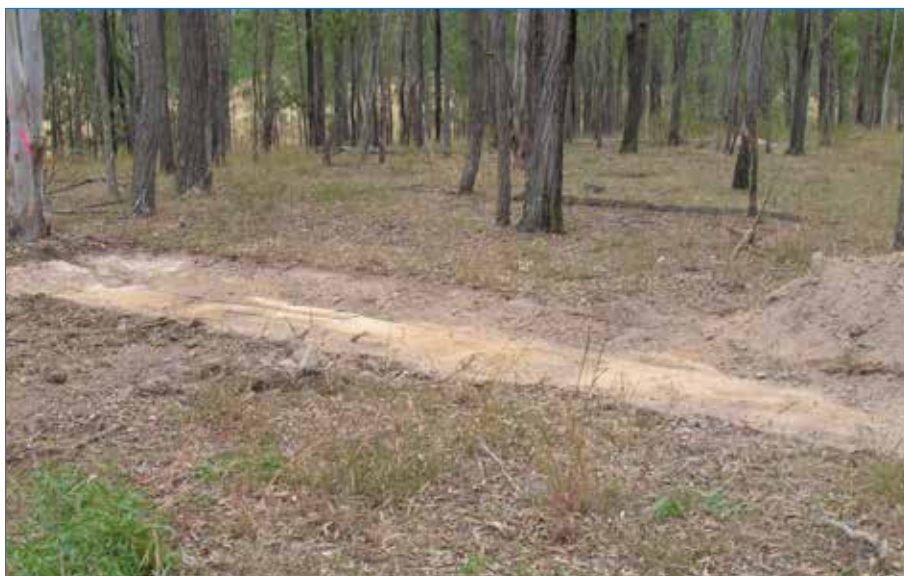
**Photo 61** Short top diversion bank level sill outlet showing the grassed slope where water spreads.

A level sill was constructed at the end of the short top diversion bank to spread water over the grassy slope below. The level sill outlet was constructed to 10 m long x 1 m wide x 0.3 m deep.

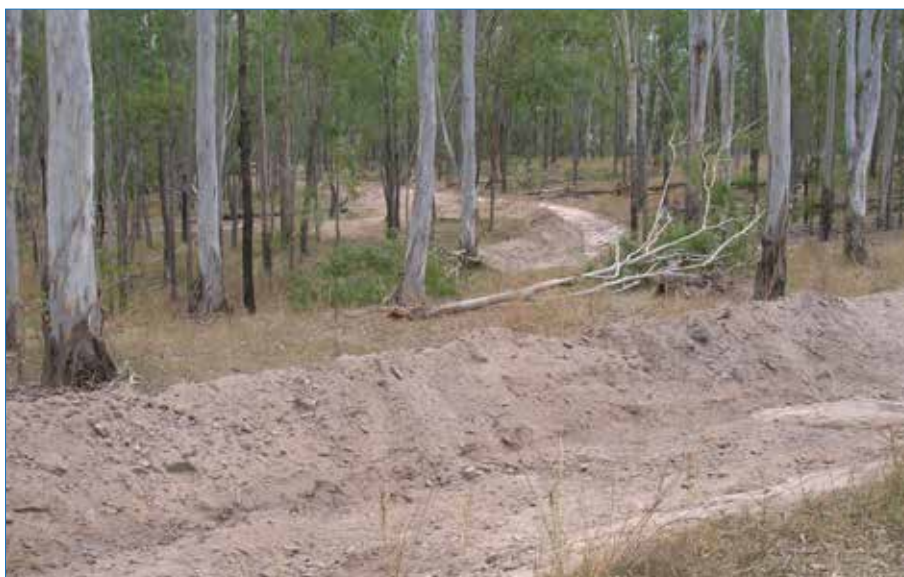
**Photo 62** Background: Main diversion bank looking along the channel towards the outlet end.

Foreground: Short diversion bank above the main bank.

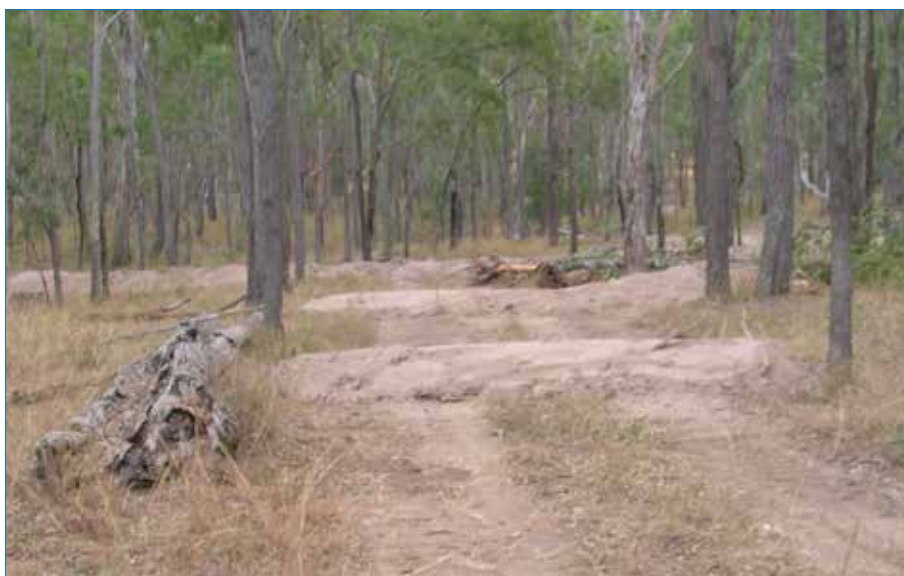
**Photo 63** Whoa boys constructed on the way out to prevent erosion of tracks created during construction.

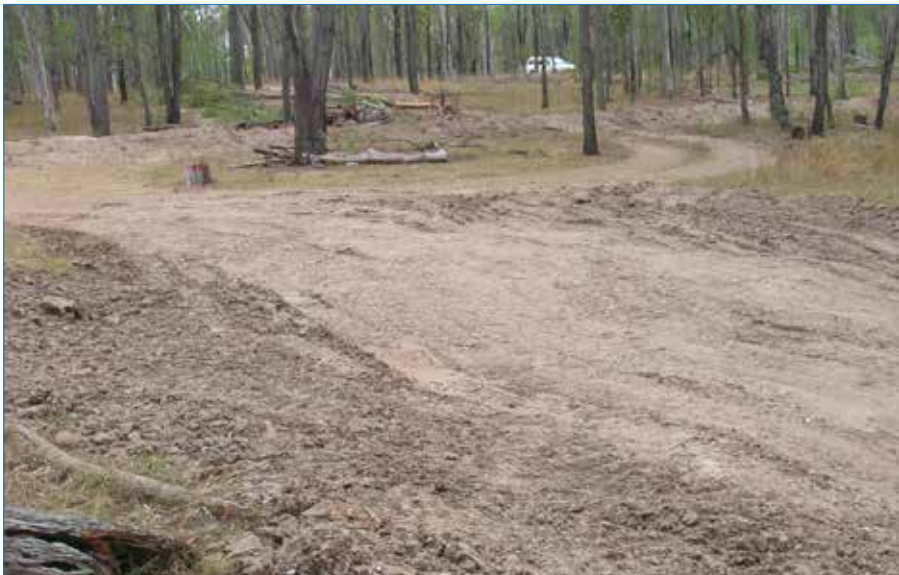
**Photo 64** Completed July 2020.

Looking upslope towards diversion banks from what was the gully head.

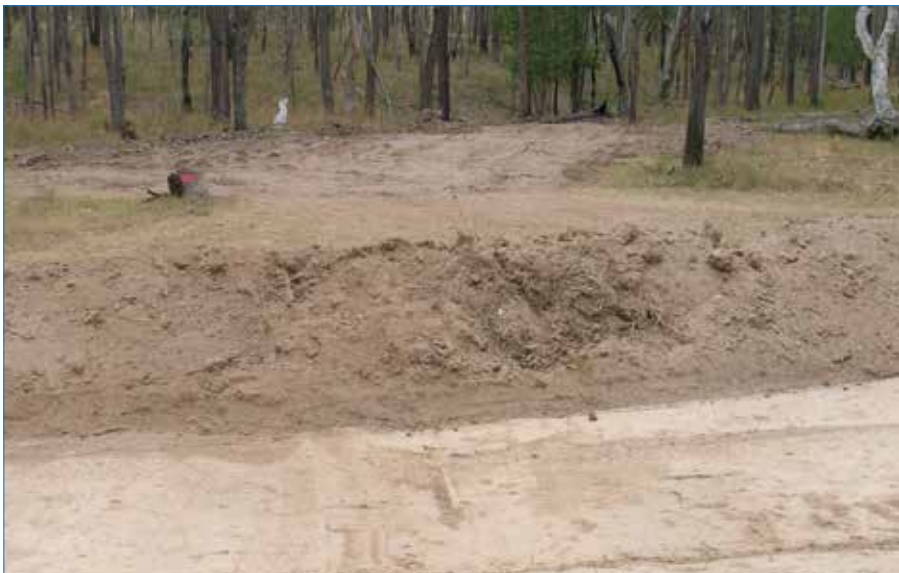
**Photo 65** Completed July 2020.

Looking downslope over diversion bank towards filled gully head.

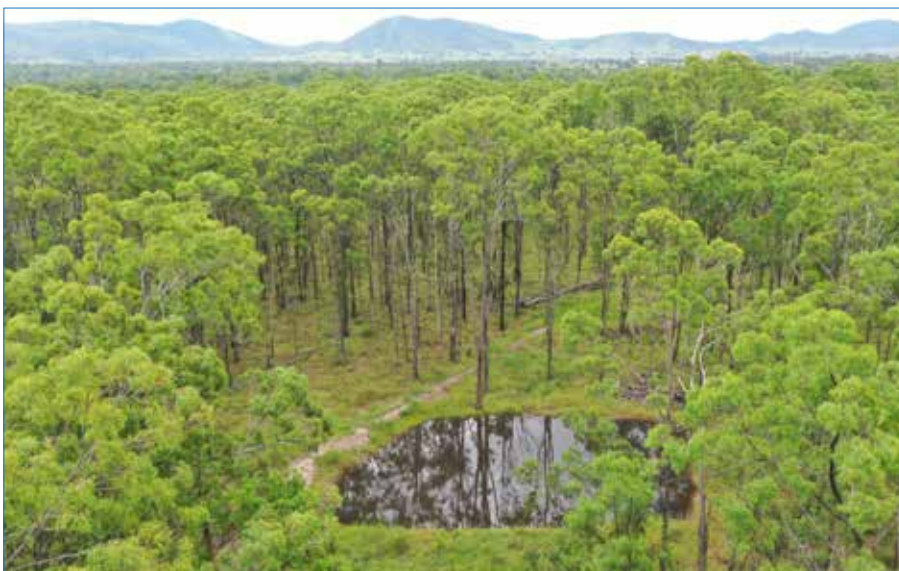
**Photo 66** February 2022 post-flood.

Detention basin full and ground cover has improved significantly.

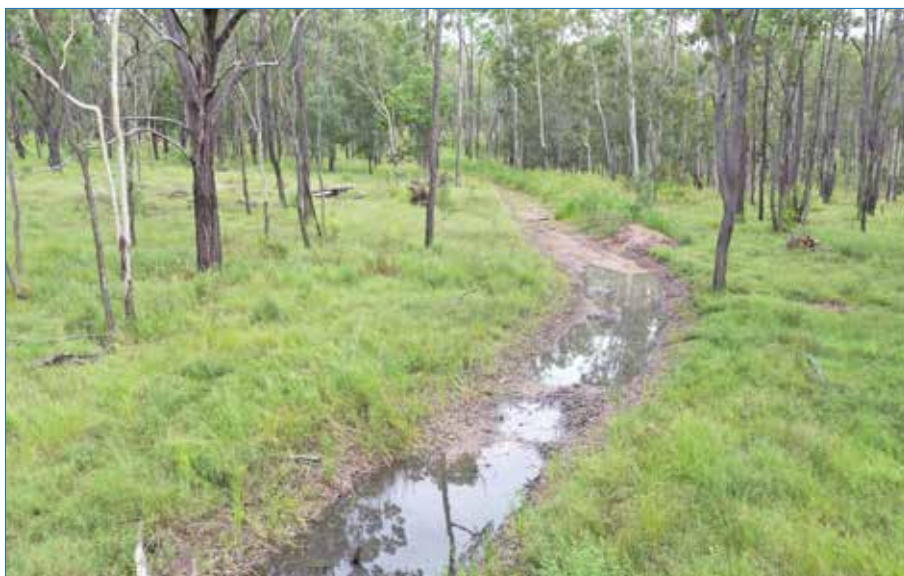
**Photo 67** February 2022 post-flood.  
Level sill at outlet still holding some water following the flood.

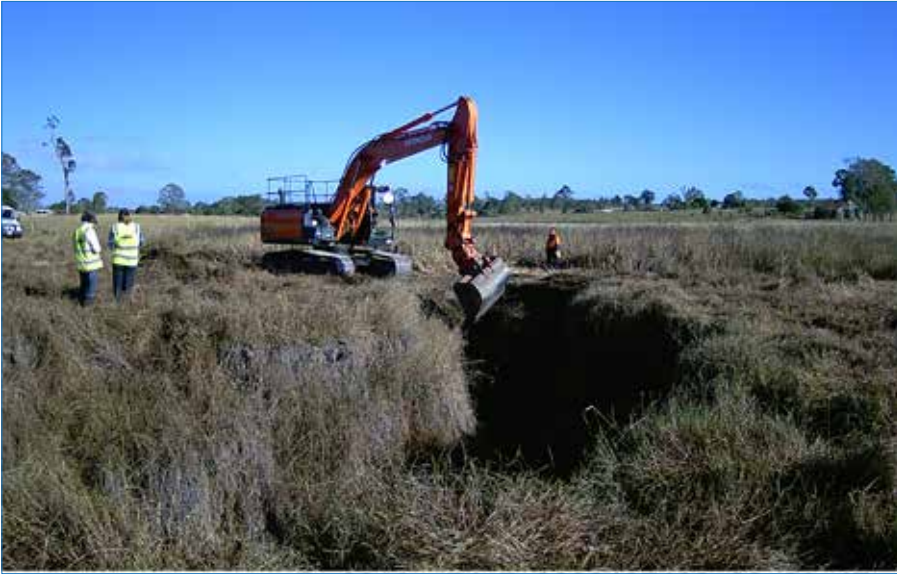
**Photo 70** Beginning of the shaping.

The rock chute crest was skewed to the south to reduce the earthworks required to form the batter and apron.

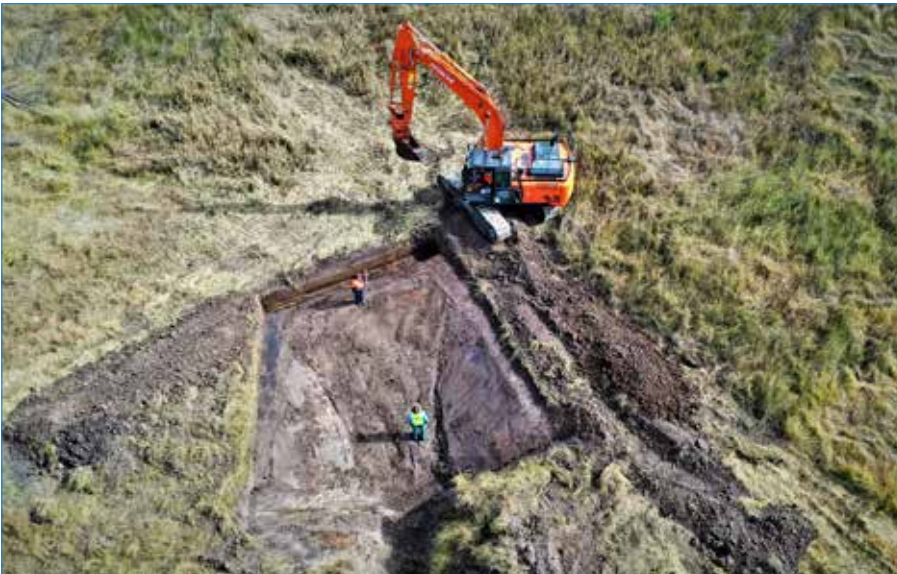
**Photo 71** Gully head chute shaping completed.

The chute level crest was 7 m across the top and the gully head was battered to 3:1 so the chute batter was approximately 6 m long.

A cut-off trench approximately 0.6 m wide x 0.6 m deep was excavated across the top of the chute crest 1 m up slope from the start of the batter. A second 0.6 m deep V-shaped cut-off trench was constructed across the bottom of the batter and up both sides of the shaped gully.

A 1 m wide x 0.3 m deep ledge on either side joined the top and bottom cut-off trenches, providing a flat surface where rock could hold the geofabric in place during construction.

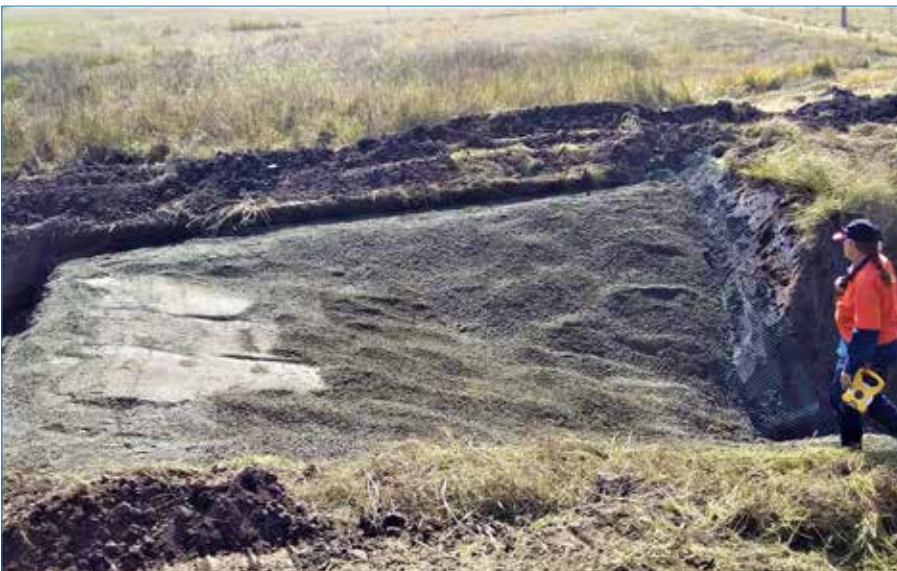
**Photo 72** Chute covered with high clay gravel.

The batter of the chute and the bottom of the cut-off trenches were covered with 10 cm of high clay gravel.

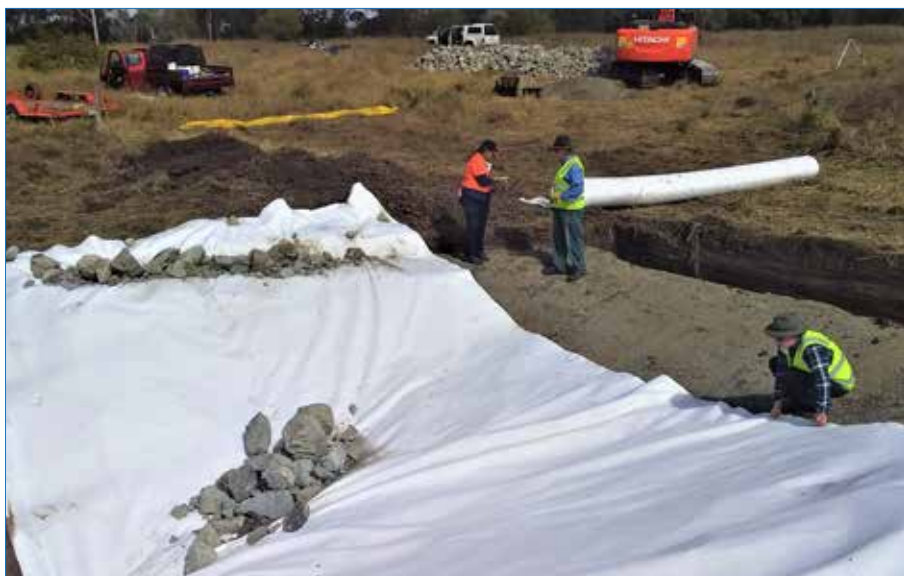
**Photo 73** Geofabric placed to cover entire structure.

Geofabric (Texel 400R) was placed over the whole chute area and into the cut-off trenches top and bottom. Geofabric was held in place with small amounts of rock.

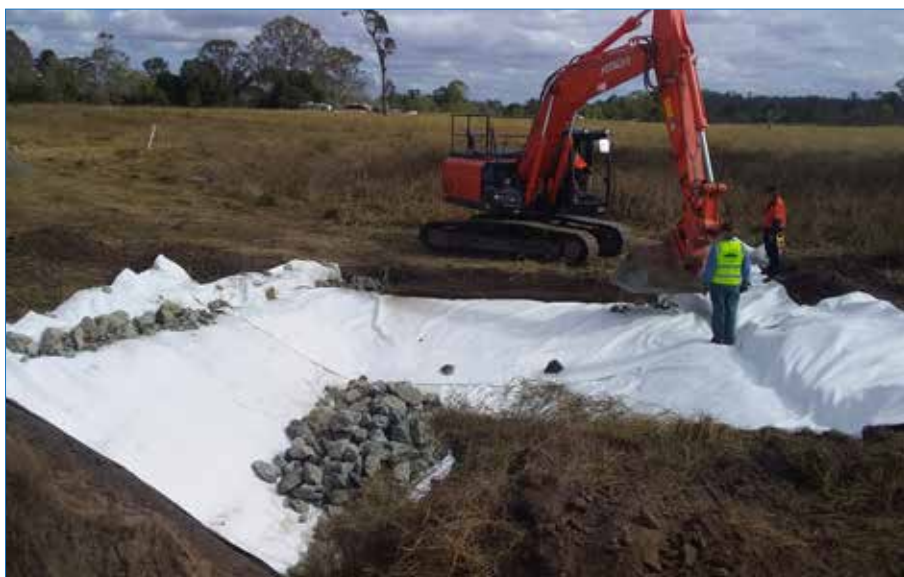
**Photo 74** Geofabric completed and rock goes on.

The cut-off trenches were filled with a gravel and smaller rock mix to 200 mm over the geofabric first. A rock mix of 100–400 mm was carefully placed and compacted on the geofabric-covered batter and cut-off trenches top and bottom. The bottom of the batter had a higher component of the large 400 mm rock arranged to assist energy dissipation.

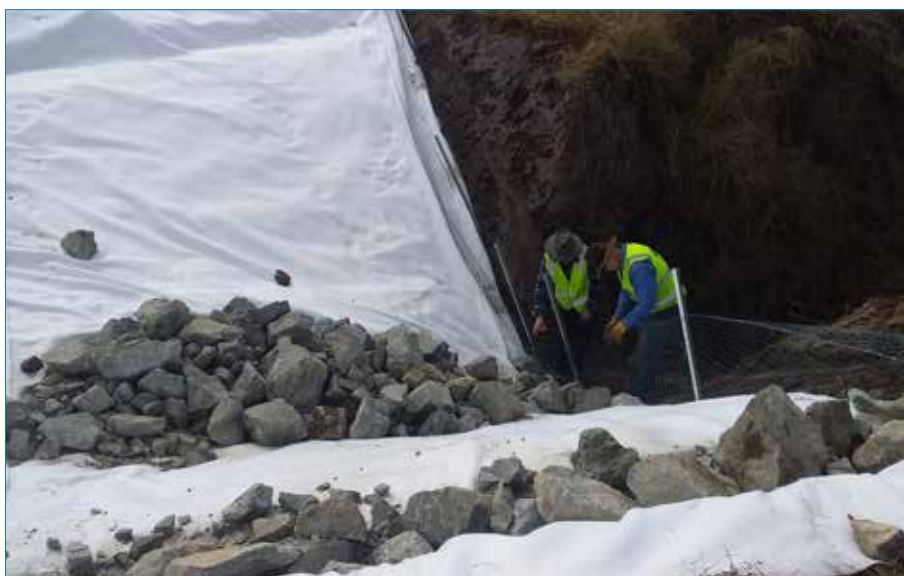
**Photo 75** Netting fence constructed in bottom cut-off trench.

Heavy wire netting was secured in the bottom cut-off trench to be used later as a weir across the bottom of the structure to hold the last rocks on the batter in place during any large flow or flood events.

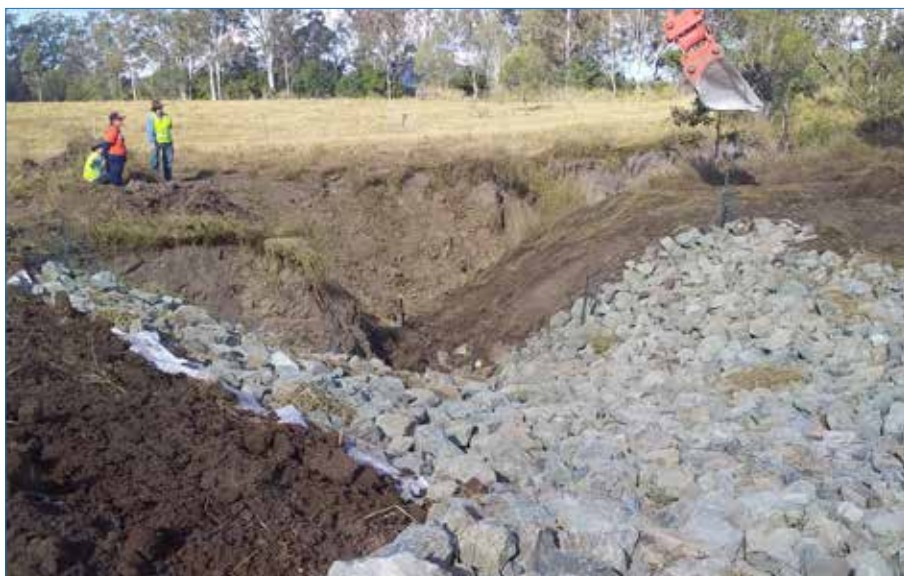
**Photo 76** Batter gully walls to encourage grass growth.

Both edges of the gully below the structure were battered at 1:1 for approximately 15 m to improve revegetation efforts. Tunnels were excavated, back-filled and compacted before the battering and bank construction was completed.

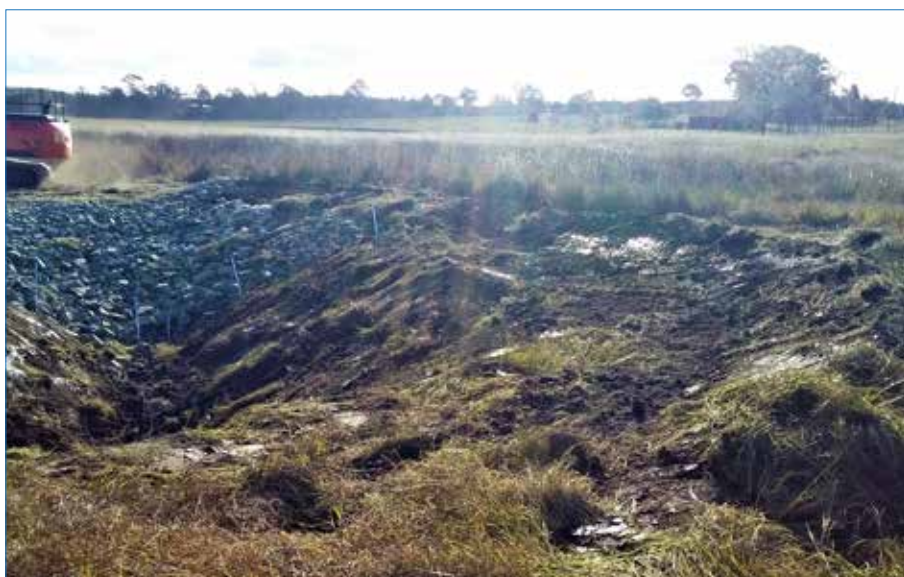
**Photo 77** Construct wing banks to direct flow over rock chute and to prevent creation of new tunnels.

Excess soil was retained and used to construct diversion wing banks at each side of the chute to direct flows over the rock chute. These banks were constructed to 1 m high.

The bank on the other side curved around the gully and captured water from the neighbour's paddock that was creating tunnels along that side of the gully wall. The end of the bank was again 0.6 m above the weir crest height.

To prevent banks eroding at the rock chute entry, banks were rock-armoured for a distance of 3 m and height of 0.5 m.

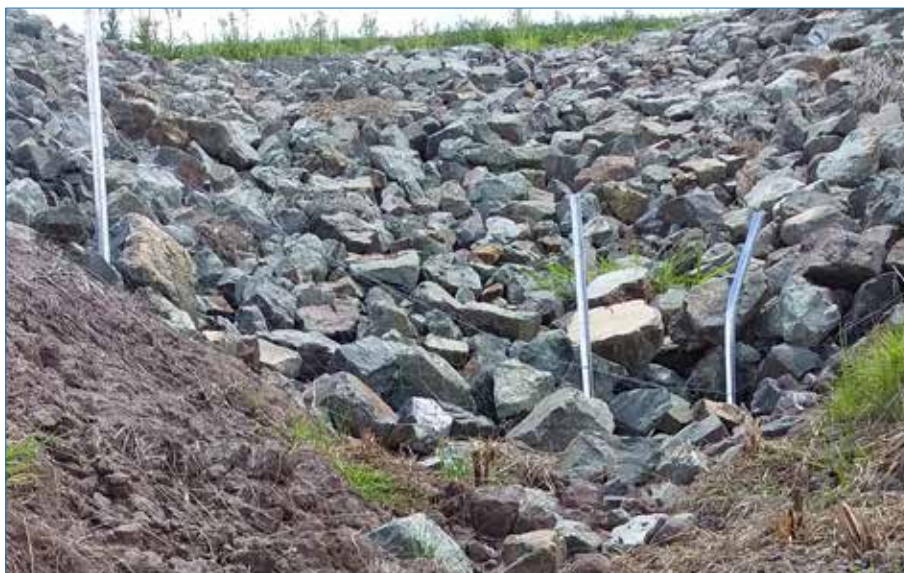
**Photo 78** Place large rocks at the base of the chute for energy dissipation.

Due to the steep narrow gully, it was impossible to construct a conventional 2 m wide energy dissipater at the bottom. Larger rock was placed in the narrow gully bed below the netting fence for approximately 5 m to reduce the 'waterfall effect' below the netting and provide some more energy dissipation.

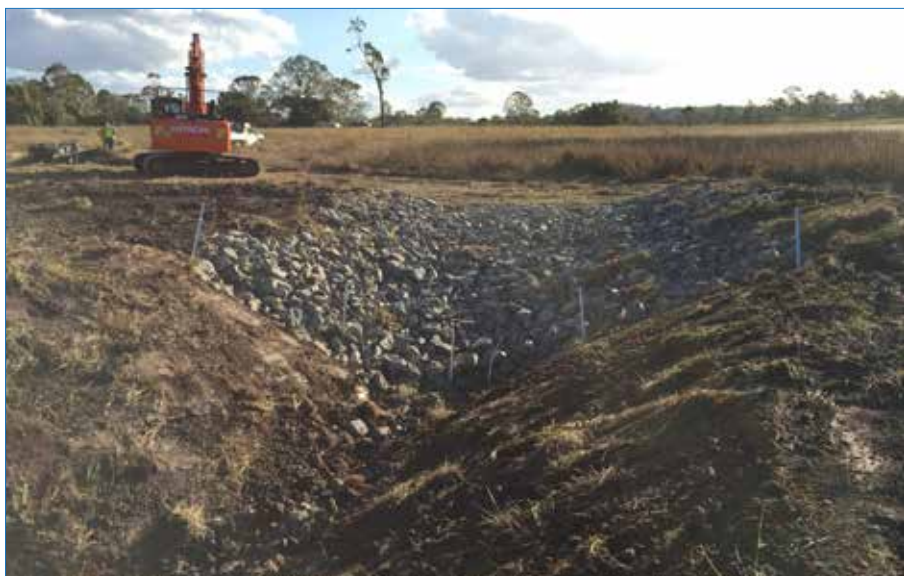
**Photo 79** Rock chute complete July 2020.

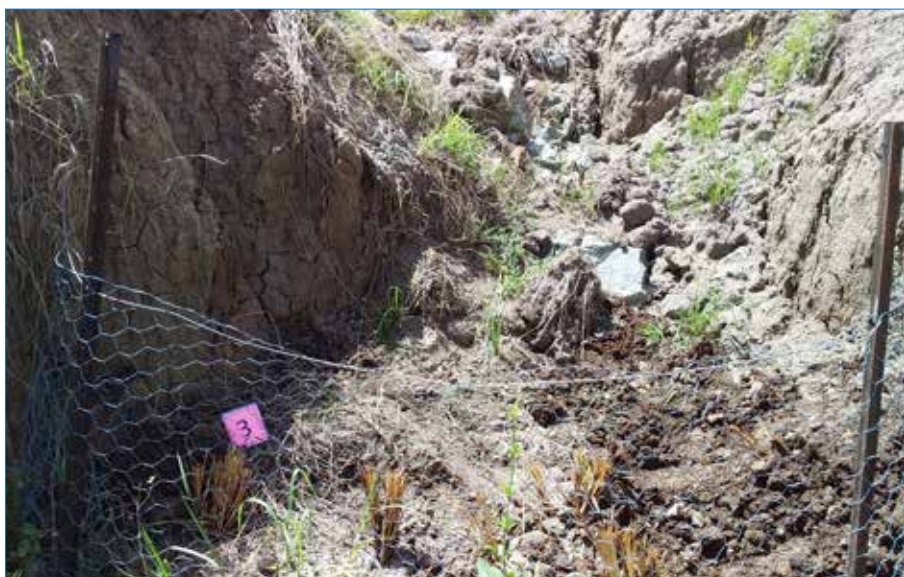
**Photo 80** Construct silt trap weirs in gully floor and plant pangola grass sods.

Two additional netting silt trap weirs were spaced at approximately 0.4 m vertical drops down the gully floor to assist with siltation and revegetation.

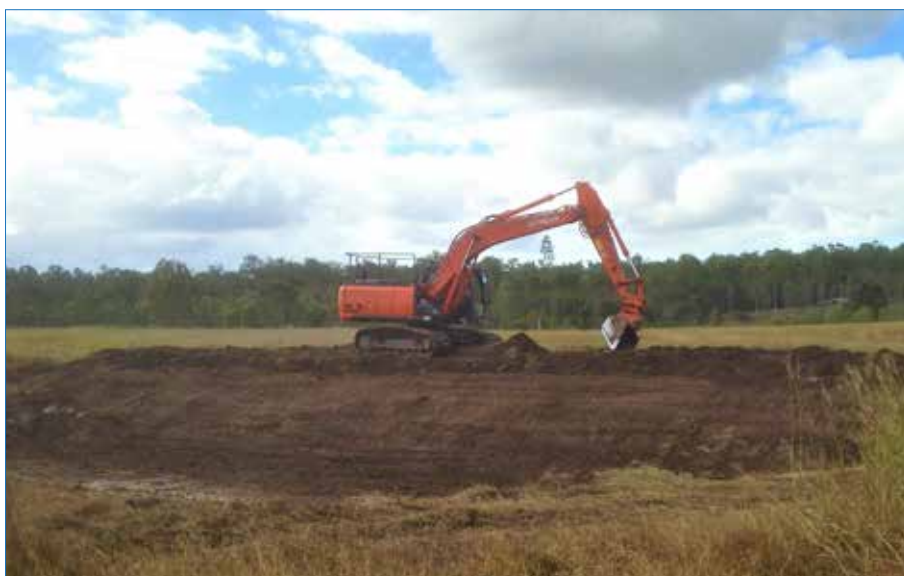
**Photo 81** Detention dam construction.

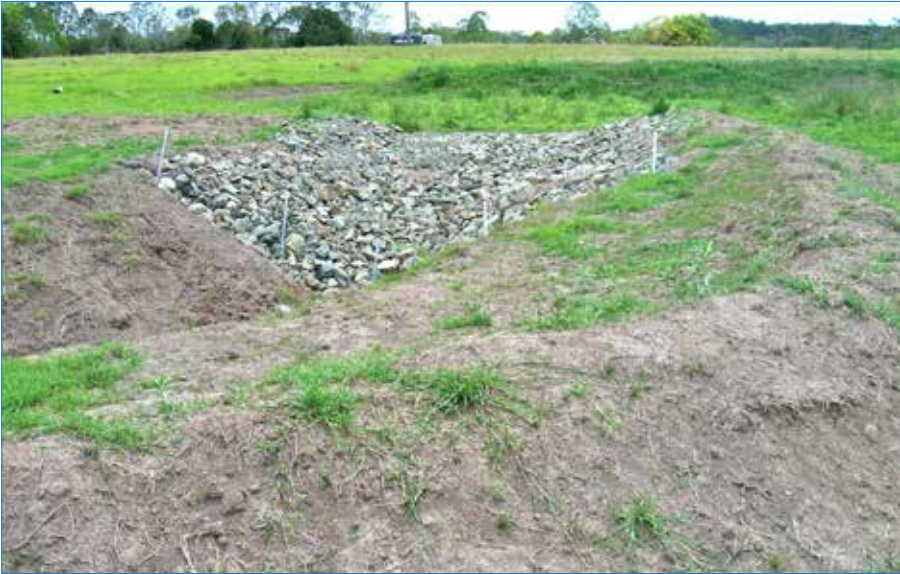
**Photo 82** Rock chute and dam wall looking upstream after rain. Ground cover is starting to establish.
