# Erosion gully rehabilitation

Adaptations and learnings from sites in the Mary River Catchment

By John Day, Becky Watson and Caitlin Mill  
Mary River Catchment Coordinating Committee

July 2023

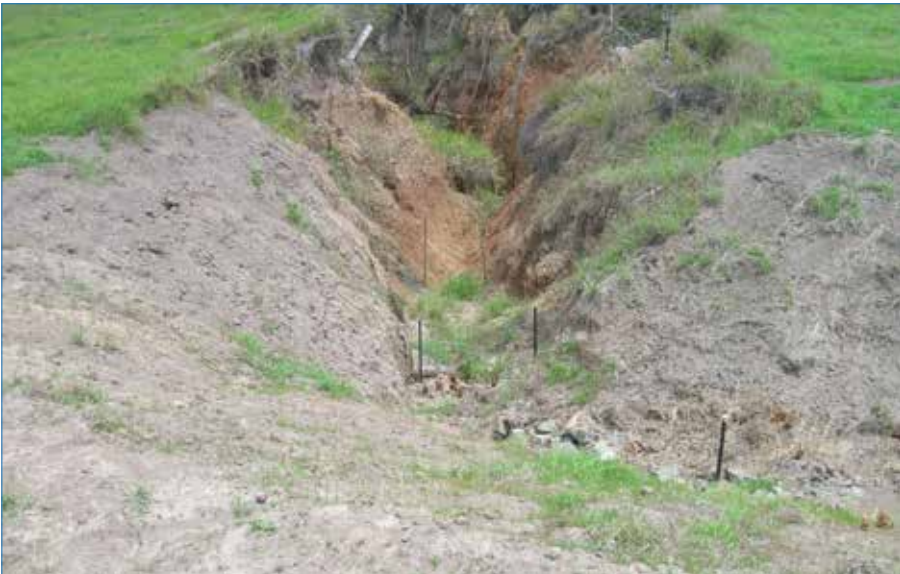
**Photo 83** Gully below chute after rain, showing netting weirs.

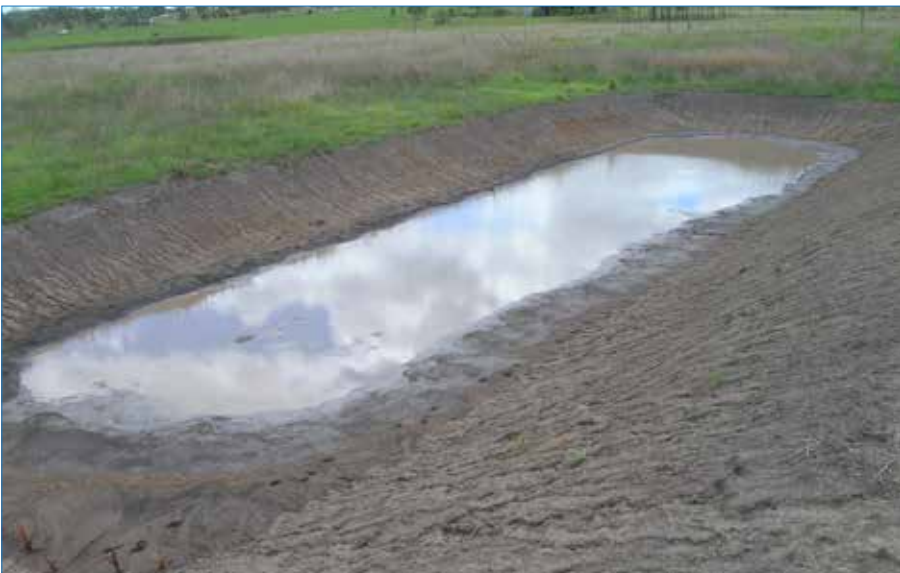
**Photo 84** Detention dam after first rain event.

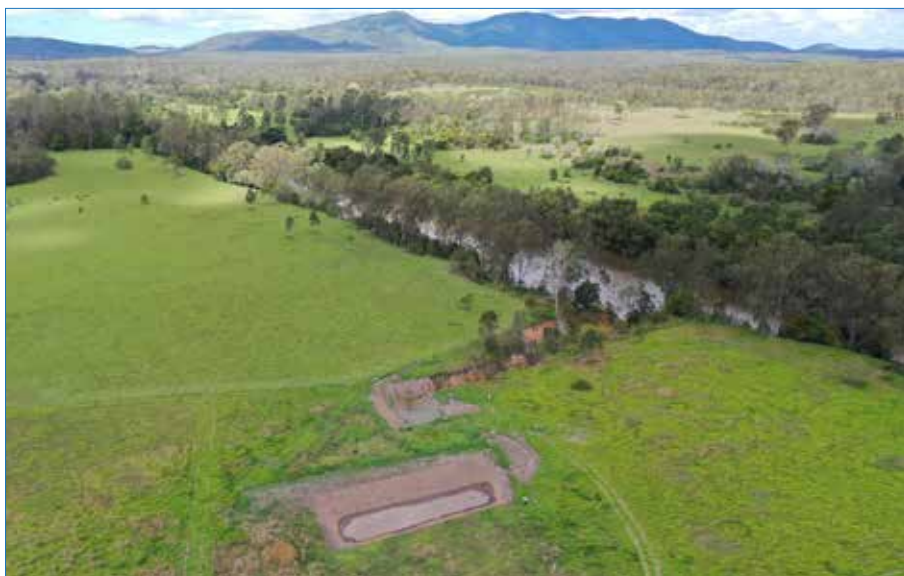
**Photo 85** November 2020 at the beginning of the first wet season.

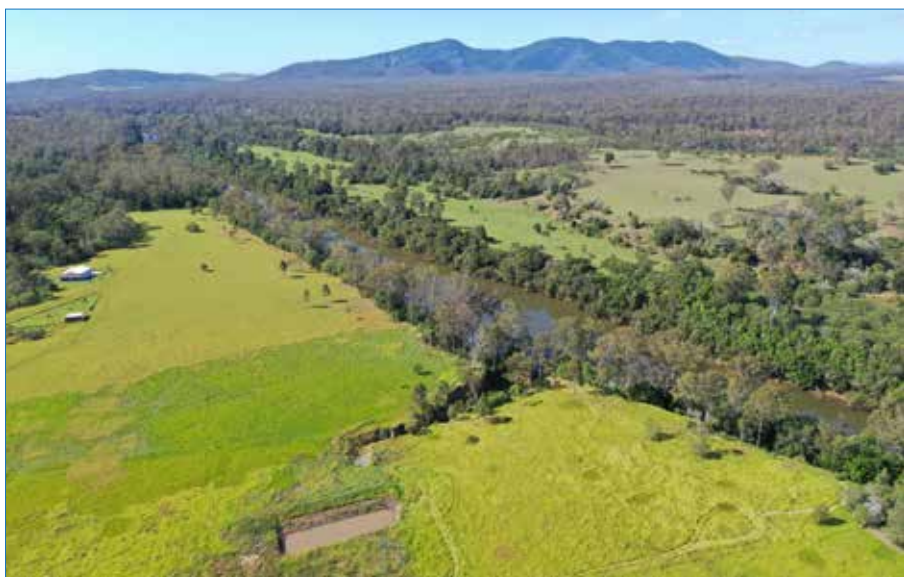
**Photo 86** May 2021 following one wet season.

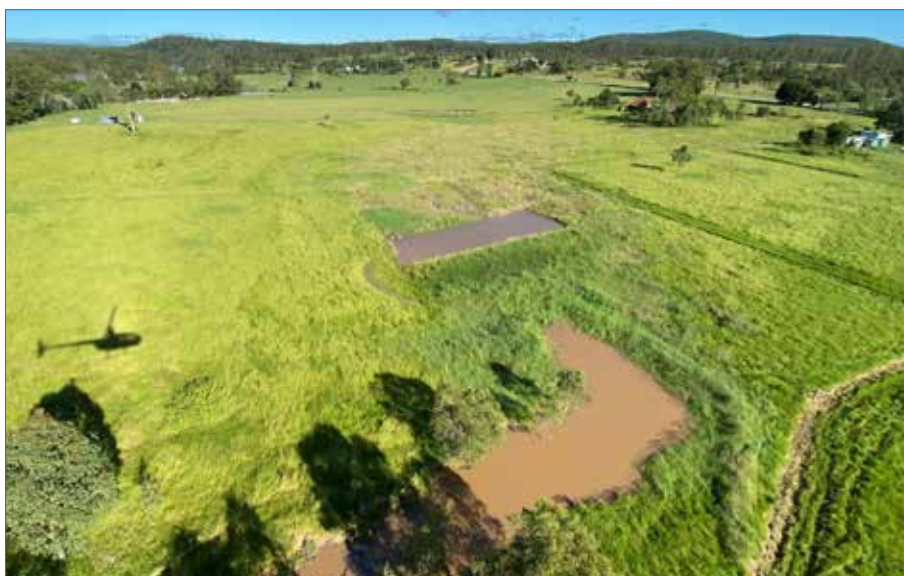
**Photo 87** February 2022 floods.

Bankfull in the gully system from the Mary River.

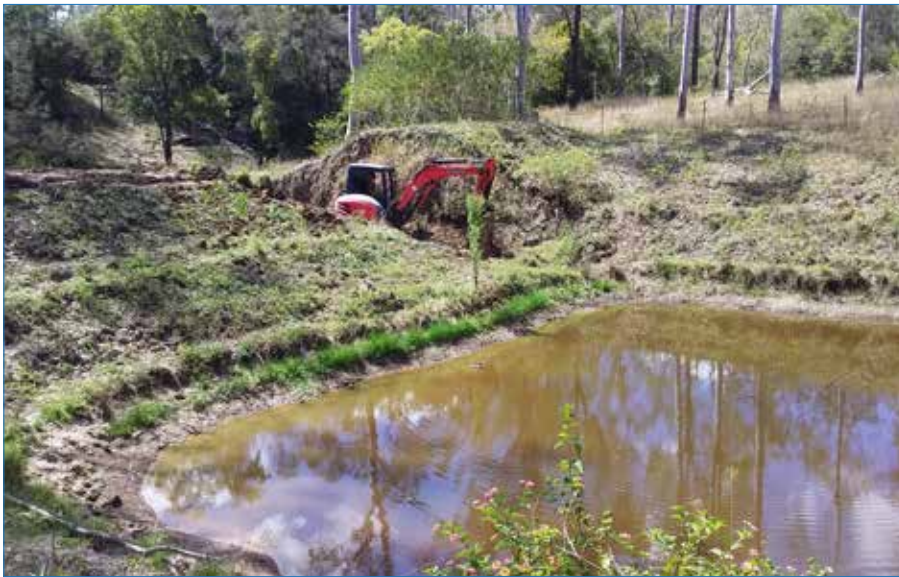
**Photo 89** Excavation of crest.

The first step was to fill and compact the gully while widening the gap in the broken wall to the design width of 25 m. During construction this width was reduced to 20 m to manage the costs and to complement the original shape and width of the stream bed. The rock chute was constructed longer and flatter to compensate for the width reduction.

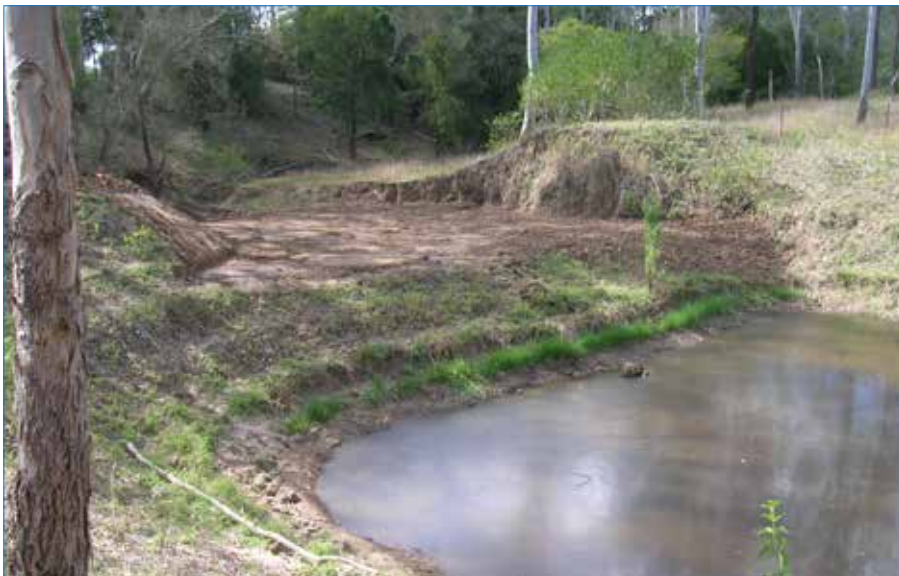
**Photo 90** Dam wall cut completed to design width.

The constructed gap was approximately 20 m at the upstream end and narrowed to 10 m at the downstream end of the gully cut. The remaining wall either side of the cut was battered back at 1:1. During this process the spoil was spread along the stream bank to above the normal flow height. This was done very efficiently with the skid steer.

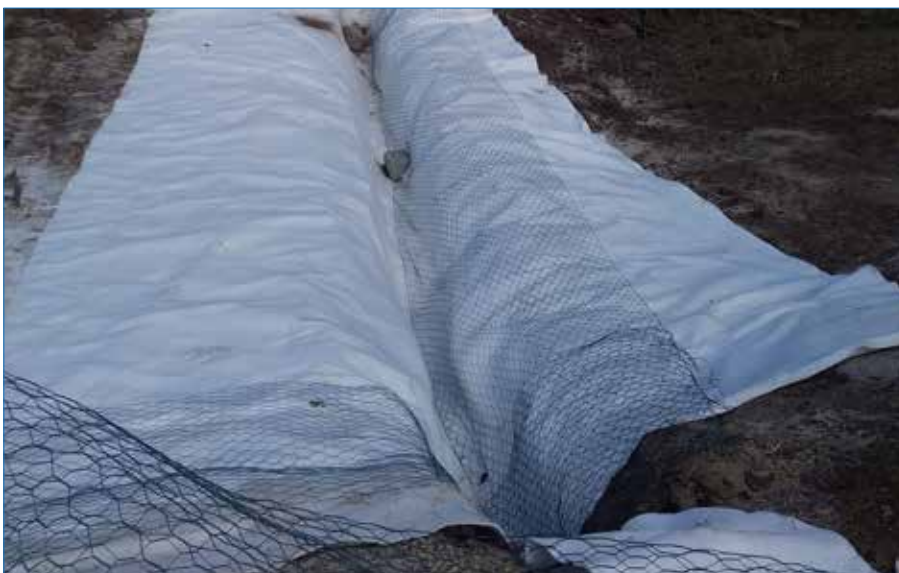
**Photo 91** Completed upstream cut-off trench with geofabric and inlaid with mesh – which secured the top mesh.

Cut-off trenches at least 0.5 m wide and 0.7 m deep (depth and width of bucket) were constructed on both ends of the levelled cut through the dam wall. Bentonite was broadcast at 10 kg/m<sup>2</sup> over the top of the whole levelled foundation to provide an impervious base layer to the structure.

Then a 10 cm layer of high clay gravel was spread over the full cut and trenches. Geofabric was laid into the trench allowing 2 m overlap and inlaid with 1.6 mm galvanised mesh. The trench was half-filled with small rock to ensure tight compaction and minimise running water contacting the subsoil.

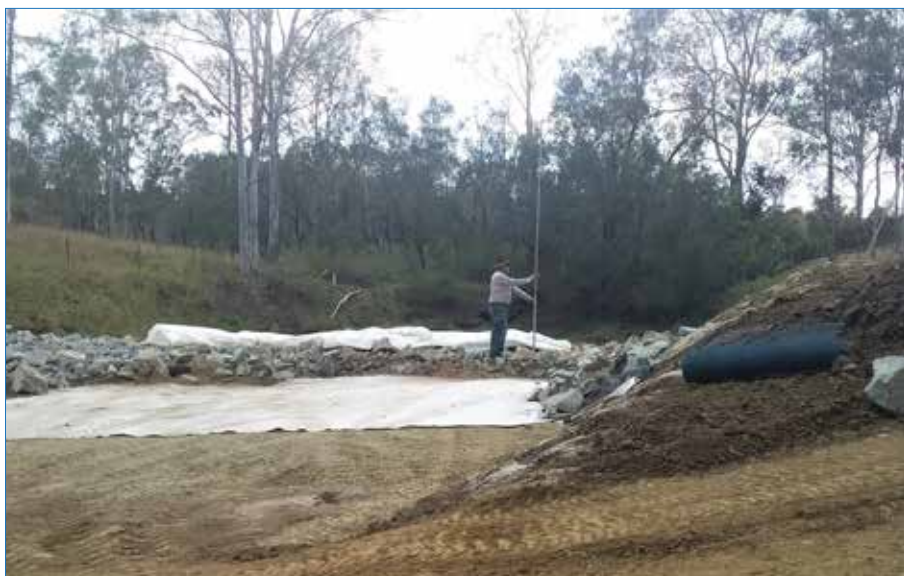
**Photo 92** Layering – first bentonite, gravel, Texcel 400R fabric then rock. Continuous surveying to ensure rock mattress was level across the width.

The layering work started with the upstream section and progressed downstream so the excavator did not travel over the geofabric.

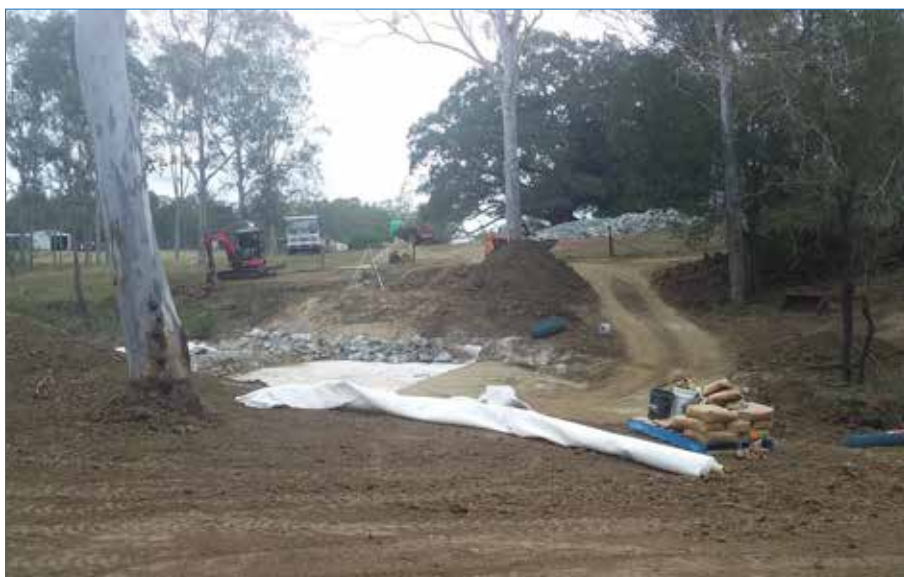
**Photo 93** Placement of materials.

The rock used was a mix of 100 mm to 400 mm that was mixed on-site as it was laid. The larger rock first with the gaps filled with the smaller rock.

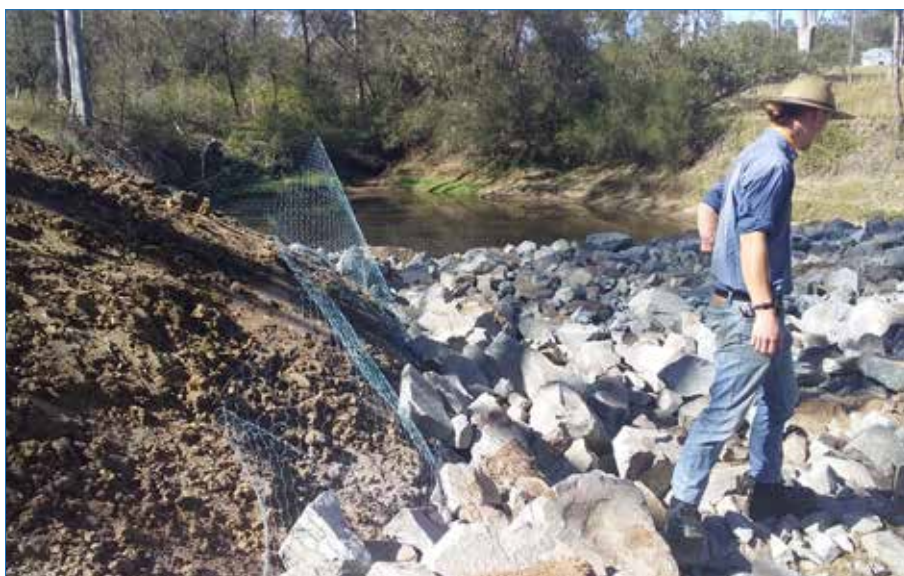
**Photo 94** Netting placed along the batter before adding rock to hold it in place.

Secured netting along the batters to provide the anchor point for attaching the final netting.

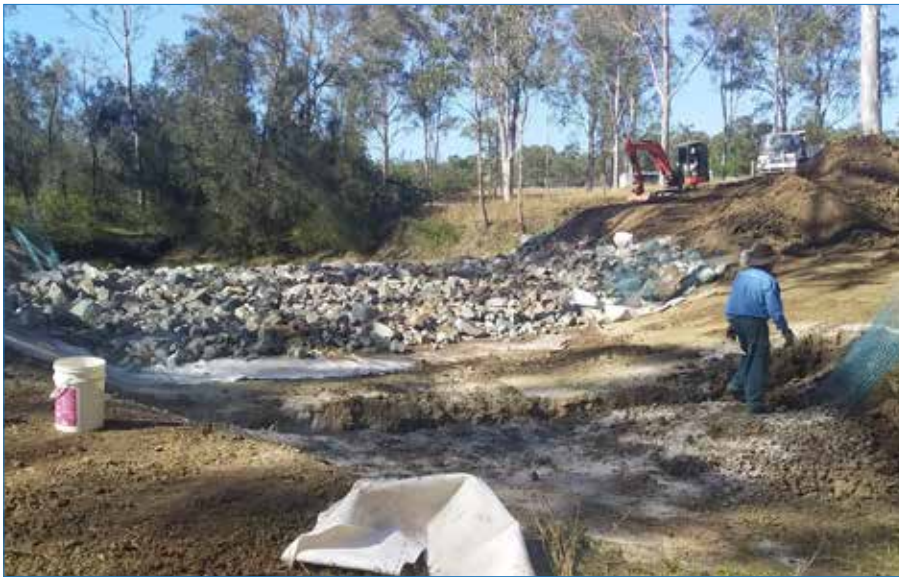
**Photo 95** Looking upstream – shows the position of netting and rock mattress.

Netting and rock was laid so it extended 1.5 m up the walls of the battered sides to ensure the exposed soil was covered by rock to protect the wall in the event of a deep flow passing through the structure.

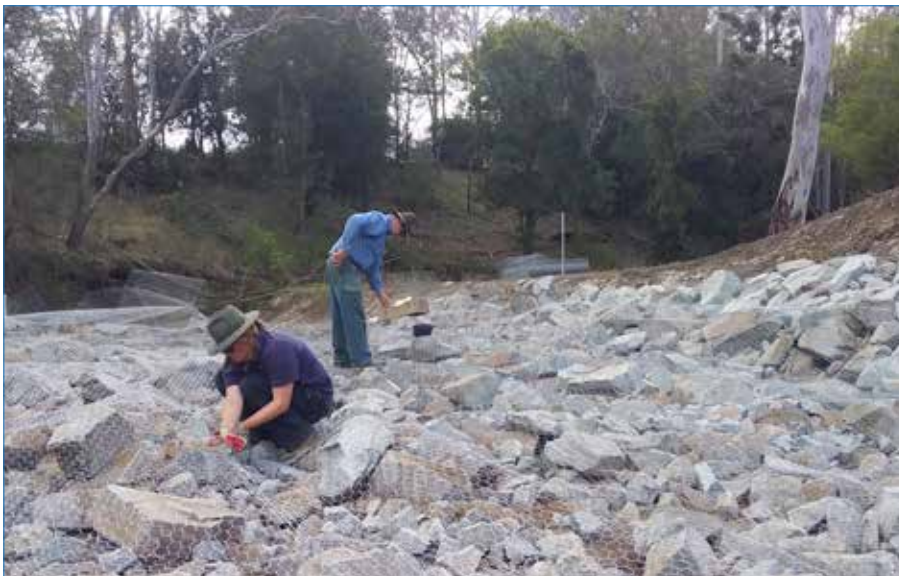
**Photo 96** Covering the rock mattress with netting and stitching the overlapping lengths together starting at the upstream end.

A length of netting was secured in the bottom cut-off trench as an anchor point and back-filled with rock. Netting strips were placed starting at the upstream end and working downstream, with a half metre overlap. Soft 2.5 mm plain wire was used to lace each end for 6 m, tying off to netting secured in the trenches and along the batter. The remaining distance (10 m) in the middle of the structure was clipped to save time. Clipping alone has failed at other sites.

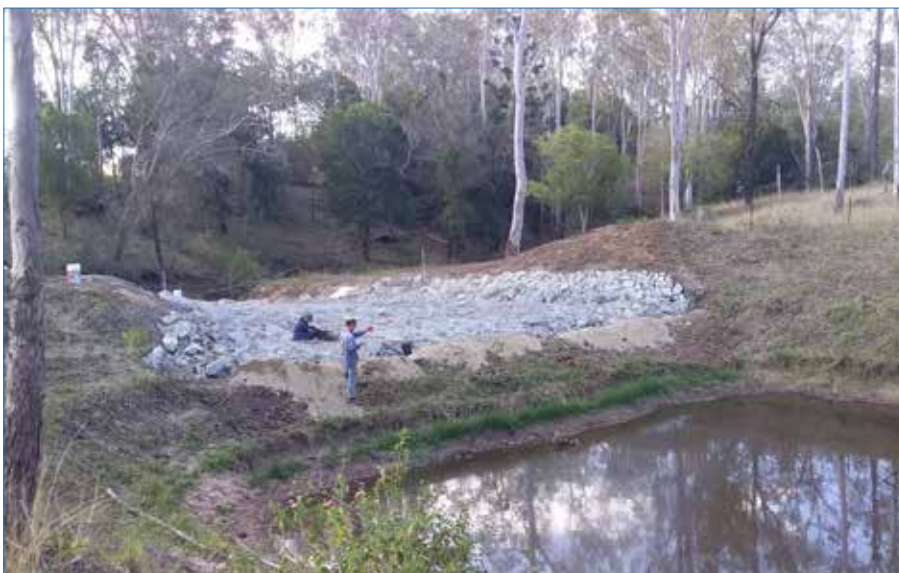
**Photo 97** Gravel placed along the top cut-off trench was then shovelled by hand into the trench to fill cavities.

The laced netting provides robust and secure entry and exit points to the structure where the erosivity is greatest.

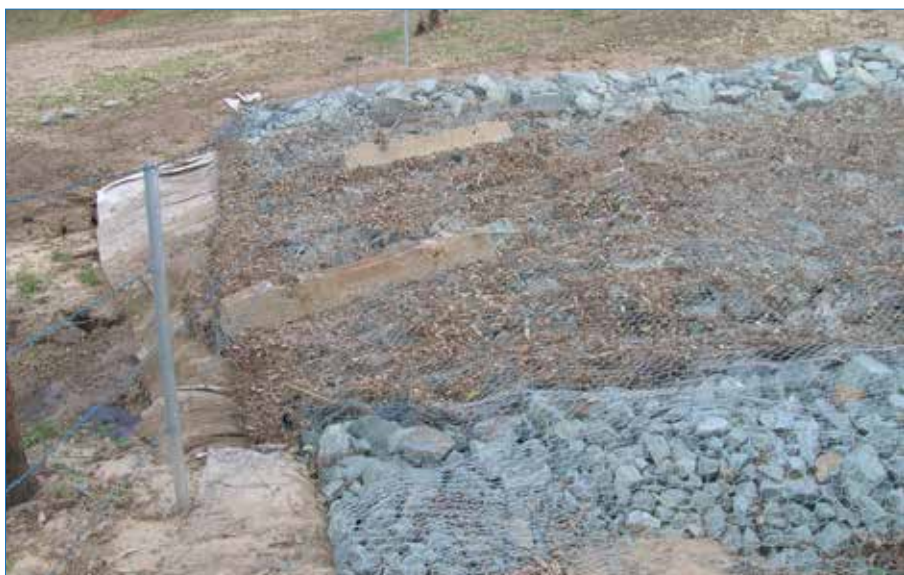
**Photo 99** Downstream end of the mattress after the first rain event.

Concrete sleepers were used to hold the fence in place. They remained in place following the rain event.

The deposition of some silt in the foreground was of note. Silt captured in the rock and netting will provide some growing medium for grasses to colonise the site.

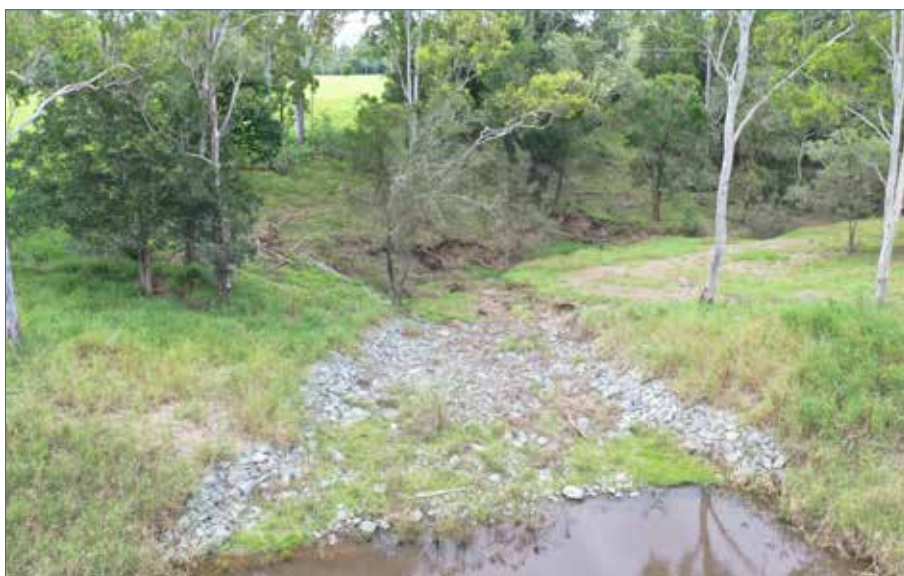
**Photo 100** February 2022 – after major flooding.

Ground cover is well established over the entire site. Livestock remain excluded from the site.

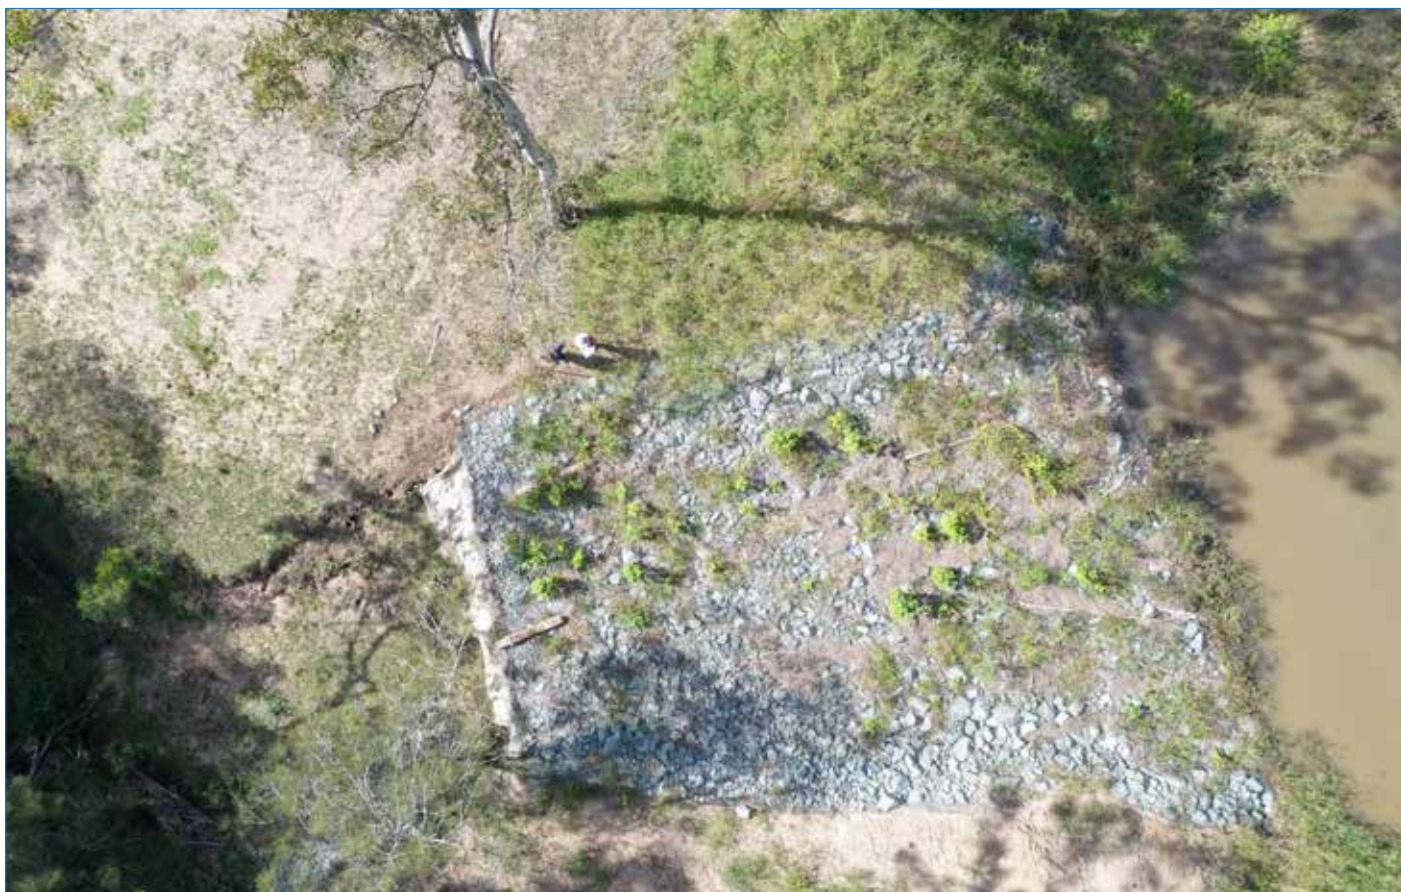
**Photo 101** Aerial image illustrating the extent of ground cover over the site.

It is evident that the adjacent paddock has less ground cover due to grazing pressure.

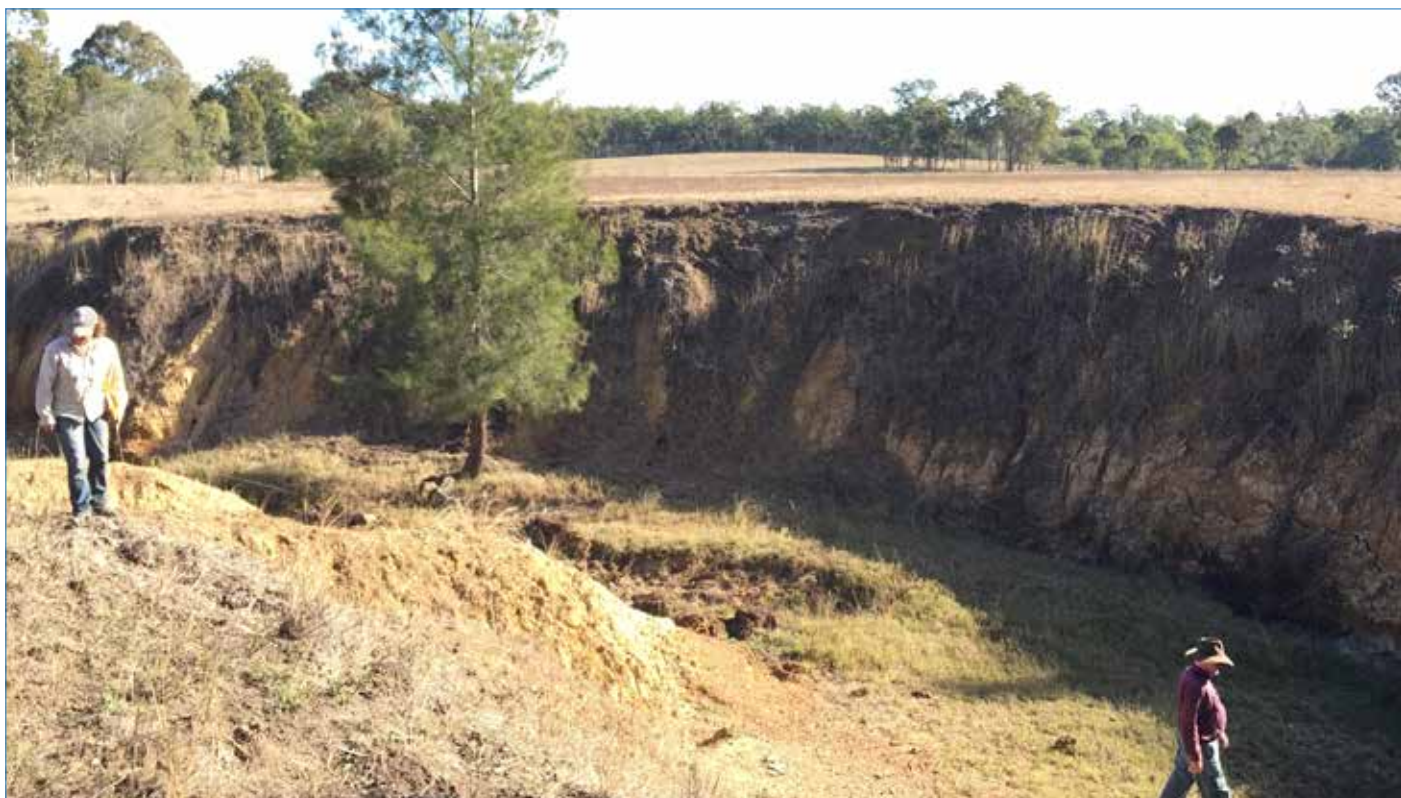
**Photo 104** Standing on the dam wall looking into the by-wash, for size perspective.

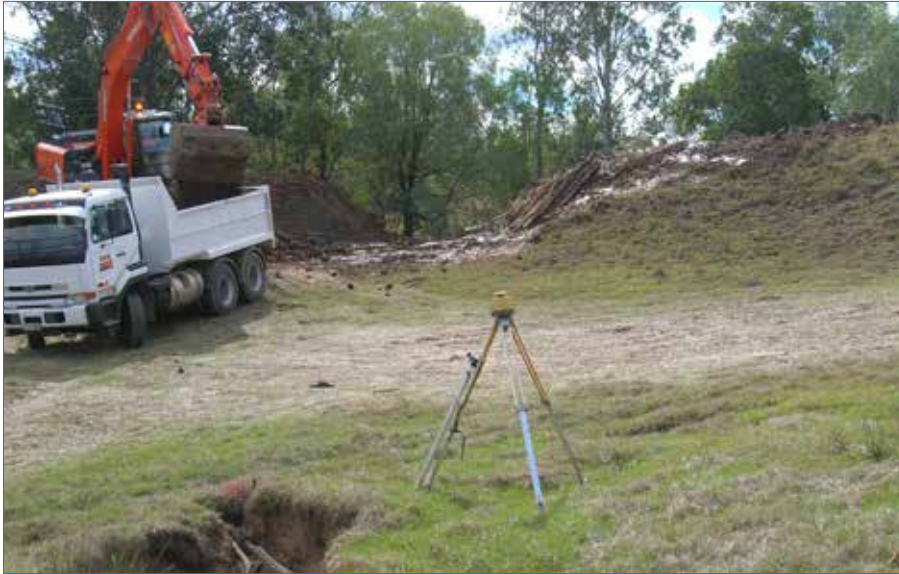
**Photo 105** Excavation through wall half completed.

Surveyed to ensure water will flow through the level sill and not pond upstream.

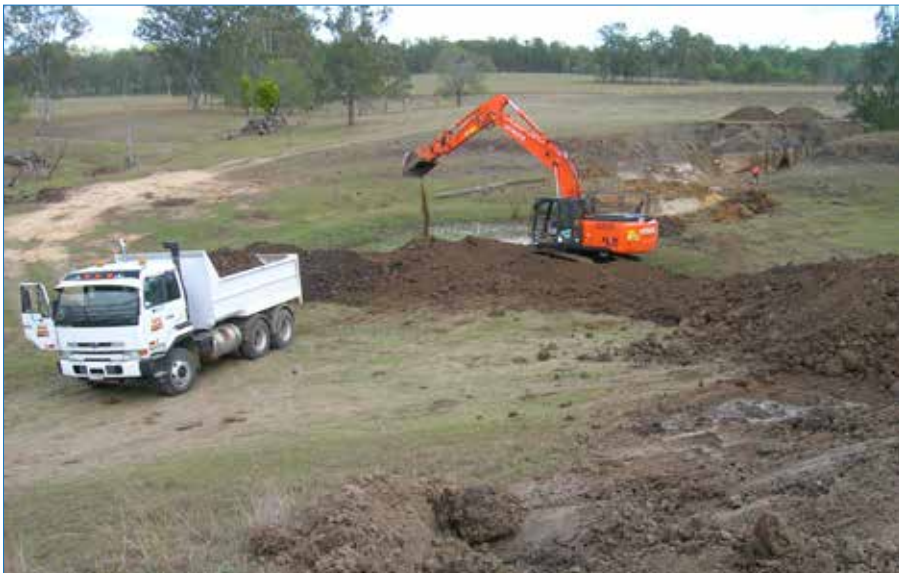
**Photo 106** Draining the waterhole and backfilling with excavated material from the dam wall.

A small channel was excavated from the waterhole to the by-wash. Material from the dam wall excavation was used to fill the waterhole, pushing the water out through the excavated channel.

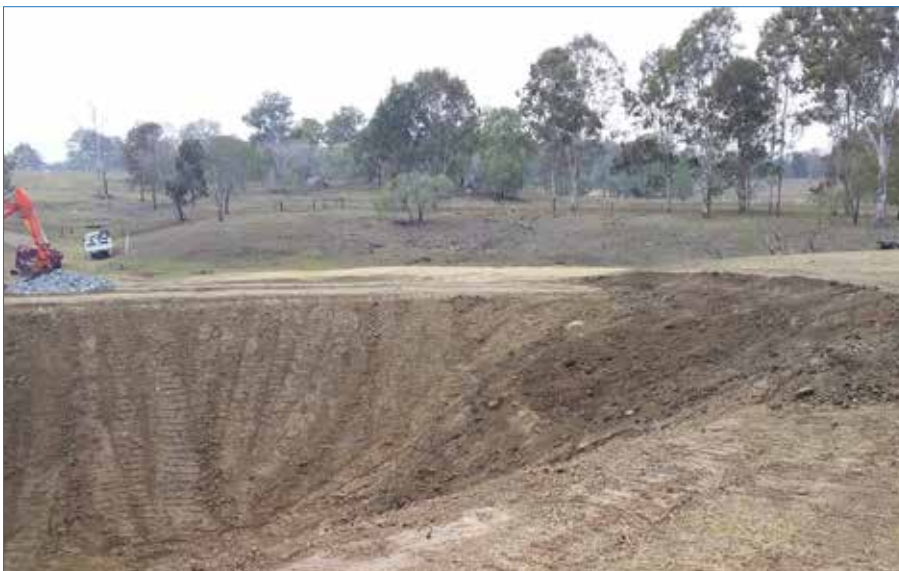
**Photo 107** By-wash end sealed, creating an extension to the old dam wall. Diversion bank constructed to redirect overland flow.

Soil was transported to form a bund wall across the failed by-wash. All water is diverted back into the original drainage line through the constructed dam wall break.

A 0.6 m high diversion bank was constructed to run parallel with the by-wash on the western side. This aims to redirect overland flow from the flats to a small rock chute.

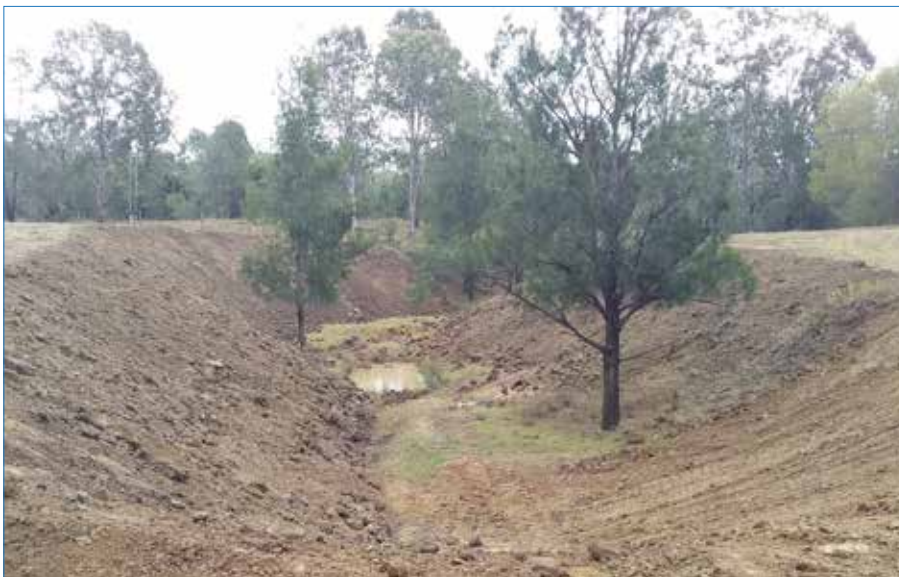
**Photo 108** By-wash gully walls battered and topsoiled.

The vertical edges of the eroded by-wash were battered to 1:1 and then covered with the topsoil that was removed during battering.

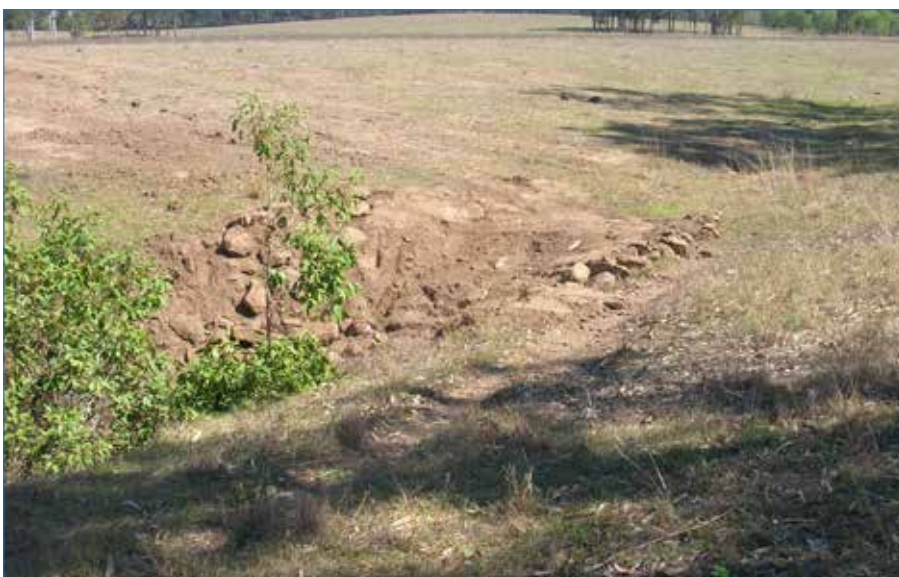
**Photo 109** Small gully on the end of the by-wash stabilised with rock-fill chute (using locally sourced larger rock and gravel).

A small gully on the north-western end of the gullied by-wash was also filled with rock and topsoiled so all eroded sites around the gullied area were stabilised during the construction.

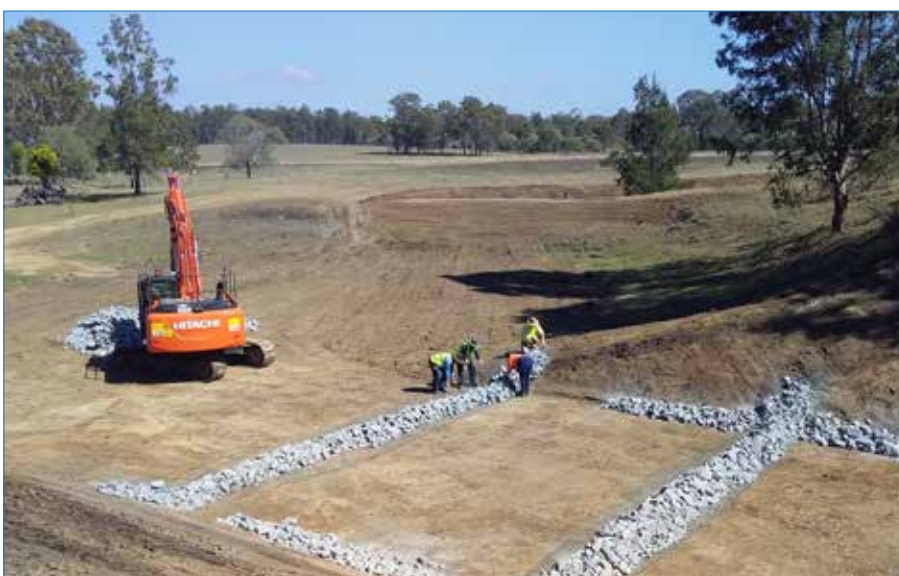
**Photo 110** Rock weirs evenly spaced along the excavated site.

Four rock weirs were positioned evenly along the excavated channel. They were 30 m in length, extended 1.5 m up the batter and were 1 m wide. Rip rap rock (100–200 mm) was used. Each weir was wrapped in galvanised wire netting to hold the small rock in place during flow events.

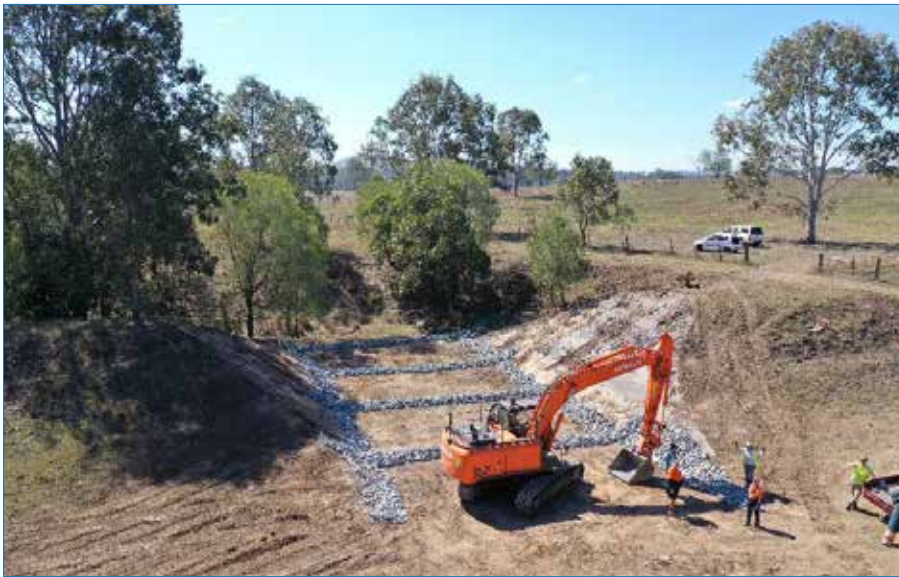
**Photo 111** Completed: Looking downstream on the cut through the dam wall.

Batters at approximately 1:1. Cut through dam wall is dead level back to front and side to side. Rock armouring to 1.5 m on the batter inlet edges and extensions of the weir ends up the batter reduce the chance of erosion during high flow events.

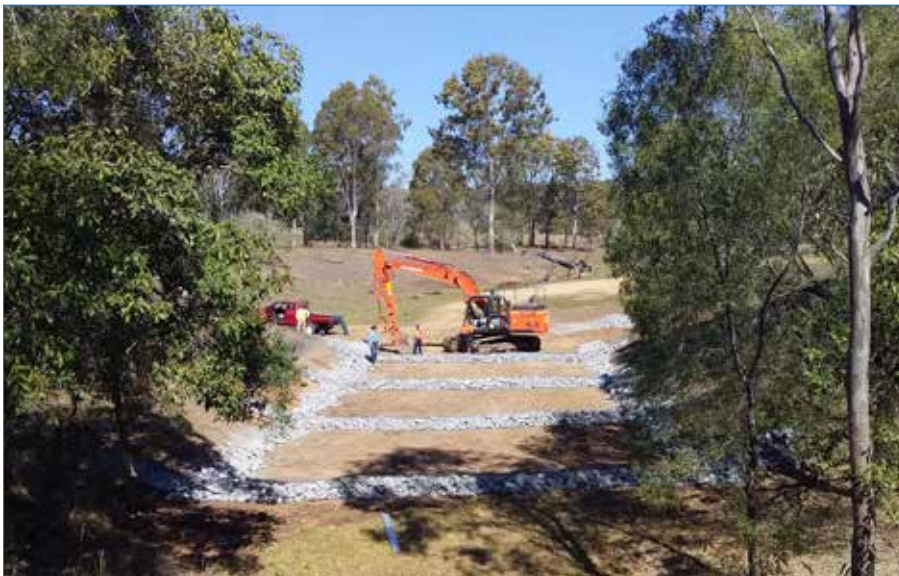
**Photo 112** Completed: Looking upstream through the cut in the dam wall that reinstates the original flow path.

Note retention of grass below the rock ~~groynes~~ to ensure as much stability as possible as the flow concentrates again to join the narrower stream below.

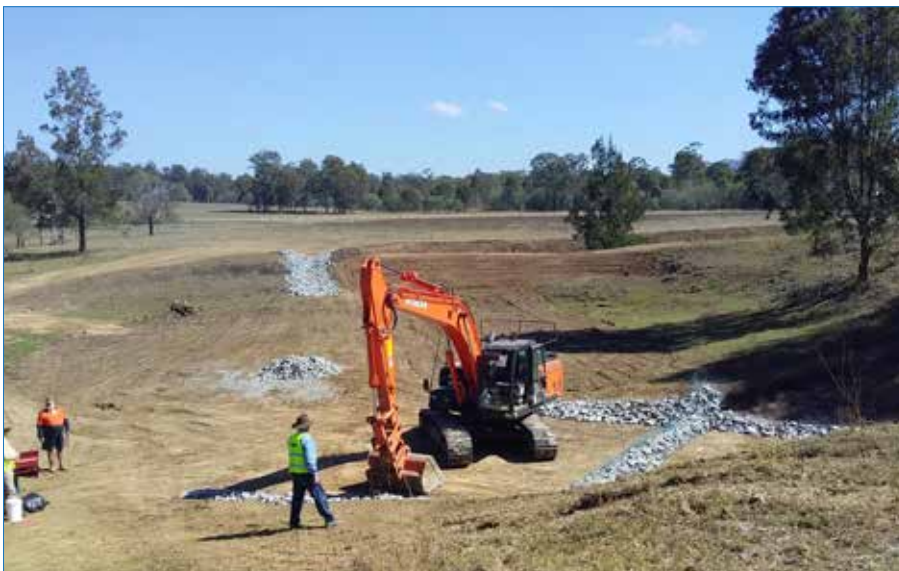
**Photo 113** Completed: from the top rock chute captures water from overland flow.

- filled by-wash end
- filled and levelled waterhole
- surplus rock for any repairs
- reinstated flow path with rock weirs.

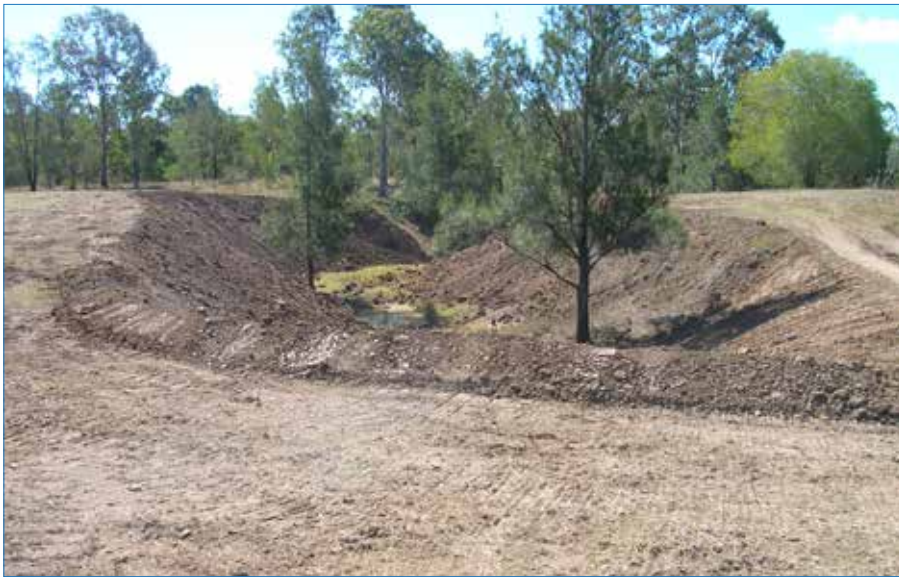
**Photo 114** Completed: looking down the old by-wash.

Note the filled by-wash entry point on the right. The diversion bank in the foreground directs flows off the flats and down the rock chute.

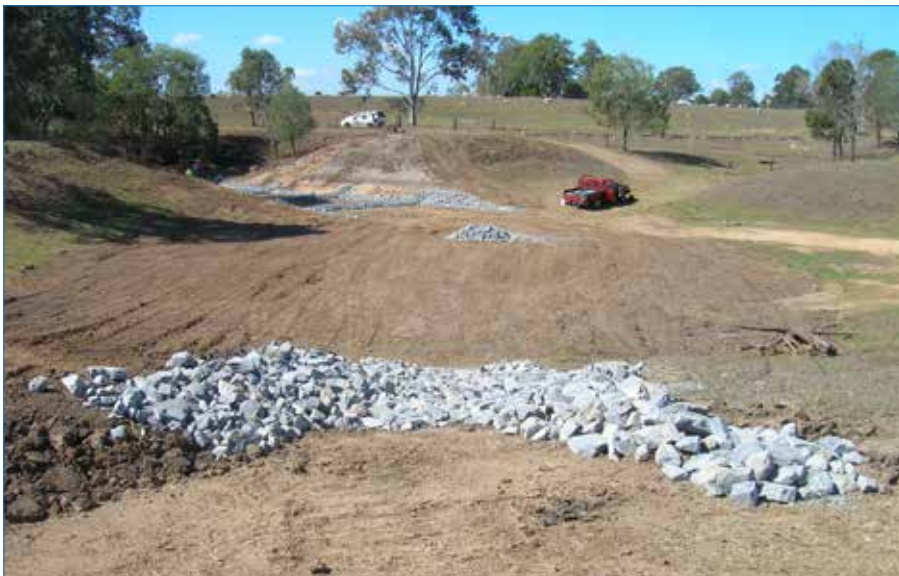
**Photo 115** Completed: looking from the rock chute constructed to take the water from the flat down to the stream bed.

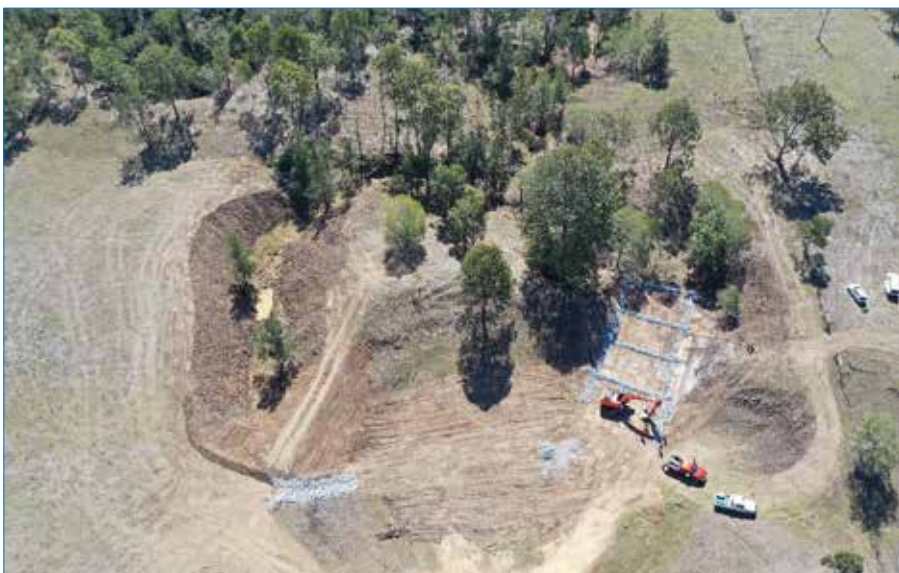
**Photo 116** Completed August 2020.

Note the position of the diversion bank along the by-wash top bank to divert water from the flats.

To ensure further gullying does not occur at the end of this bank, the landholder will need to be vigilant in sealing any signs of rilling.

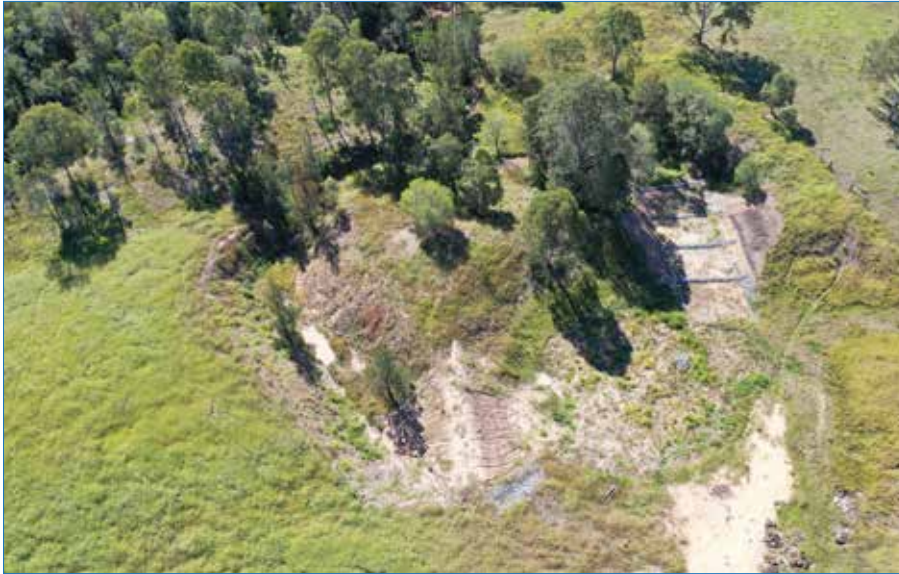
**Photo 117** May 2021 – post wet season.

Nine months since construction. Some rilling has occurred over the wet season. More grass seed was applied to the exposed areas.

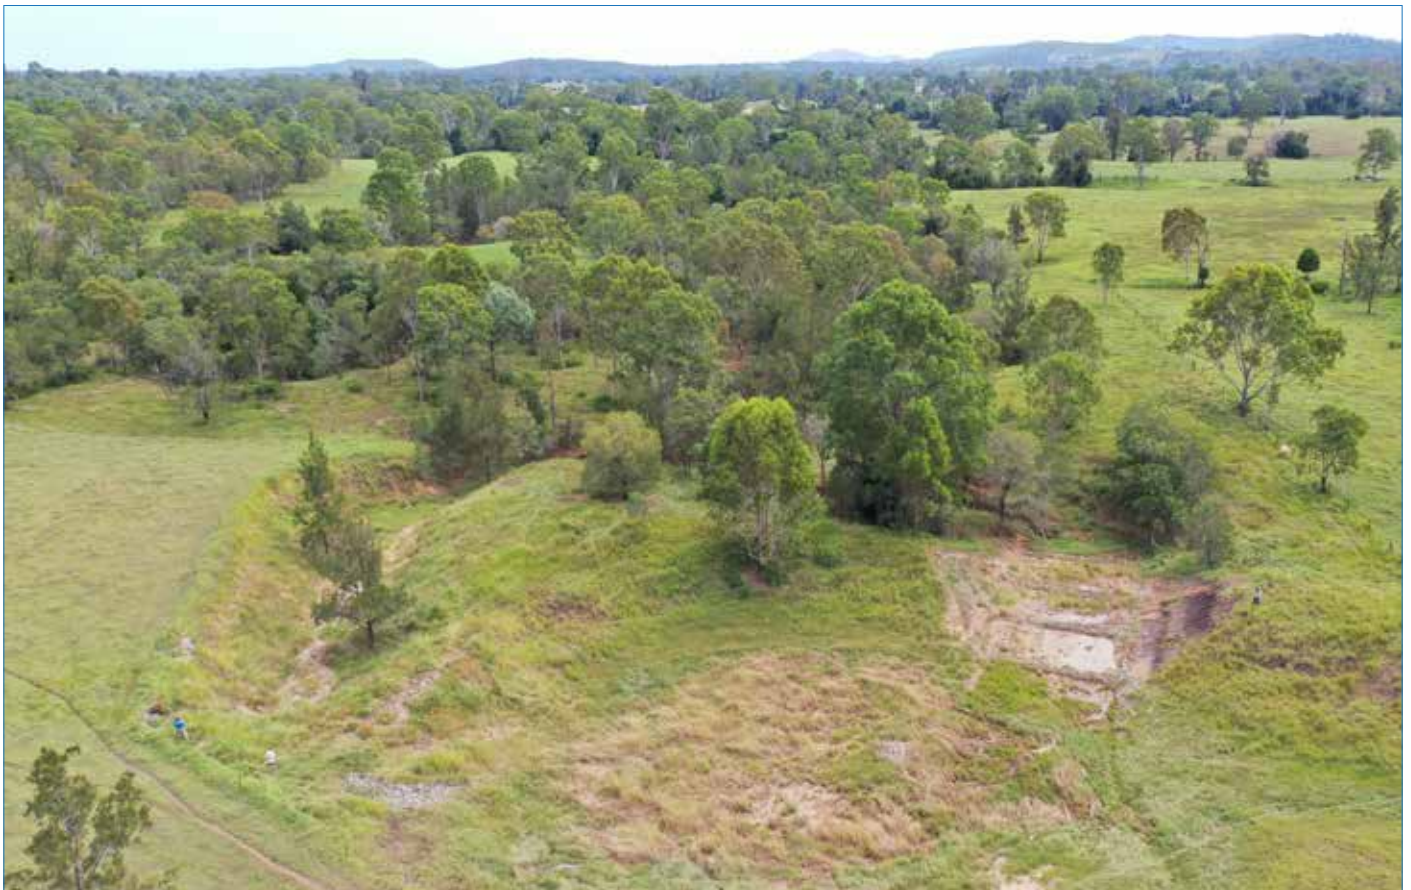
**Photo 118** February 2022 – mid wet season.

There was no significant damage to the structures following the 2022 floods. Most of the site has grass cover. The batters on the dam wall cut are still bare but stable.

Overland flow from the flats broke the diversion bank on the downstream side of the by-wash bund and caused some erosion. The landholder will extend the diversion bank to again take the flows down the rock chute on the upstream side of the bund wall.

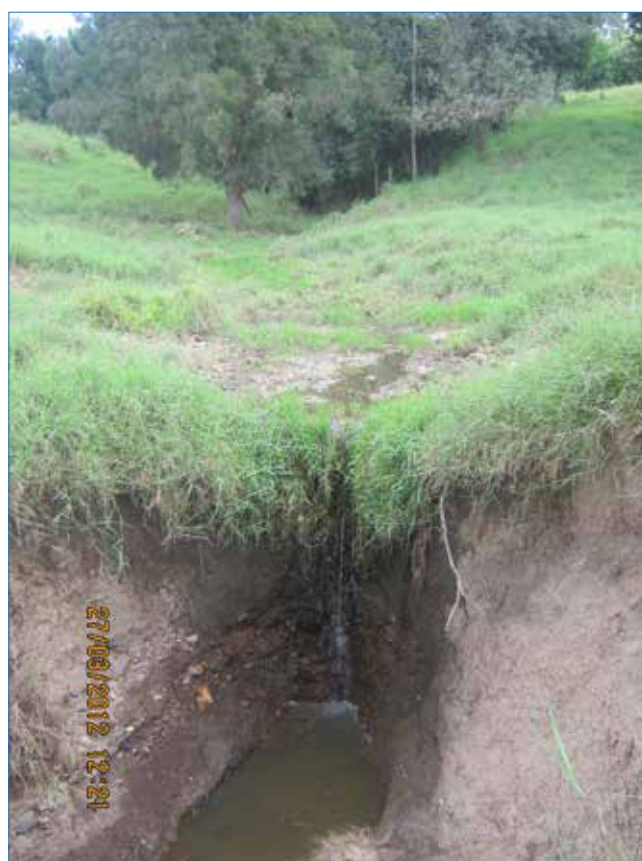
This site becomes inundated in medium to major flood events. The narrow, deep gully shape limits the crest length and restricts access to the gully floor. There was insufficient room to accommodate a rock chute and farm vehicle access.

**Photo 119** Gully head March 2012.

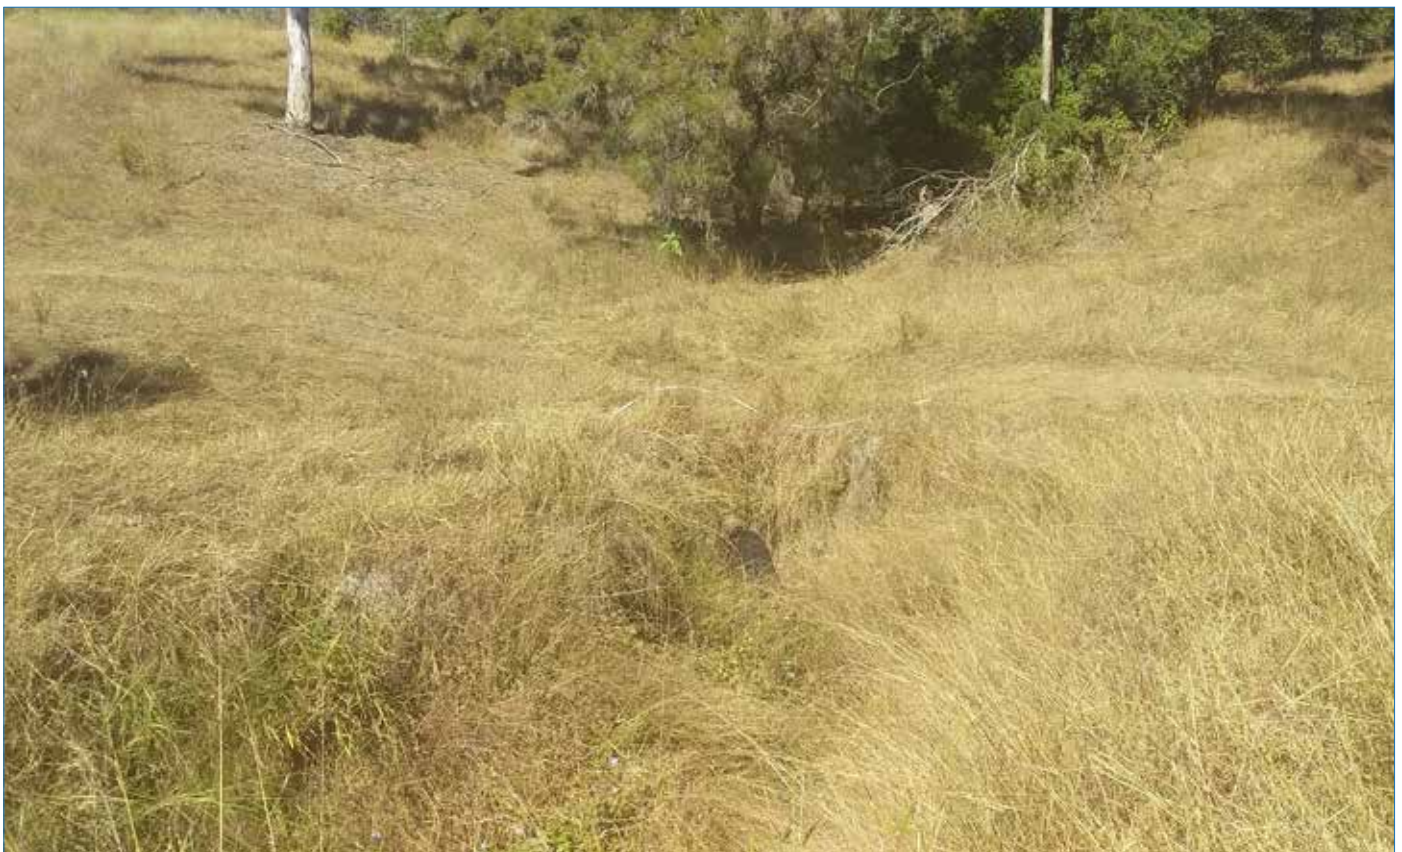
**Photo 120** Gully head prior to rehabilitation in 2020.
