# Erosion gully rehabilitation

Adaptations and learnings from sites in the Mary River Catchment

By John Day, Becky Watson and Caitlin Mill  
Mary River Catchment Coordinating Committee

July 2023

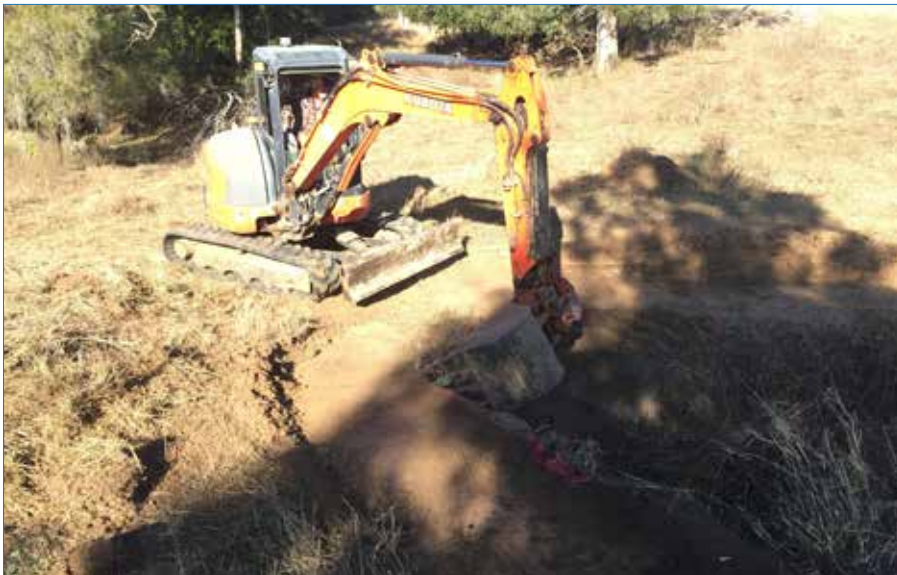
**Photo 121** Shaping the gully head and removing any overhangs and grass sods.

The 16 m crest was levelled to a width of 1.5 m while removing the topsoil, any overhangs and the grass from the gully head and walls below the crest.

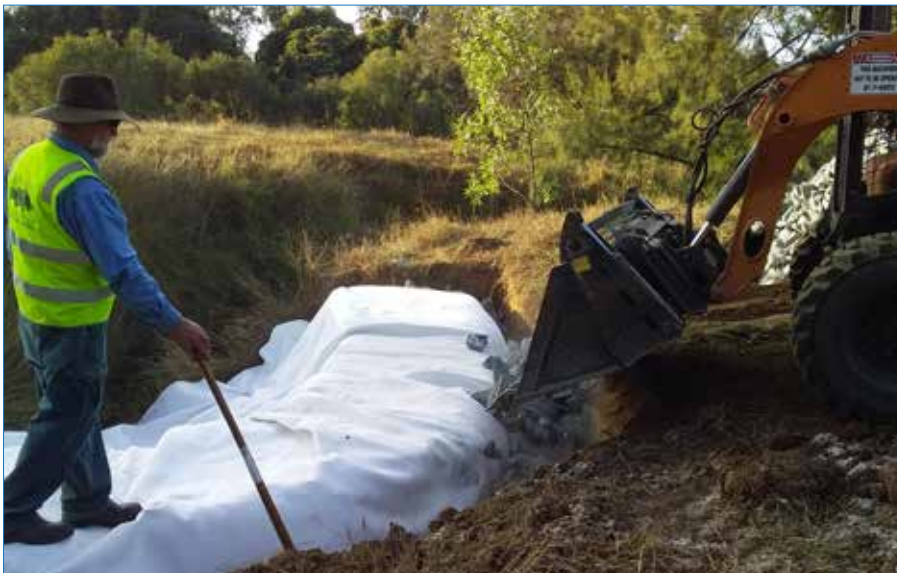
**Photo 122** Excavated top cut-off trench and geofabric shaped over the gully head.

A cut-off trench was constructed 0.5 m by 0.5 m, 1 m upstream from the lip of the gully head. A similar cut-off trench was constructed across the gully bottom and up the sides to meet with the ends of the top trench.

The top trench, the exposed subsoil lip around the level crest, the gully bed and bottom cut-off trench were lined with the geofabric (Texcel 400R). A single sheet of 6 m wide geofabric was stretched and arranged to create a smooth curtain over the gully head and walls.

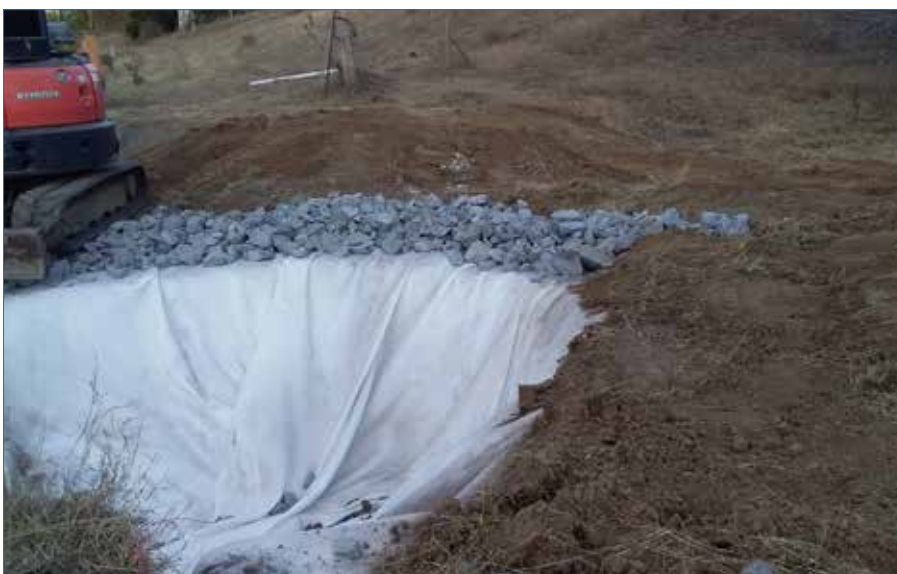
**Photo 123** Top cut-off trench filled with rock.

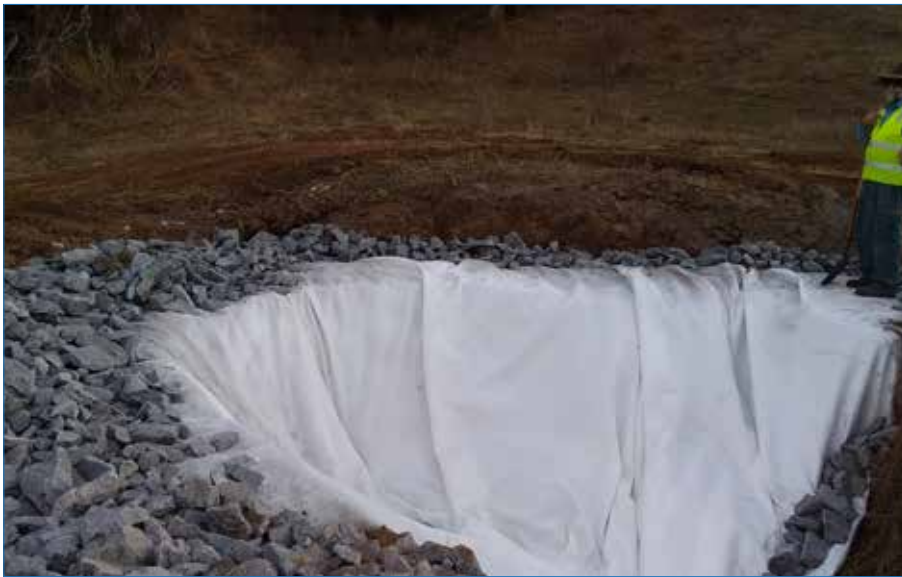
**Photo 124** Top and bottom cut-off trenches and side wall trenches filled with rock.

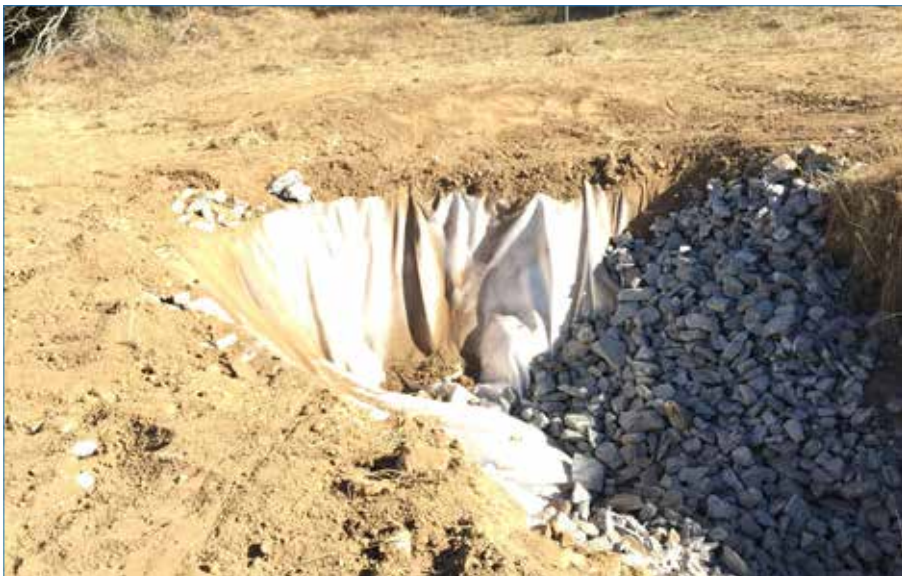
**Photo 125** Covering the cut-off trench rock-fill with topsoil to encourage revegetation.

At this site there was excess rock available, so it was spread over the gully floor and walls and below the bottom cut-off trench.

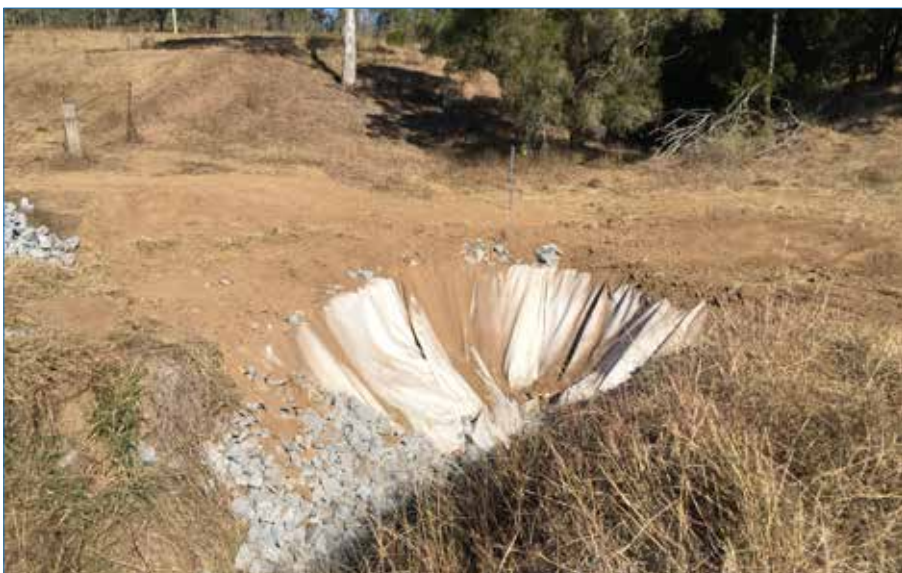
**Photo 126** Drop structure completed – looking upstream.

The soil taken from the gully head shaping and cut-off trenches was used to cover the top cut-off trench rock-fill to encourage rapid grass growth.

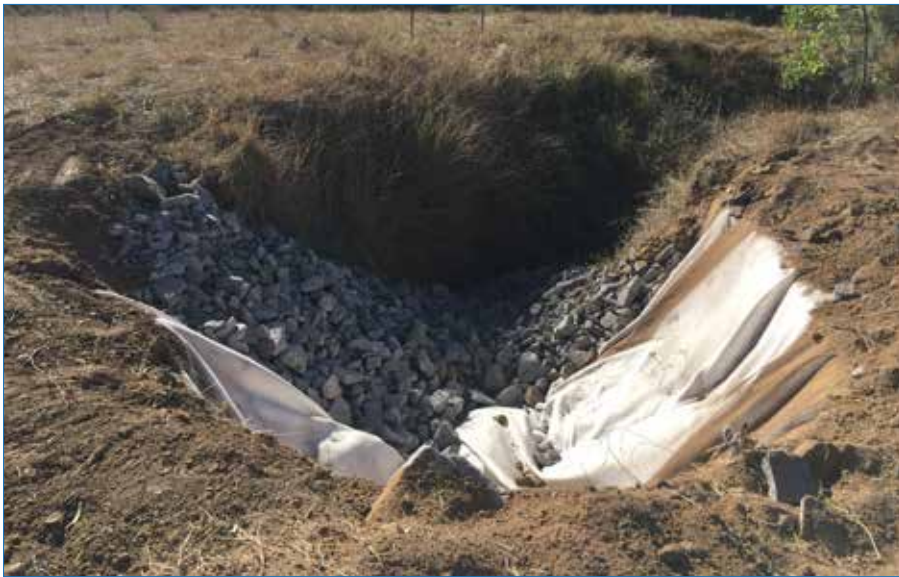
**Photo 127** Drop structure completed – looking downstream.

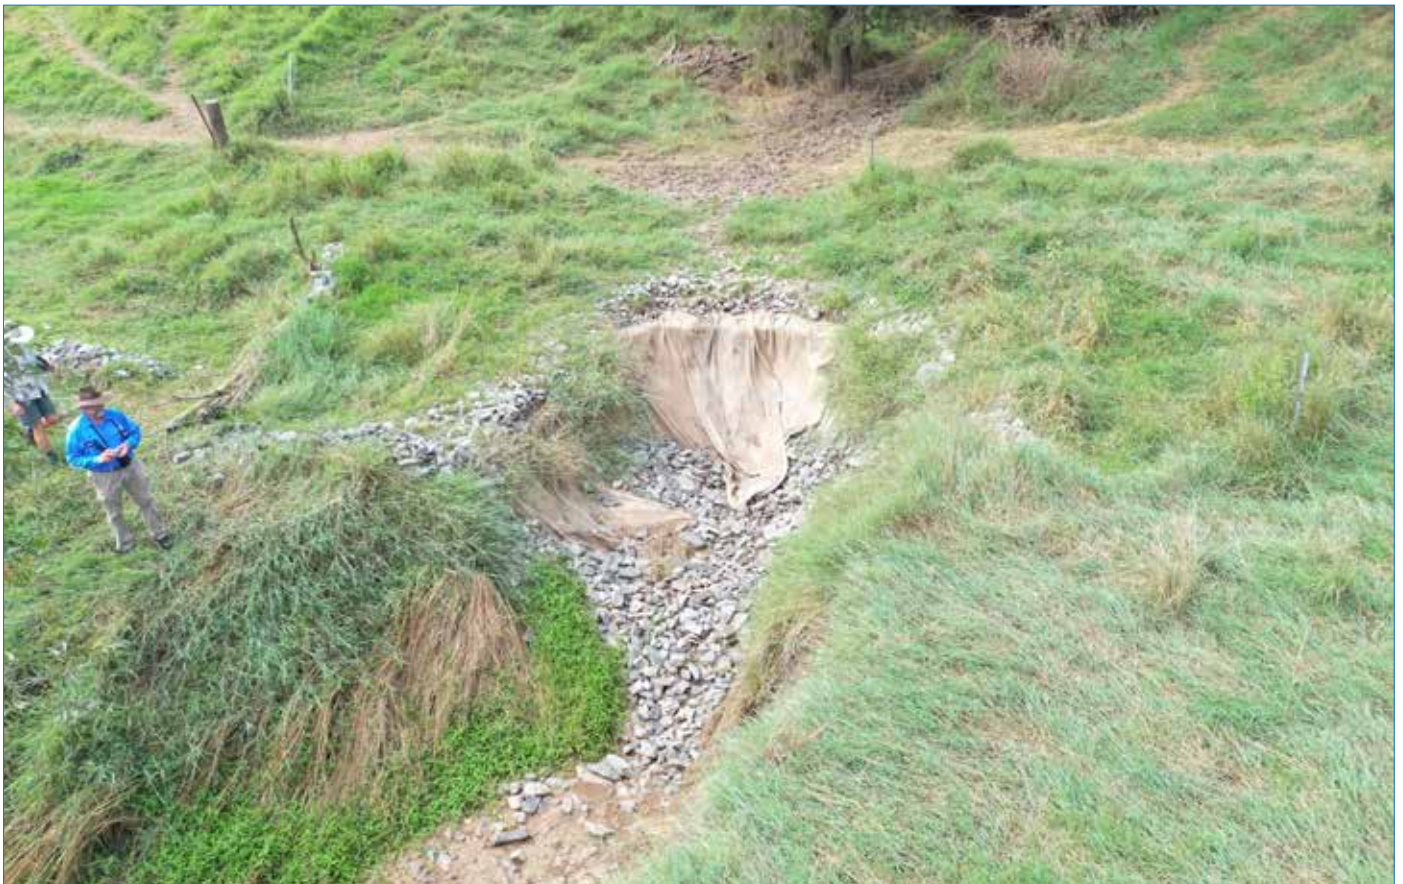
**Photo 128** February 2022, after major flooding in the area.

The wing wall on the left of the gully was repaired with logs and small rock. The repairs remained intact following the 2022 floods.

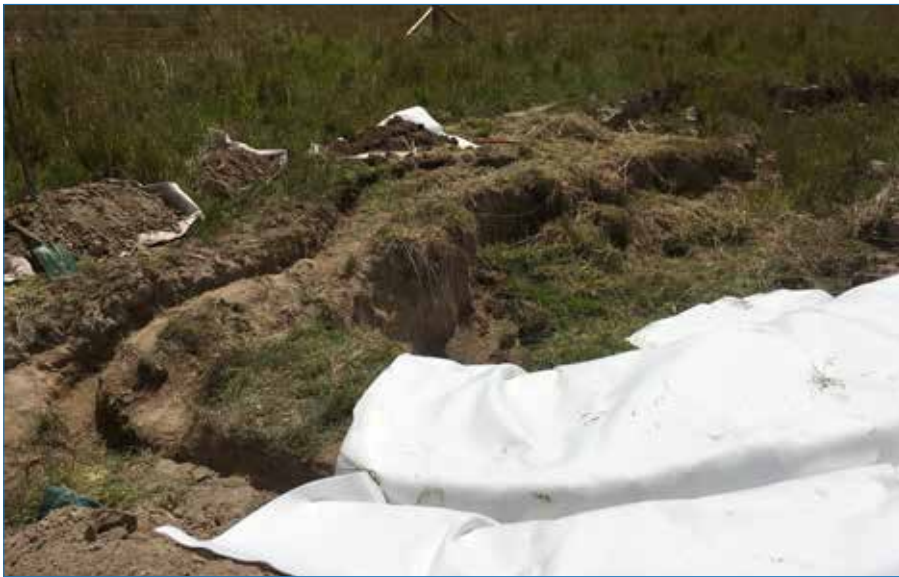
**Photo 130** Dig cut-off trench, following the natural shape of gully head and including the cattle tracks.

Mark out the position of the structure, considering concentrated flow paths and including cattle tracks etc. Dig trench 1 m from the crest edge, to the depth of the spade (approx. 30 cm).

Place the fill on geofabric offcuts (this makes it easy to retrieve later).

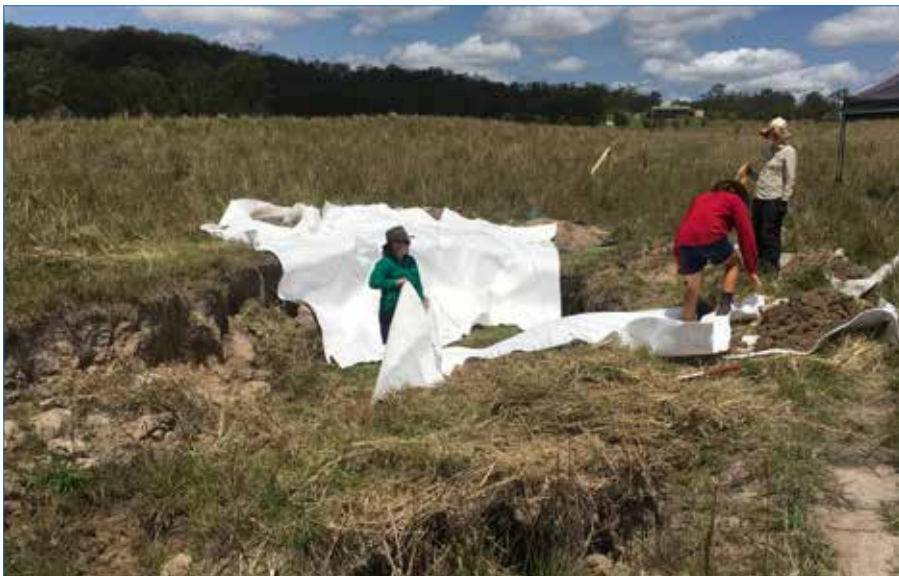
**Photo 131** Geofabric cut and placed over trench and into gully bed.

Cut the geofabric to length. The fabric should start almost at the centre of the gully floor and extend up the walls and into the trench. Cut the geofabric approximately 1 m past the trench to allow enough fabric to double back over the trench once it is filled.

Overlap the fabric starting with the outside layer first, working to the middle. The final middle section should cover the ends of side pieces and cover the length of the gully floor to create a continuous mat.

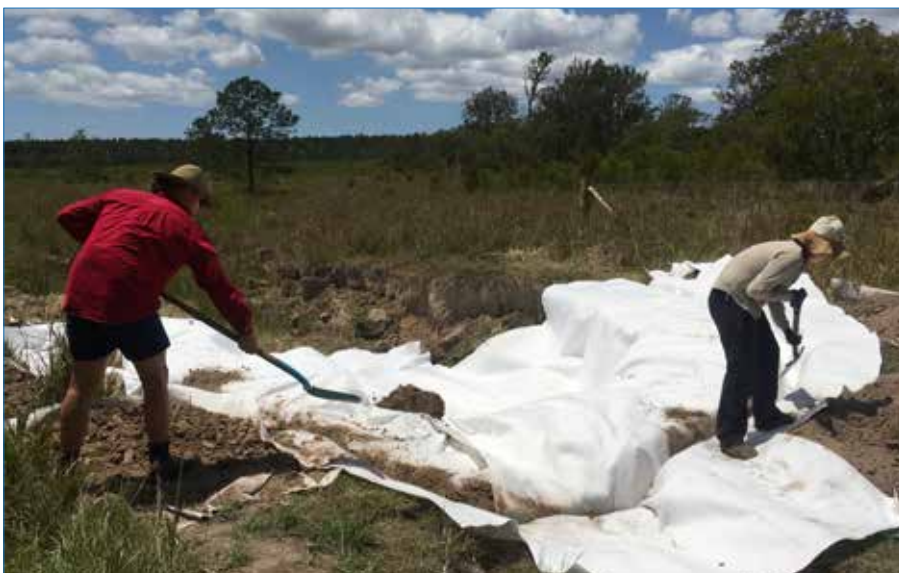
**Photo 132** Backfill the trench with spoil and compact.

Back-fill the trench with spoil and compact as much as possible. Make sure to not overfill as this could divert water away from the structure.

Fold the fabric back over the filled trench, facing downstream.

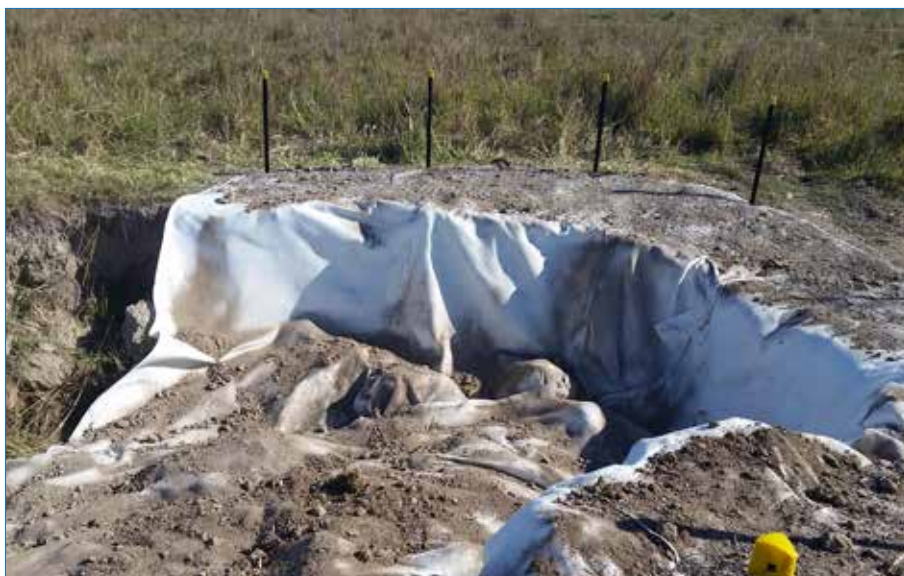
**Photo 133** Mesh secured along the crest and joins stitched.

Lay mesh along the crest, folding pleats to follow the shape with the gully. Peg down the mesh and fabric every ~0.5 m using tent pegs or fabric pins.

Drive star pickets through the edge of the mesh and fabric, into the trench, every 1–2 m.

Stich all the joins of the geofabric with soft wire, securing to the mesh at the top and a tent peg at the bottom of the structure.

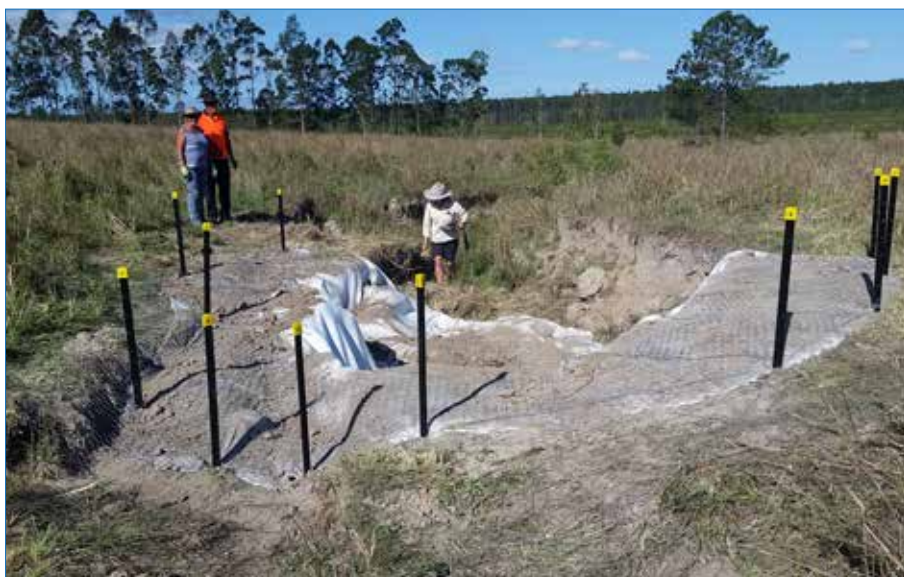
**Photo 134** Tension wire around the crest.

Spread soil and seed over the fabric and bare areas.

Thread a stronger gauge plain wire through the pickets and secure to the picket at each end. Carefully hammer in the star pickets to tension the wire. Without care, the wire can easily snap.

Lightly spread the remainder of the soil onto the fabric and seed with annual grass such as millet in summer or ryegrass in winter. Plant pangola runners in any areas of moisture-holding pools or low points in the gully bed.

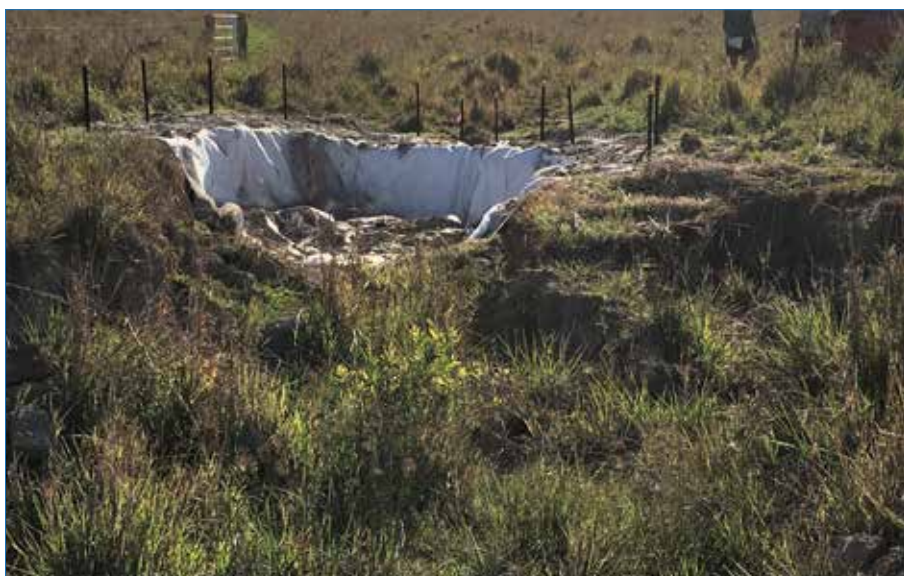
**Photo 135** Completed October 2019.

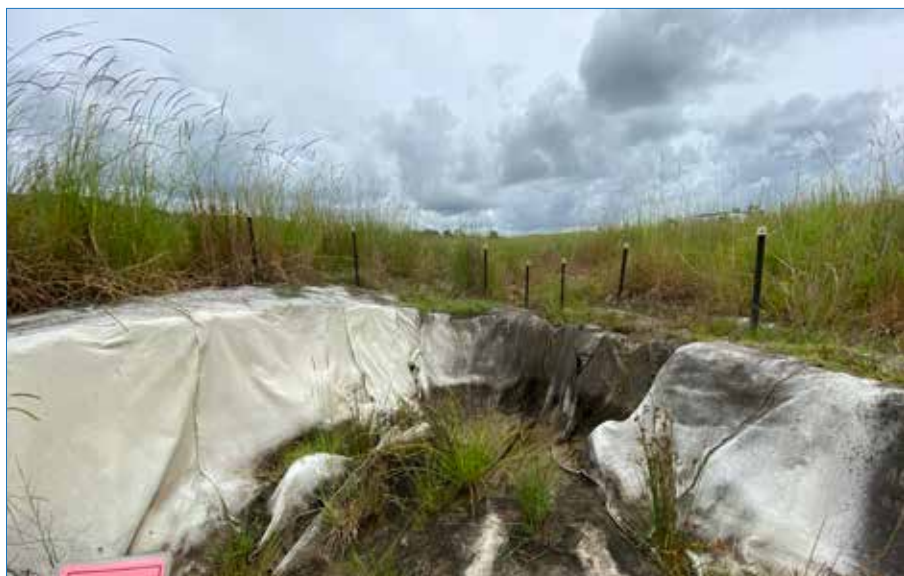
**Photo 136** February 2021 monitoring, following two wet seasons.

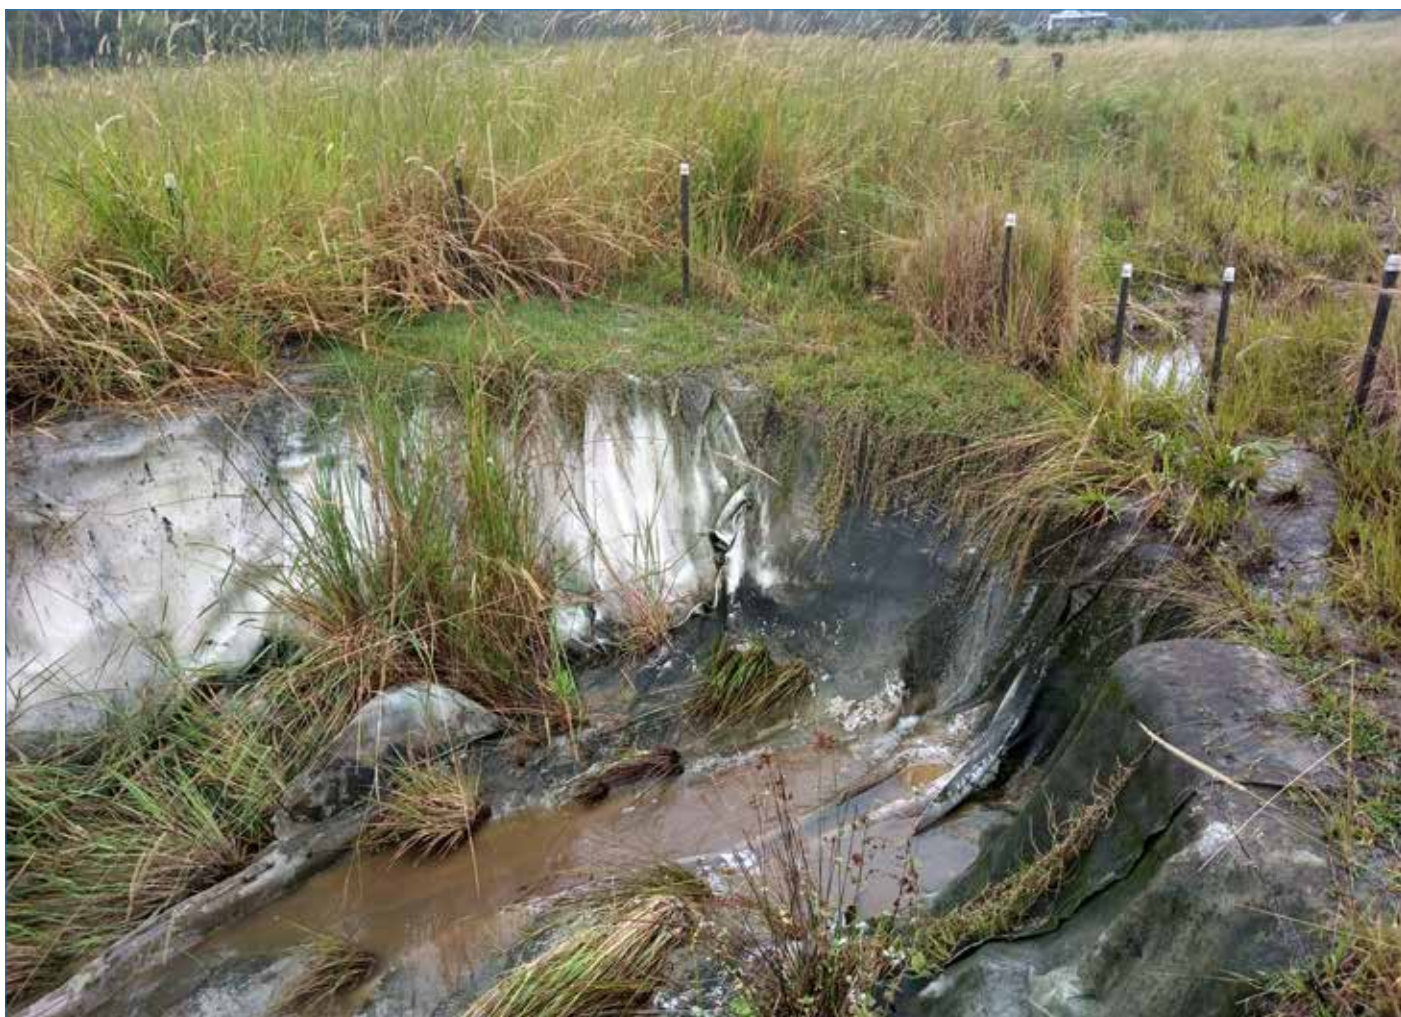
**Photo 137** February 2022 post floods.
