## Mary River Rehabilitation Plan – Gympie Reach

May 2026

This report has been prepared by Alluvium Consulting Australia Pty Ltd for **[Mary River Catchment Coordinating Committee]**

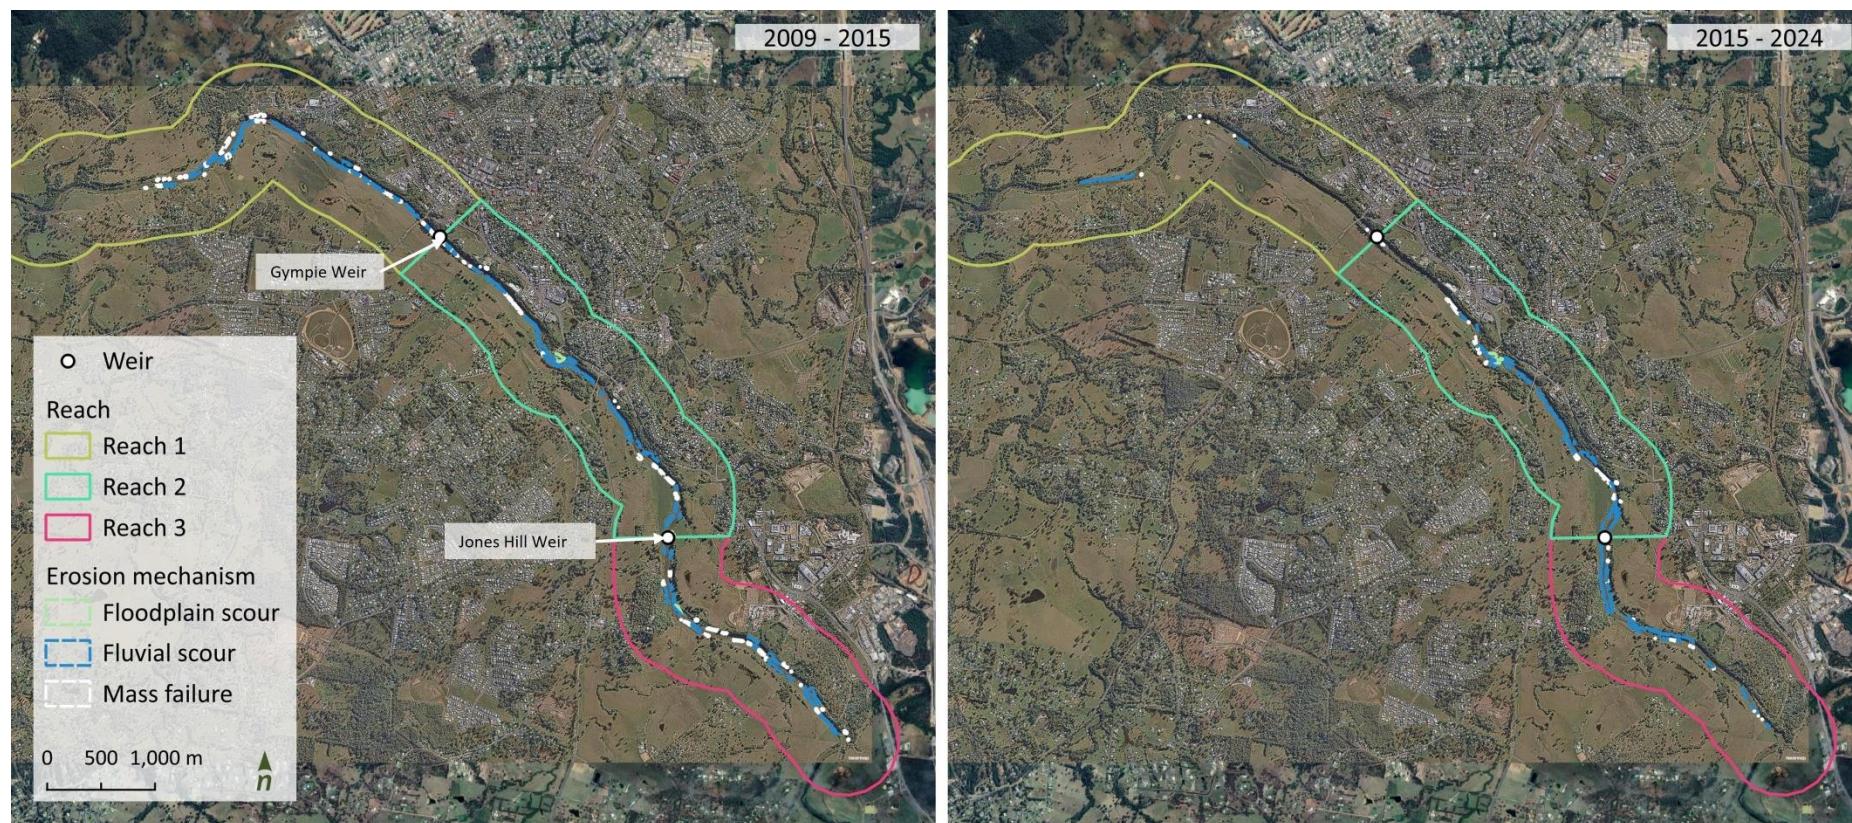
An analysis of the key erosion mechanisms was also undertaken and an overview provided in Figure 15. During Period 1, almost 40% of the total erosion volume came from mass failures and 60 % from fluvial scour. The spatial extent of the erosion was reasonably evenly distributed across the study reach. During Period 2, the total proportion of erosion from mass failures reduced to approximately 20%, and a large proportion of the erosion occurred through the mid to upper reaches (Sub-reach 2 and Sub-reach 3).

**Figure 15.** Erosion mechanisms identified across the study reach between 2009 – 2015 and 2015 - 2024

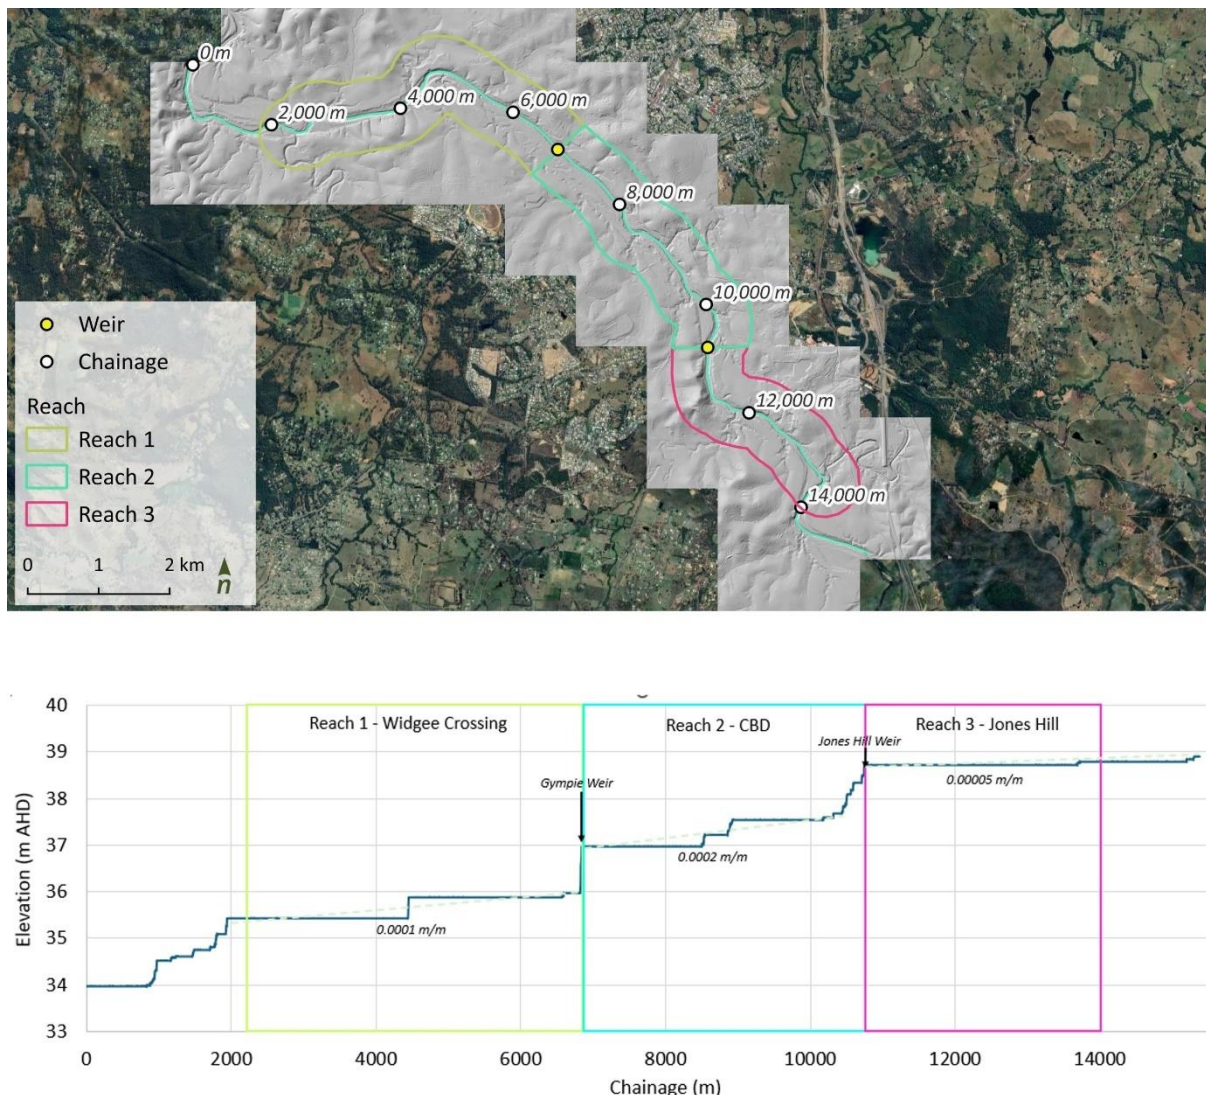
Figure 16. Longitudinal bed grade within the study area

A longitudinal profile has been developed using the 2024 DEM (Figure 16). The bed grade across the upper portion of study reach is controlled by the Gympie Weir and Jones Hill Weir. There is a drop in bed elevation downstream of the study area (Chainage 1,000 – 2,000) of approximately 1.2 m, which appears to be a series of riffles and short pools. It is difficult to see the bed material in the imagery across these riffles and whether there is any underlying bedrock control controlling the bed grade in this location. However recent historic imagery analysis does not suggest any significant adjustment of the location of these riffles which indicates they are likely to be relatively stable. Generally, the overall gradient of the entire study reach is relatively low, approximately 0.0004 m/m. The decrease in bed elevation is largely controlled by the weirs, which have created weir pools.

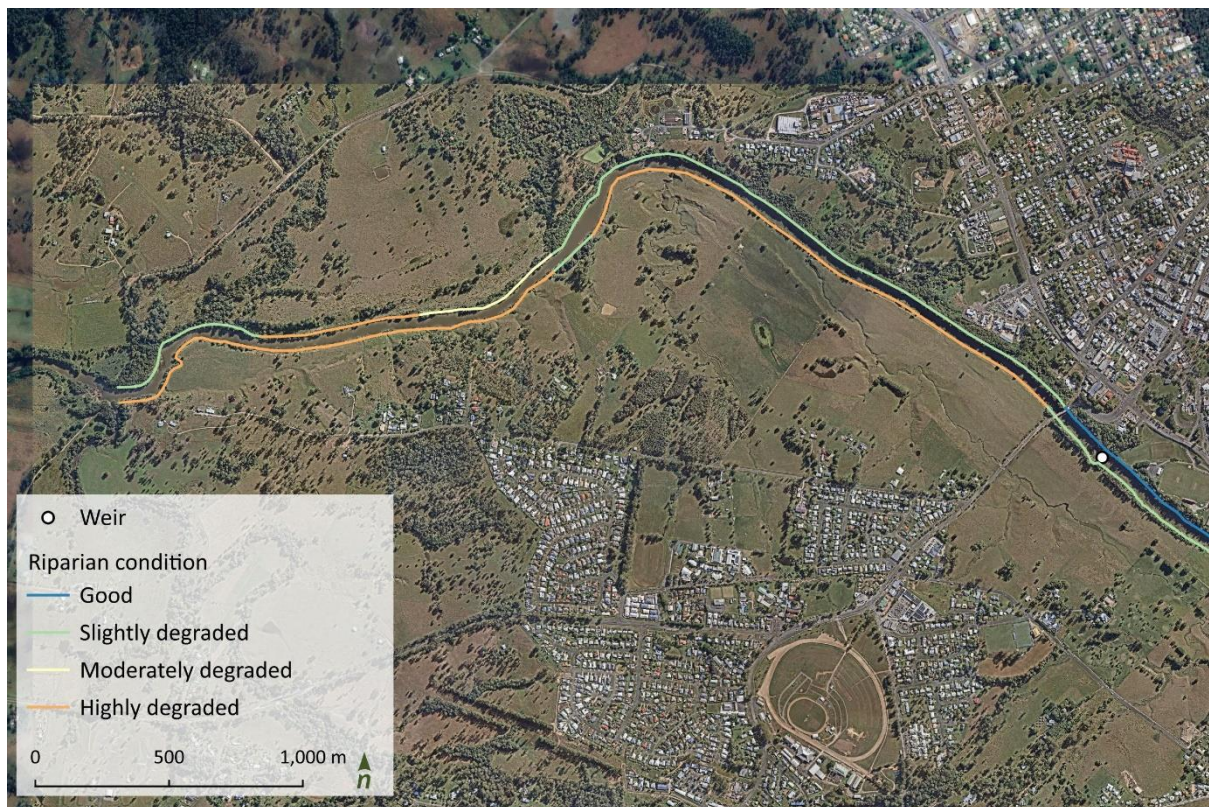
**Figure 22.** *Sub-reach 1 riparian condition*

The riparian condition across Sub-reach 1 is presented below in Figure 22. The riparian condition across the southern side of the channel is highly degraded. The riparian zone is largely devoid of any canopy or shrub species and the bank is either exposed or covered in pasture grasses. The riparian vegetation extent of the northern bank through the upstream half of the reach is typically good; however, it was classified as slightly degraded due to known Cat's Claw vine weed infestations, particularly near the large meander, with Chinese Elm also present throughout. The riparian extent of the northern bank at the downstream end becomes fragmented and has been classified as slightly or moderately degraded. Typical examples of the varying riparian conditions found in Sub-reach 1 is provided below in Figure 23 and Figure 24.

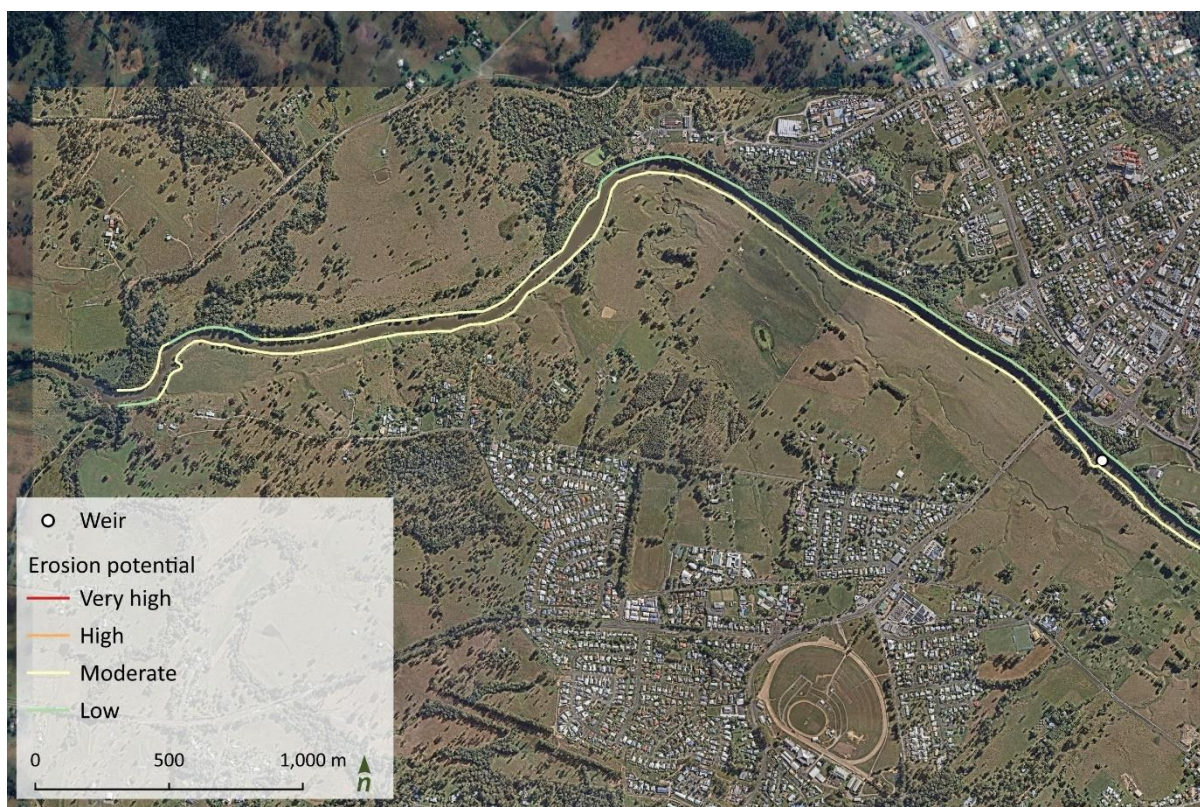
**Figure 25.** *Sub-reach 1 erosion potential*

The erosion potential across Sub-reach 1 is presented below in Figure 25. The erosion potential was classified as Low on the northern bank at the upstream extent as the channel is significantly confined by the terrace margins, there is reasonable existing riparian vegetation extent and there has been minimal historic erosion. The majority of the southern bank and lower portion of the right bank was classified as moderate erosion potential. The channel abuts the grazed floodplain through these sections and there is limited existing riparian vegetation. There is currently unrestricted stock access to the banks, which can result in increased erosion risk through pre-weakening or sub-aerial preparation and limits the chance of natural vegetation regeneration. Some erosion is likely in future flood events either through wet flow failures or fluvial scour. Vegetation may be able to reduce the likelihood of erosion. An example of a section of the southern bank with a moderate erosion potential is presented below in Figure 26.

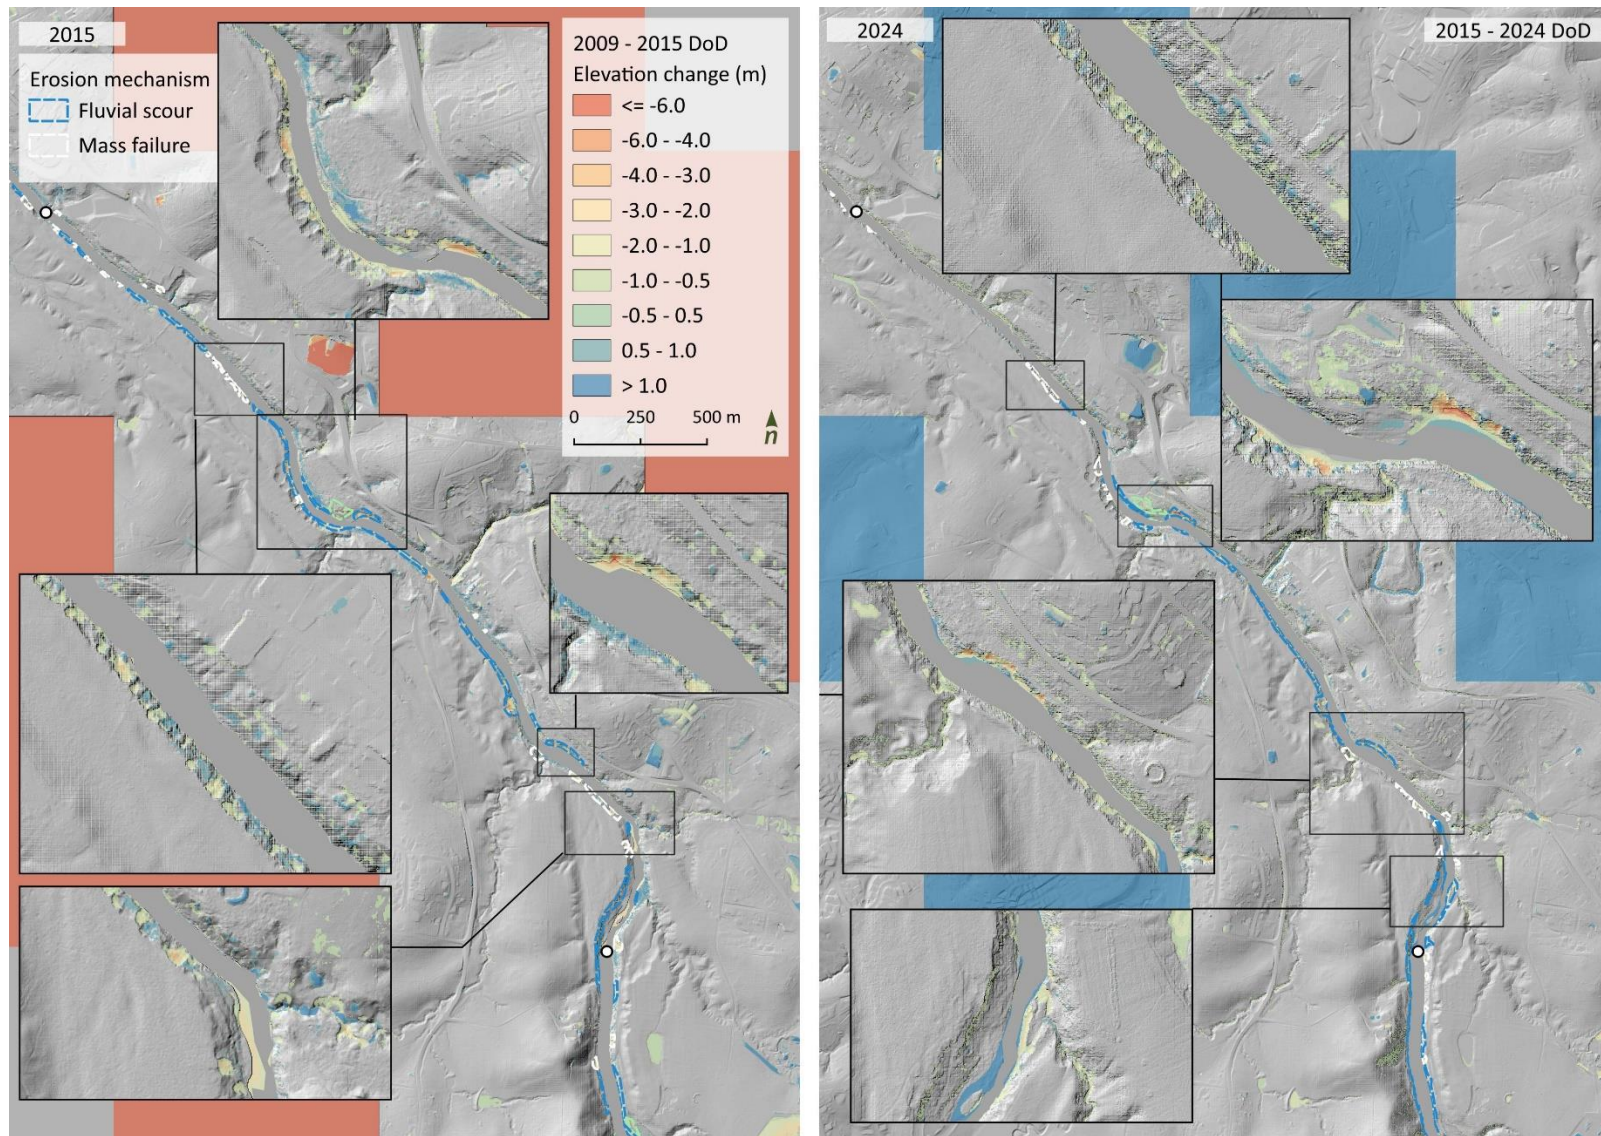
A summary of the erosion rates and mechanisms between 2009 -2015 (Period 1) and 2015 – 2024 (Period 2) is presented in Table 7. The erosion rate in Period 1 (6,056 m<sup>3</sup>/year) was significantly higher than in period 2 (3,308 m<sup>3</sup>/year). Fluvial scour was the dominant erosion process across Sub-reach 2, accounting for approximately 75% of the total erosion volume between 2009 and 2024. It is estimated that approximately 20 % of the total erosion volume across Sub-reach 2 came from the two meander migration sites discussed above.

**Figure 30.** Multi-temporal LiDAR analysis across Sub-reach 2– 2009 – 2015 DoD (left), 2015 – 2024 DoD (right)

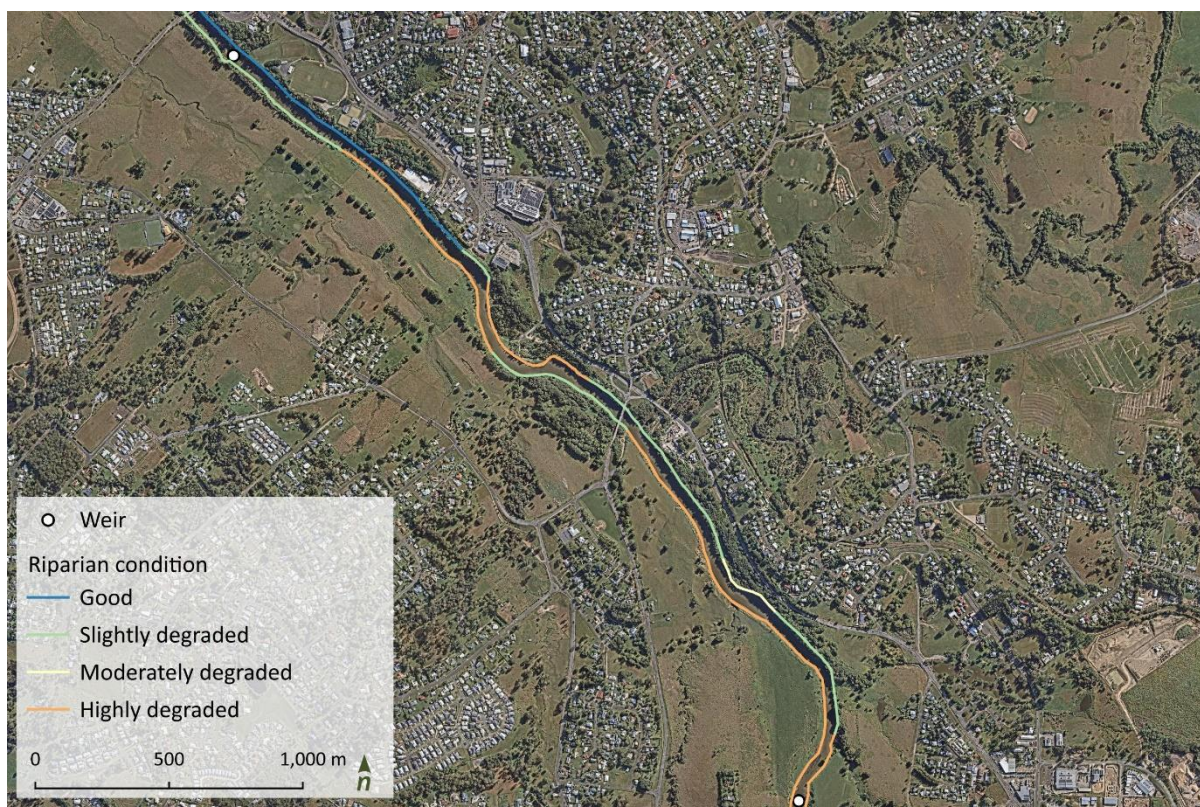
**Figure 34.** *Sub-reach 2 riparian condition*

The riparian condition across Sub-reach 2 is presented below in Figure 34. The riparian condition across the southern side of the channel is typically highly degraded however there are two sections where the vegetation extent increases and has been classified as slightly degraded, these are located immediately downstream of the Mary Valley Road Bridge and immediately upstream of the Gympie Weir. The riparian vegetation extent of the northern bank downstream of the Sands is typically good however is fragmented by the public track along the lower bank. The riparian condition at the Sands is highly degraded with limited existing vegetation. Upstream of the Sands the condition has been classified as slightly degraded as there is known Cat's Claw vine weed infestations and Chinese Elm throughout. Typical examples of the varying riparian conditions found in Sub-reach 2 is provided below in Figure 35 and Figure 36.

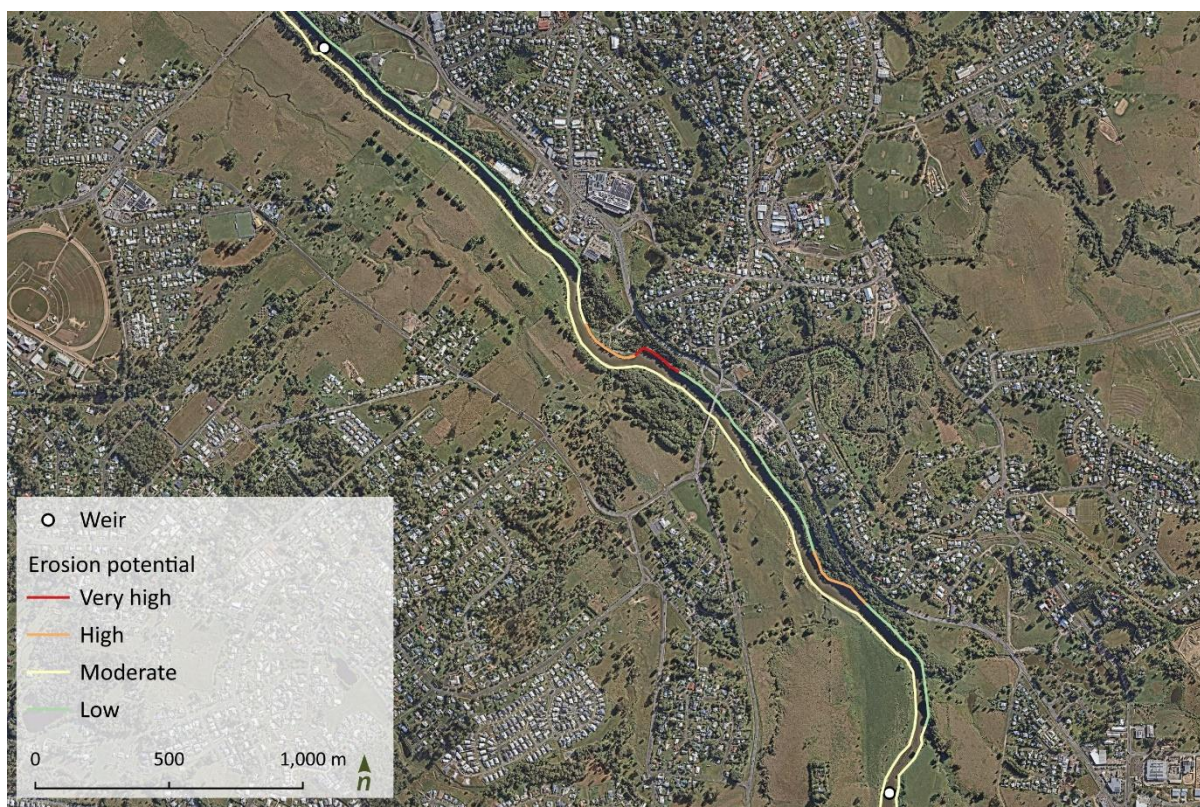
Figure 37. Sub-reach 2 erosion potential

The erosion potential across Sub-reach 2 is presented below in Figure 37. The erosion potential has generally been classified as low on the northern bank except for the two locations where there is active meander migration occurring and the erosion potential has been classified as High or Very High. Outside of these locations the channel is significantly confined by the terrace margins, there is reasonable existing riparian vegetation extent, and there has been minimal historic erosion. The majority of the southern bank and upstream portion of the northern bank was classified as Moderate erosion potential. The channel abuts the grazed floodplain through these sections and there is limited existing riparian vegetation. There is currently some stock fencing on the southern bank downstream of Normanby Bridge however limited riparian fencing upstream of the bridge. In the absence of management intervention erosion is likely in future flood events, either through wet flow failures or fluvial scour. Vegetation may be able to reduce the likelihood of erosion along much of the southern bank. Isolated bank toe stabilisation works will likely be required at meander migration sites to limit ongoing erosion (see Figure 38 and Figure 39).

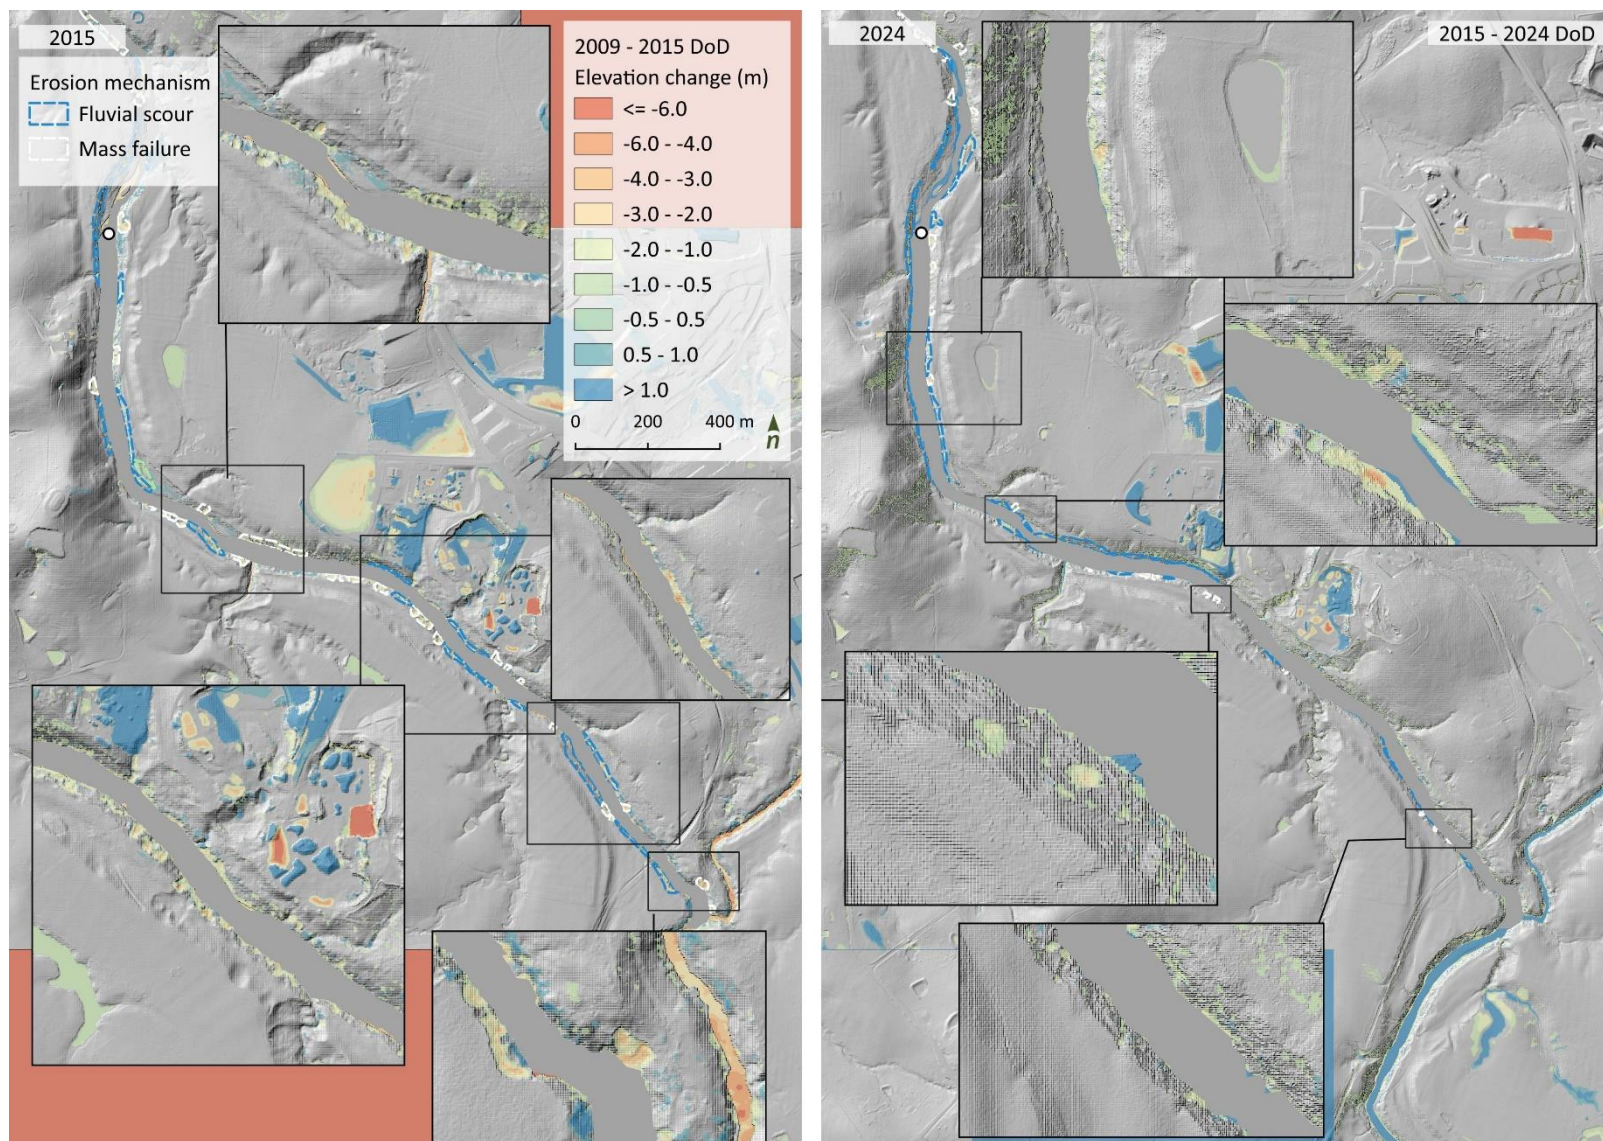
**Figure 43.** Multi-temporal LiDAR analysis across Sub-reach 3 – 2009 – 2015 DoD (top), 2015 – 2024 DoD (bottom)

Multi-temporal LiDAR analysis was undertaken for two periods between 2009 and 2024 (Figure 43). The analysis shows that there was relatively widespread erosion of the floodplain units on both sides of the channel. The erosion identified was a combination of mass failures or 'wet flow failures' and fluvial scour, there was no significant planform adjustment or bank retreat identified through the reach.

A summary of the erosion rates and mechanisms between 2009 -2015 (Period 1) and 2015 – 2024 (Period 2) is presented below in Table 8. The erosion rate in period 1 (5,081 m<sup>3</sup>/year) was significantly higher than in Period 2 (1,510 m<sup>3</sup>/year). During Period 1, mass failures accounted for approximately 40 % of the total erosion whereas in Period 2 accounted for approximately 15%. The fluvial scour identified typically included surficial scour of the exposed lower and mid-banks however, there was minimal significant retreat of the toe of the bank.

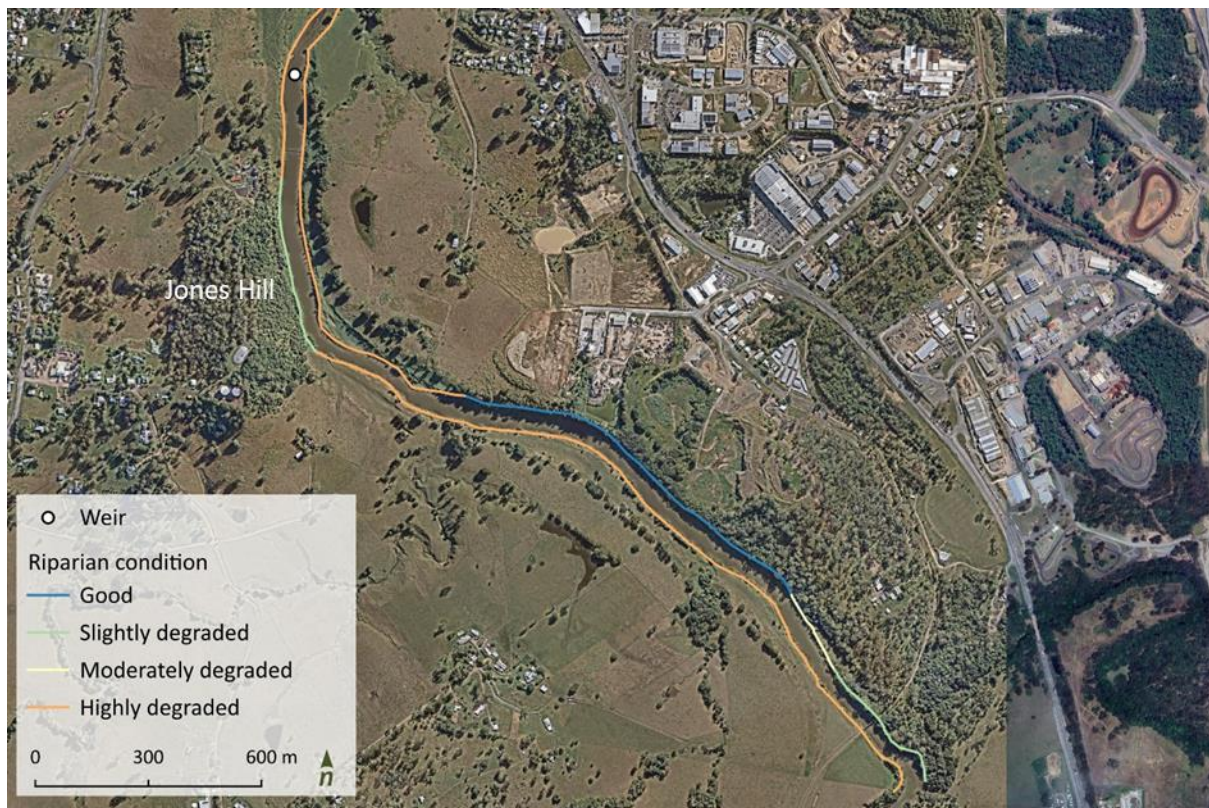
**Figure 44.** *Sub-reach 3 riparian condition*

The riparian condition across Sub-reach 3 is presented below in Figure 44. The riparian condition across the southern side of the channel is typically highly degraded, however there is a patch of reasonable vegetation at the base of Jones Hill where the Gympie town water supply is extracted and treated (see Figure 45). The riparian vegetation extent of the northern bank upstream of The Sands is typically good through the upper half of the reach however there is a known presence of Cat's claw vine and Chinese Elm near the confluence of Six Mile Creek. The downstream portion of the northern bank is highly degraded with no existing riparian vegetation present (see Figure 46).

Appropriate rehabilitation options could include riparian fencing for stock management, weed control and widespread revegetation works, which aim to increase the density and width of woody vegetation across the Sub-reach, expanding on patches of existing vegetation. Generally, works within highly degraded reaches should be implemented across a significant length of the Sub-reach (i.e. not an isolated site) to help improve recovery potential and desired riparian functions.

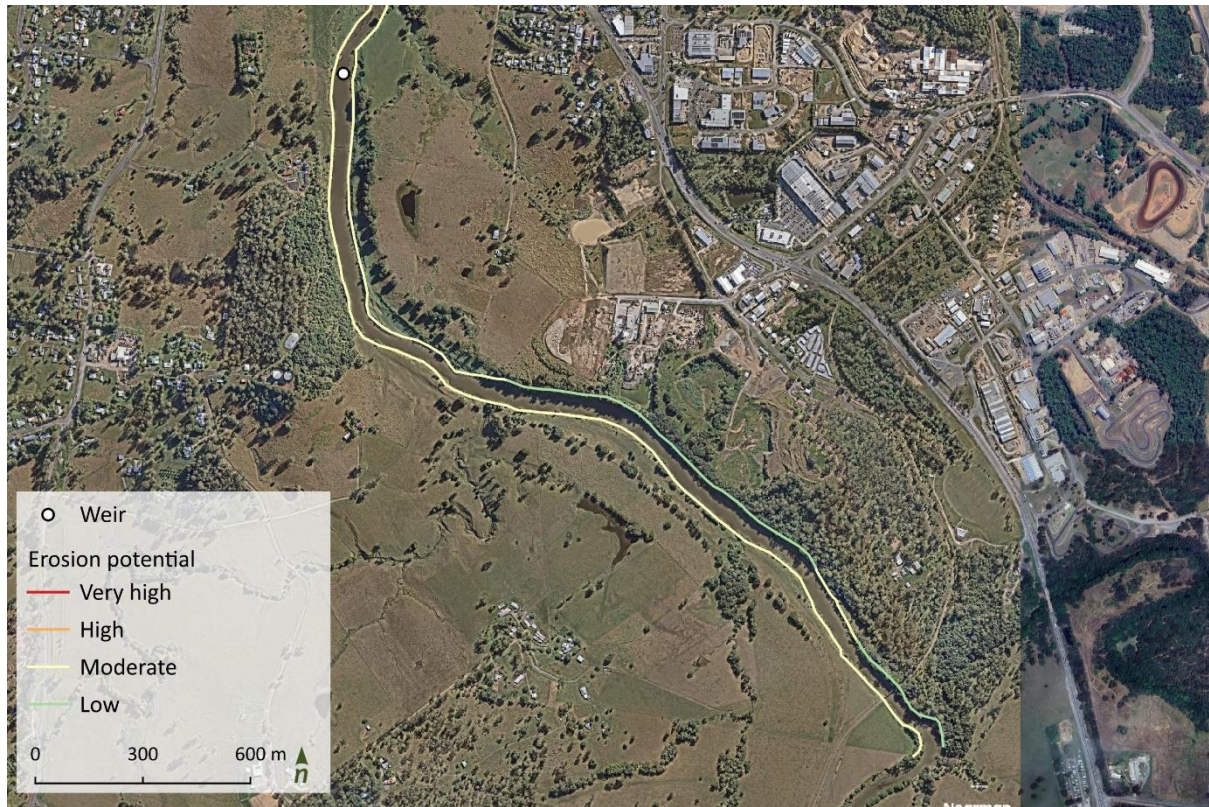
**Figure 47.** *Sub-reach 3 erosion potential*

The erosion potential across Sub-reach 3 is presented below in Figure 47. The erosion potential was classified as Low on the northern bank at the upstream extent as there is reasonable existing riparian vegetation extent and there has been minimal historic erosion. The majority of the southern bank and lower extent of the northern

bank was classified as having Moderate erosion potential. The channel abuts the grazed floodplain through these sections and there is limited existing riparian vegetation. There is currently large areas of unrestricted stock access to the banks, which can result in increased erosion risk through pre-weakening or sub-aerial preparation, and limits the chance of natural vegetation regeneration. Some erosion is likely in future flood events either through wet flow failures or fluvial scour. Vegetation may be able to reduce the likelihood of future erosion. An example of a section of bank with a moderate erosion potential is presented in Figure 48.

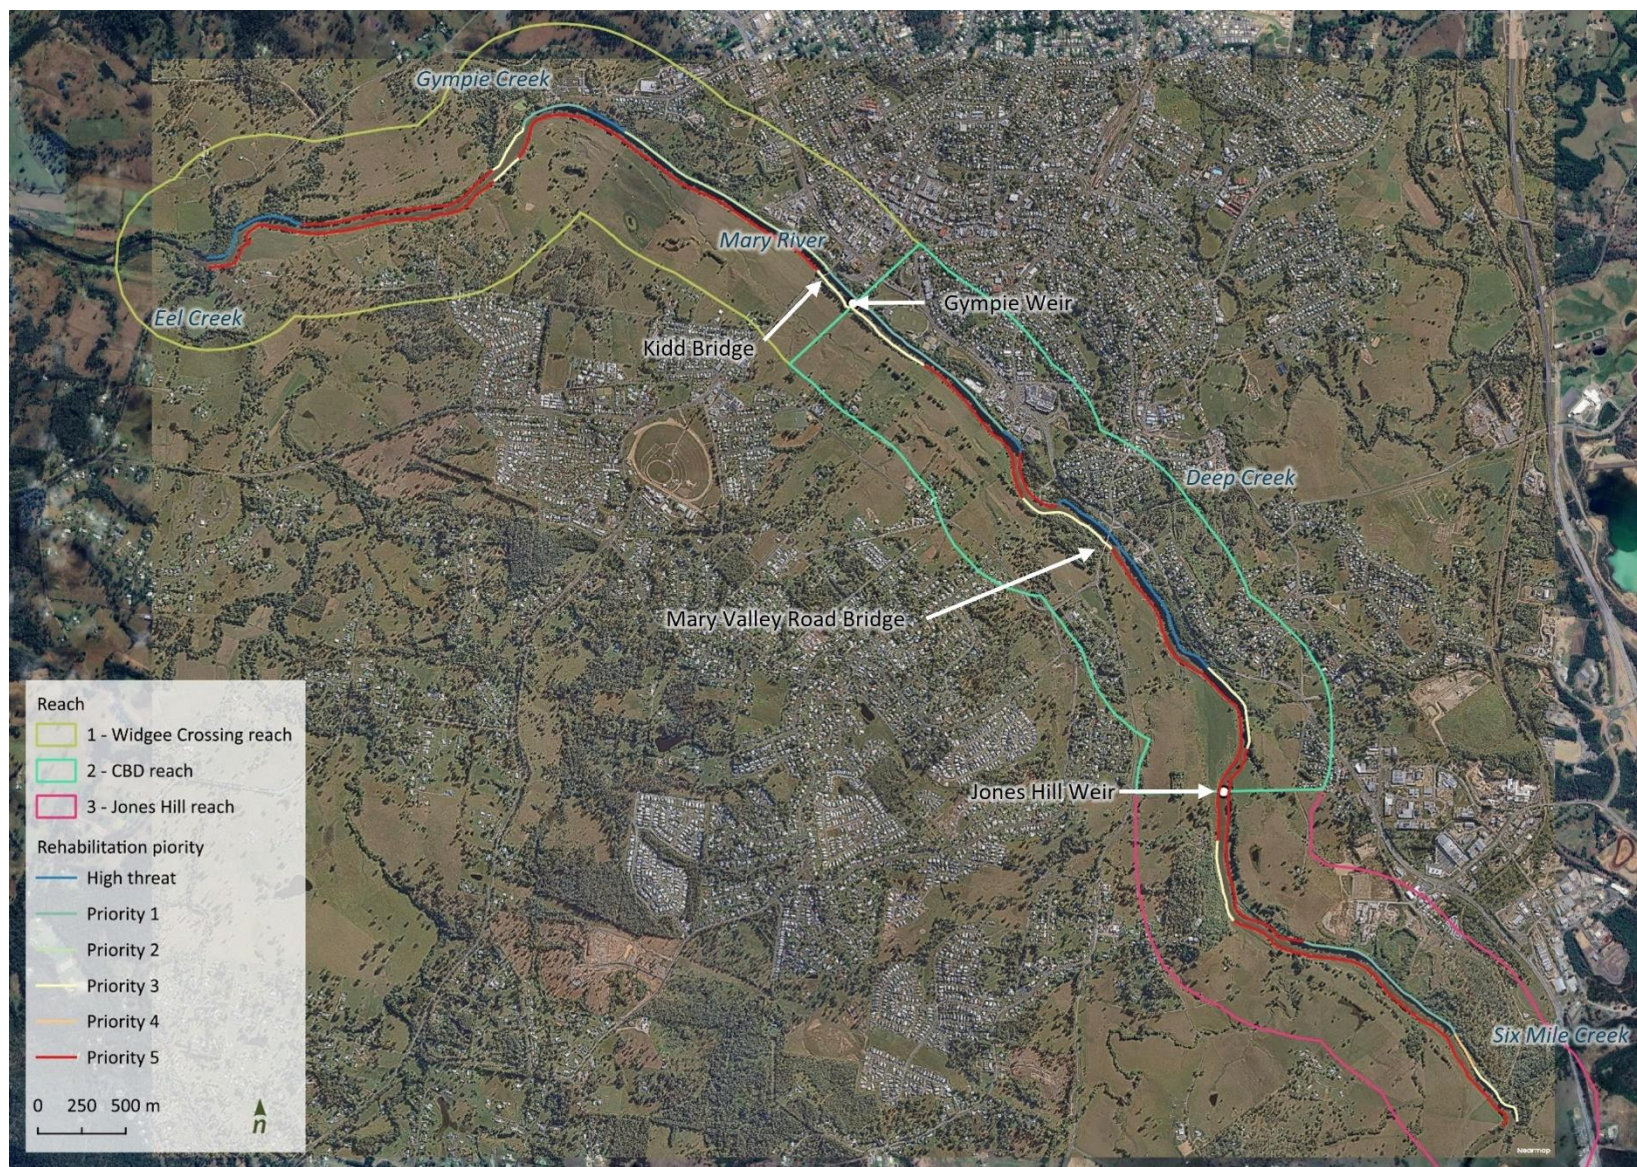
Figure 56. Overview of rehabilitation prioritisation across the study reach

The prioritisation approach was applied to the Sub-reaches delineated above based on the existing riparian condition. The results of the prioritisation for rehabilitation works across the study reach is presented below in Figure 56.
