**IMPLEMENTING THE MARY RIVER
& TRIBUTARIES
REHABILITATION PLAN**

**MONITORING & EVALUATION REPORT
2003**

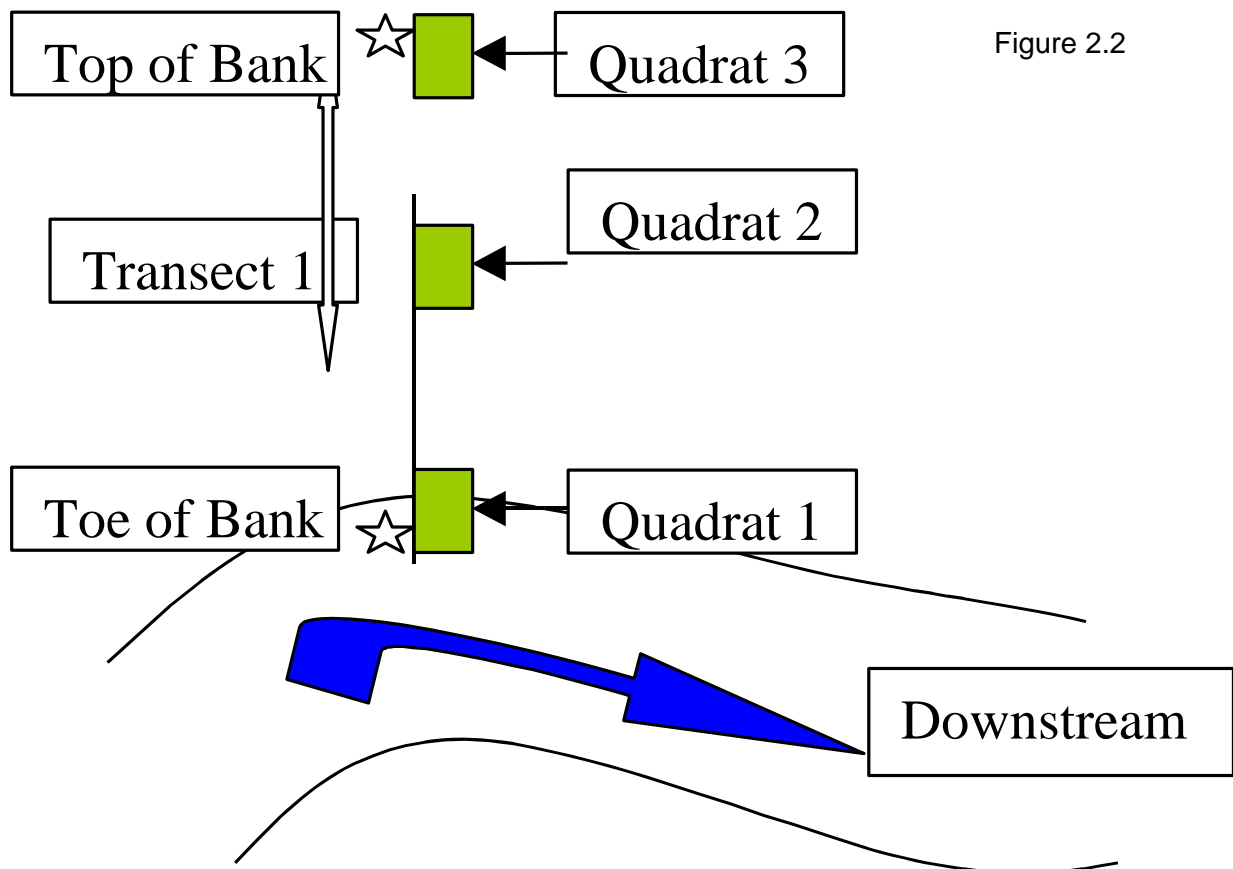
Figure 2.2

- 1) Tape measure is laid out between the star pickets to provide a straight line to base the quadrats on.
- 2) GPS location at the toe of the bank is recorded. Three, five metre by three metre quadrants are located along the transect on the downstream side (see figure 2.2).
- 3) Quadrant 1 was located at the toe of the bank, the second in the middle and the third at the top of the streamside zone.
- 4) Plants that affect the quadrant through shading or protection from wind are to be included as part of the quadrant. If all the plants surrounding the quadrant were removed a very different result would be recorded. A specimen of any plant species not known is to be taken for identification by a botanist, recording the date, location, and name of the collector on a bag containing the specimen. Recording species A, B, etc., on the data sheet and on the bag ensures accurate data collection.

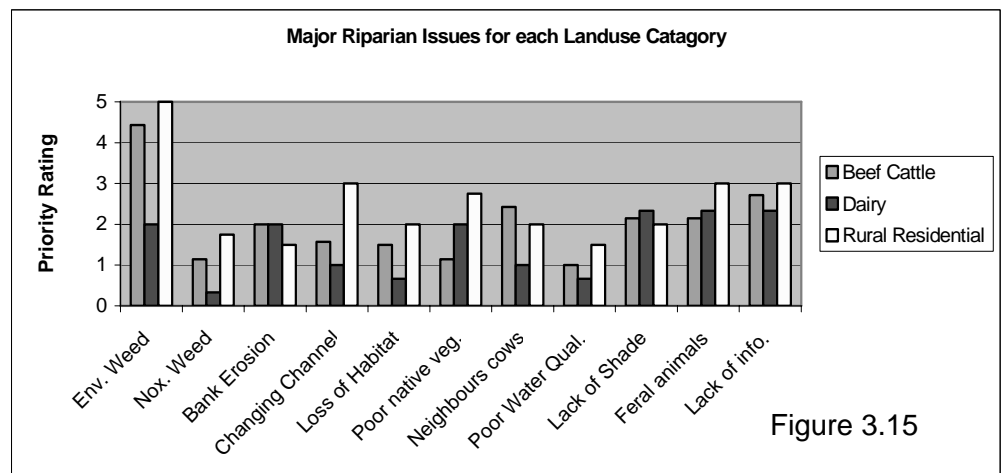
Figure 3.15 uses the same information gathered by the survey (represented in Figure 3.14) but looks at the priority of concerns for each of the three separate land uses. This was performed to investigate any differences in priority riparian issues between the three groups. The figure shows that the Dairy farmers surveyed were least concerned with the issues of environmental weeds and loss of native habitat, but were however, most concerned regarding the issue of lack of shade. Figure 3.15 also suggests that the Rural Residential landholders felt the most strongly about the ecological health of their streams.
