Gympie – Amamoor & Eastern Mary River Catchment Waterwatch Report 2012 – 2013

Report prepared by: Brad Wedlock, Steve Burgess MRCCC Catchment Officers October 2013

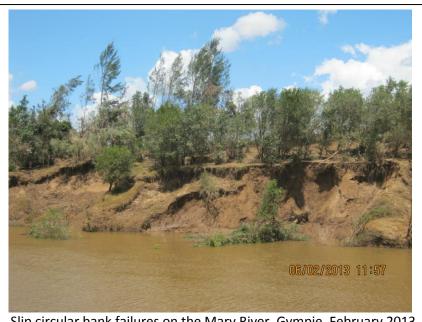
Slip circular bank failures on the Mary River, Gympie, February 2013

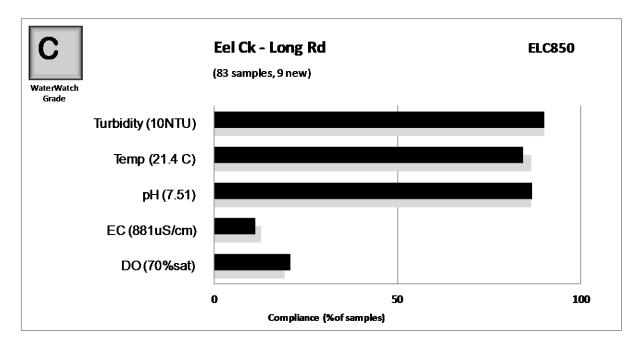
- Good sample size
- Consistently higher electrical conductivity (salinity) levels than Amamoor and Deep Creeks
- This year the site has maintained good compliance for turbidity, temperature and pH values
